Re: Backfill Request 1RP-5091  
Former DCP Pump Station Historical Release  
Legal: Unit F, Sec 4, T22S R36E, Lea County, NM  
Latitude/Longitude: 32.422898/ -103.274162  
Etech Proj. Number: 876-9521-000  
Depth to Groundwater: 200-275 feet - Chevron/Texaco Lea County Depth to Groundwater Map  
- OSE NM Water Rights Reporting System

Etech Environmental & Safety Solutions, Inc. (Etech) is submitting the following corrective action plan on the aforementioned site for your review and approval.

Former DCP Pump Station Historical Release

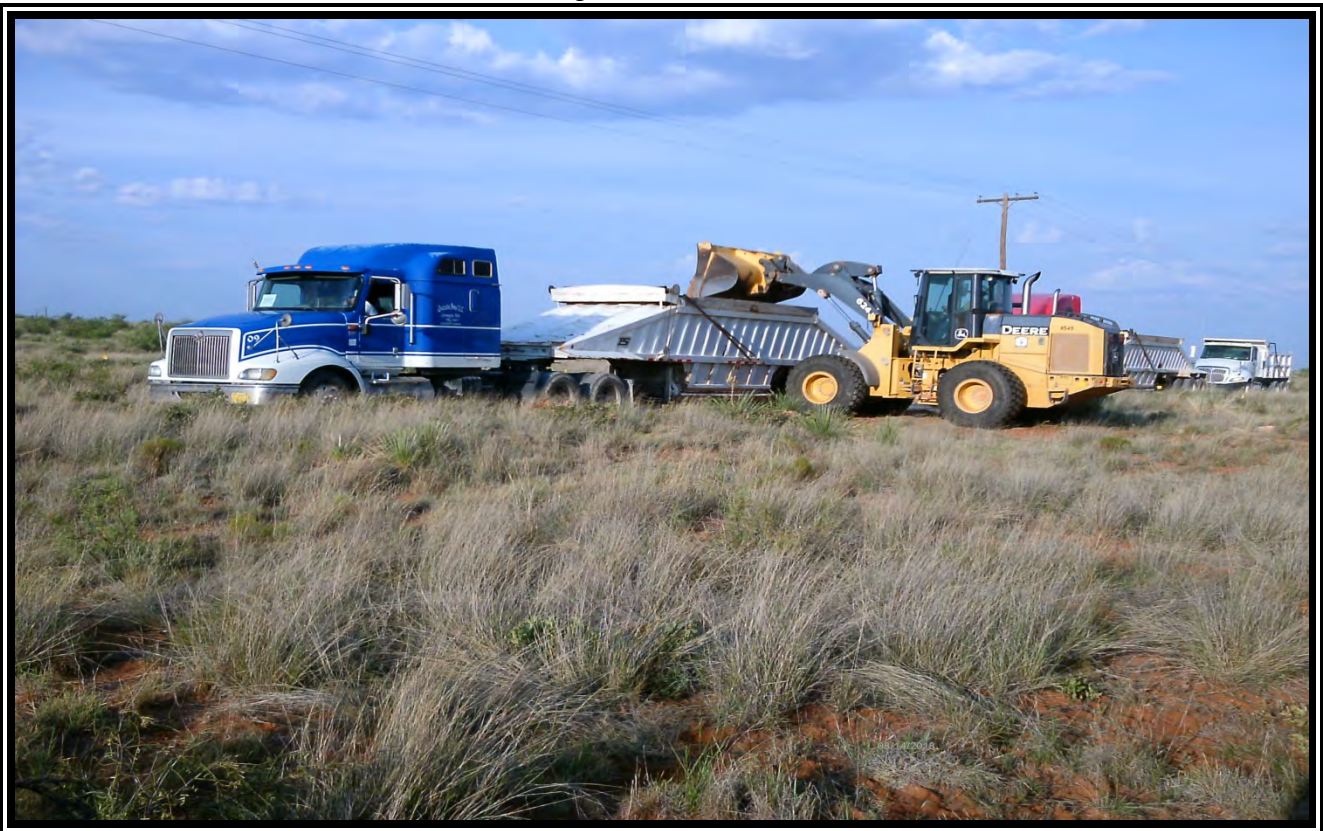
Loading excavated soil into dump trucks looking southwest.

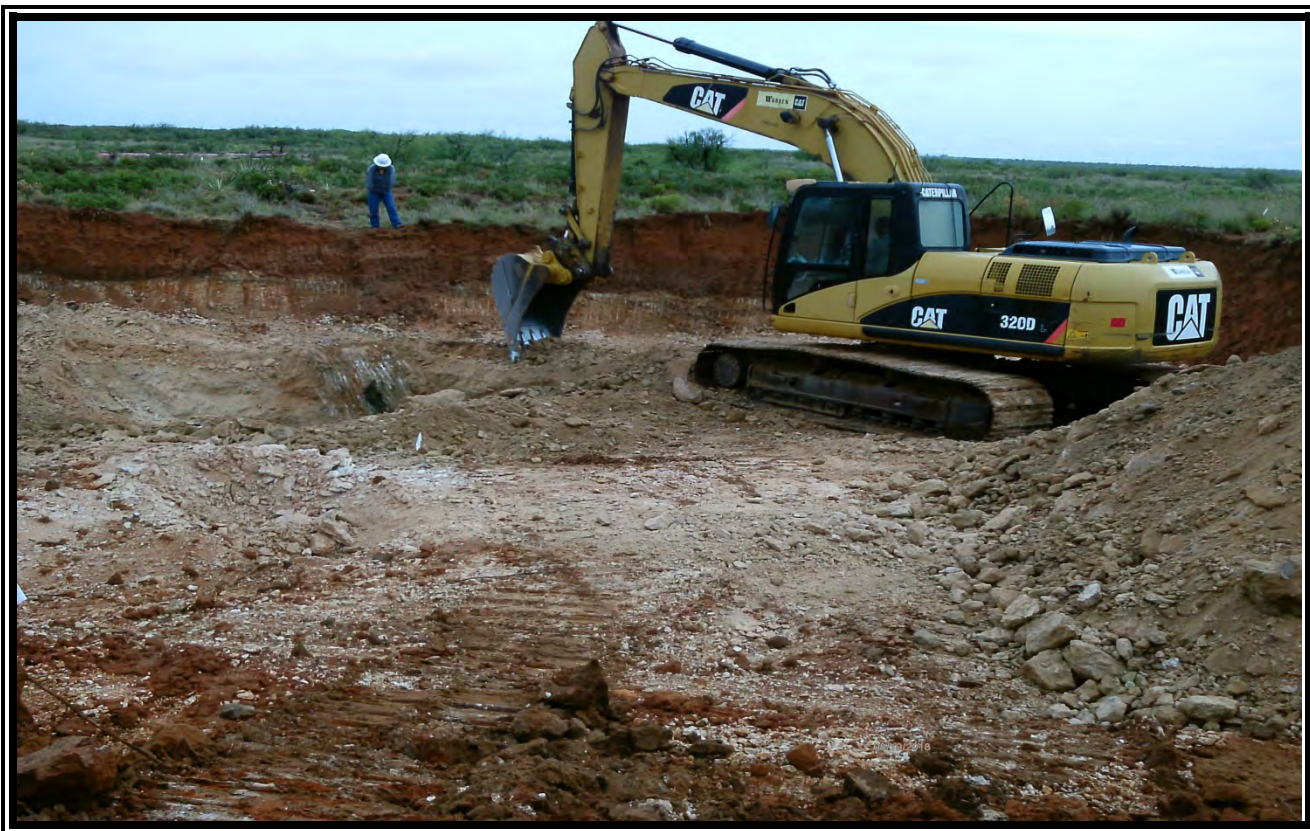
Excavating discolored area in northwest portion of site looking southwest.

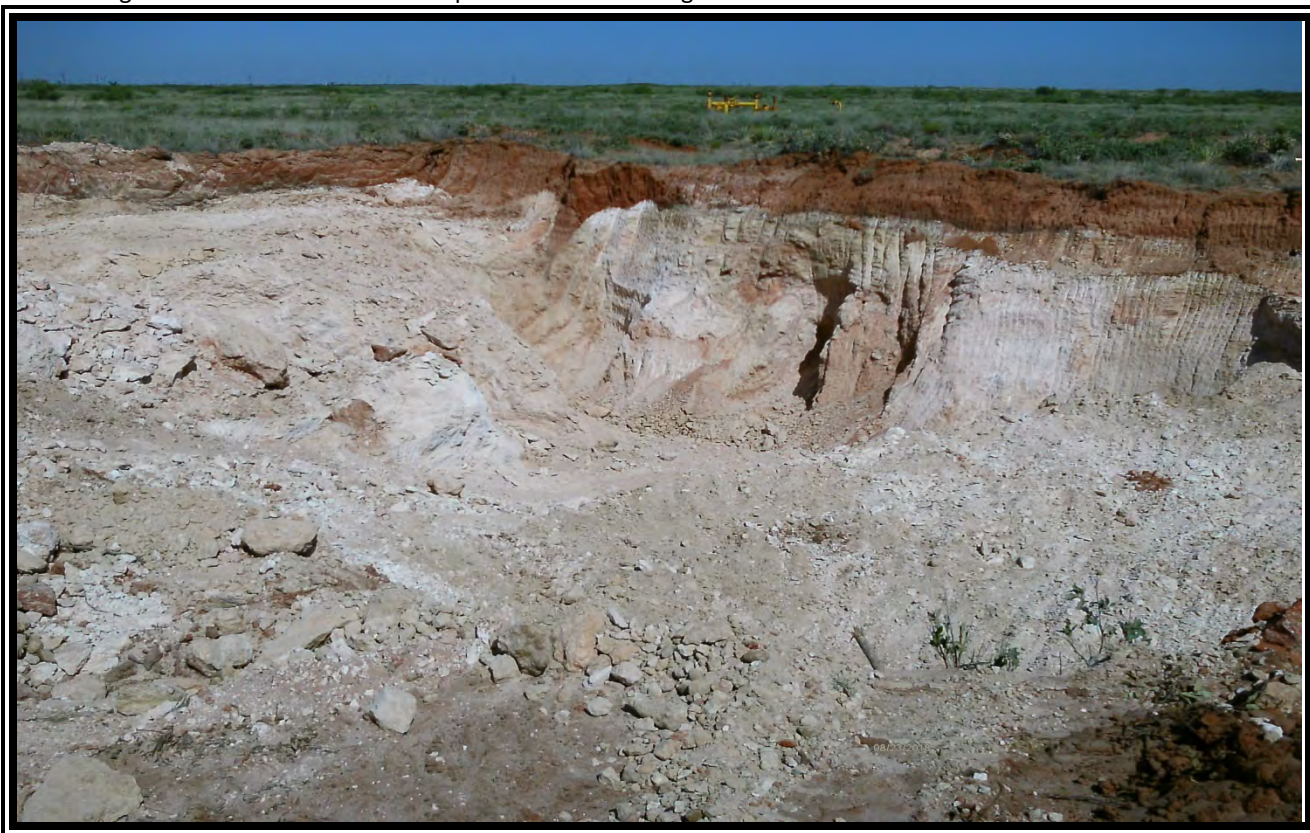
Northwest portion of excavation looking northwest.

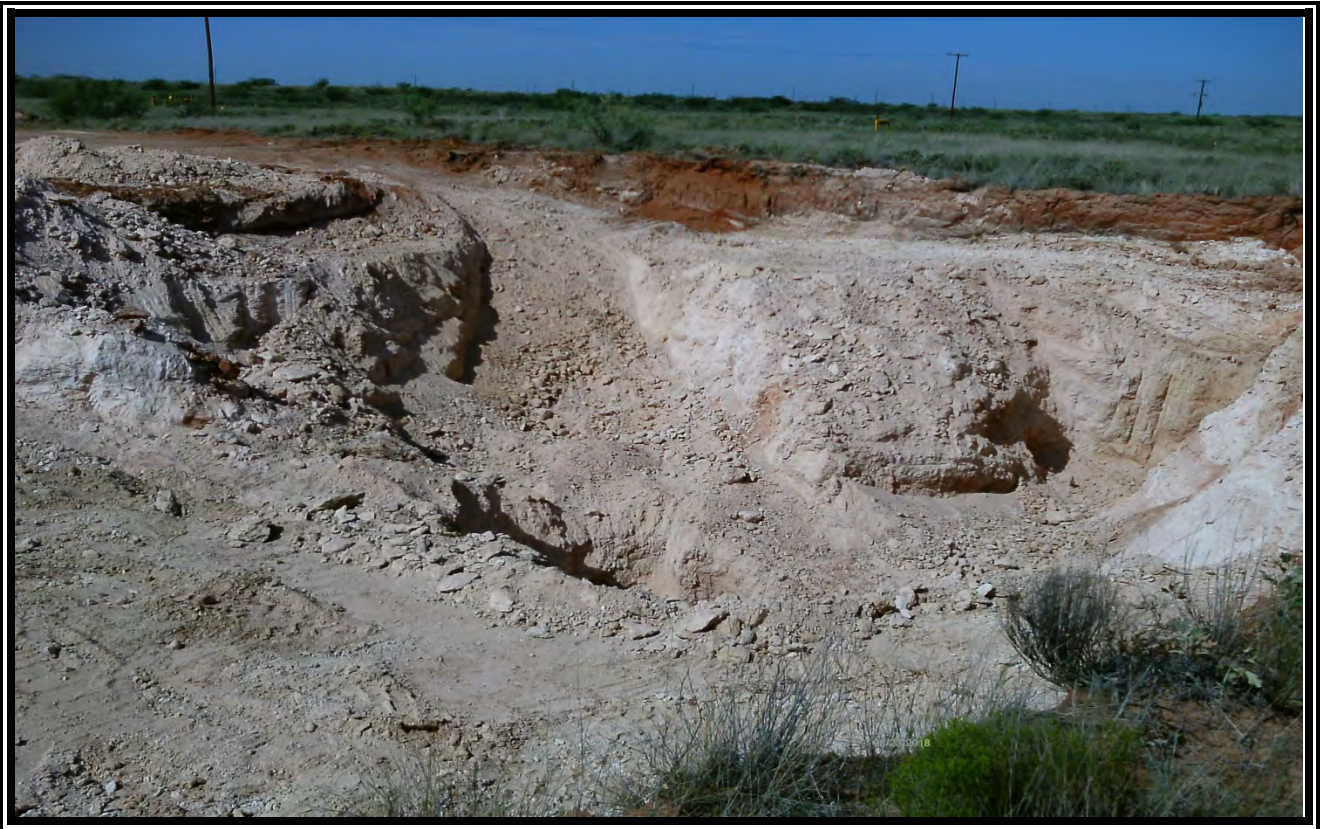
Northwest portion of excavation looking southwest.

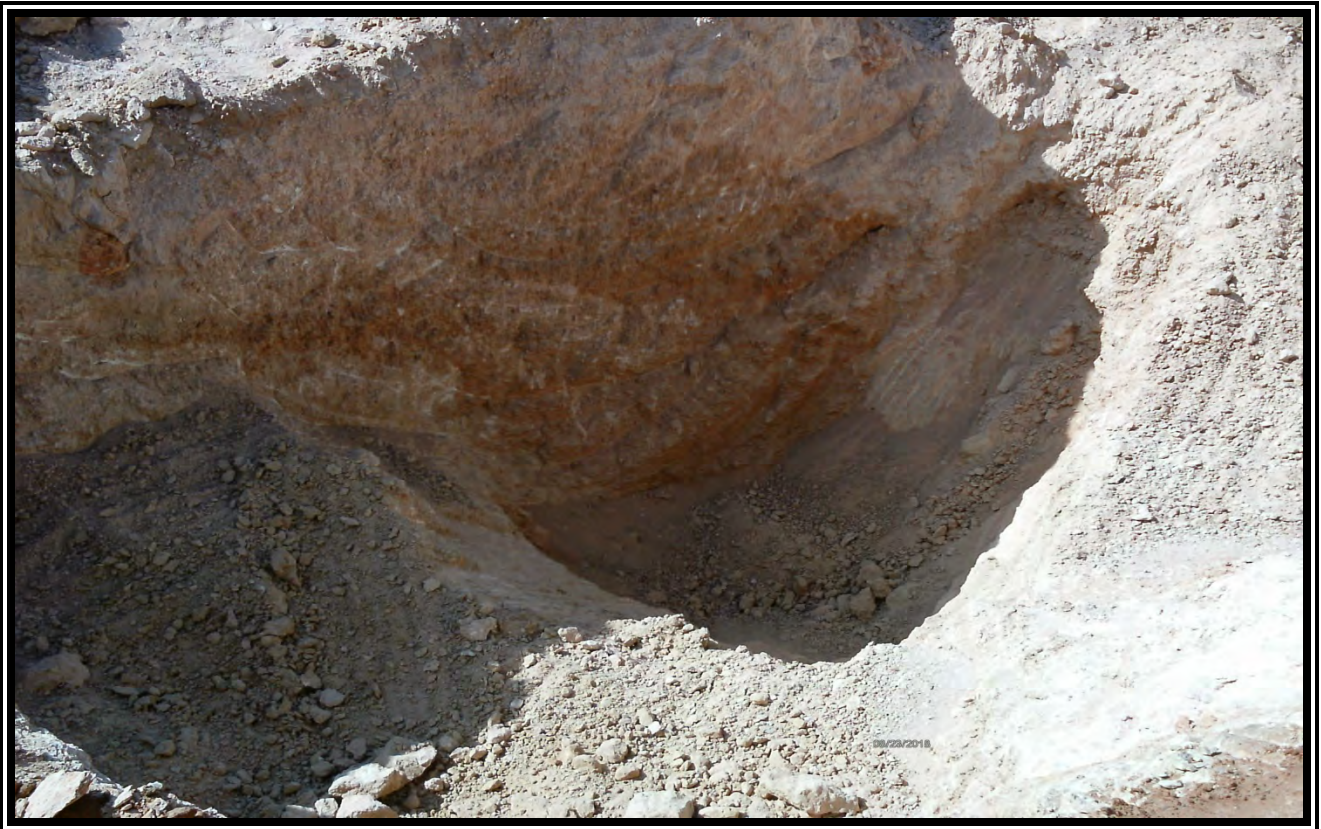
North central portion of site excavated to 29 feet bgs looking southeast.

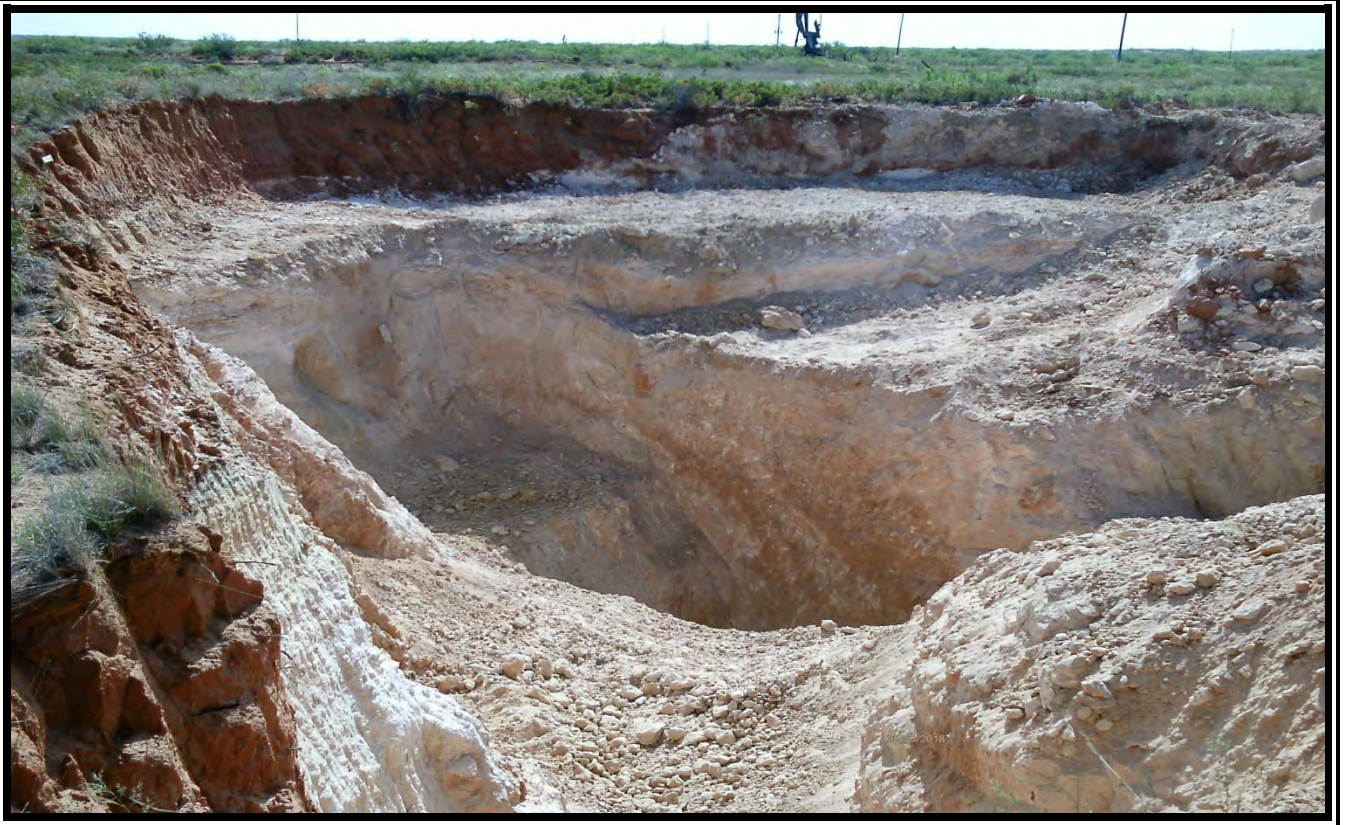
East side of site looking east.

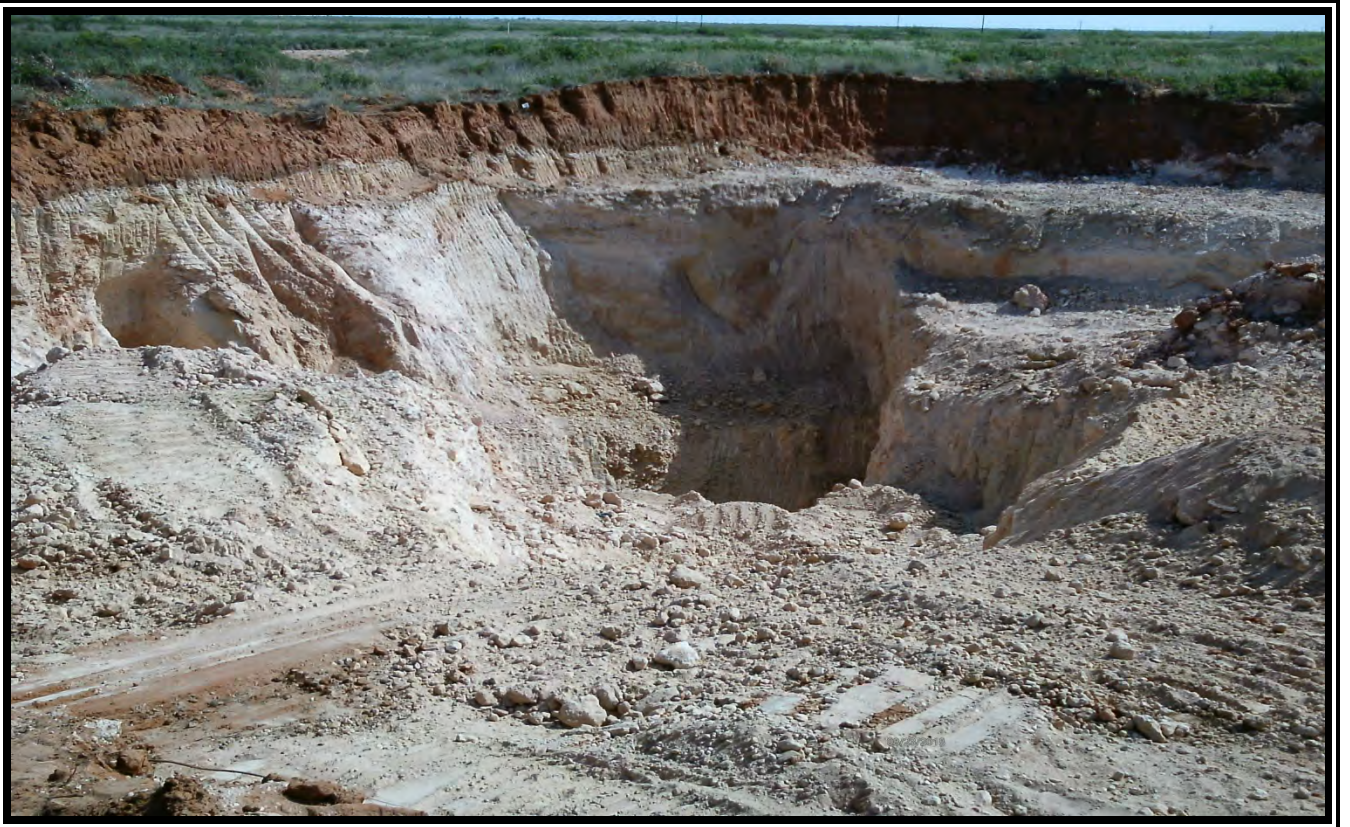
Northeast portion of site looking northeast.

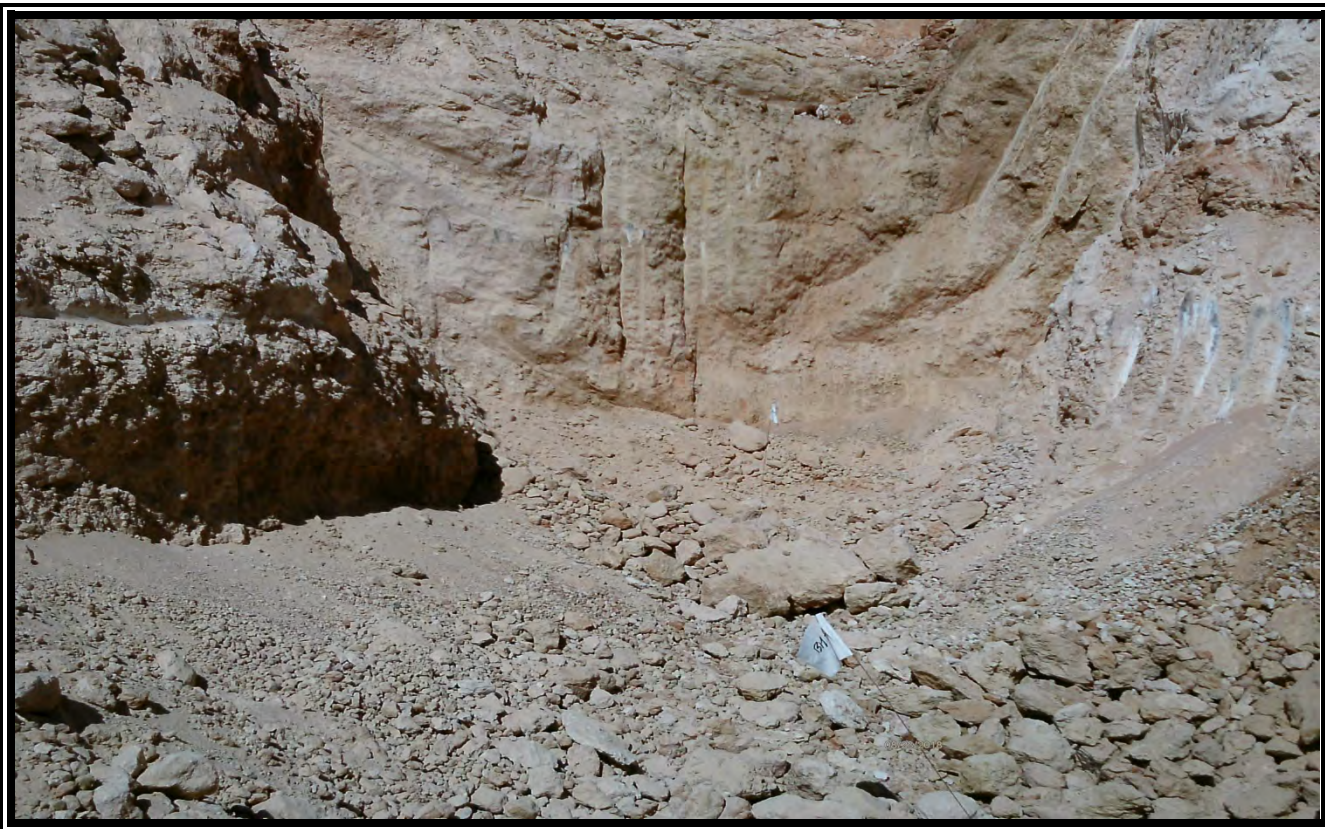
Soil sample locations BH 7 (foreground) and BH 6 looking west.

On August 17, 2018, Etech collected six (6) confirmation soil samples labeled SESW 1A (Southeast Sidewall 1A), BH 6 (Bottom Hole 6), NESW 3 (Northeast Sidewall 3), SESW 3 (Southeast Sidewall 3), SWSW 3 (Southwest Sidewall 3), and NWSW 3 (Northwest Sidewall 3) and one (1) delineation soil sample labeled TT 1 (Test Trench 1). This sampling event included sampling of the excavated northwest heavily stained area and additionally excavated southeast wall of the south central heavily stained area (see Attachment B – Annotated Aerial Imagery for sample locations). The soil samples were submitted to Cardinal Laboratories and analyzed for TPH, benzene, and BTEX. The laboratory results determined that the TPH levels ranged from 216 mg/kg to 31,120 mg/kg. All benzene levels and BTEX levels were no analytical detection (See Table 1 Summary of Delineation Sampling Analytical Results and Table 2 Summary of Remediation Sampling Analytical Results below).

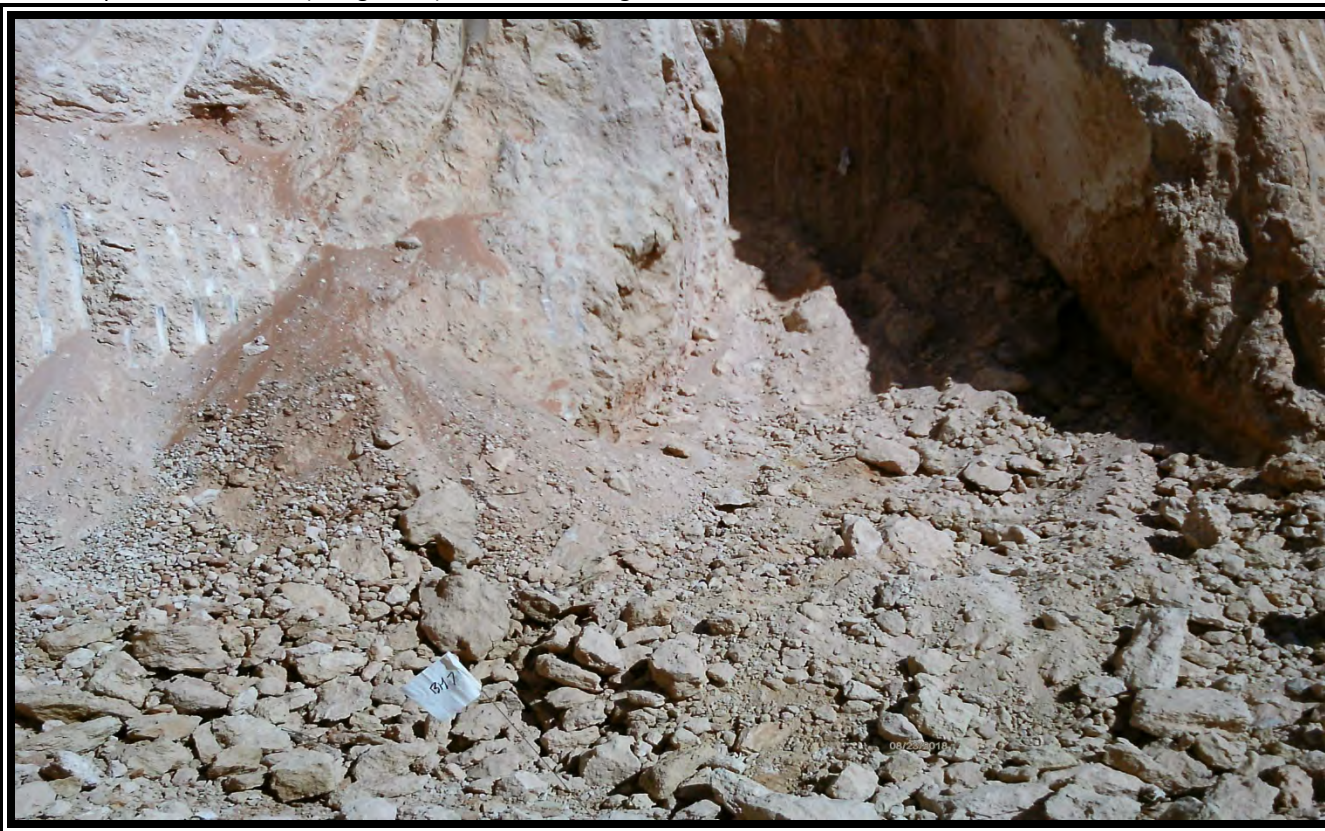
Soil sample locations BH 7 (foreground) and NSW 3 looking northeast .

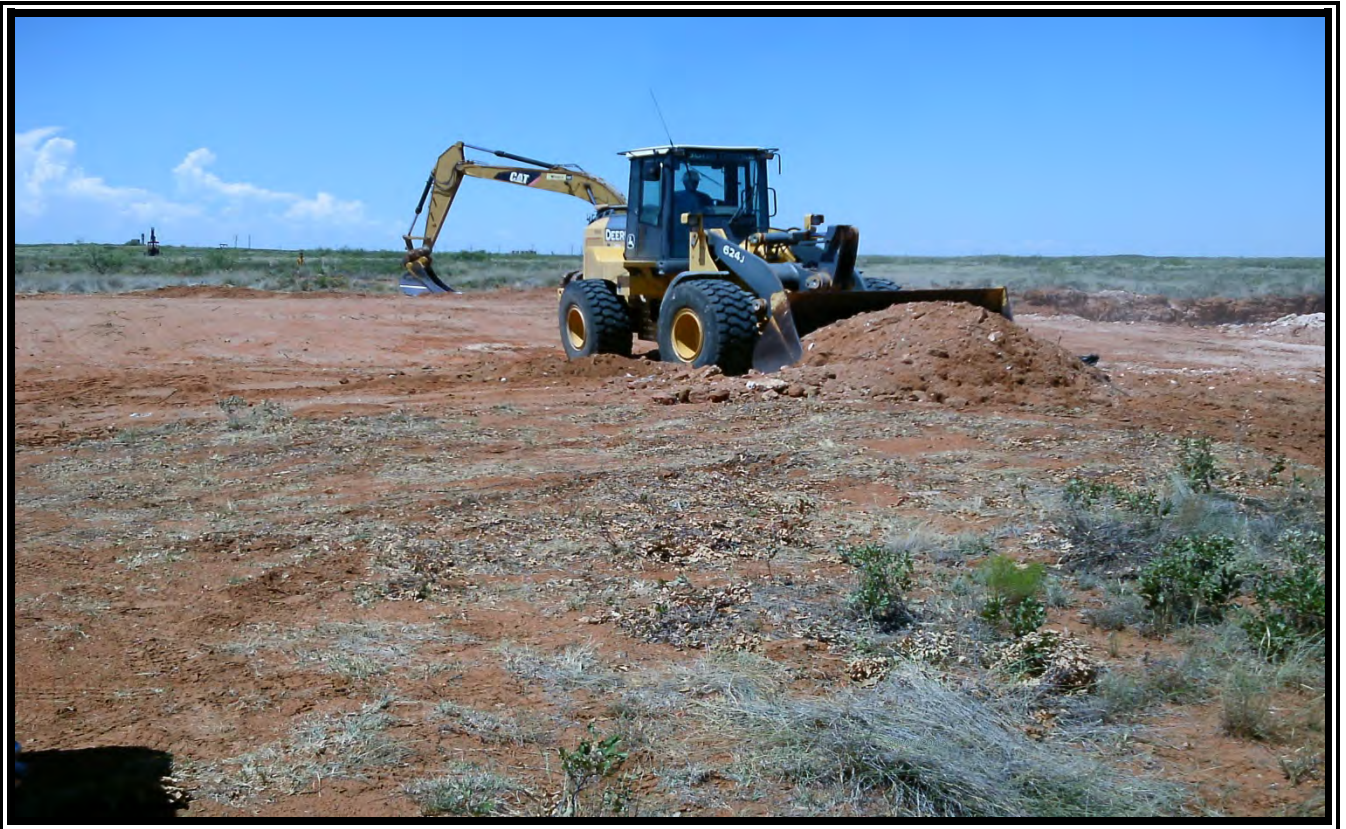
Picking up last of excavated soil for hauling to J&L Landfarm looking northwest.

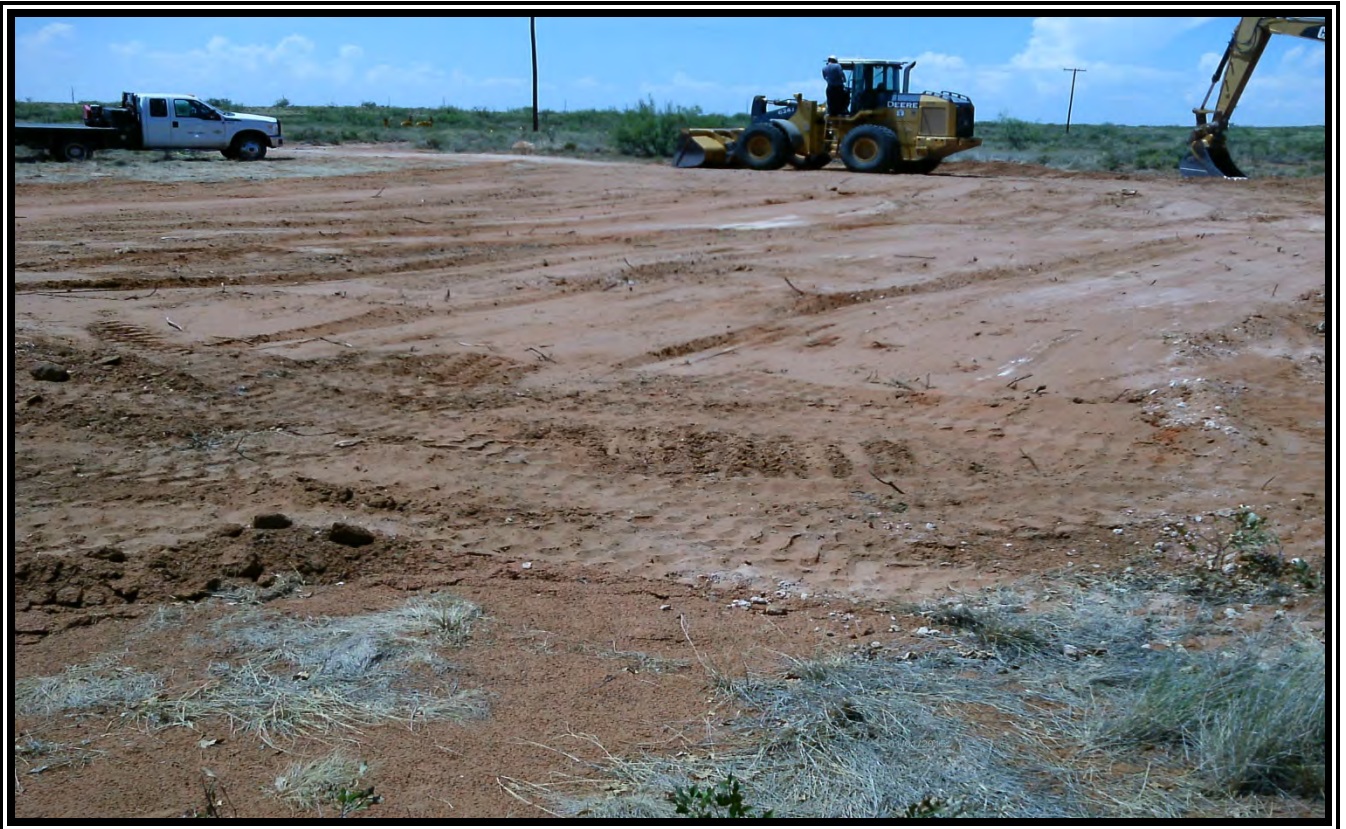
Site after all excavated soil was loaded and hauled looking southwest.
