**Report Type: Closure Report    1RP-4783**

Site:	Lusk Deep Unit A #22H					
Company:	COG Operating LLC					
Section, Township and Range	Unit C	Sec. 17	T 19S	R 32E		
Lease Number:	API No. 30-025-40705					
County:	Lea County					
GPS:	32.6668205° N			103.7912445° W		
Surface Owner:	Federal					
Mineral Owner:						
Directions:	From intersection of 126A & Dry Lake Rd travel EAST on Dry Lake for 0.25 mi to location on south side of the road.

**Re: Closure Report for the COG Operating LLC., Lusk Deep Unit A #19, Unit N, Section 17, Township 19 South, Range 32 East, Lea County, New Mexico. 1RP-4783.**

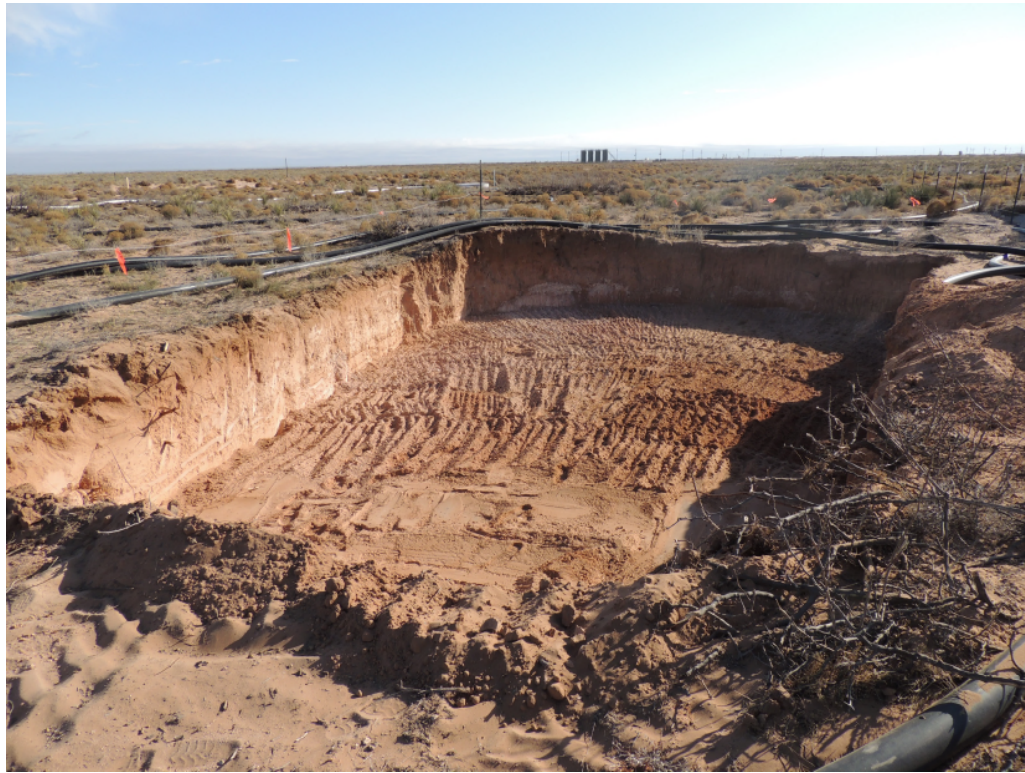
View East – Excavated Area

On February 20-22, 2018, Tetra Tech personnel were onsite to supervise the excavation and remediation activities. The excavated areas and depths are shown on Figure 4 and highlighted (green) in Table 1. The area of trench (T-1) was excavated to 4.0' to 5.0' below surface and measured approximately 25' x 41'. As requested by the NMOCD, bottom hole and sidewall samples (Bottom hole, North Sidewall, South Sidewall, West Sidewall, and East Sidewall) were collected to confirm the proper removal of the impacted soils. The confirmation samples were submitted to the laboratory for chloride analysis by EPA method 300.0. Copies of laboratory analysis and chain-of-custody documentation are included in Appendix C. The results of the sampling are summarized in Table 1. The sample locations are shown on Figure 4.

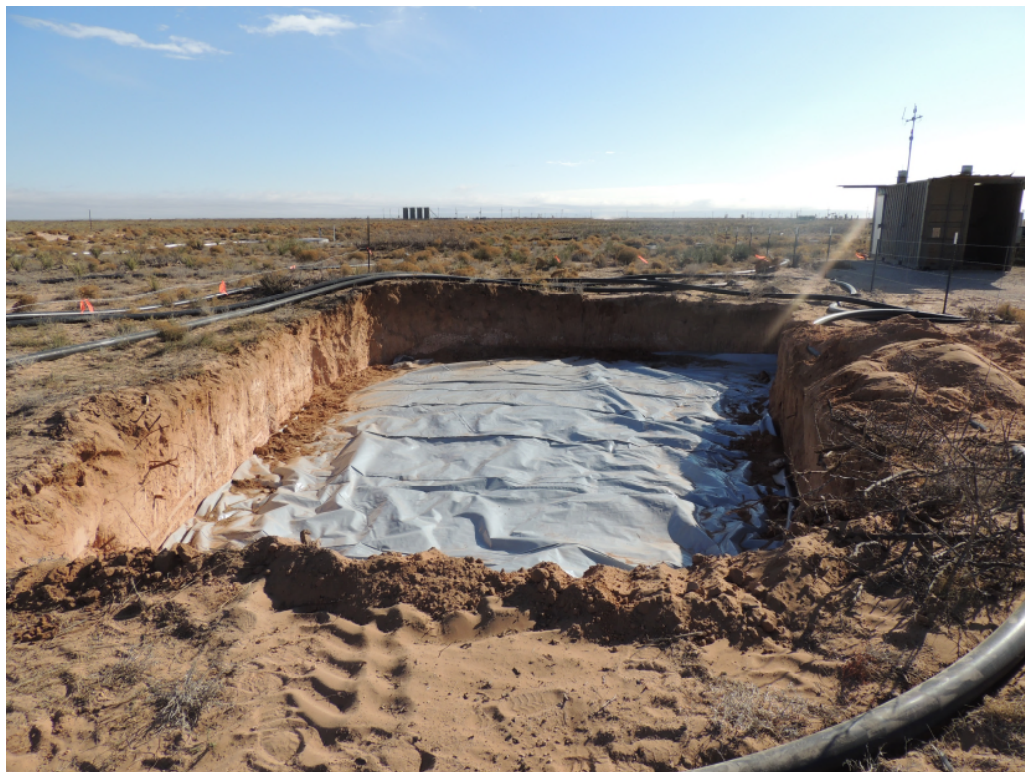
View East – Lined Excavation

Tetra Tech inspected site and collected samples to define spills extent. The area was excavated to 4'-5' to remove elevated chloride concentrations and a liner was installed at 4'-5' below surface. Site was then brought up to surface grade with clean backfill material. Tetra Tech prepared closure report and submitted to NMOCD for review.

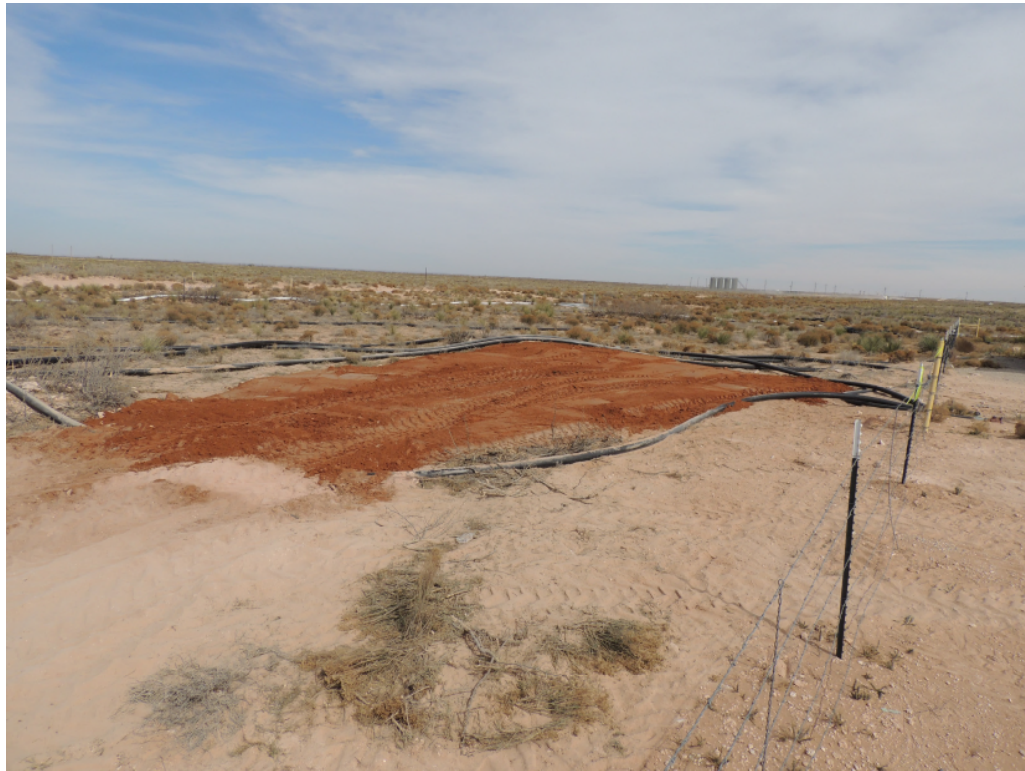
View Northeast – Backfilled Excavation

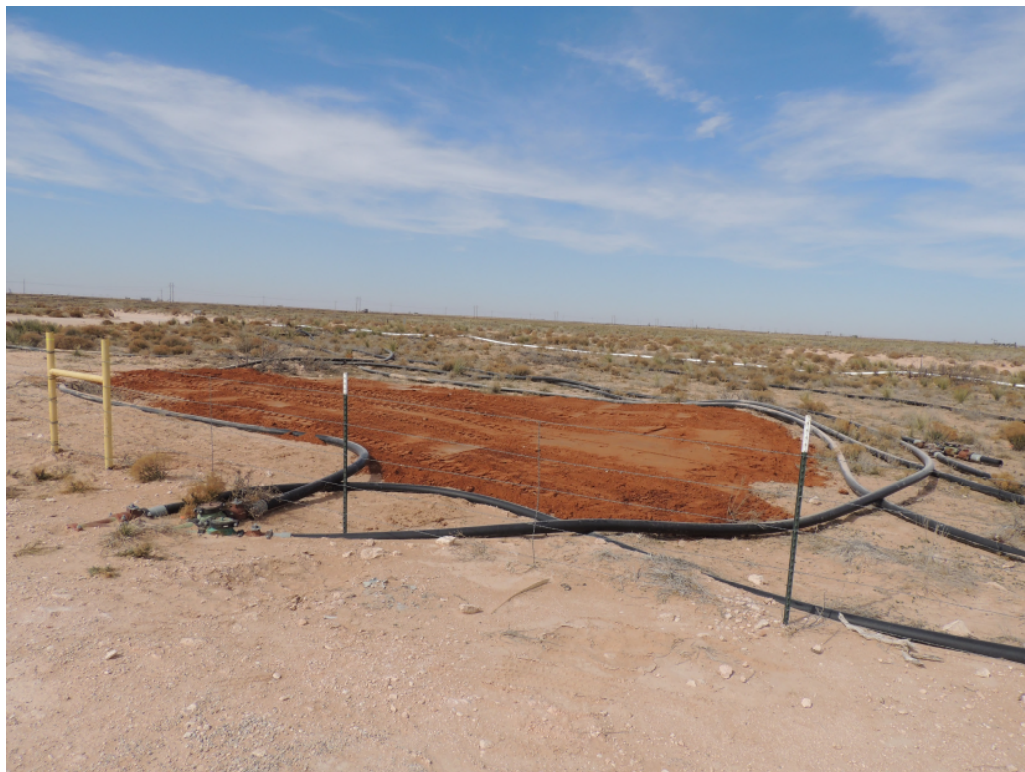
View North – Backfilled Excavation
