Re: Work Plan
Transfer line from Terrapin Frac Pond to Arabian 30-19 Fed Com 2H
NMOCD Reference #: 1RP-4854

RXSoil, Inc. is pleased to submit the work plan summarizing the on-site remediation of treated produced water impacted soil for the above release, associated with the Arabian 30-19 Fed Com 2H site located in Lea County, New Mexico. Remediation work plan follows in the attached report.

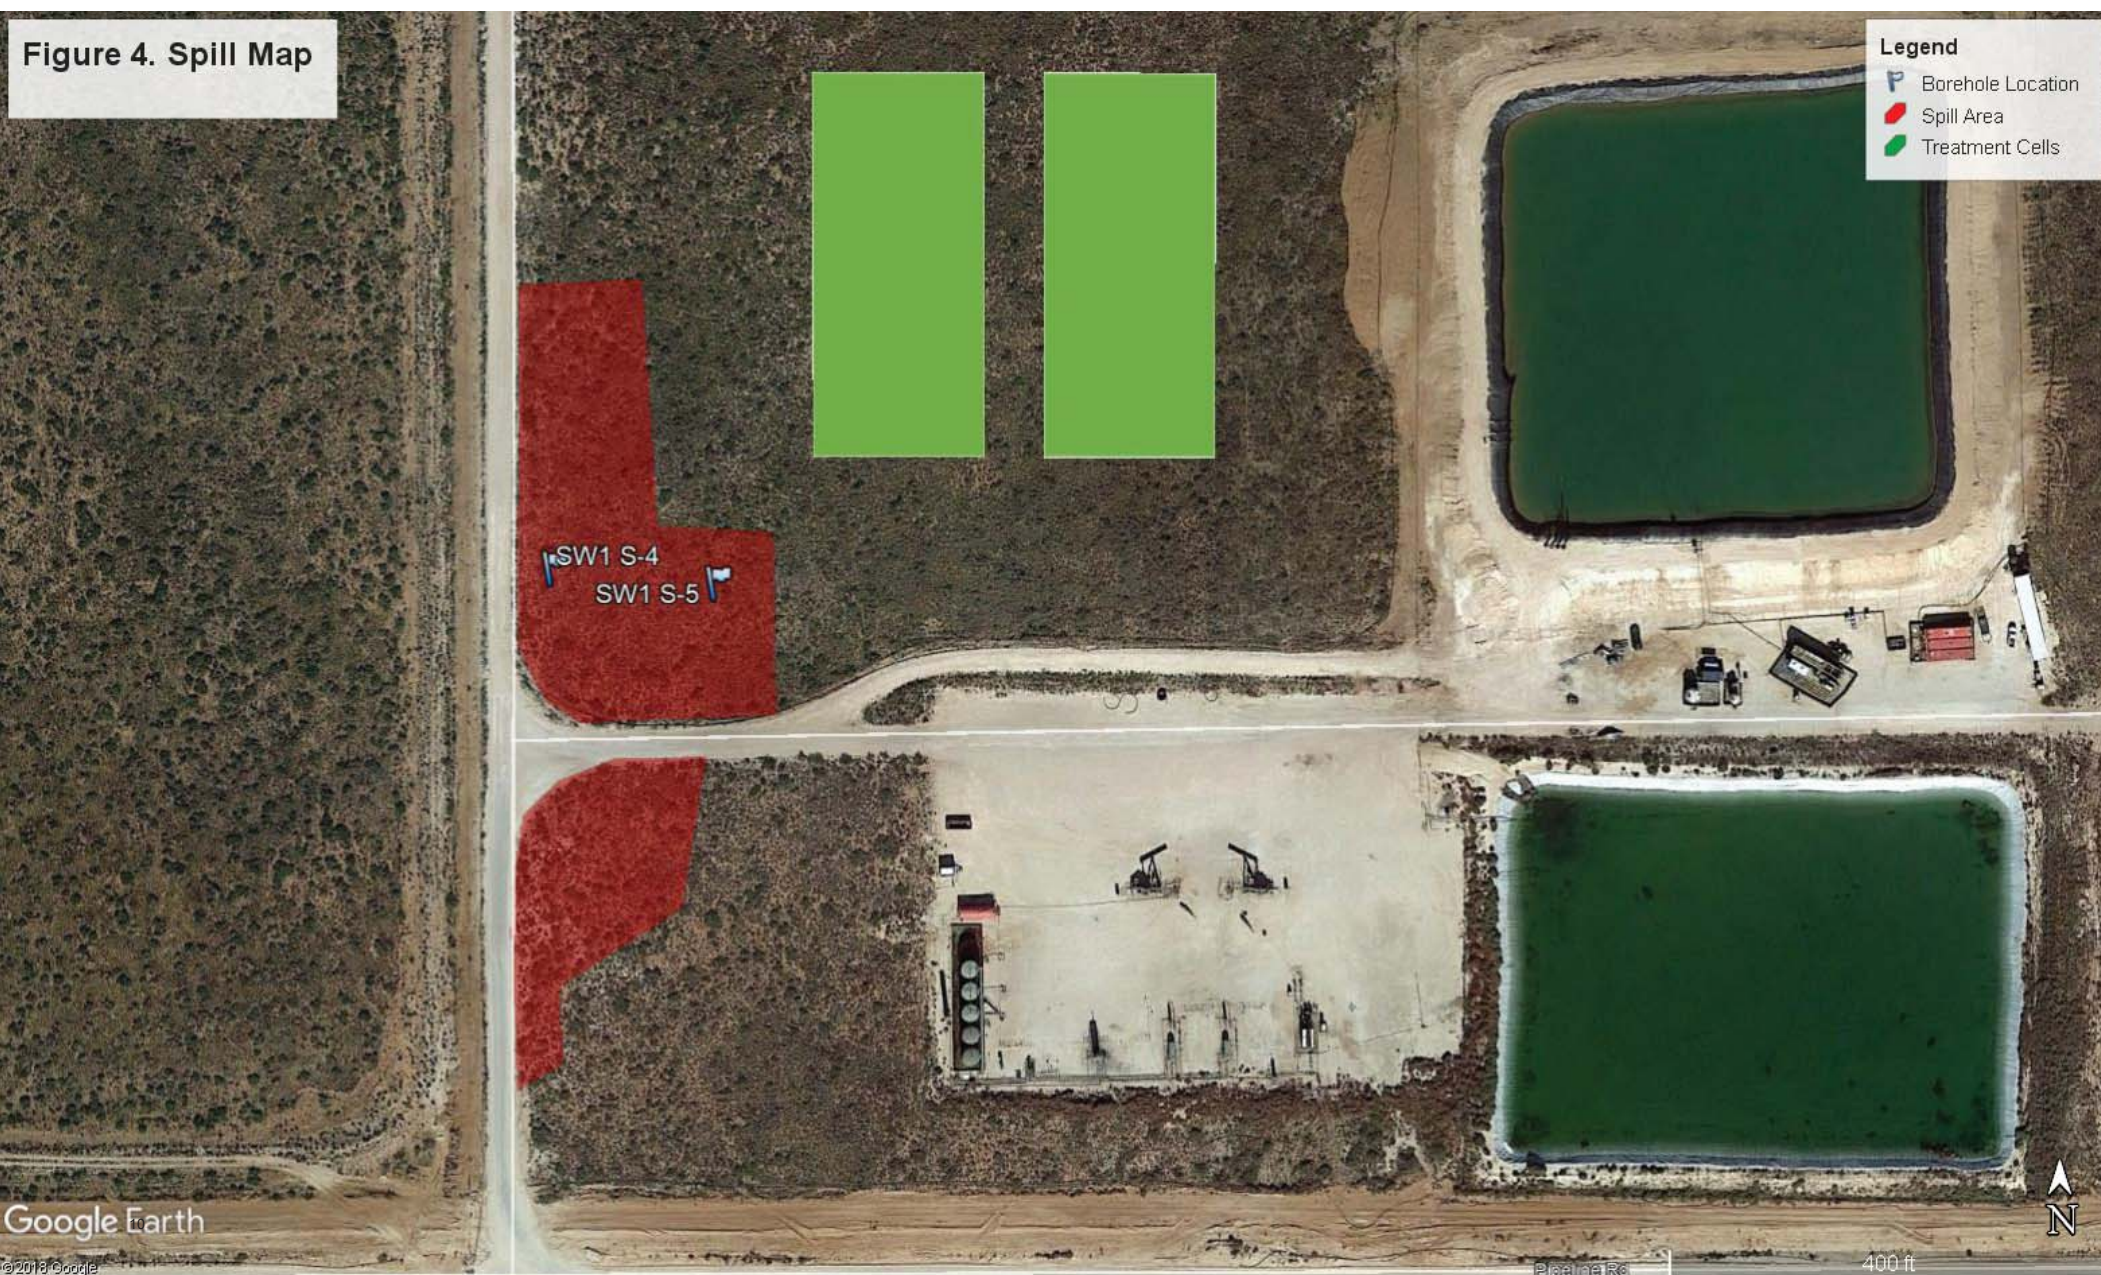
Figure 4. Spill Map

RXSoil will construct two in-ground treatment cells adjacent to the contaminated area (see *Figure 4* for projected placement). Once the final location of the treatment cells has been field verified, District 1 will be notified. These cells will be excavated to a depth of 4'. A 30-mil poly liner will be installed on the bottom and sides of cells to contain treatment (to be demarcated on map in Closure Report). A proprietary drainage and collection system will be installed. The background material (not affected by the release) will be staged away from any contaminated material to avoid cross-contamination. The cells are planned to cover an area of 150' by 320' each. Final dimensions will be included in the closure report and the area will be demarcated on a map.

Throughout excavation one bottom sample will be taken near each sample point labeled **S-X** on *Figure 4*, where **X** is the sample number. Excavation occurs until testing determines that the chloride levels are below 600 ppm or until excavation depth reaches 4'.

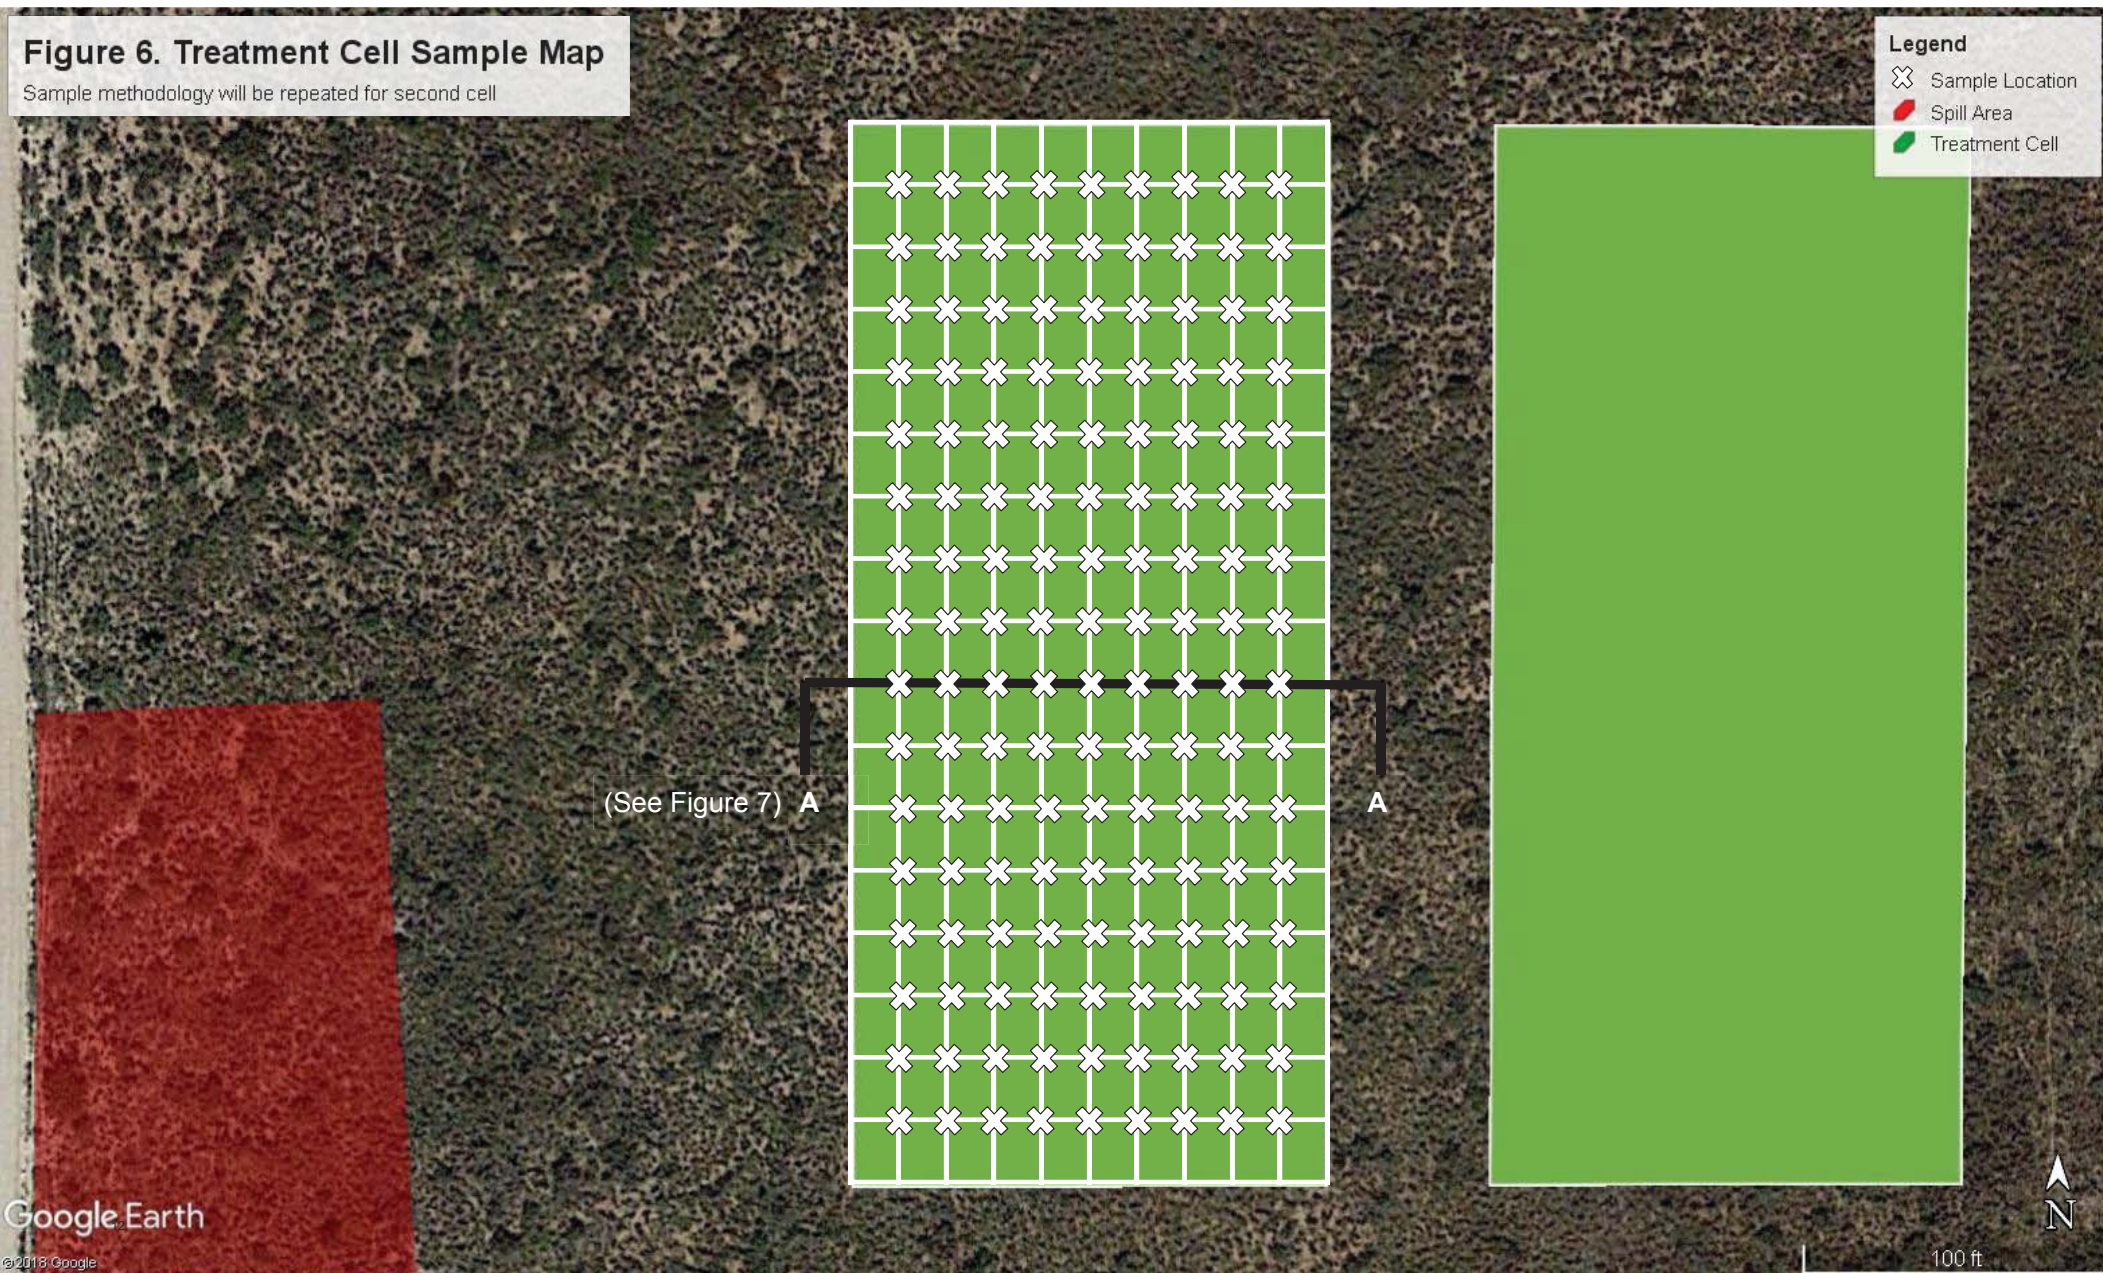
Figure 6. Treatment Cell Sample Map

Sample methodology will be repeated for second cell

The current proposed cell dimensions are approximately 150' by 320' by 4' depth each. This cell would hold 7,111 cubic yards, requiring no fewer than 143 samples per cell (7,111 cubic yards * 1 sample per 50 cubic yards). The planned sample grid will be an evenly spaced grid of 16 columns by 9 rows (144 samples) with samples taken at a depth of 36"-48". Due to the nature of the RXSoil Process, deeper samples tend to clean up last, since all contamination must push through the bottom of the profile. A diagram of the spacing can be seen in *Figure 6*, representing the sampling plan for one cell. A cross section view of the sampling can be seen in *Figure 7*.

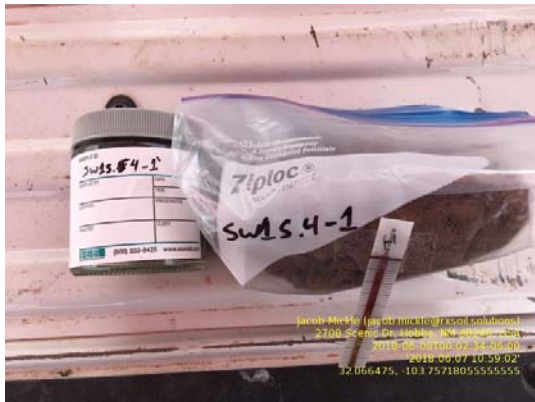
Type of Field Test: Soil
 Method of Testing: Sample to Lab
 Name of Sample Point: SW1S.4-1'
 Method of Sample Collecting: DRILL RIG
 Depth (inches): 12"
 Comments: FIELD TEST: CHLORIDES (1:4)
 LOW: -
 HIGH: 5.4 = 4,768 PPM

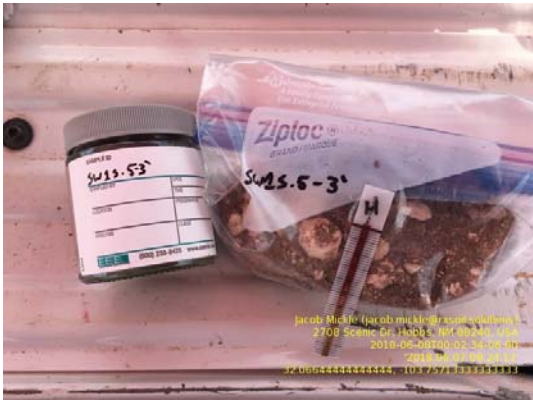
Type of Field Test	Soil
Method of Testing	Sample to Lab
Name of Sample Point	SW1S.5-3'
Method of Sample Collecting	DRILL RIG
Depth (inches)	36"
Comments	FIELD TEST: CHLORIDES (1:4) LOW: - HIGH: 5.6 = 5,164 PPM

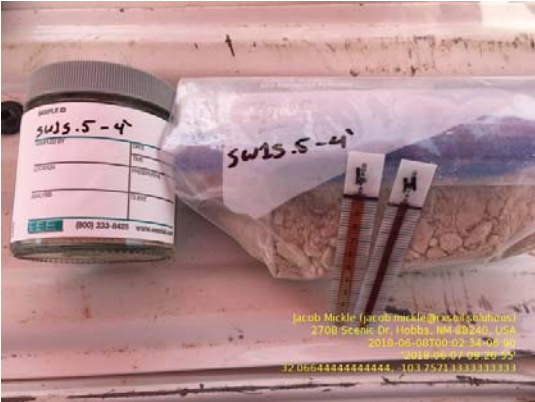
Type of Field Test	Soil
Method of Testing	Sample to Lab
Name of Sample Point	SW1S.5-4'
Method of Sample Collecting	DRILL RIG
Depth (inches)	48"
Comments	FIELD TEST: CHLORIDES (1:4) LOW: 4.8 = 776 PPM HIGH: ND
