From: [Yu, Olivia, EMNRD](#)
To: ["Lucas Middleton"](#)
Cc: [Dan Lewis](#); rmann@slo.state.nm.us
Subject: RE: SOIL REMEDIATION CLOSURE REPORT FOR THE ANGLE STATE #3 TANK BATTERY
Date: Friday, September 14, 2018 9:10:00 AM
Attachments: image001.png
approved_finalC141_1RP4670_ANGLE STATE #3.pdf

Detailed Site and Sample Map
 Angle State #3- ABo Empire
 S:9 T17S, R34E , New Mexico

PHOTO LOG FOR ANGLE STATE #3 1RP-4670

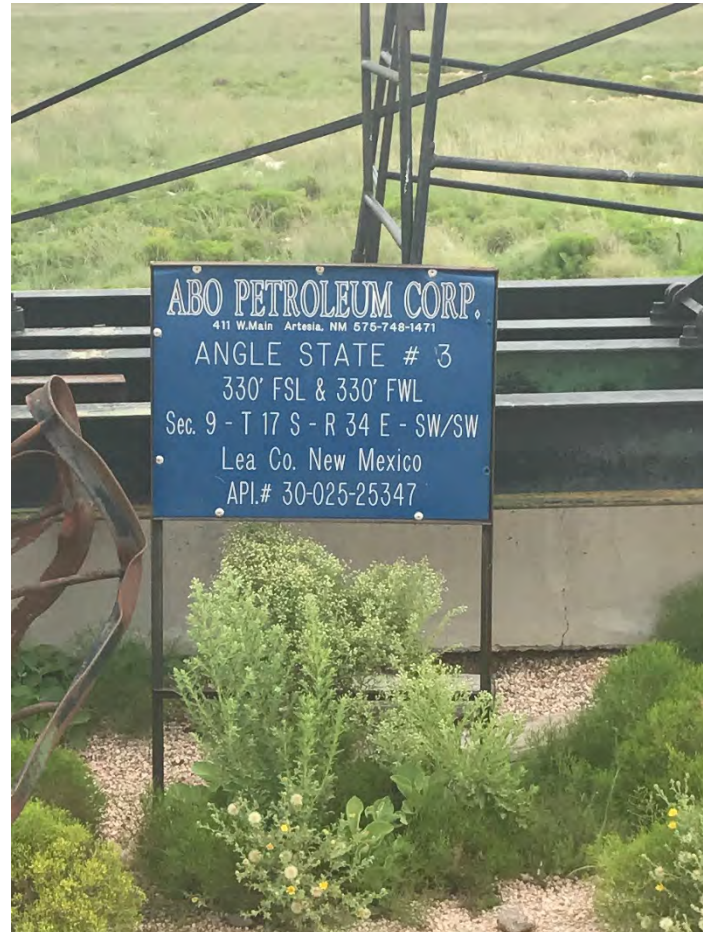
Photo 1

Well Head Sign 9/25/17

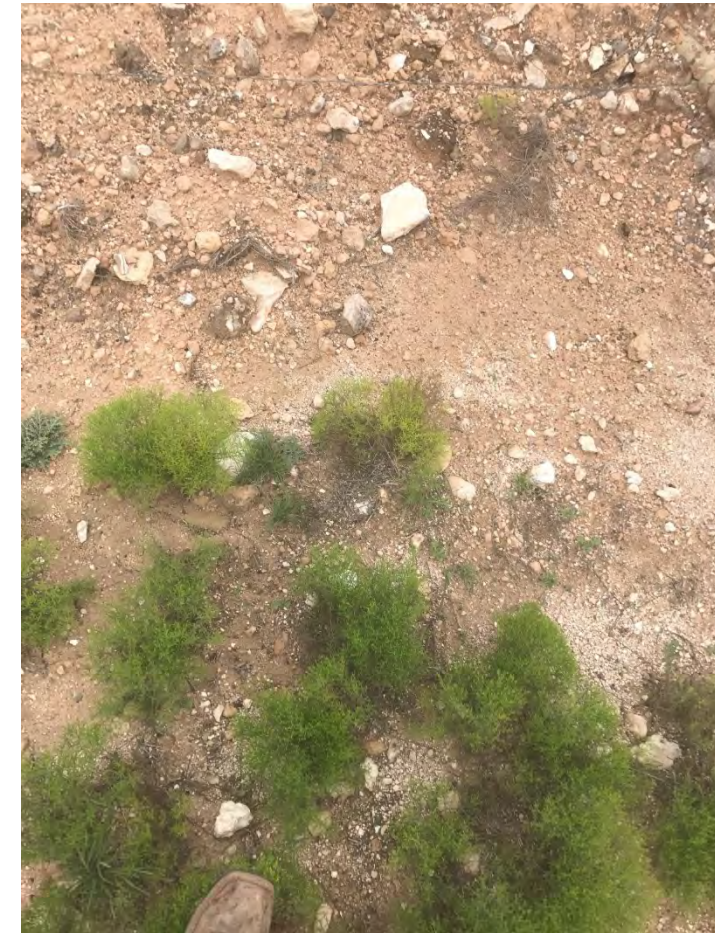
Photo 2

Over spray area edge looking west 9/25/17

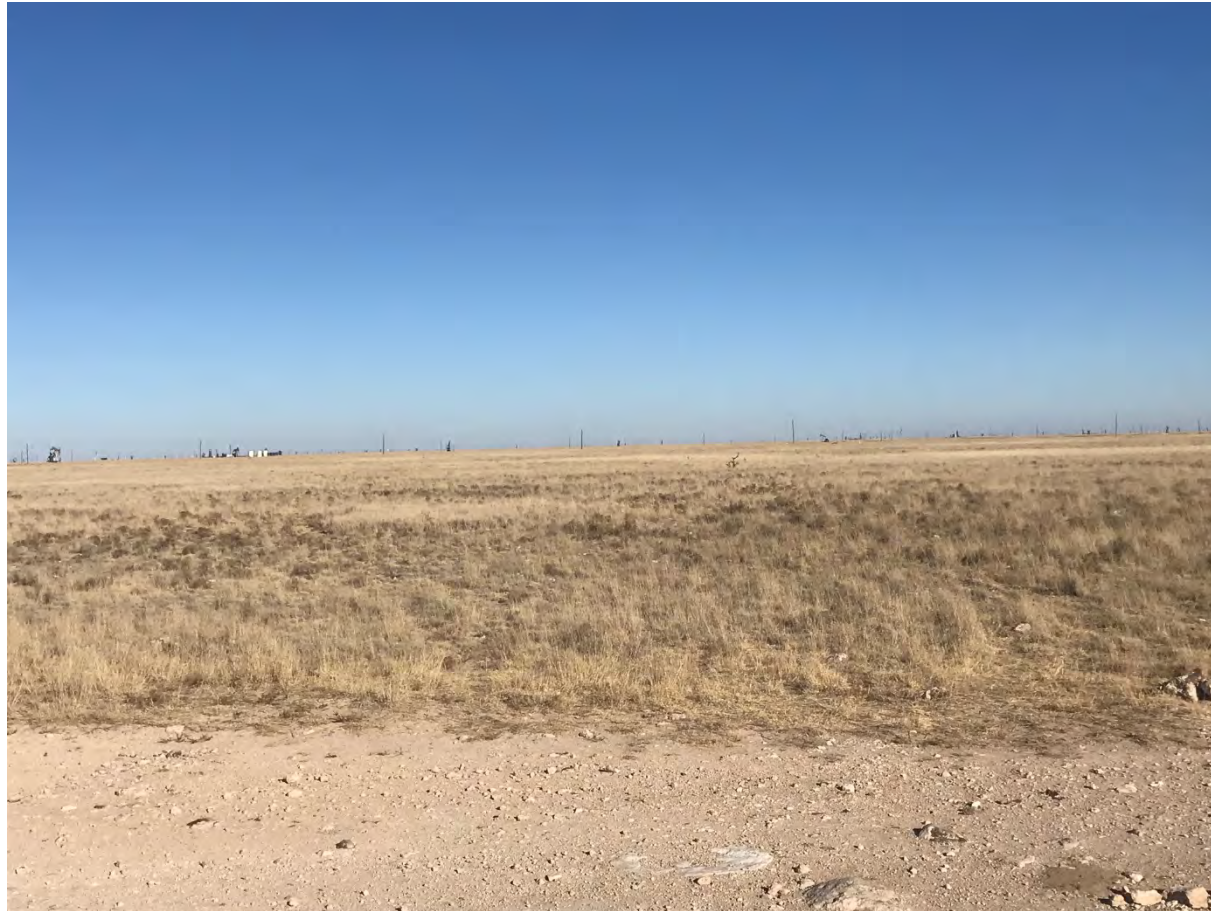
Photo 3

Over spray area sample P1 collected 1/31/18

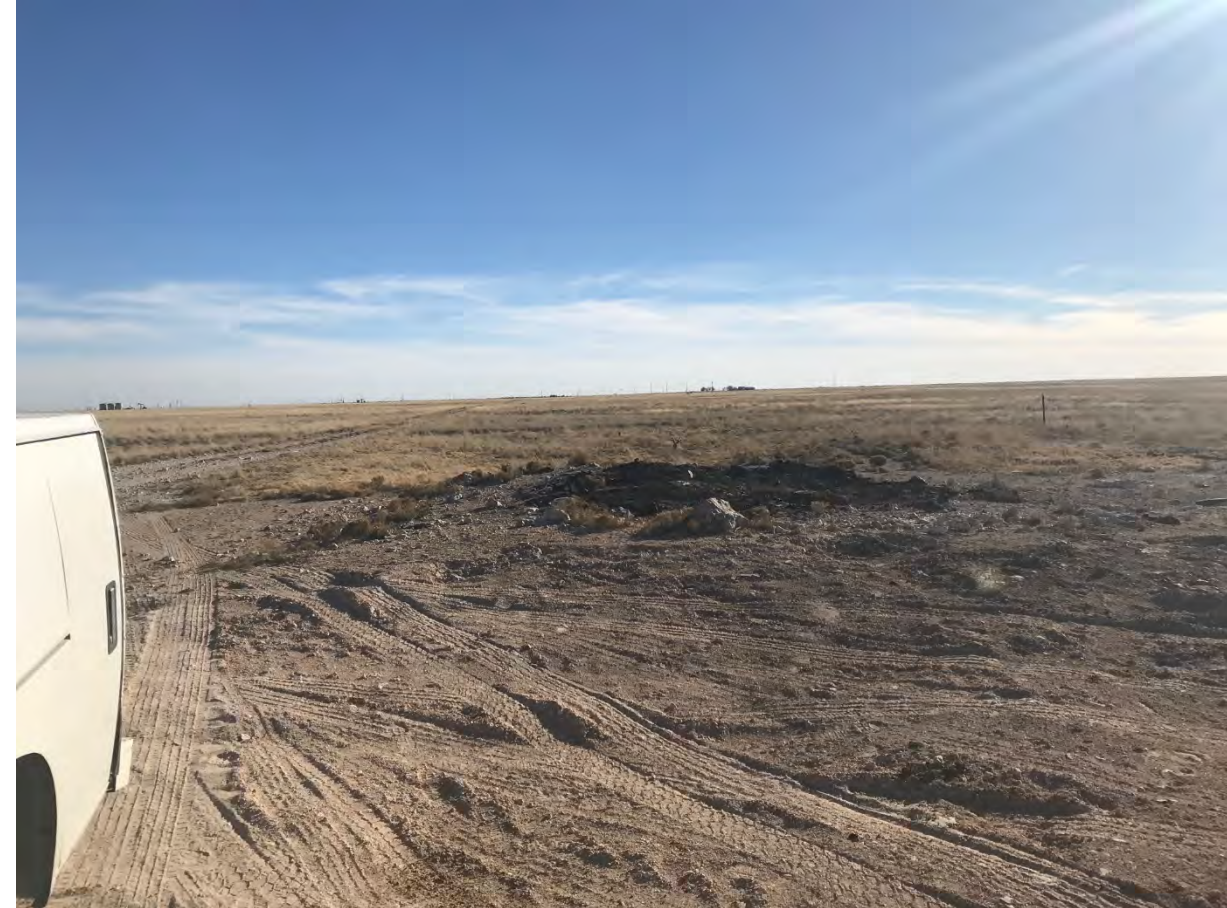
Photo 4

Excavation Area 1/31/18 looking south

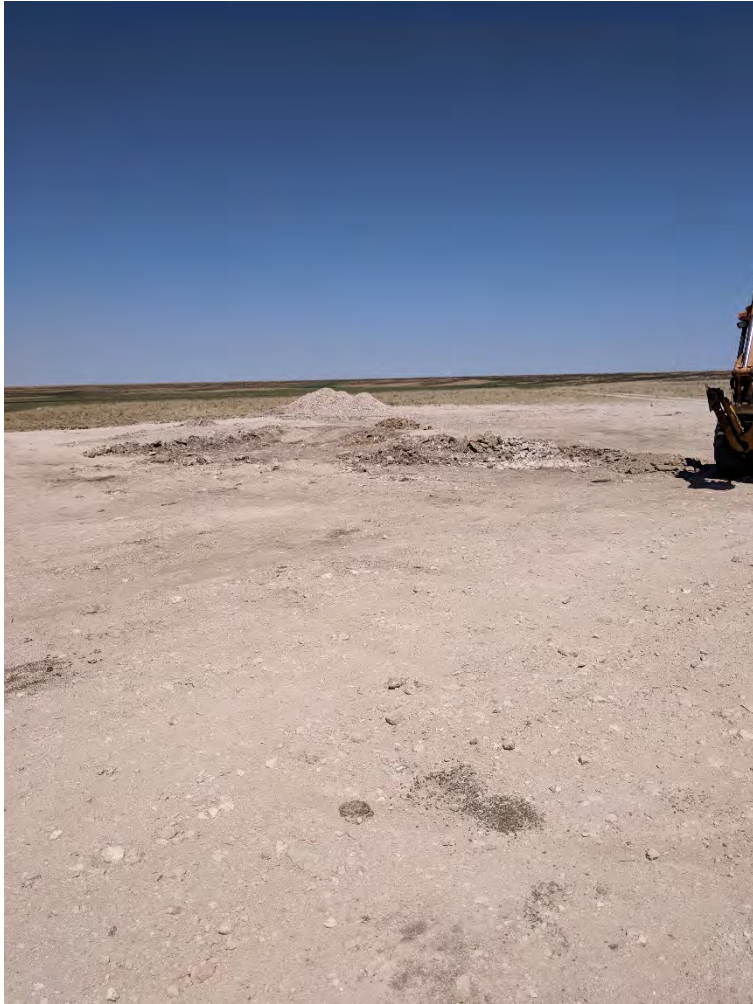
Photo 5

Location after equipment removal looking North
4/23/18

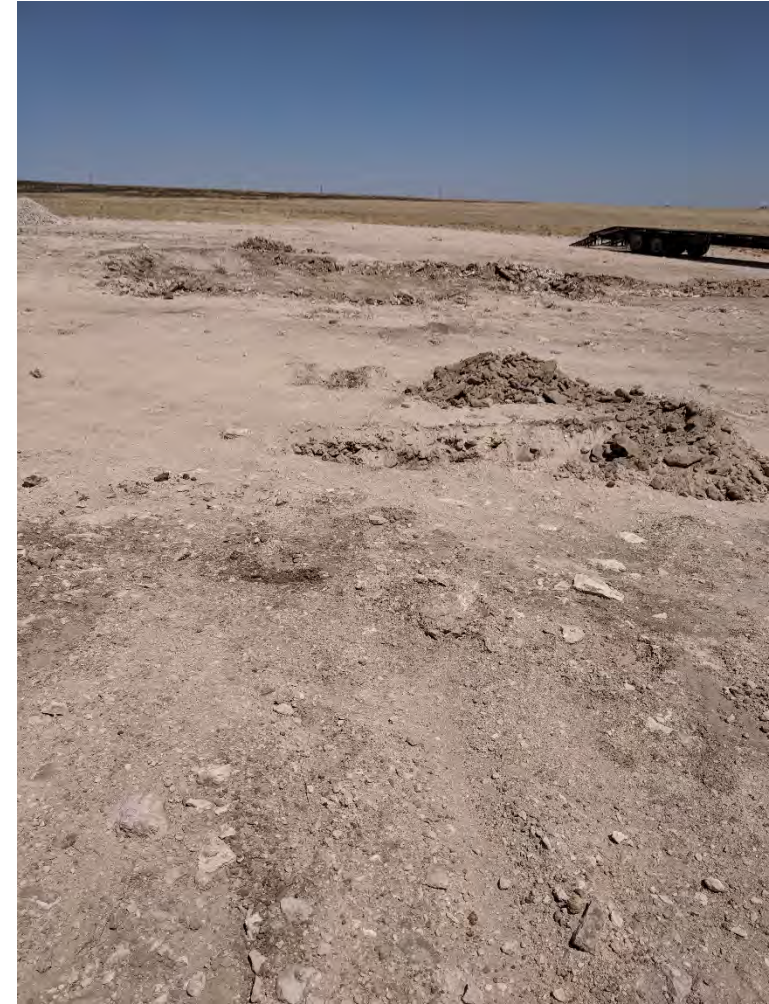
Photo 6

Location after equipment removal looking east
4/23/18

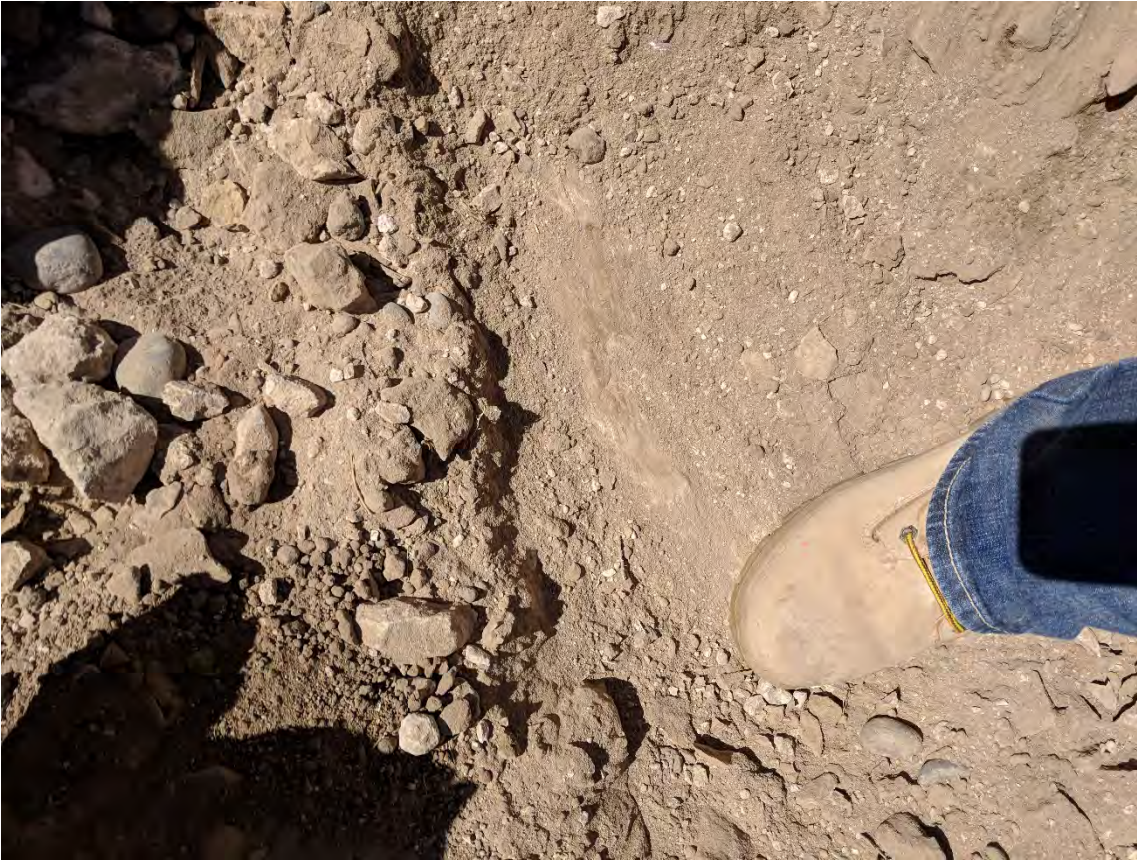
Photo 7

For the request on the 5ft. further sample. During excavation refusal was hit at 1.5 feet below ground surface (bgs). Also we have videos of refusal at L1-L5. According to the Web Soil Survey the soil type is KU—Kimbrough-Lea complex and has cemented material from 10”-80” bgs.

L5 refusal 4/23/18

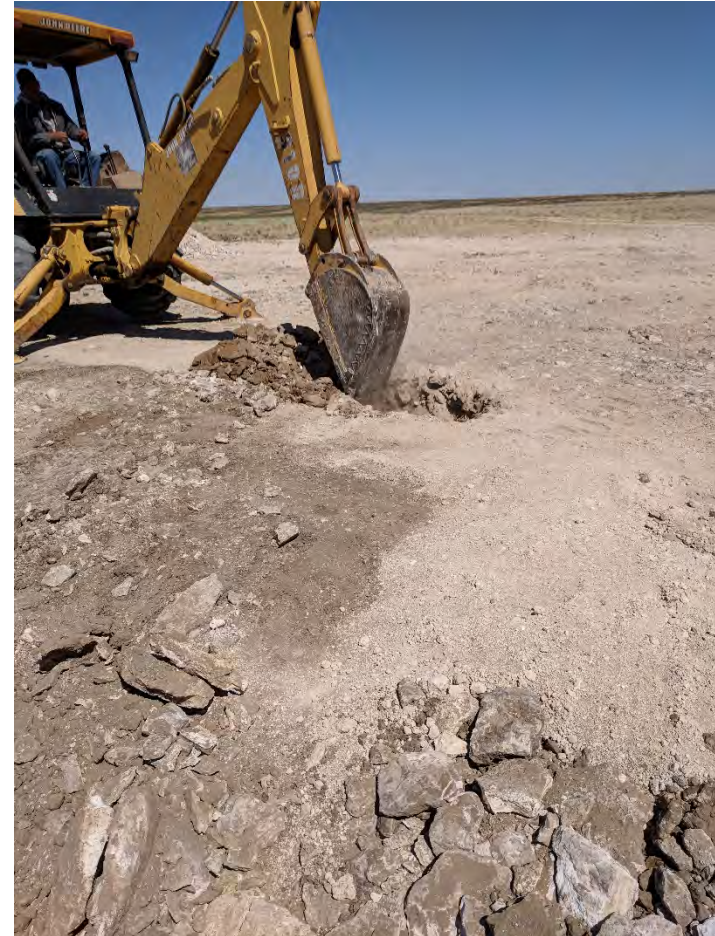
Photo 8

Excavation of North side wall 4/23/18

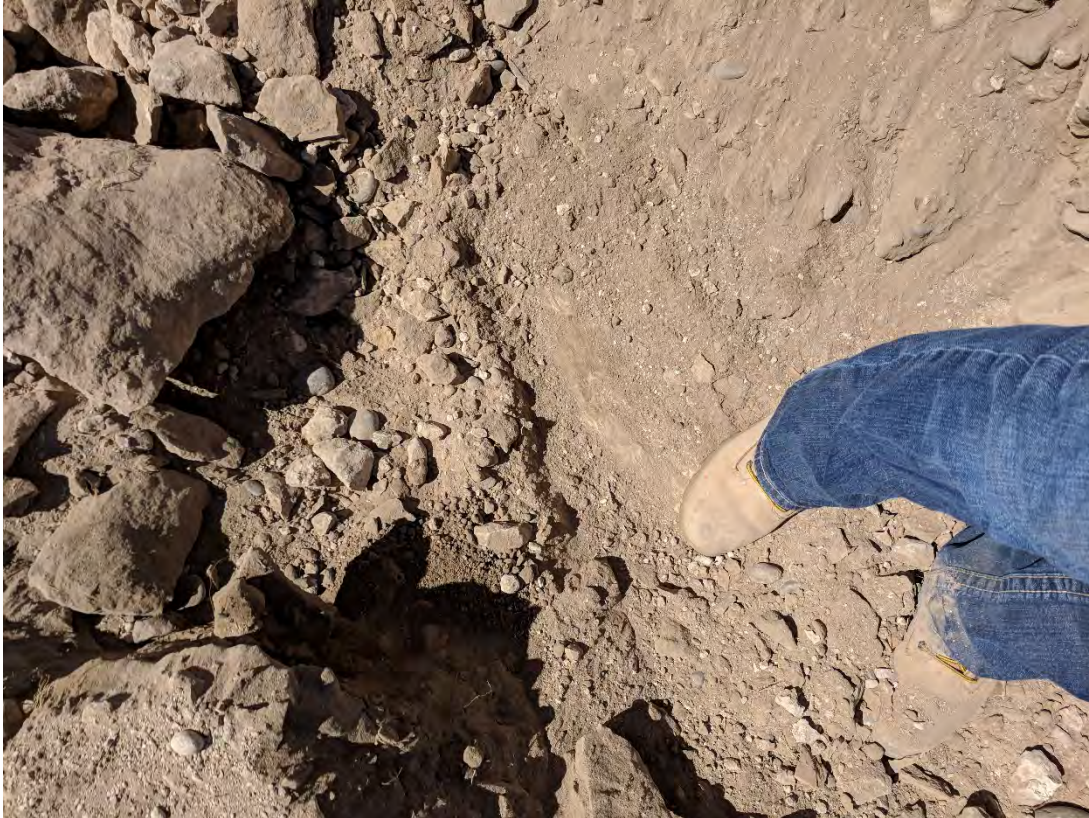
Photo 9

L3 refusal 4/23/18

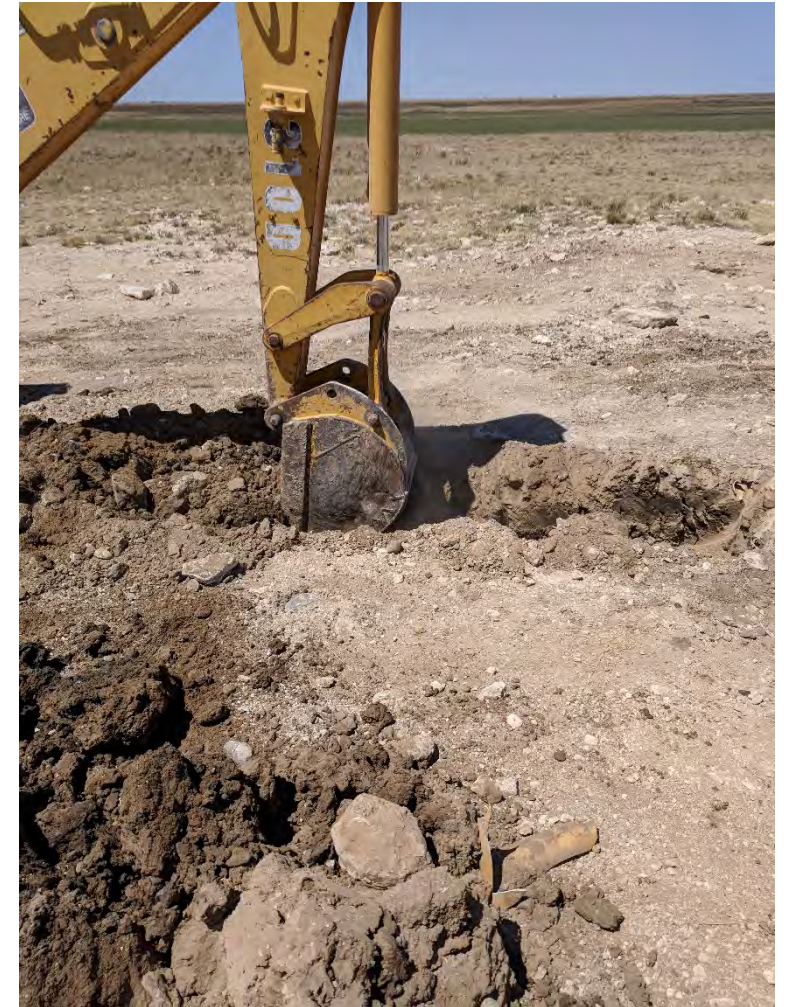
Photo 10

Excavation of the East side wall 4/23/18

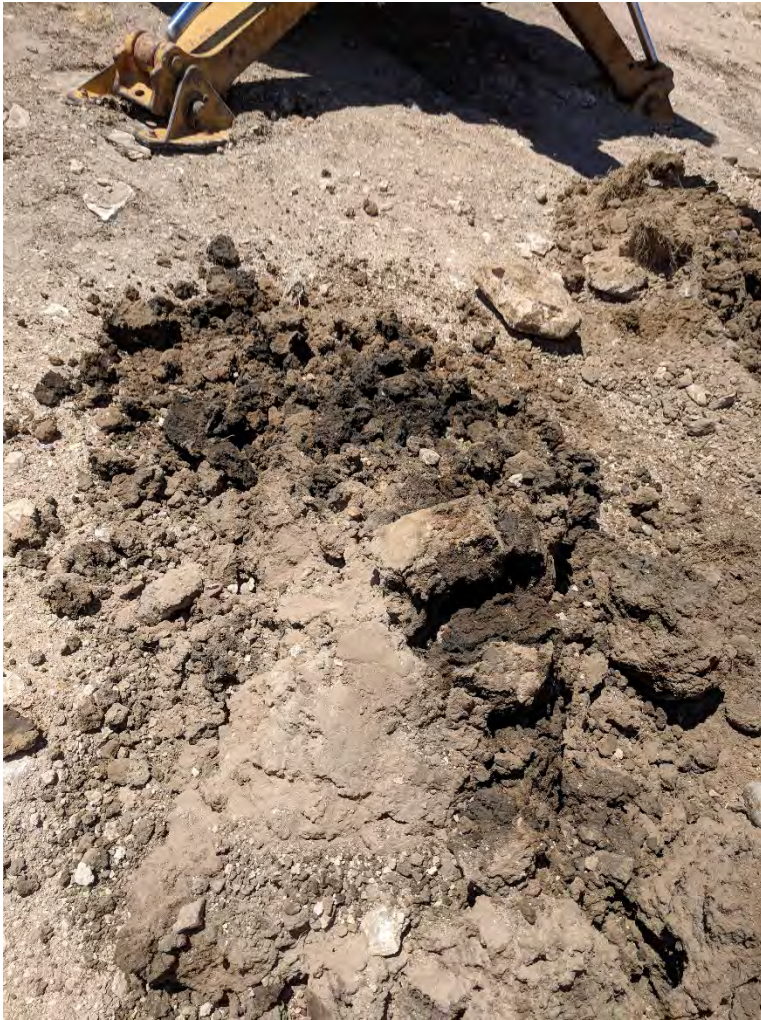
Photo 11

Material excavated from L2 4/23/18

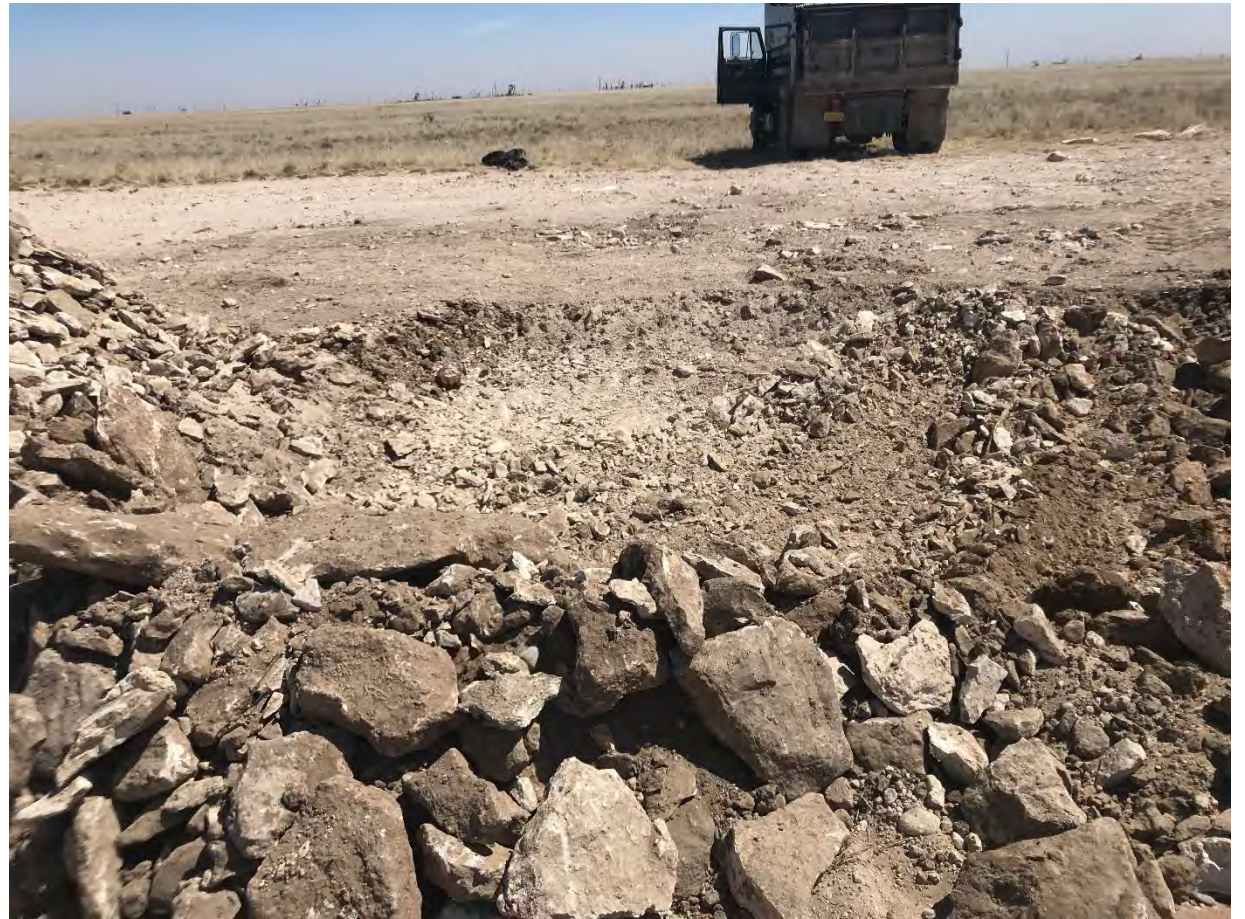
Photo 12

Material excavated and final depth 4/23/18
