**Re: Chevron Lovington Paddock Unit No. 89 Well-Site  
2017 Soil Assessment and Delineation Report  
Case No. 1RP-4017  
Lea County, New Mexico**

# Soil Assessment and Delineation Activities Report

Lovington Paddock Unit No. 89 Well-Site  
1RP - 4017

Unit E, Section 31, Township 16 South,  
Range 37 East  
Lovington, New Mexico

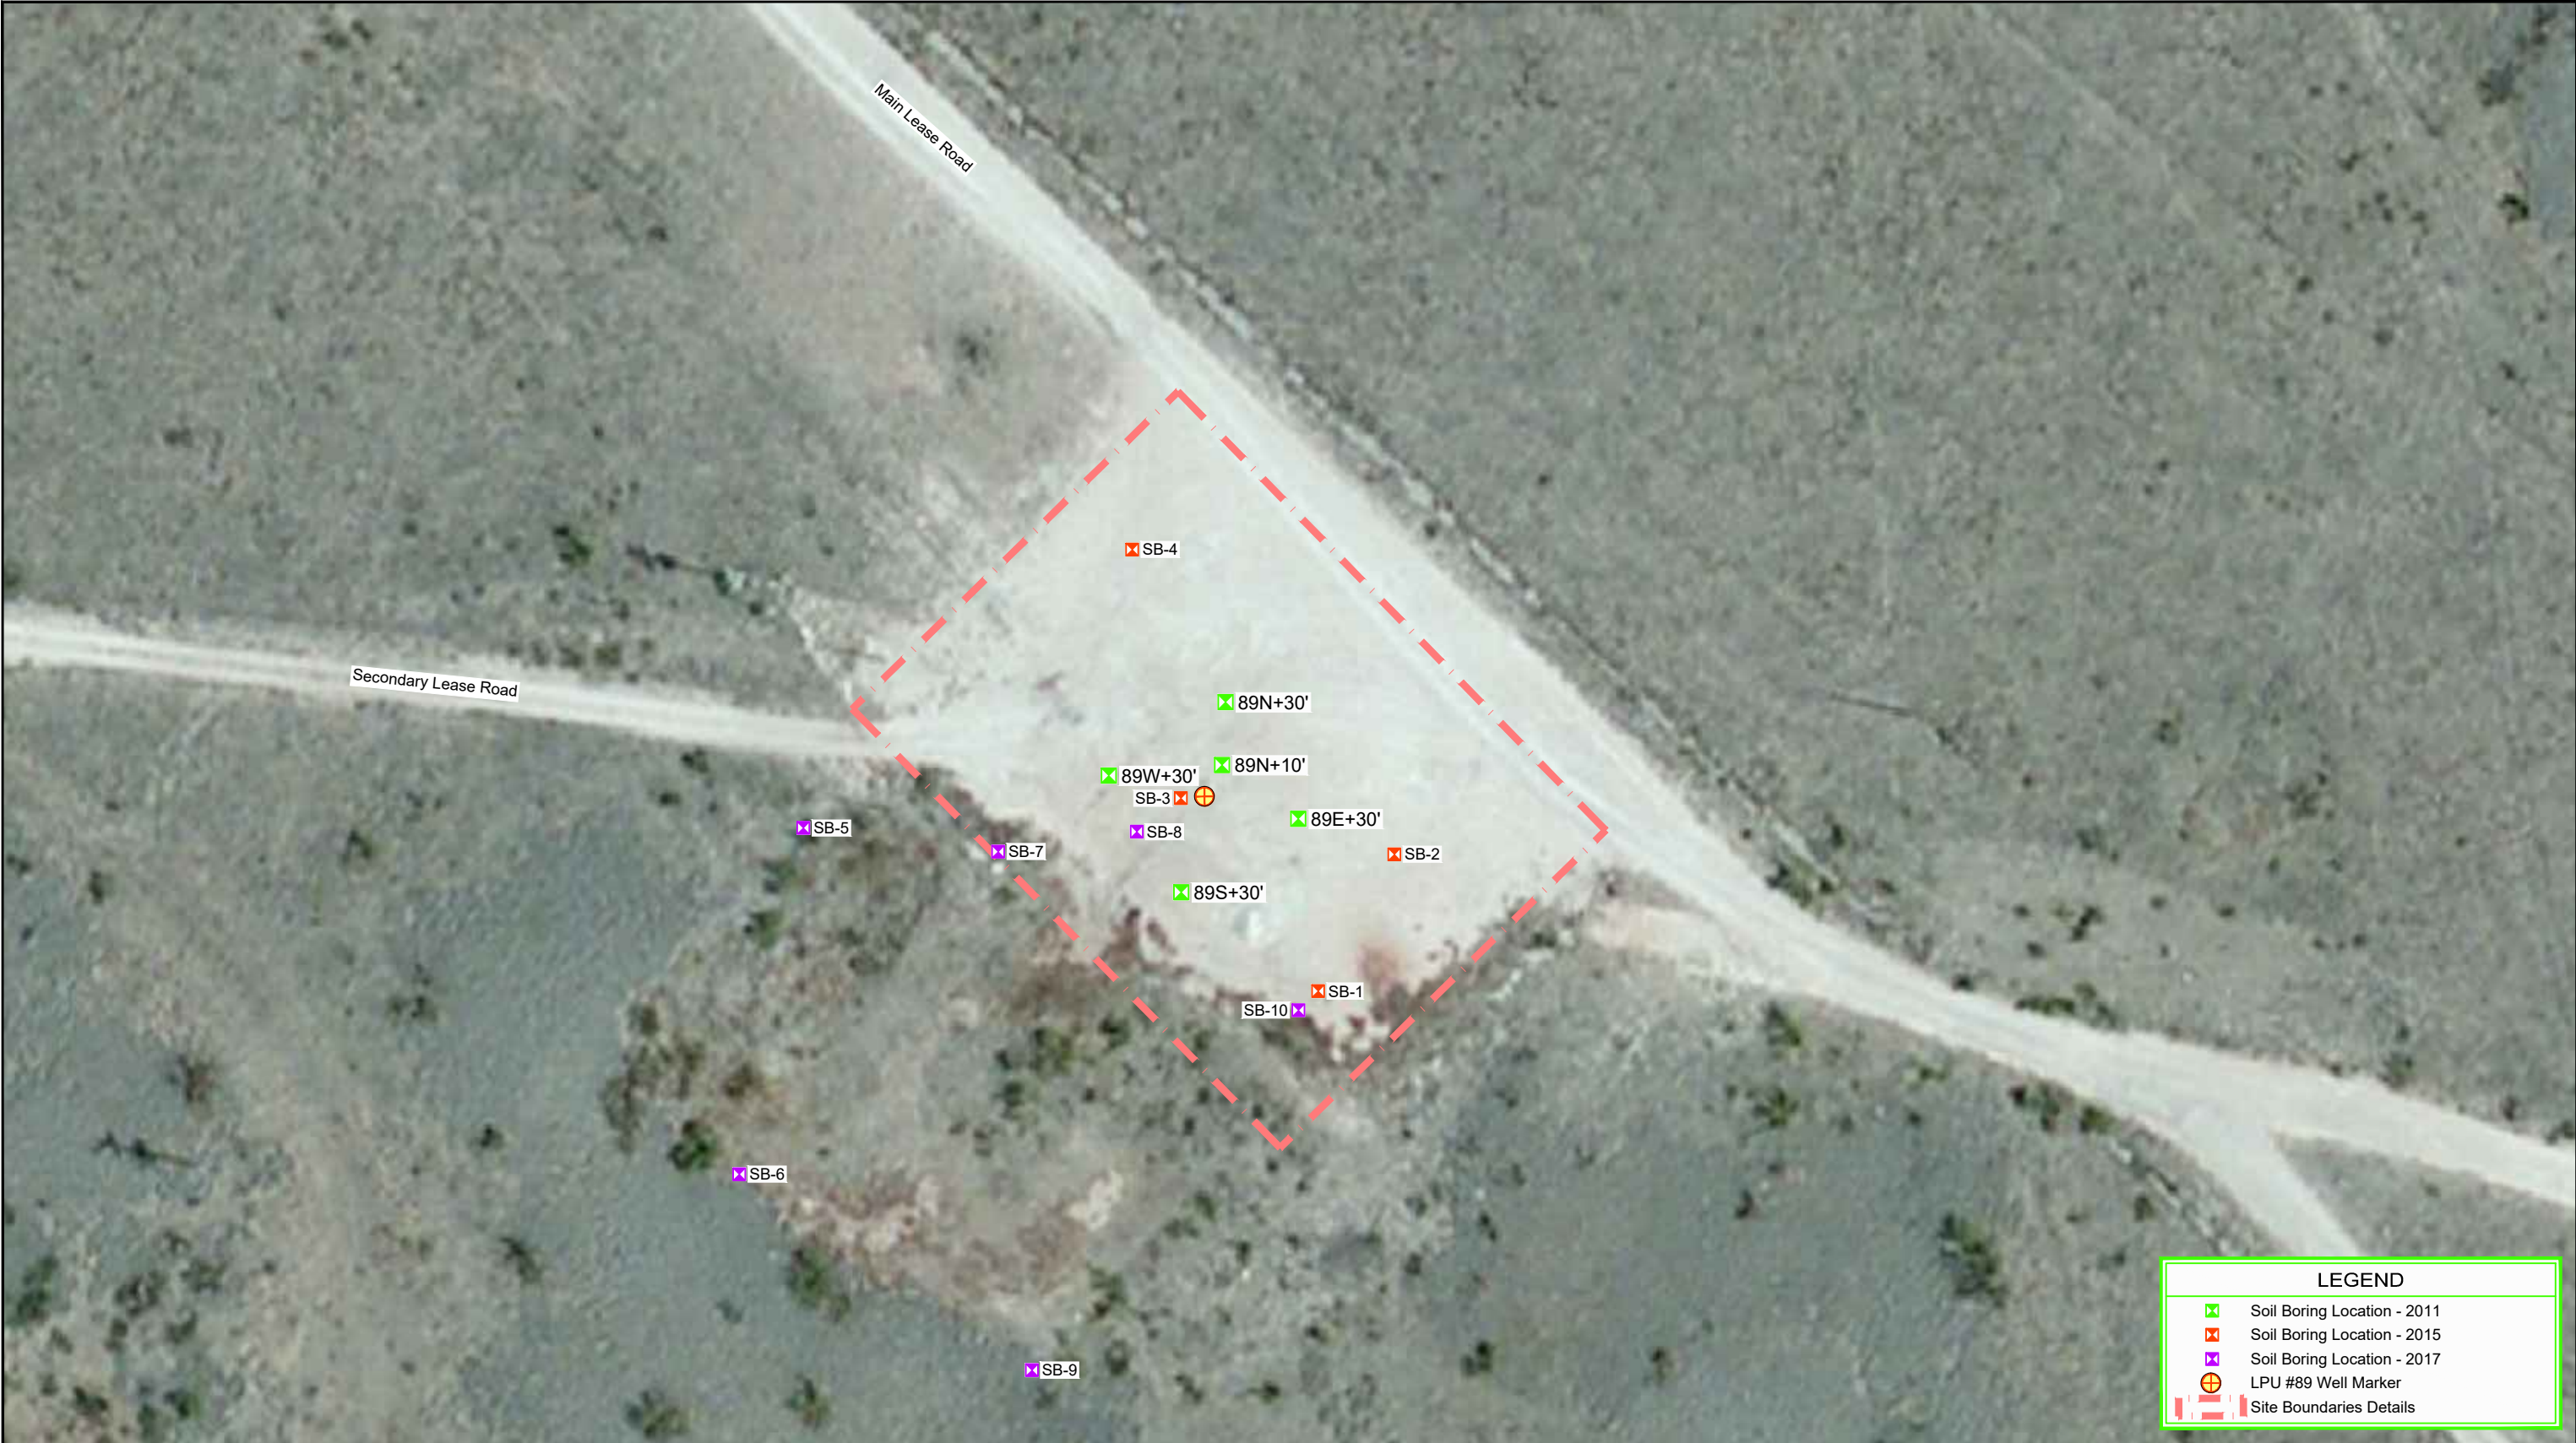
FIGURE 3

knife up to a depth of 5.0 feet bgs or refusal. SB-5 through SB-9 were advanced to 50 feet bgs and SB-10 was advanced to 60 feet bgs. Site details and boring locations are shown on Figure 3.

SOIL BORING LOCATION MAP

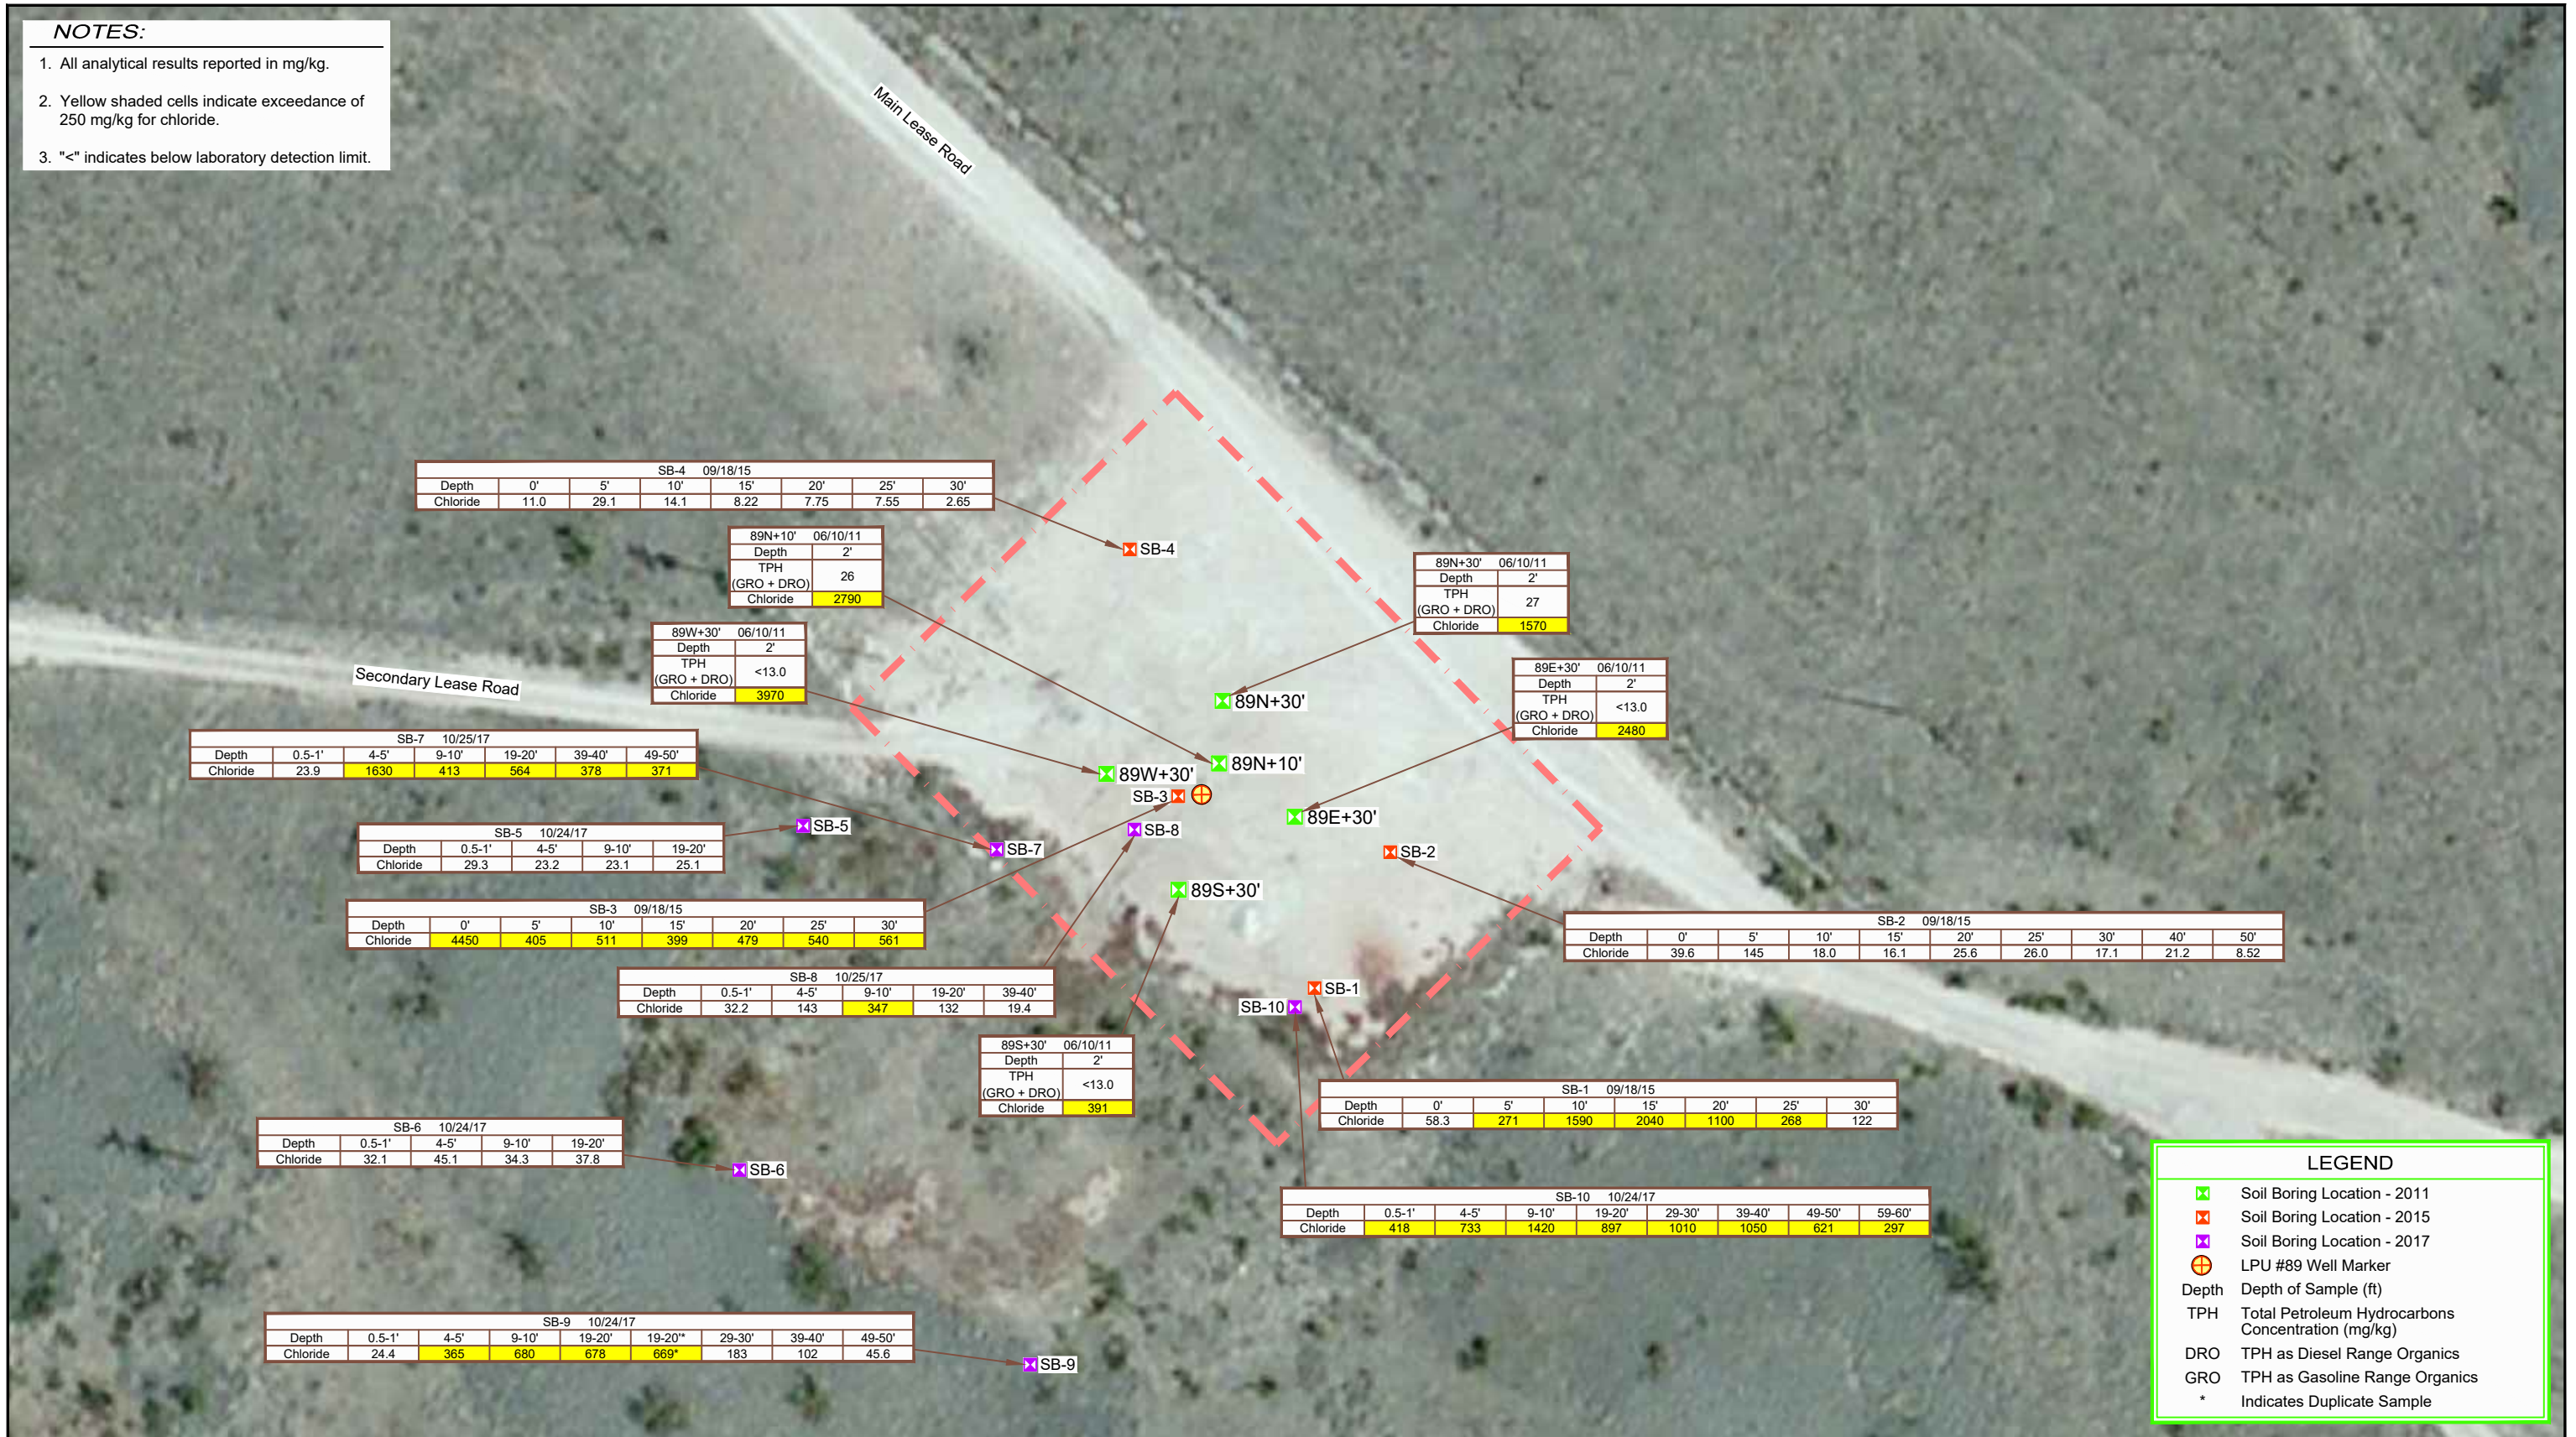
FIGURE 6

Analytical results associated with the soil boring activities of October 2017 are included in Appendix B and discussed in the following section. Based on analytical results from the shallow soil samples, some deeper soil samples collected during this assessment were not analyzed at the direction of GHD. Analytical results are presented in Table 1, shown in map view on Figure 6, and are summarized below:

- Soil samples collected from SB-5 and SB-6 demonstrated chloride concentrations below the site specific RRAL of 250 mg/kg for chloride from 0.5 to 20 feet bgs. As such, the deeper interval soil samples collected (20 to 50 feet bgs) were not analyzed.

- SB-7 exhibited chloride concentrations exceeding the RRAL beginning at sample interval 4-5 feet bgs (1630 mg/kg), and continued through to the soil boring terminal depth at 49-50 feet bgs (371 mg/kg).

- SB-8 demonstrated chloride concentrations below the site specific RRAL in all but one sample interval (9-10 feet bgs at 347 mg/kg).
- SB-9 exhibited chloride concentrations exceeding the RRAL in sample intervals beginning at 4-5 feet bgs (365 mg/kg), continuing through 19-20 feet bgs (669 mg/kg). The highest concentration reported was 680 mg/kg at the 9-10 feet bgs interval.

- SB-10 exhibited chloride concentrations exceeding the RRAL in all sample intervals (0.5-1 feet bgs at 418 mg/kg through 59-60 feet bgs at 297 mg/kg). The highest reported concentration was 1,420 mg/kg at the 9-10 feet bgs interval.

CHLORIDE ANALYTICAL RESULTS MAP

Analytical results associated with assessment activities conducted in 2017 indicate the horizontal extents of the chloride impact in soil have not been fully delineated. The vertical extent of chloride impact appears delineated to concentrations protective of groundwater, and confined to shallow soils less than 60 feet bgs.

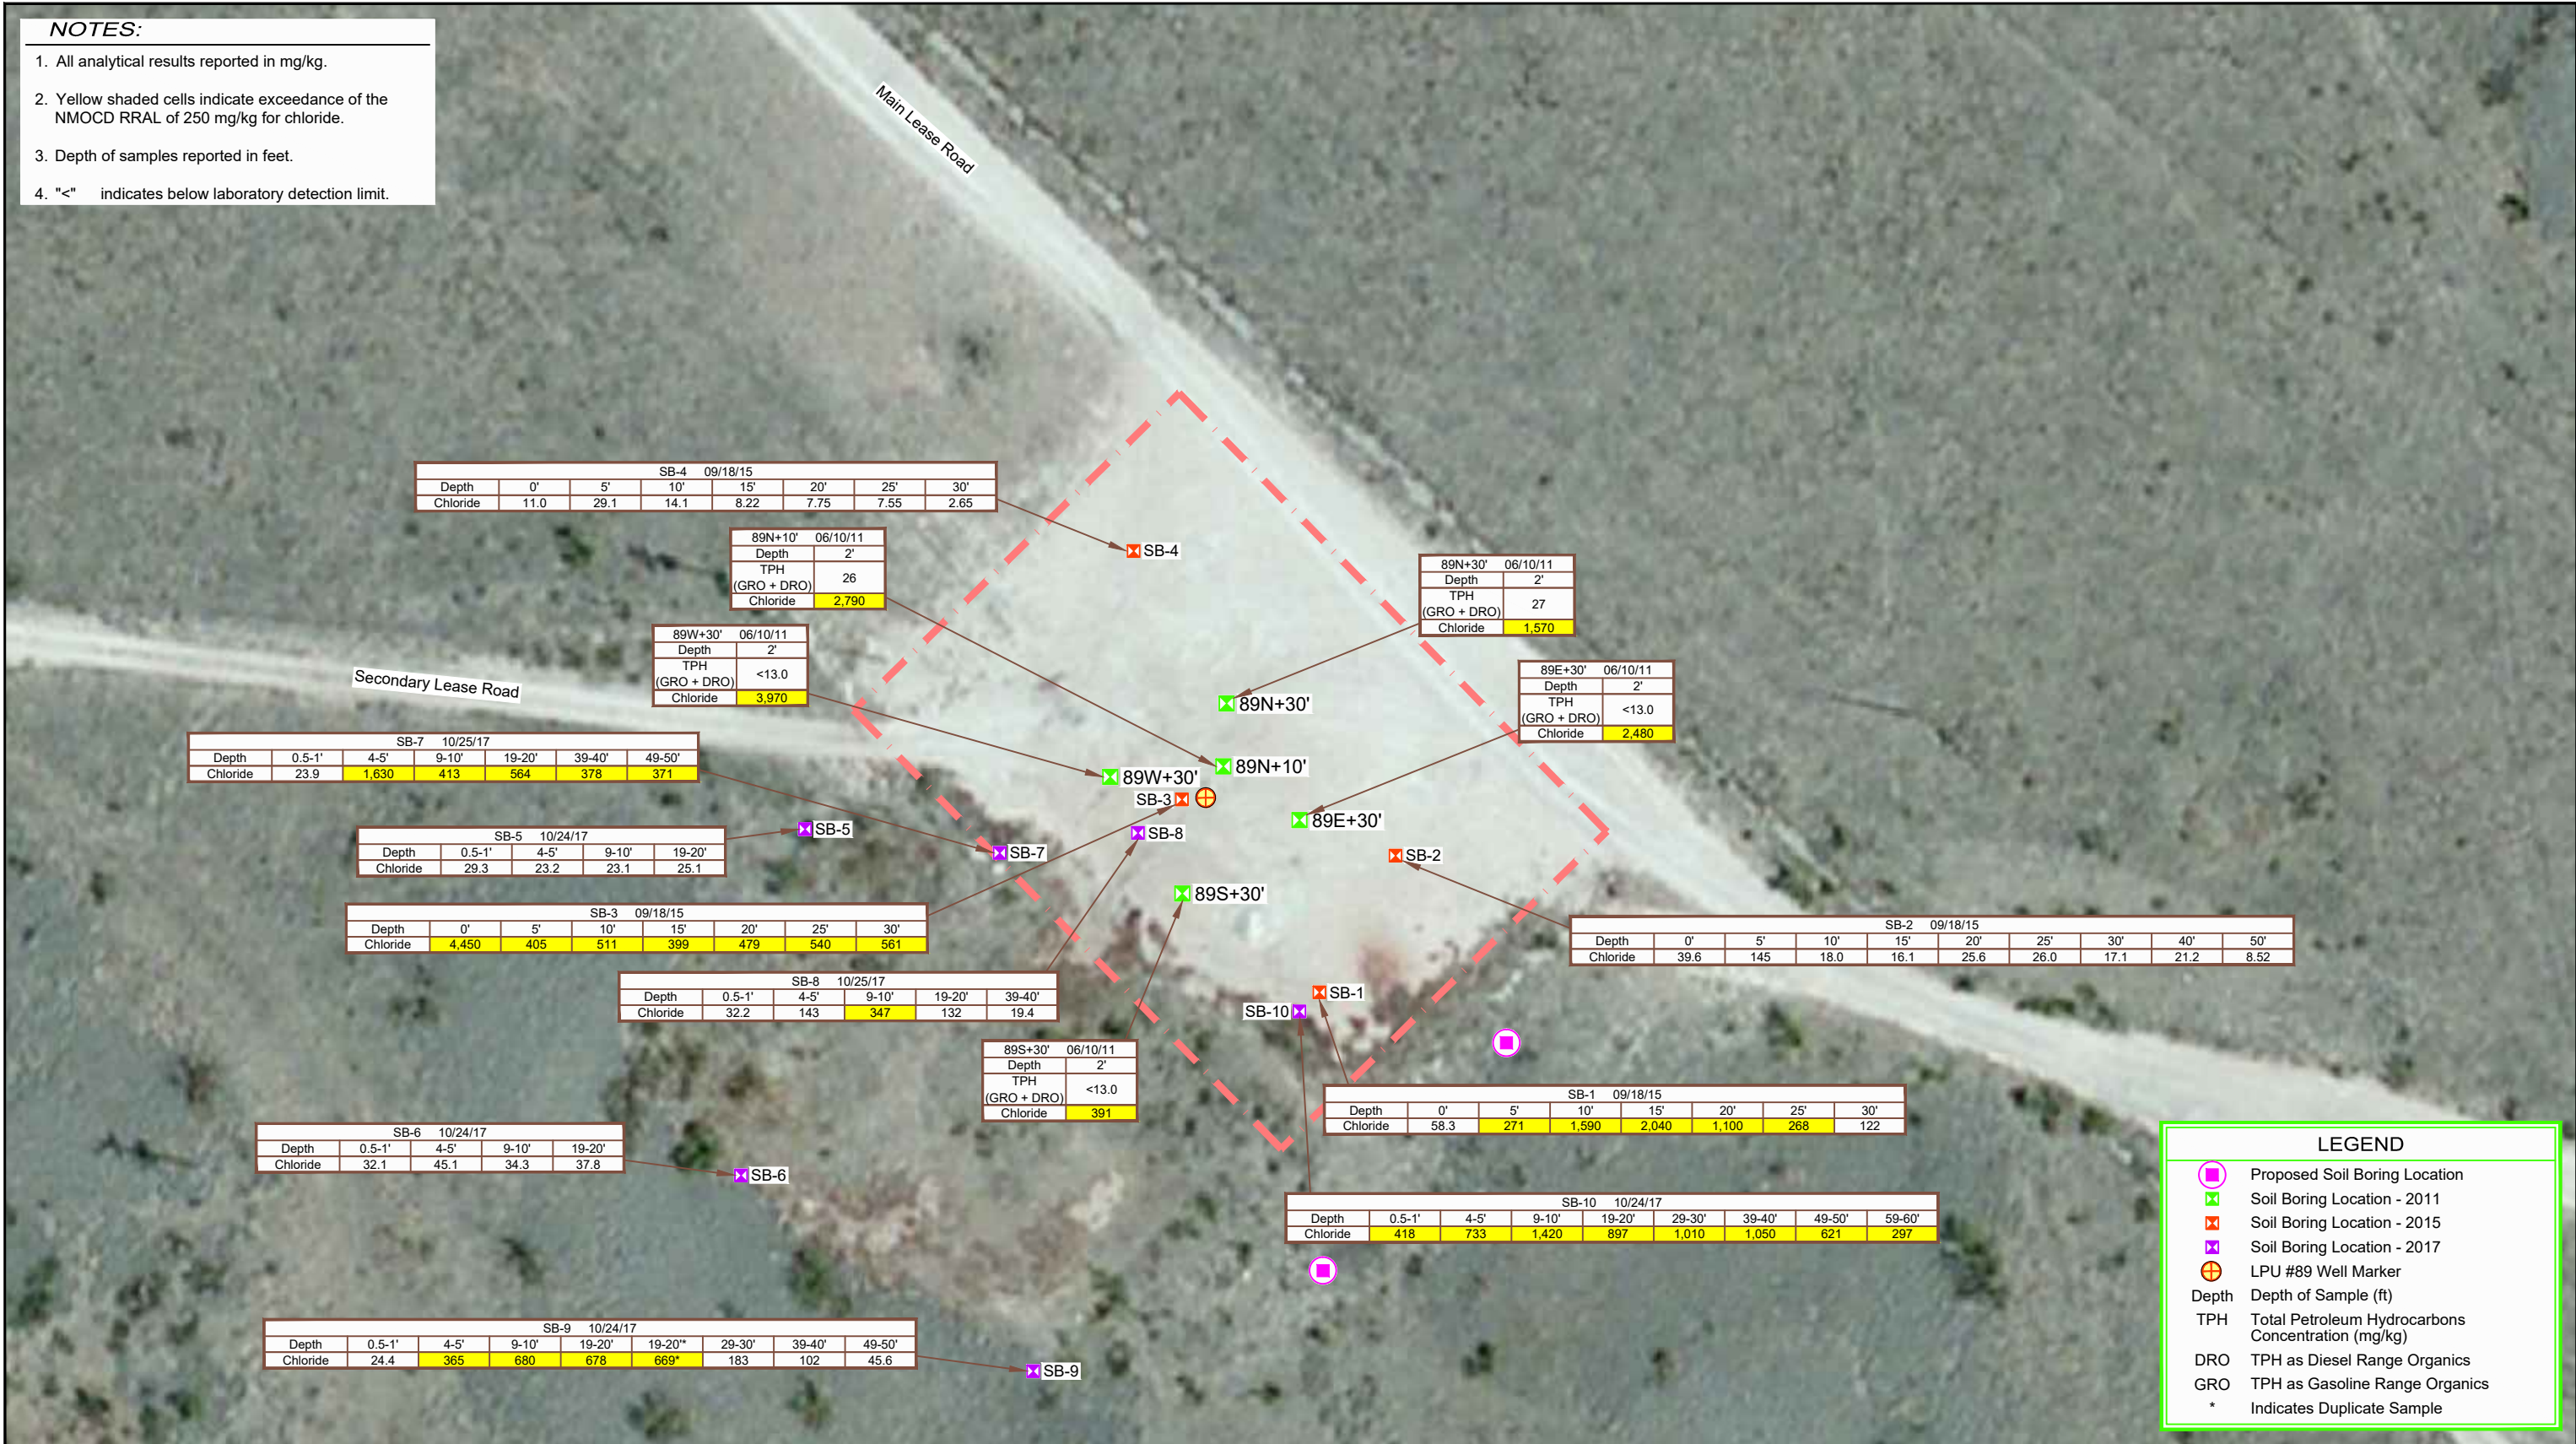
Attachment: Figure 1 – Proposed Soil Boring Location Map

- NOTES:**
- 1. All analytical results reported in mg/kg.
  - 2. Yellow shaded cells indicate exceedance of the NMOCD RRAL of 250 mg/kg for chloride.
  - 3. Depth of samples reported in feet.
  - 4. "<" indicates below laboratory detection limit.

On February 13, 2018, GHD and Chevron representatives met with NMOCD and the New Mexico State Land Office (NMSLO) regarding further delineation activities and future remedial actions addressing the presence of chloride concentrations at the Site. Further delineation activities recommended include the advancement of two soil borings to 70 feet bgs (see Figure 1). The specific locations of the soil borings have been determined based on the geophysical survey and previous soil sample analytical results. The following sections outline the scope of work that will be completed by GHD.
