## **Final Closure Report**

**Chevron USA, Inc.  
Capps Federal #1  
Lea County, New Mexico  
Unit Letter "B", Section 24, Township 20 South, Range 38 East  
Latitude 32.564022 North, Longitude 103.099990 West  
NMOCD Reference #1RP-4579**

**August 2017**

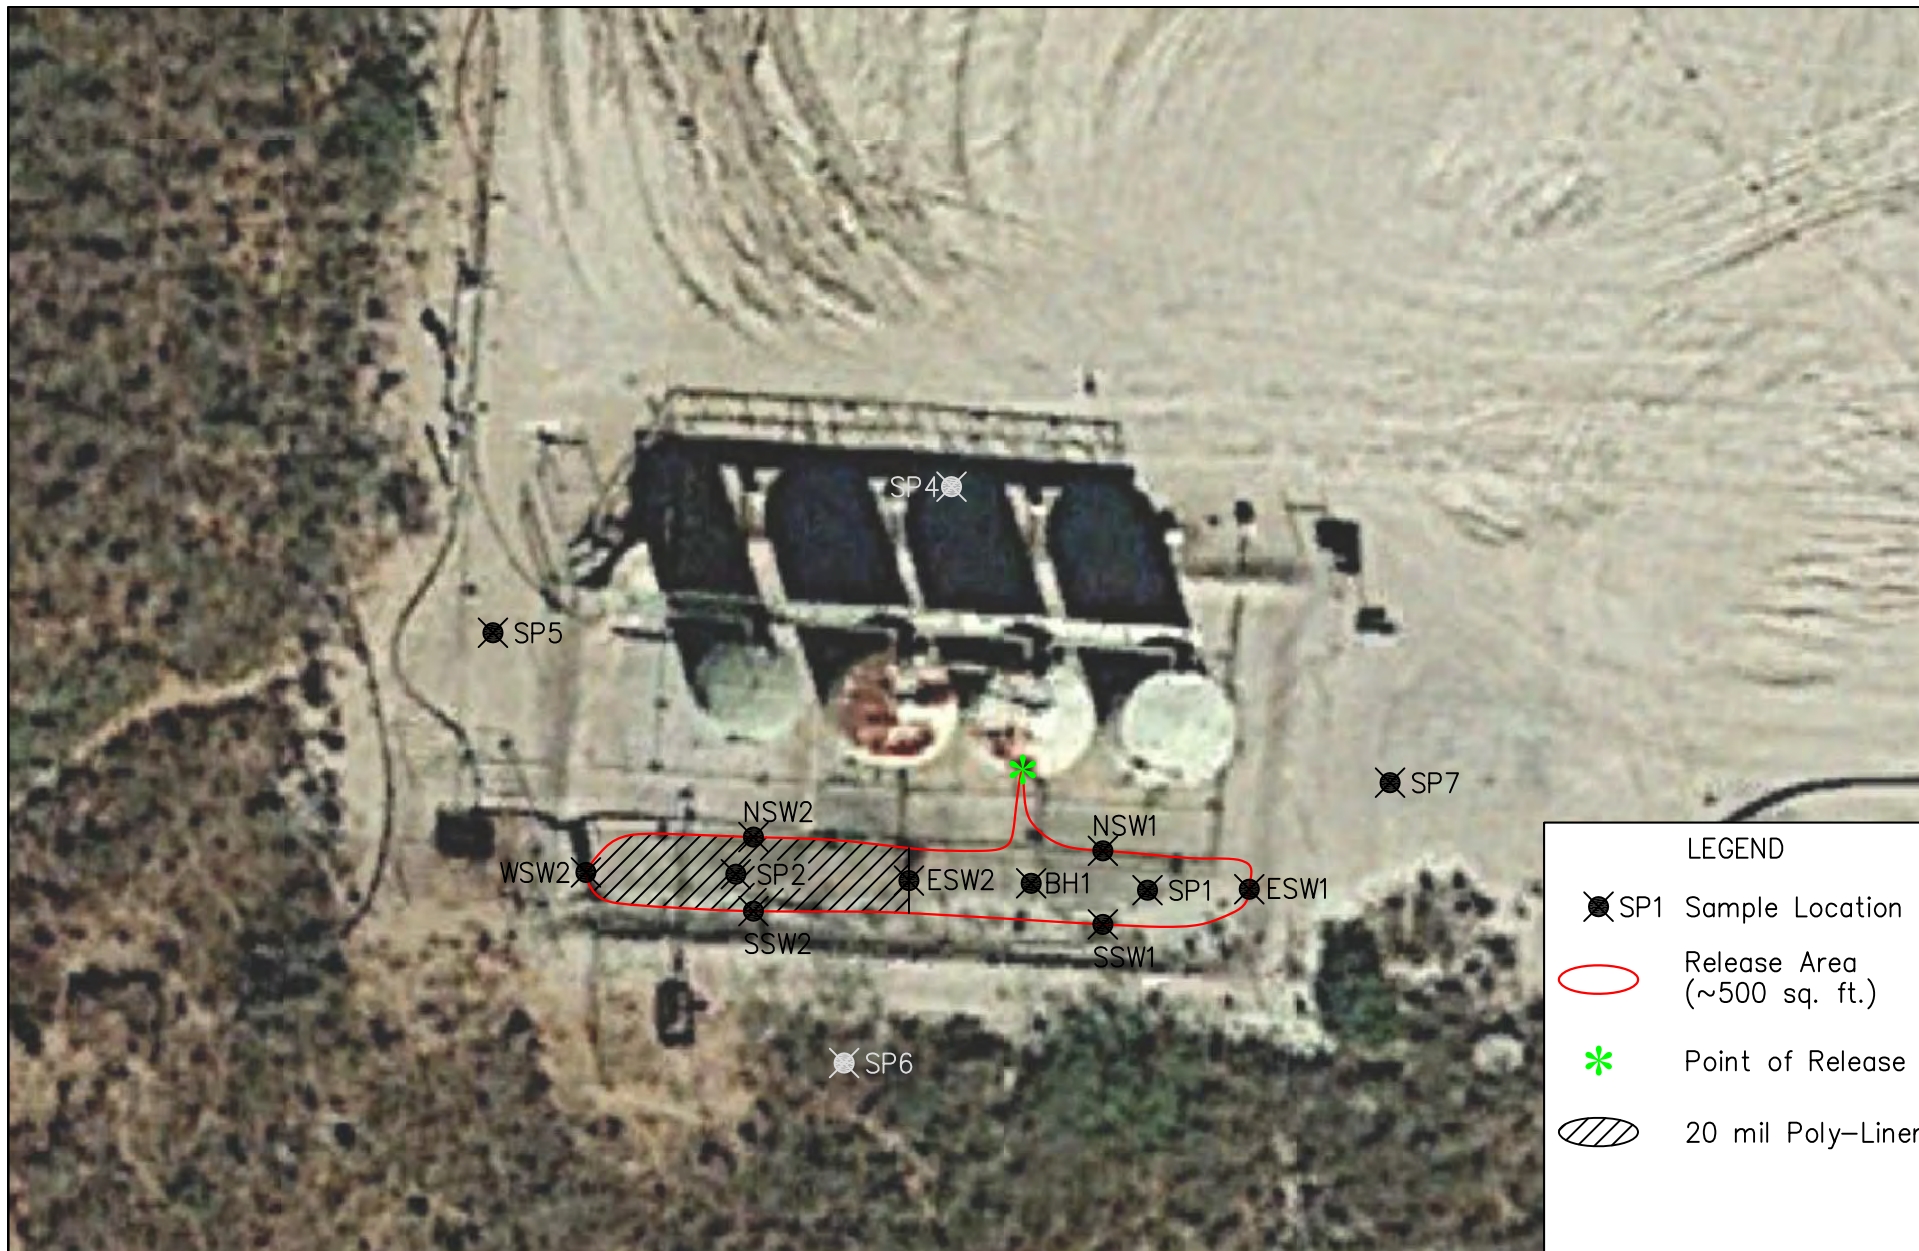
Figure 3  
Site/Sample Map  
Chevron  
Capps Federal #1

On January 26, 2017 EPI personnel mobilized on site to collect soil samples to determine the vertical extent of contamination. A total of fourteen soil samples were collected from two sample locations; SP1 – SP2. Sampling activities ceased when refusal was met at SP2 with a hard caliche layer at ten feet bgs. These fourteen soil samples were field tested only (reference *Figure 3* and *Table 2*).

A total of eight horizontal soil samples were collected from four sample locations surrounding the release area; SP4 – SP7. All eight soil samples were sent to Cardinal Labs in Hobbs, New Mexico, for chloride testing. Laboratory analytical results indicate that Chloride concentrations in the area adjacent to the release area, horizontally, are below NMOCD RRALs of 600 mg/Kg (reference *Figure 3* and *Table 2*).

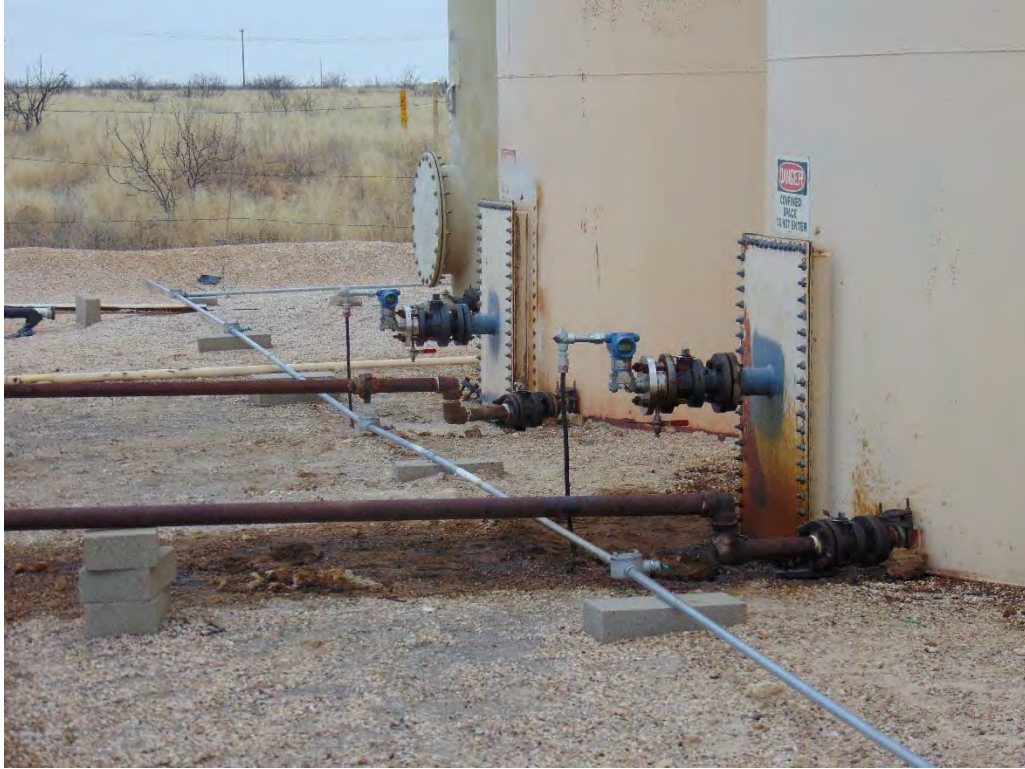
Photograph #1- Point of release

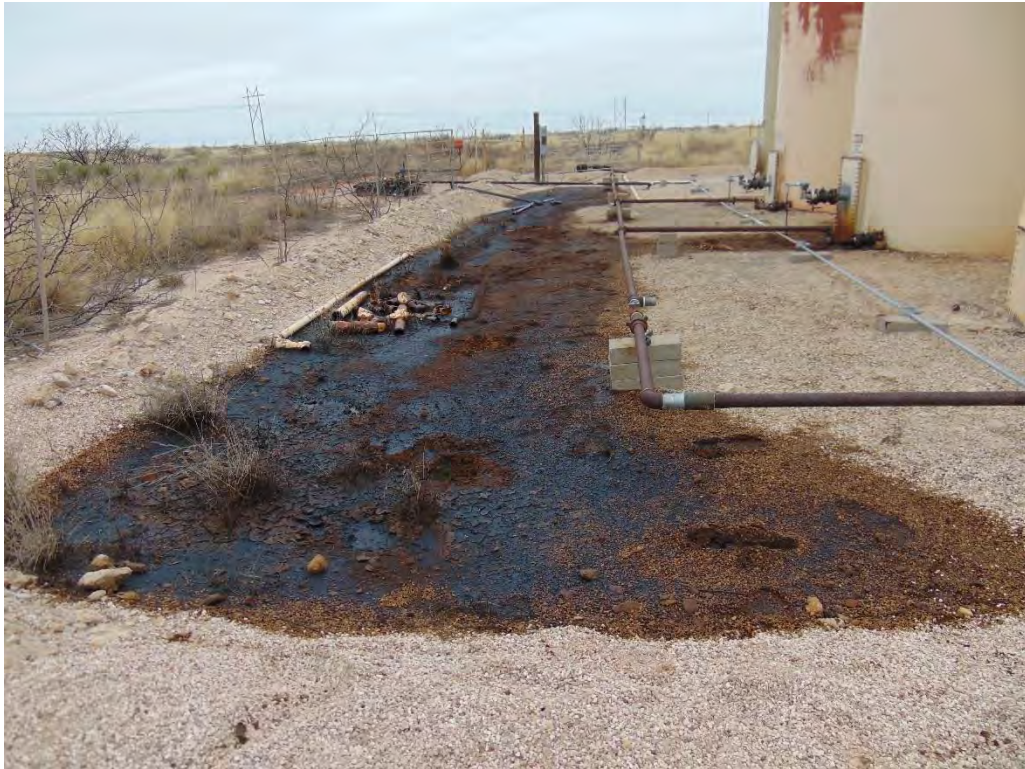
Photograph #2- Looking across release area

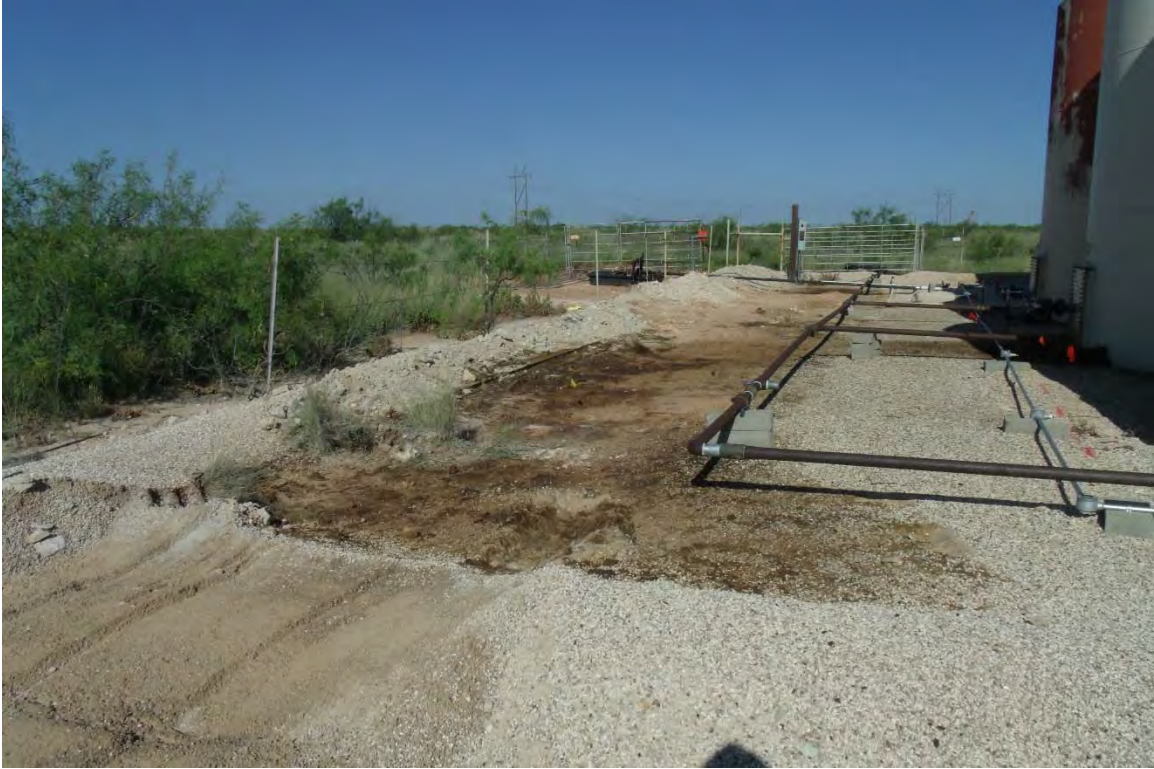
Photograph #3- Excavation

Taking into consideration the release occurred on an active tank battery, field testing indicating TPH and Chloride levels above NMOCD RRALs between surface and twenty-two feet bgs (reference *Table 2*), and with NMOCD approval EPI personnel excavated the tank battery area around SP1 to one-foot bgs and the area around SP2 to four feet bgs. After excavation activities were completed, a 20-mil poly-ethylene liner was installed on the floor of the four-foot excavation over the area of SP2. Confirmation samples were collected from sidewalls and floor of excavation (reference *Figure 3* and *Table 2*). The excavation was then backfilled with clean caliche to impede further vertical migration of impacts. The area adjacent to the release area on the tank battery pad, horizontally, was not disturbed.

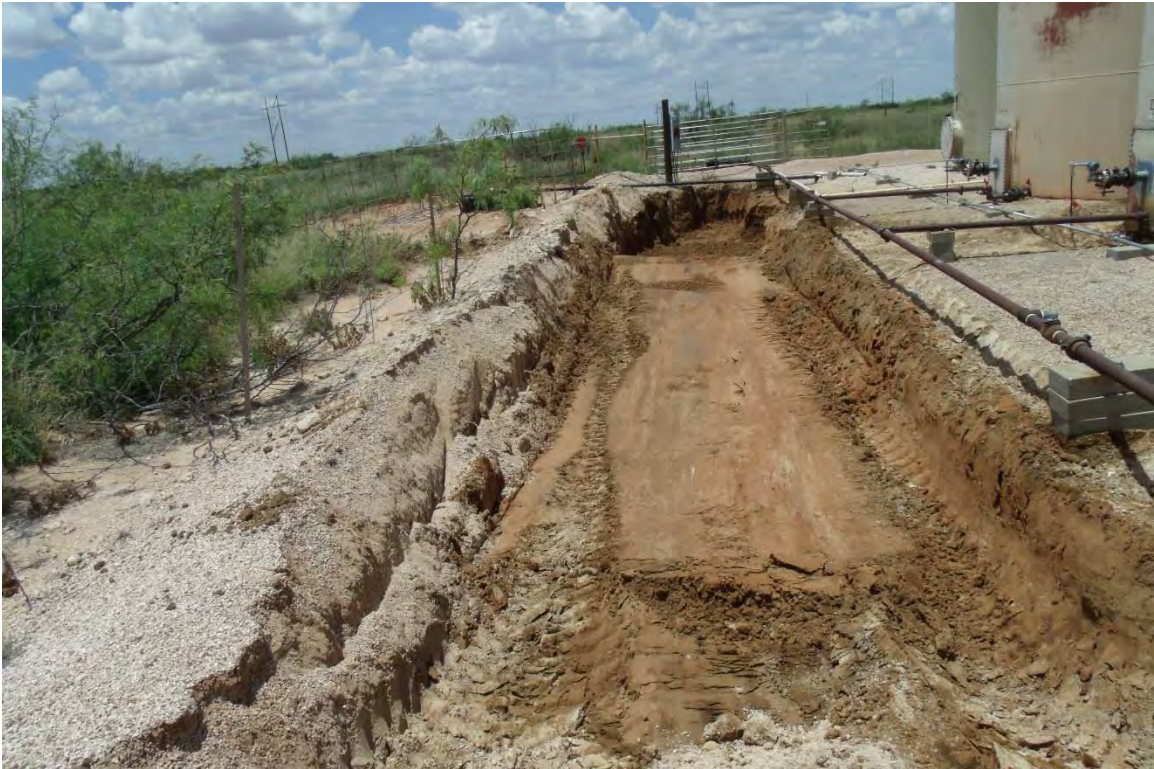
Photograph #4- Excavation

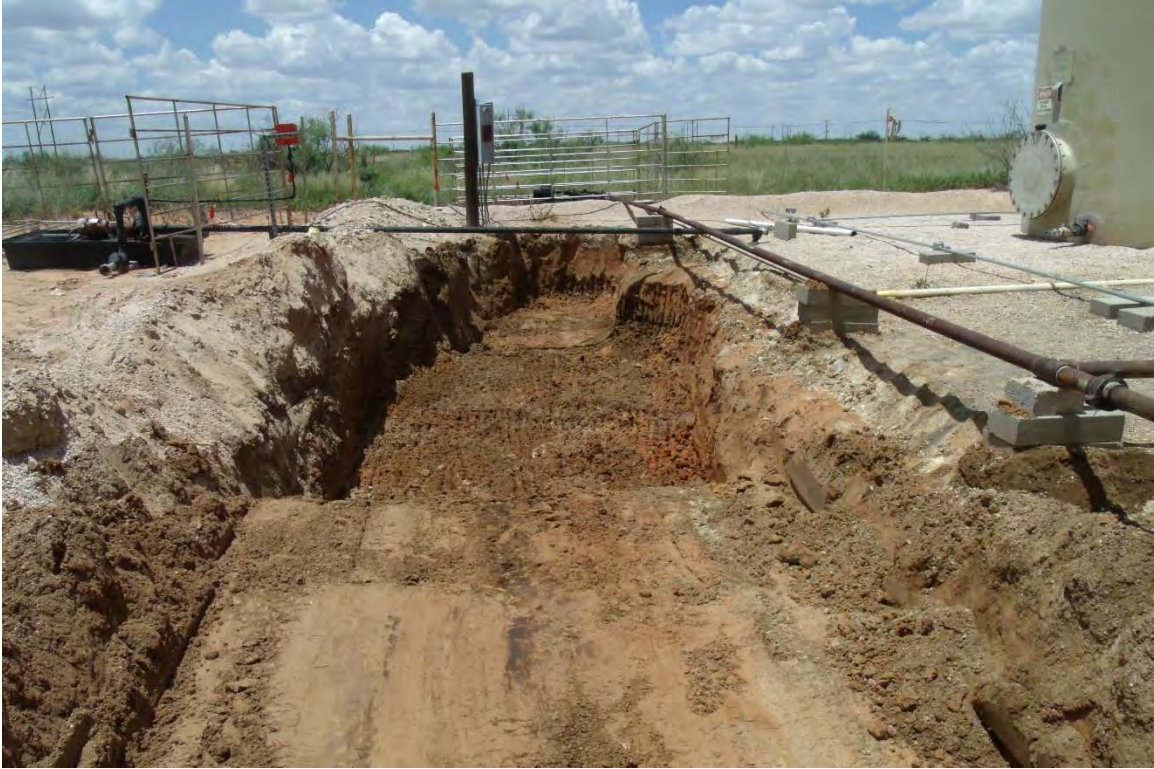
Photograph #5- Excavation

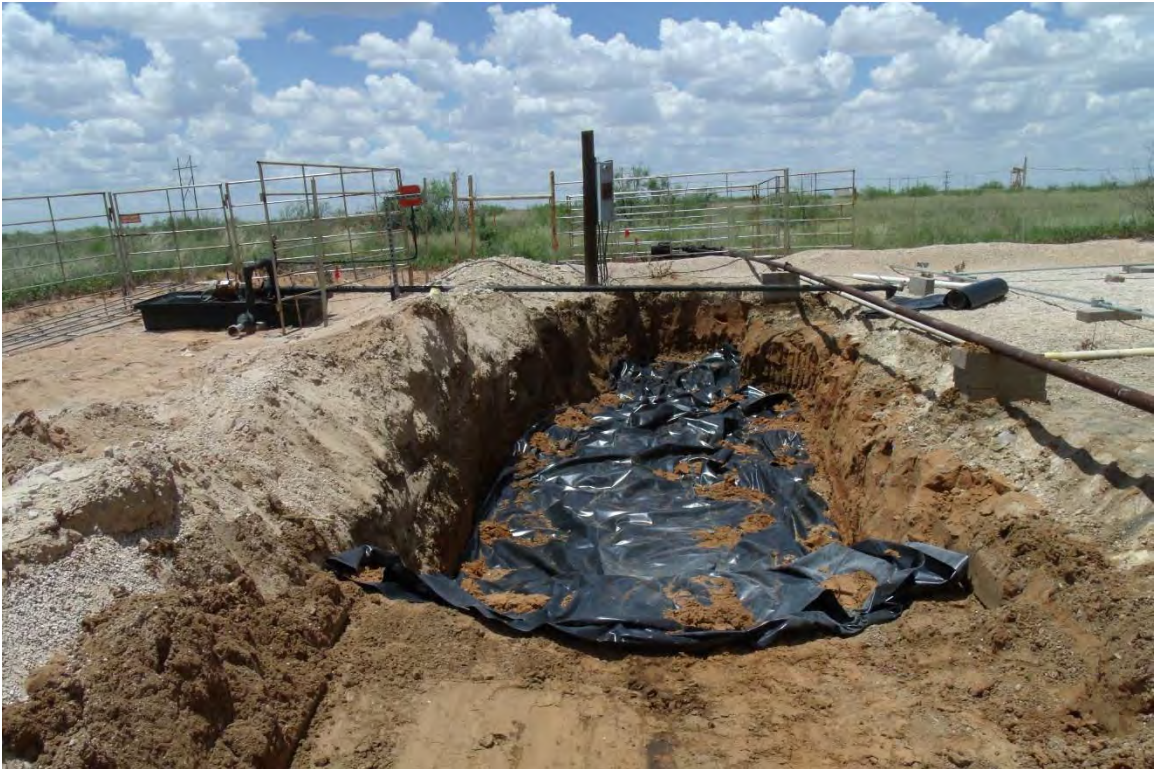
Photograph #6- Excavation and liner

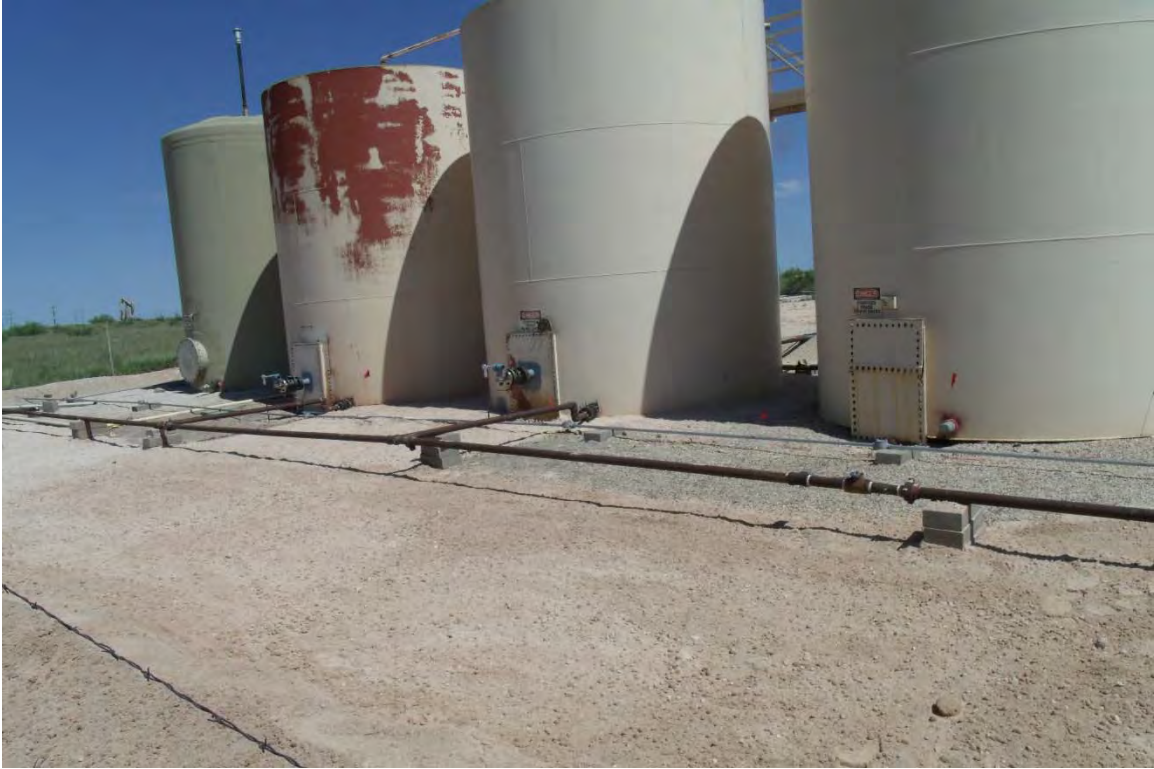
Photograph #7 – Backfilled

Caliche was free of deleterious material or rocks or large clumps. Backfilling continued until the entire excavation was closed. Upon completion of backfill activities, the entire disturbed area was contoured to blend with tank battery area and protected against wind/water erosion.

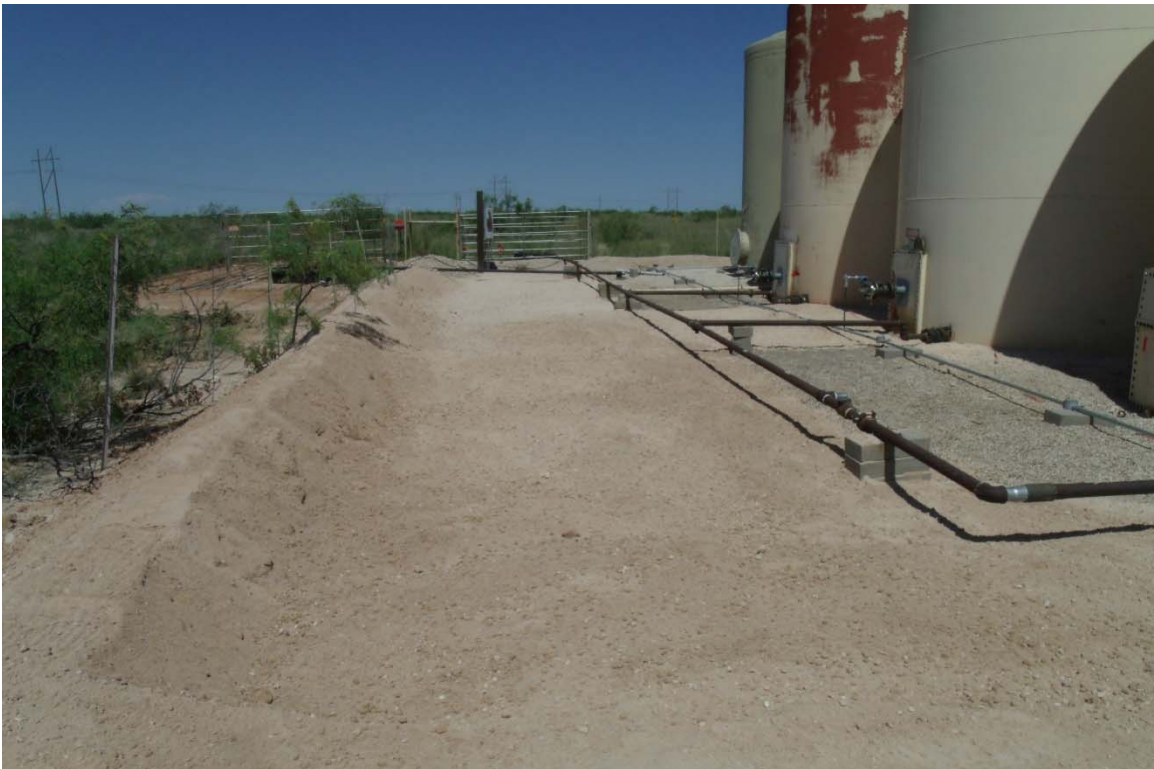
Photograph #8 – Backfilled
