**Release Notification and Corrective Action**

Name of Company: Vanguard	Contact: Chuck Johnston	
Address: 4001 Penbrook, Suite 201, Odessa Texas 79762	Telephone No. 432-202-4771	
Facility Name: Bimini 13 State #4	Facility Type: Tank Battery	
Surface Owner: Dar Angell	Mineral Owner: State	API No. 30-025-35150

1RP-2755

The following *Site Characterization and Work Plan* serves as a condensed update on field activities undertaken and proposed actions for the afore referenced Site.

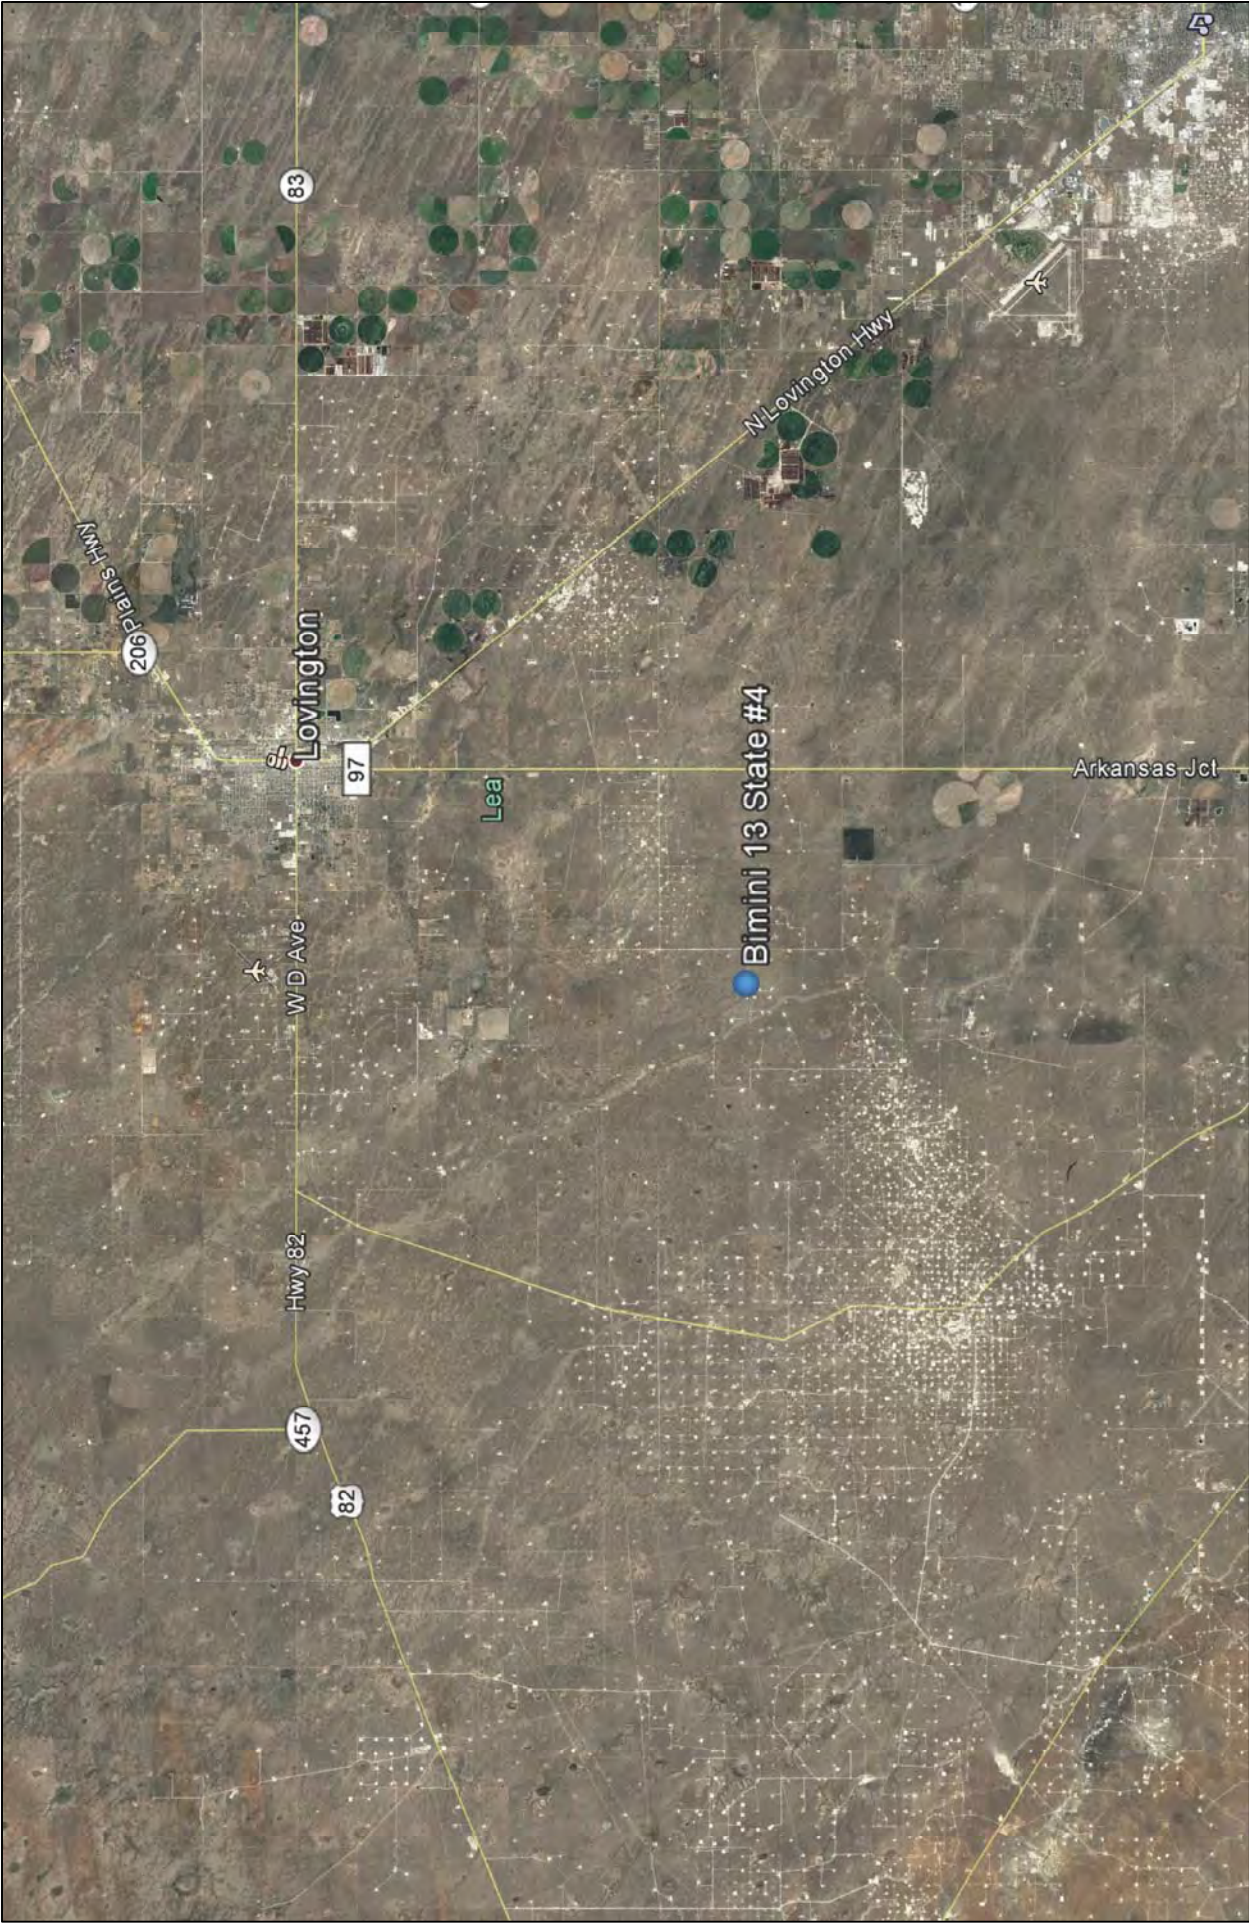
Figure 1 Area Map Vanguard Bimini 13 State #4	Lea County, New Mexico SE 1/4 of NW 1/4, Sec. 13, T17S, R35E N 32° 50' 09.61" W 103° 24' 43.90" Elevation: 3,926 feet amsl	DWG By: D Dominguez August 2017	REVISED:

The release site is located on the pad of an active well and lease road; latitude 32.83595 North, longitude 103.412082 West. Area Map, Site Location Map, and Sample/Site Map are included as Figure 1, Figure 2, and Figure 3, respectively. The Initial NMOCD Form C-141 indicates the connection on a frac tank leaked. The leak was immediately isolated and the connection was replaced. A vacuum truck was brought to the site and 30 barrels of standing fluids were recovered. The area affected was from the frac tank, across the location and flowed off the location pooling next to the lease road. The flow path area measured approximately 321' x 12'. The Initial NMOCD Form C-141 is included as Attachment IV.

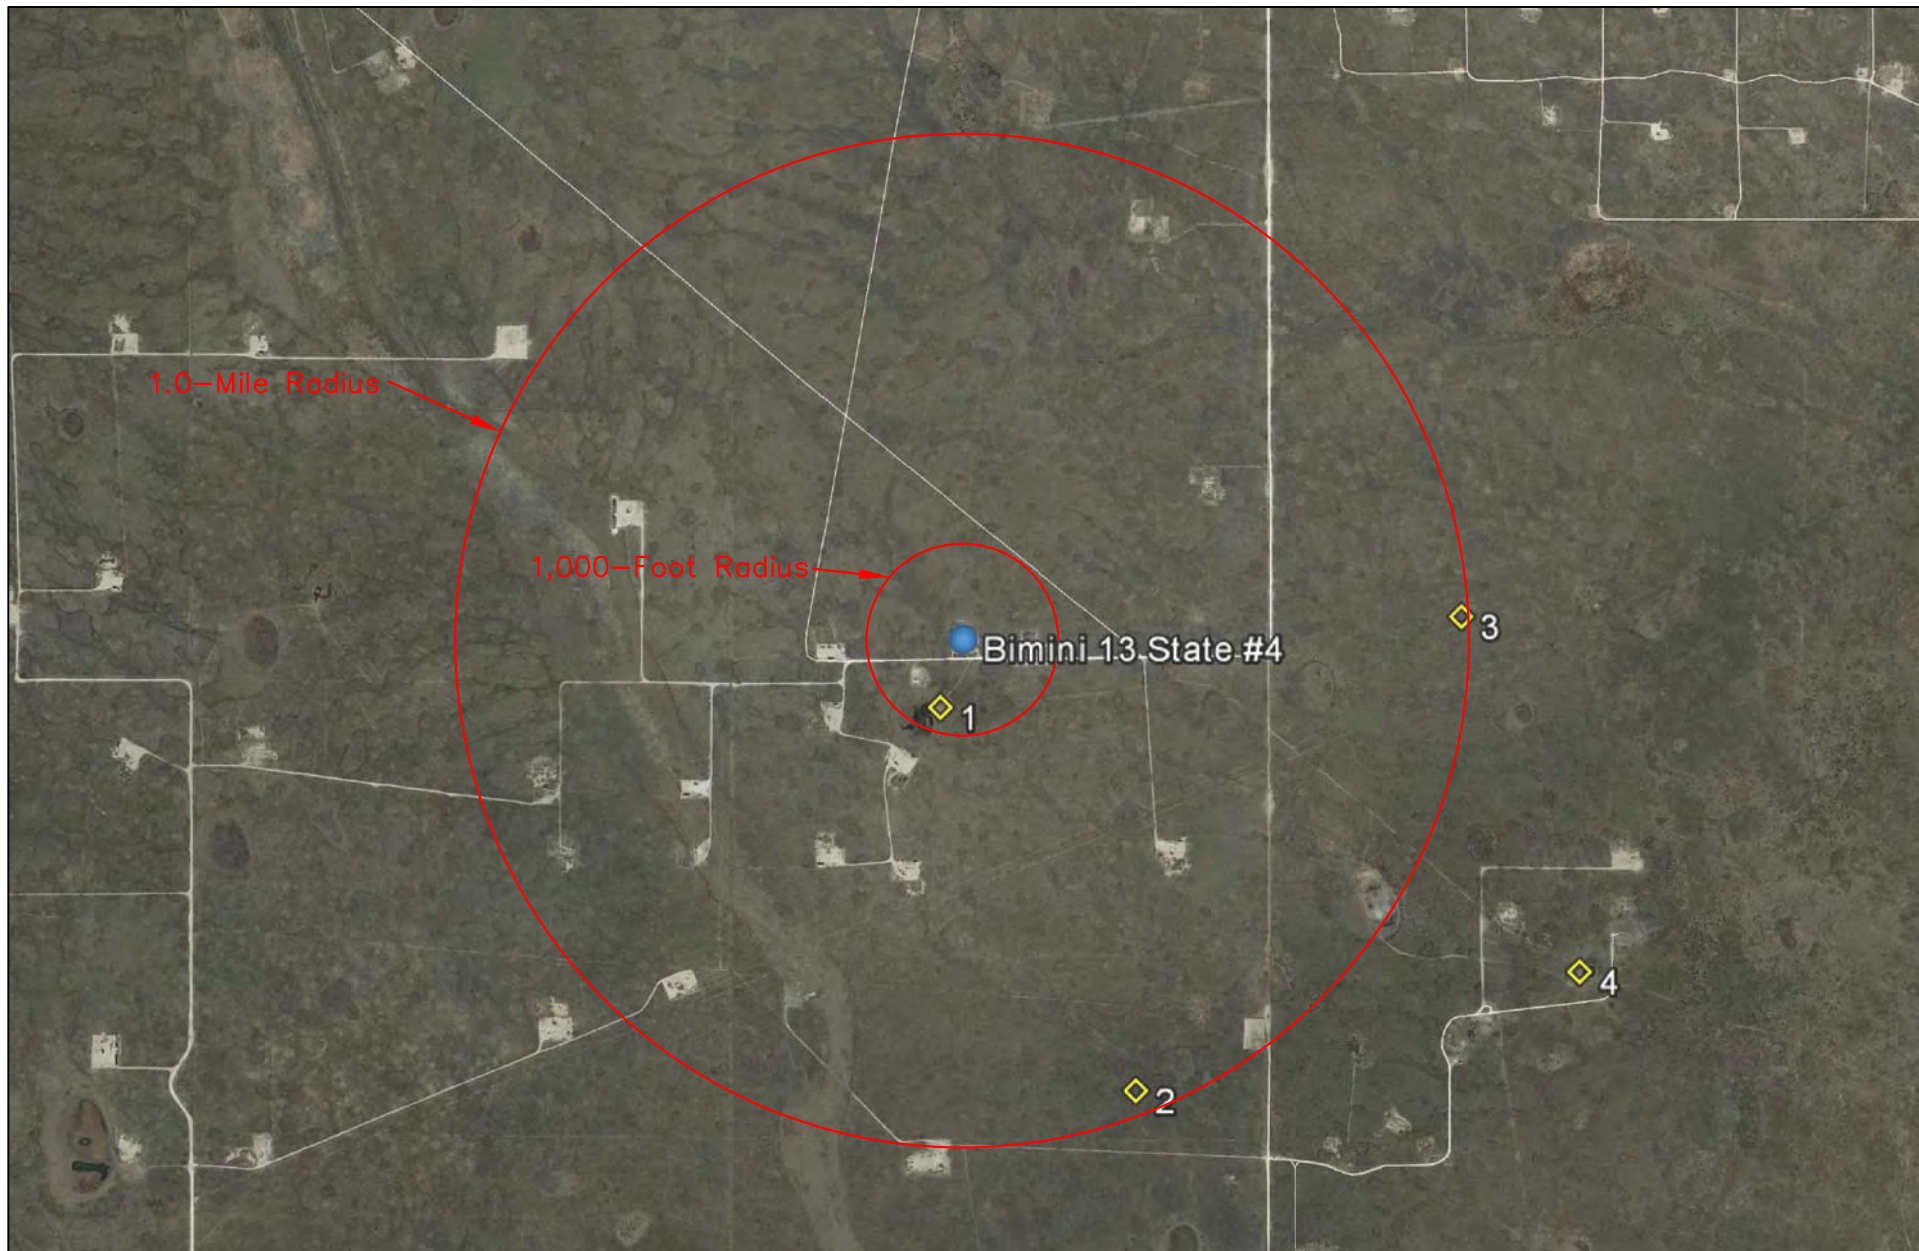
Figure 2  
Site Location Map  
Vanguard  
Bimini 13 State #4

Lea County, New Mexico  
SE 1/4 of NW 1/4, Sec. 13, T17S, R35E  
N 32° 50' 09.61" W 103° 24' 43.90"  
Elevation: 3,926 feet amsl

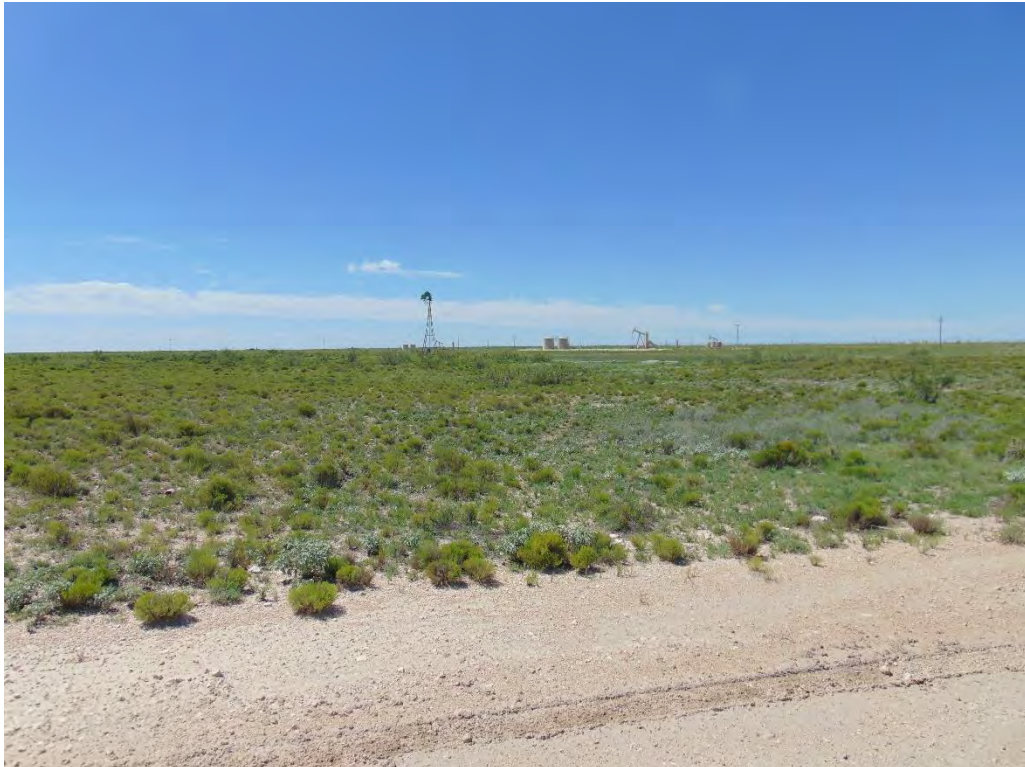
Photograph #8- Well less than 1,000' from location

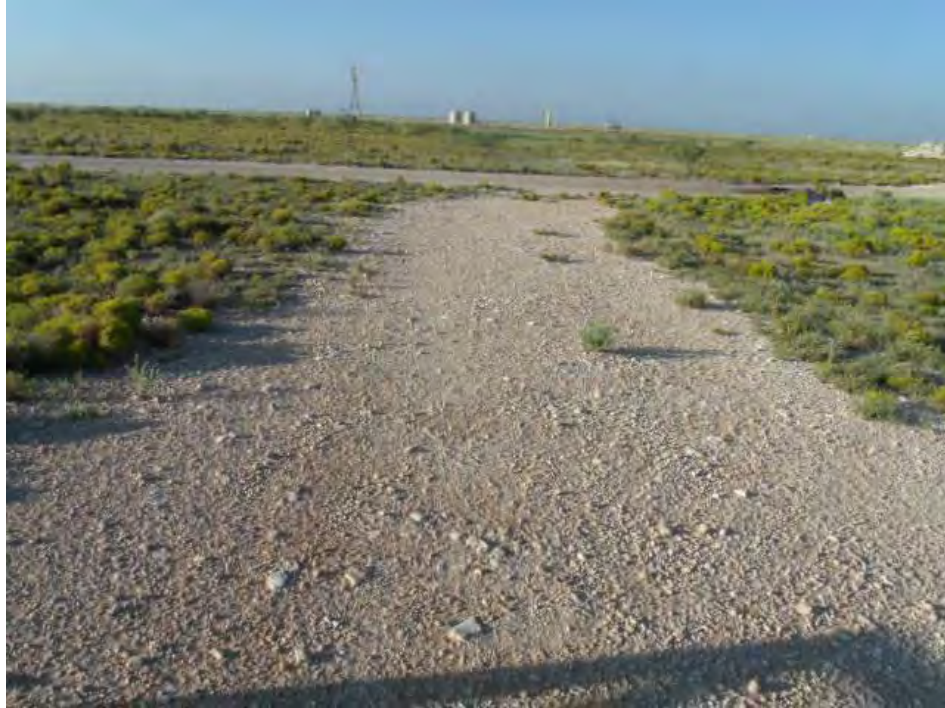
Photograph #9 SP2 prior to excavation

Describe Area Affected and Cleanup Action Taken.\*  
EPI was contacted to sample the location to see if we could find contamination. We found the area around sample point two to be above allowable limits. We dug out sample point two to four ft. Bgs took conformation sample and installed a 20-mil liner and backfilled excavation.

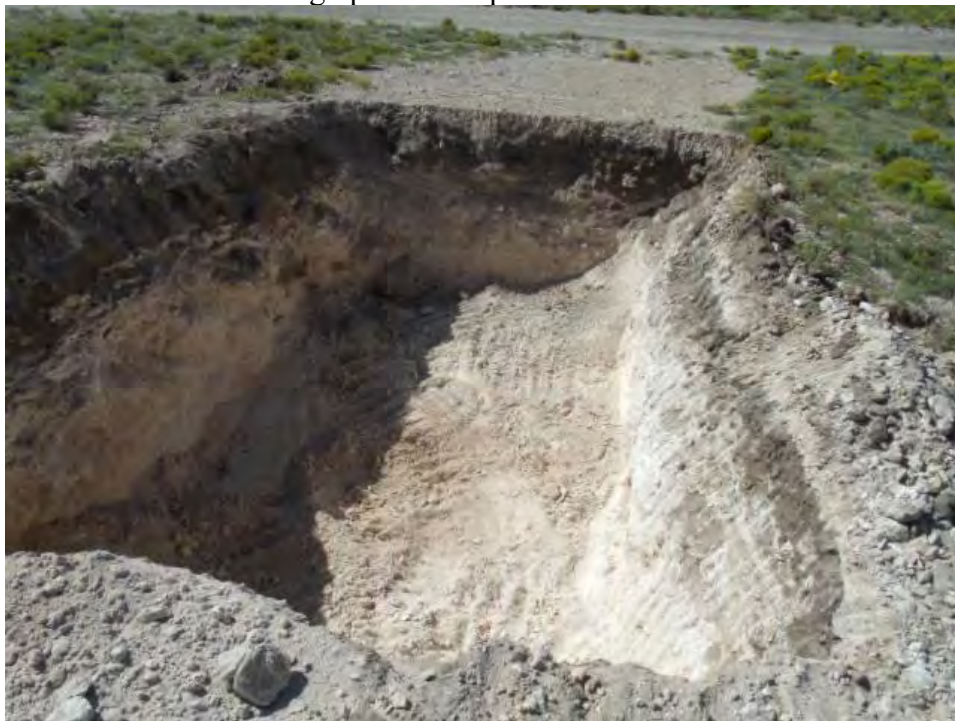
Photograph #10 SP2 excavated

EPI mobilized on the Bimini 13 State #4 with equipment and excavated an area approximately ten ft. wide by fifteen ft. long to 4 ft. bgs. Once excavation activity was complete a conformation sample was taken at the bottom of the excavation. Sample was taken to Cardinal labs in Hobbs, NM, and method 300 was ran on the soil for closure. Soil was then hauled to a state approved disposal facility. A 20-mil liner was installed with a topsoil base to protect liner, then caliche was used to backfill remainder of excavation.

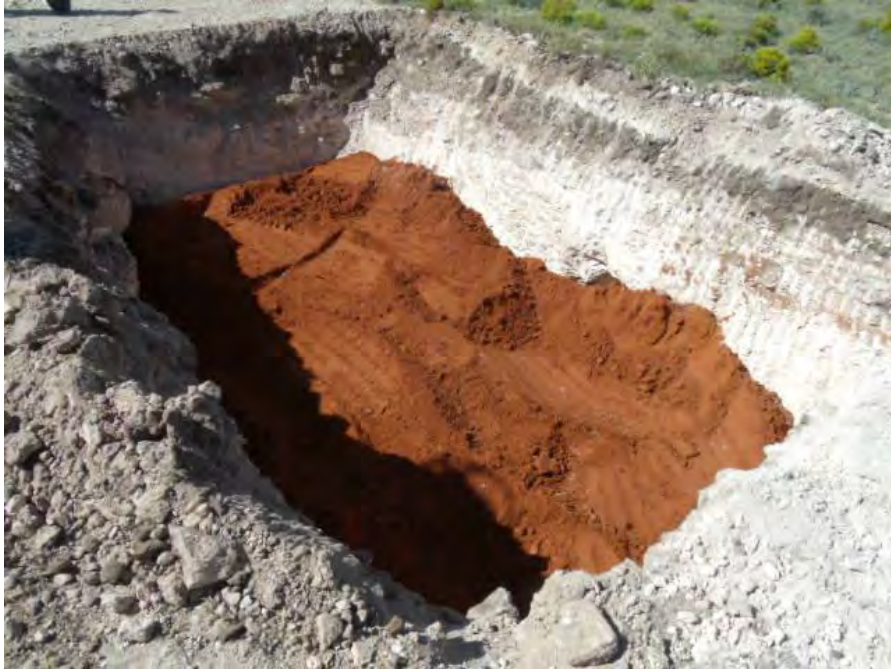
Photograph #11 Topsoil base

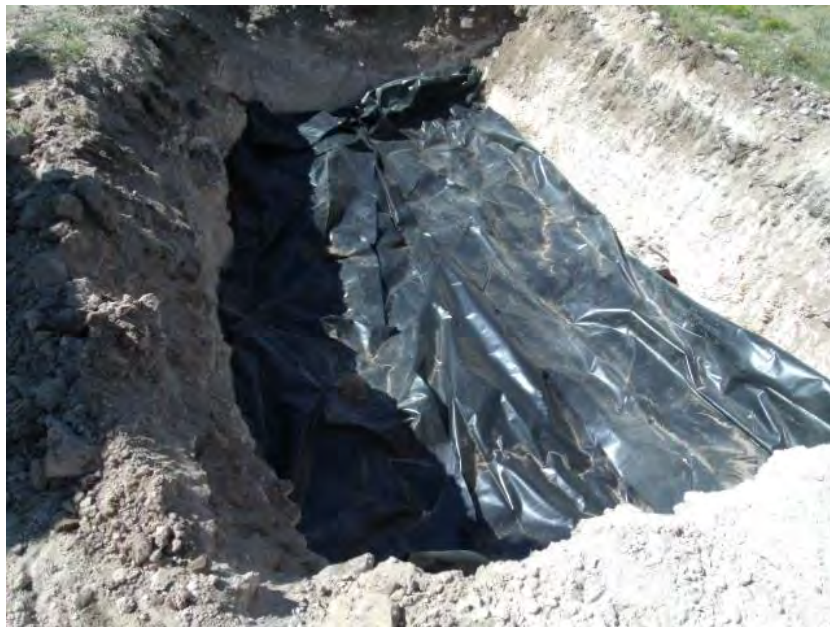
Photograph #12 Liner installed

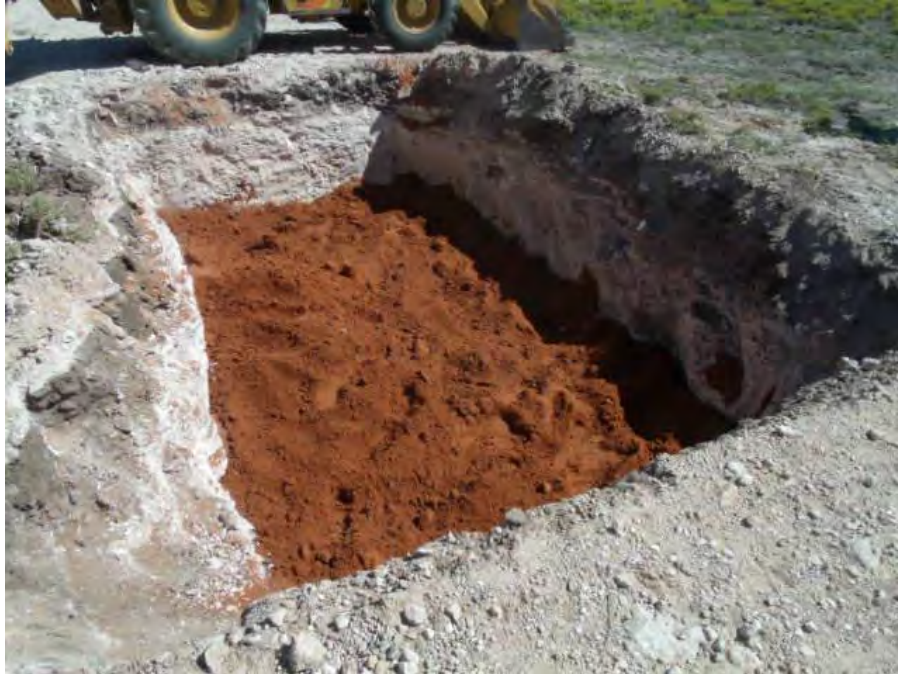
Photograph #13 Topsoil base on top of liner

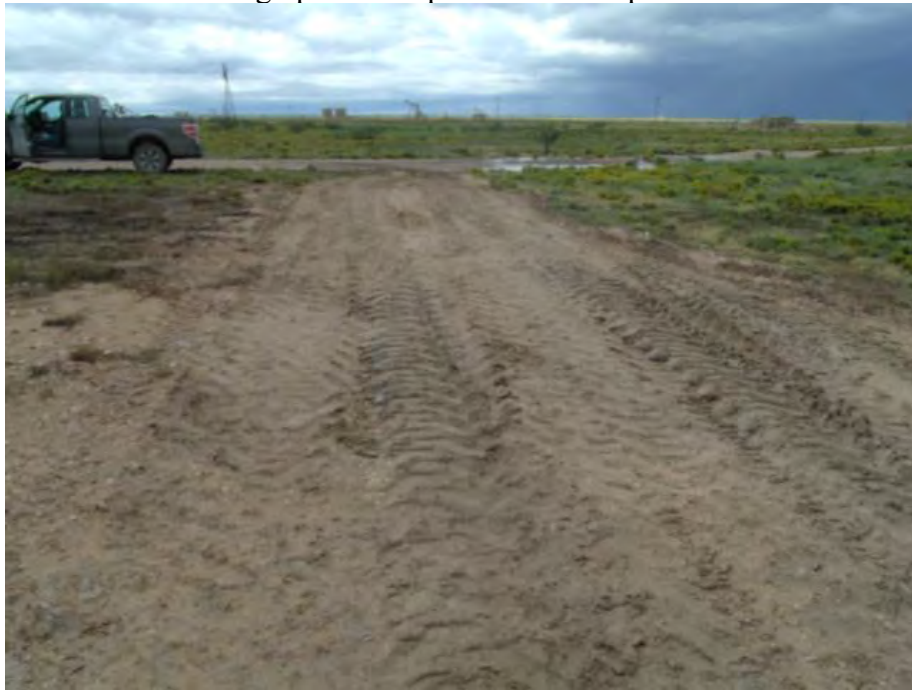
Photograph#14 Excavation backfilled
