Report Type: Closure Report 1RP-4744

| Site: | Speedy 16 State Com 501H | | | | | |
| Company: | EOG Resources | | | | | |

Re: Closure Report for the EOG Resources, Speedy 16 State Com 501H, Unit B, Section 16, Township 22 South, Range 33 East, Lea County, New Mexico. 1RP-4744

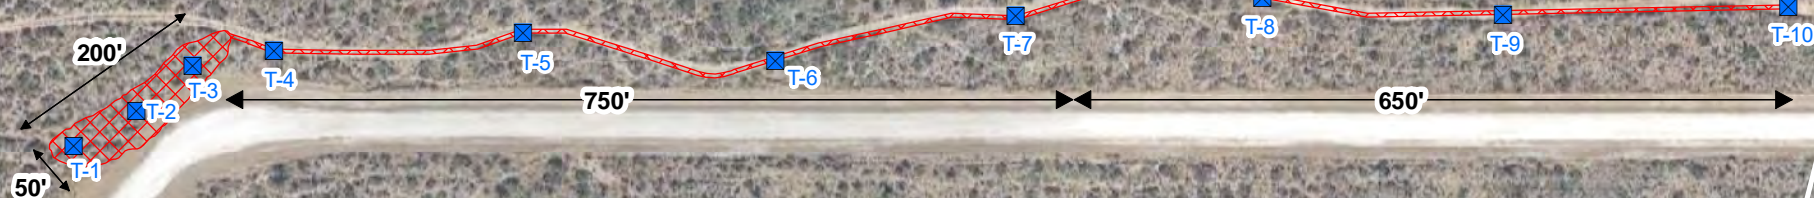
Figure 3

According to the State of New Mexico C-141 Initial Report, the release was discovered on July 27, 2017. Approximately two hundred and forty (240) barrels of produced water was released from an illegal dump by a water haul truck. None of the fluids were recovered. The release impacted an area measuring approximately 50' x 200' in the pasture and migrated onto the adjacent two-track road impacting an area measuring approximately 10' x 1,400'. The initial C-141 form is included in Appendix A. The release areas are shown on Figure 3.

- TRENCH SAMPLE LOCATIONS
- ▨ SPILL AREA

Spill Assessment Map

Tetra Tech personnel field screened selected samples for salinity using an ExStick II EC400 meter. Selected samples were analyzed for TPH analysis by EPA method 8015 modified, BTEX by EPA Method 8021B and chloride by EPA method 300.0. Copies of laboratory analysis and chain-of-custody documentation are included in Appendix C. The sampling results are summarized in Table 1. The trench locations are shown on Figure 3.

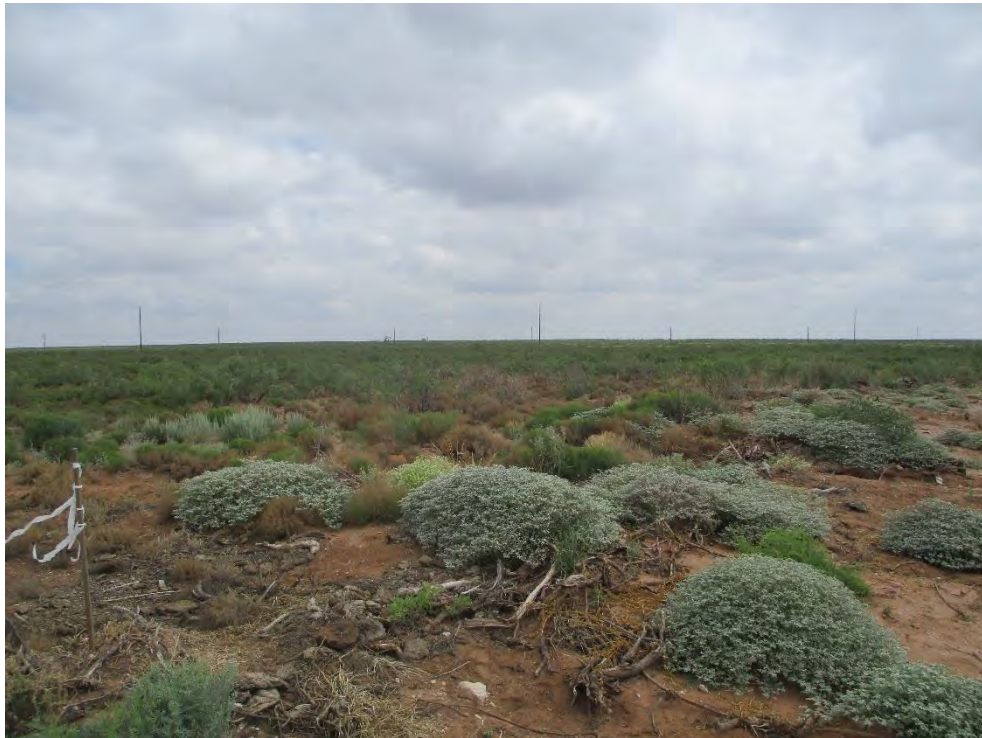
However, elevated chloride concentrations were detected in the shallow soils. In the pasture, the areas of trenches (T-1, T-2 and T-3) showed chloride highs of 6,550 mg/kg at 1.0', 2,170 mg/kg at 0'-1', and 8,730 mg/kg at 1.0' below surface respectively. The chloride concentrations significantly declined with depth between 2.0' and 4.0' below surface.

View North- Area T-1, T-2 and T-3

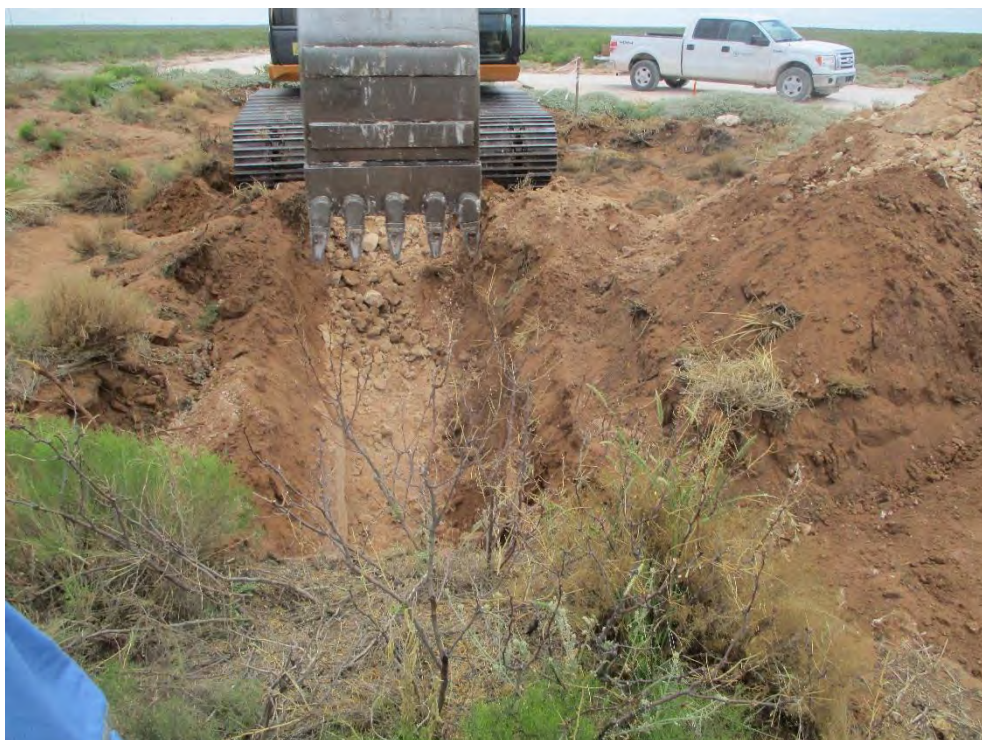
View South, Trench#1

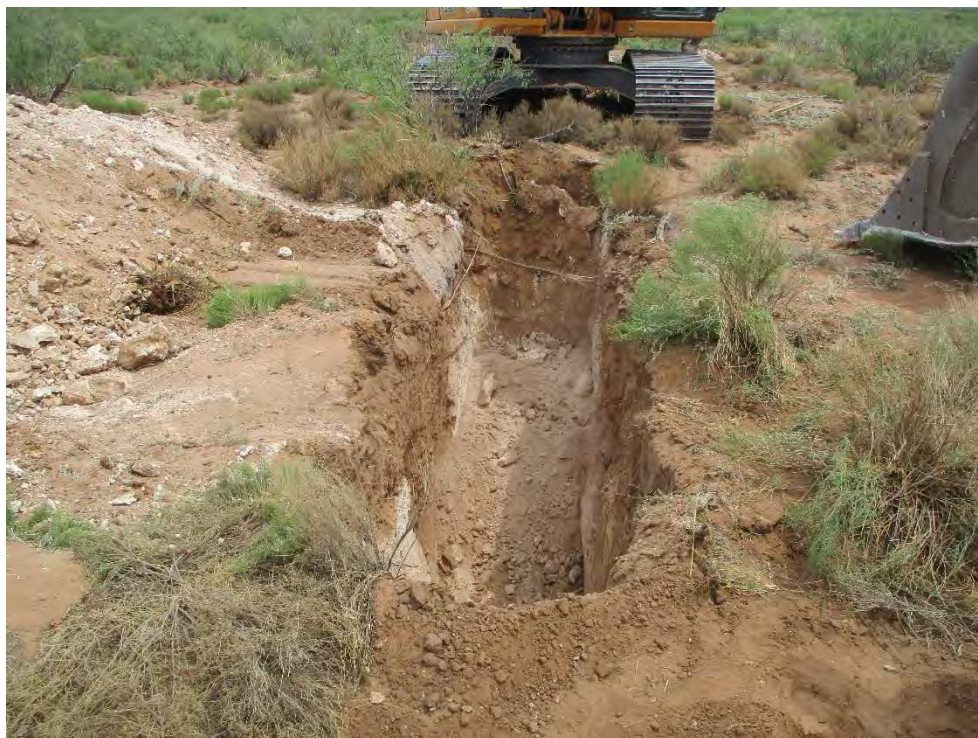
View North East, Trench #2

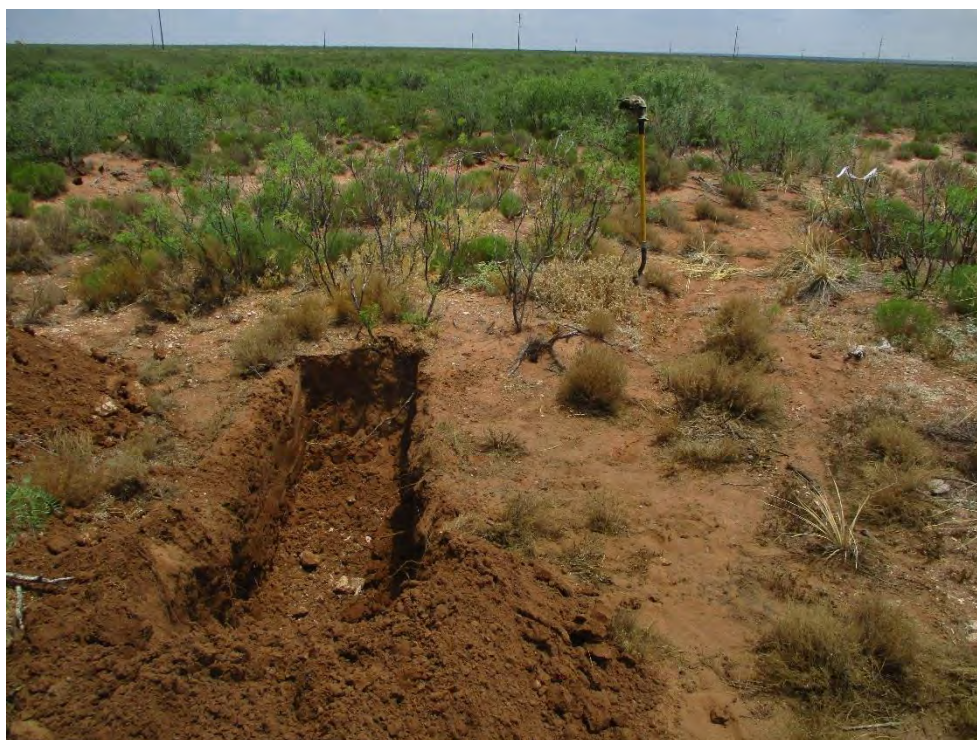
In the area of trench (T-3), elevated chlorides were detected in the shallow soils from surface to 2.0', which then declined with depth at 4.0' below surface. The samples collected at 4.0' and 7.0' below surface did not show significant chlorides to the soils with concentrations of 180 mg/kg and 66.5 mg/kg, respectively. However, a chloride spike of 822 mg/kg was detected at 9.0' below surface. The sample was re-analyzed to confirm and showed a chloride concentration of 748 mg/kg. Based on the sample detected at 4.0' and 7.0', the chloride spike at 9.0' appears to have been cross-contaminated with the upper impacted soils due to sloughing of material to the trench bottom during sampling.

View North, Trench #3

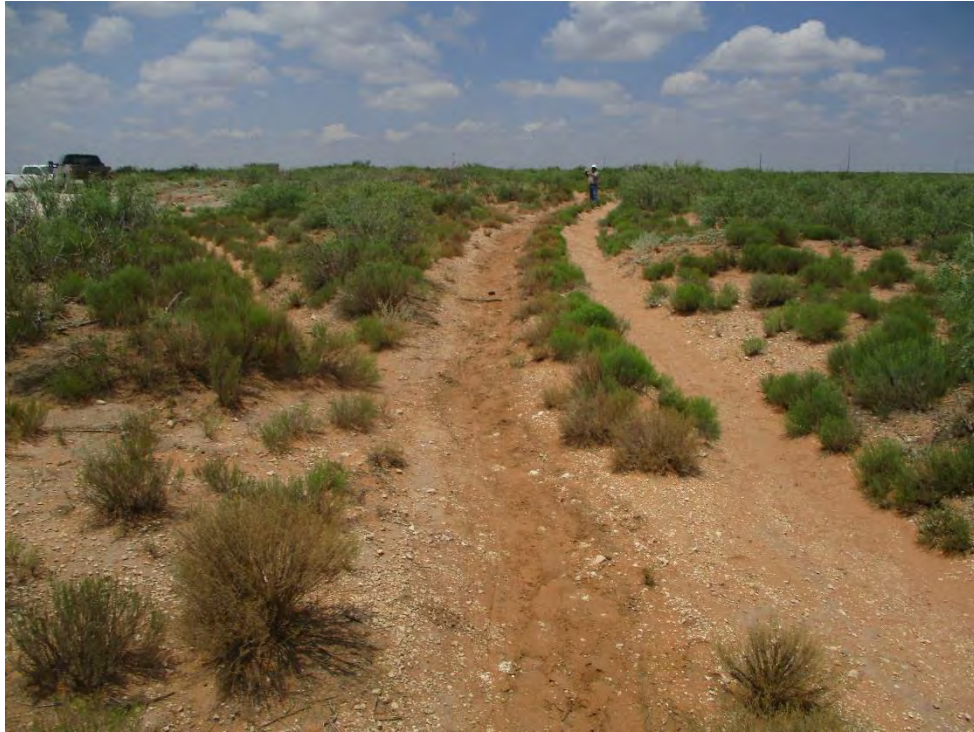
View West, Area of T-4

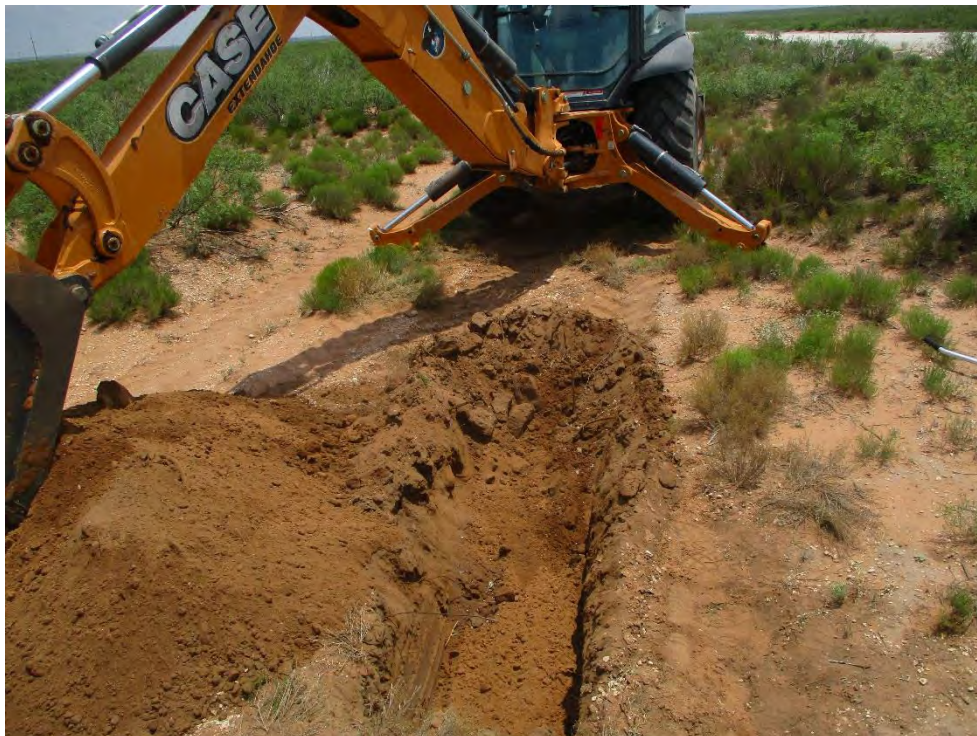
View South East, Trench #4

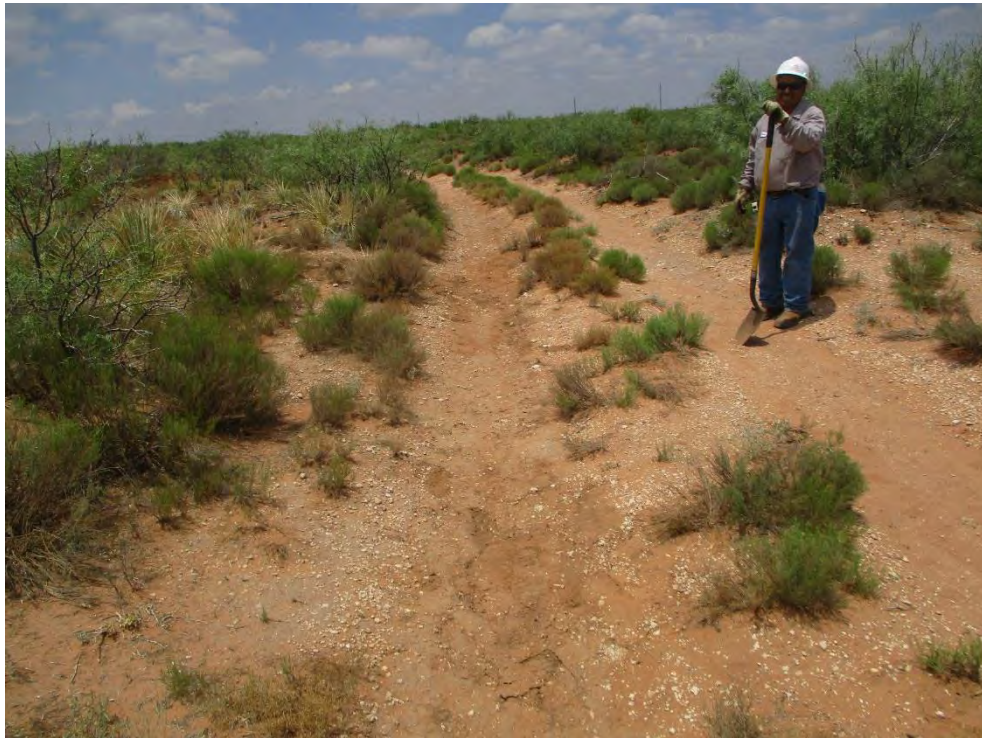
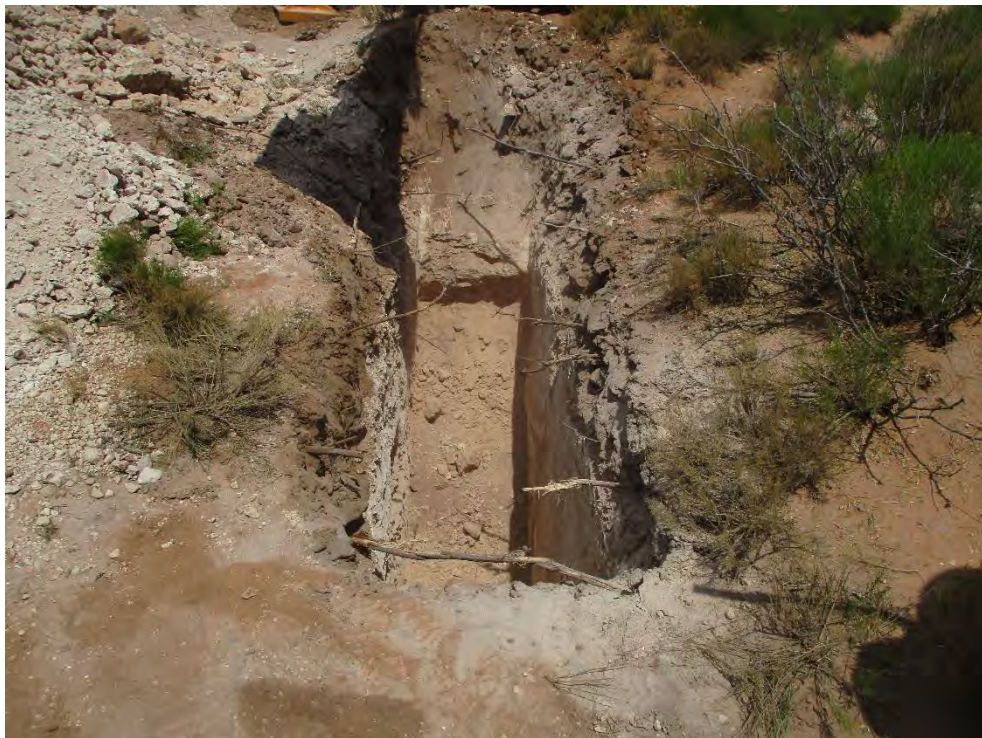
View West, Trench #5

View East, Trench#5

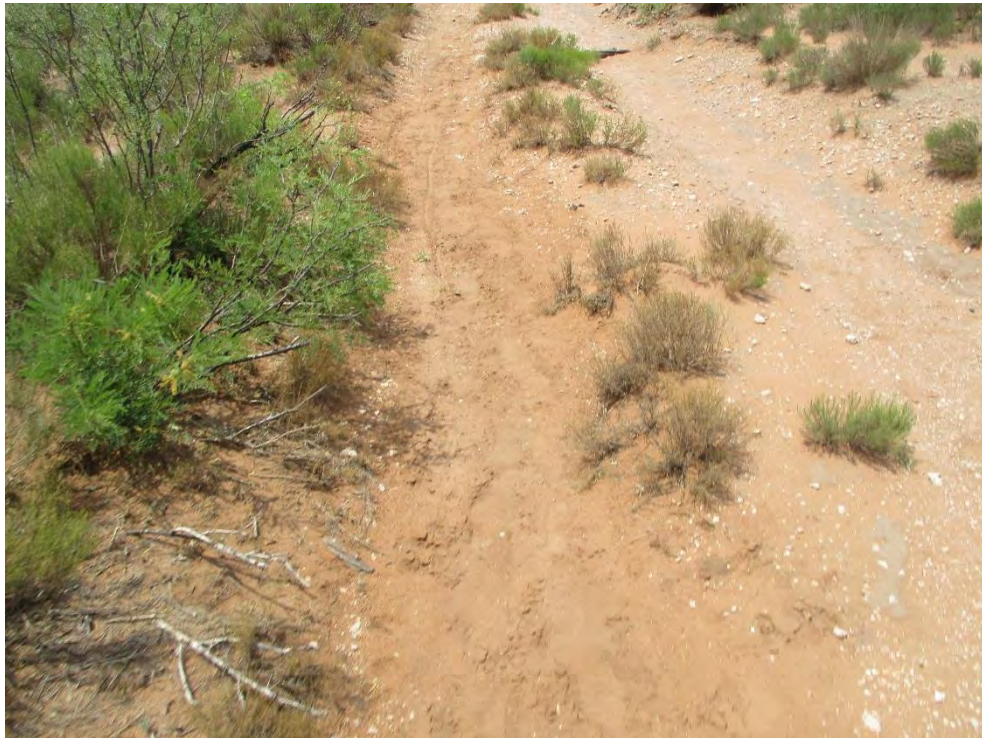
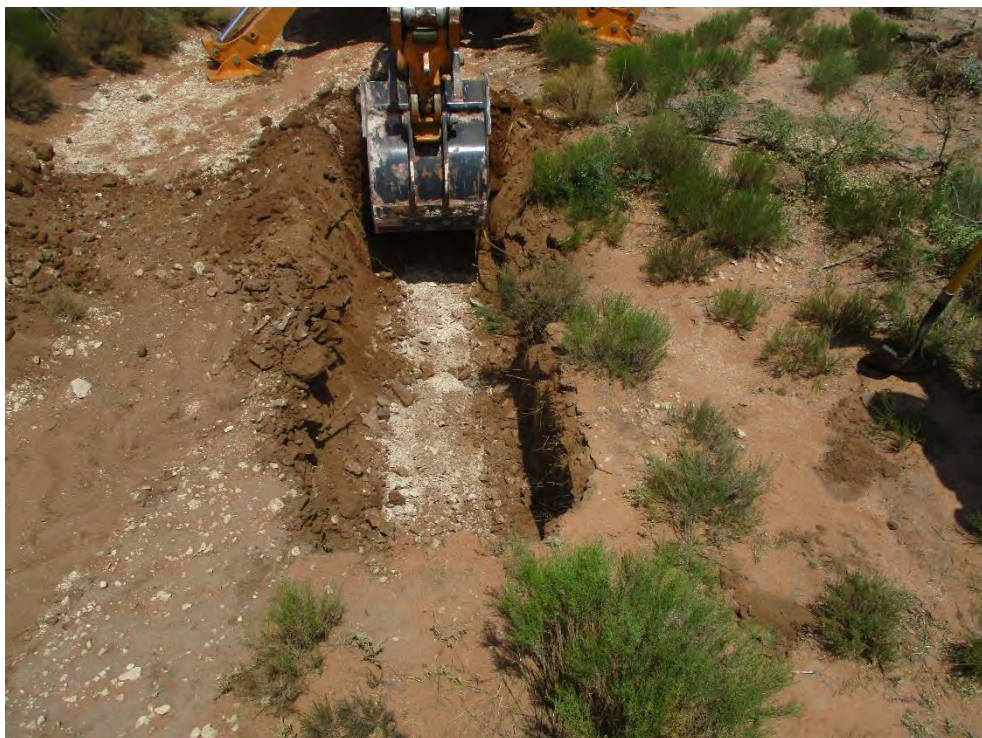
View West, Trench#6

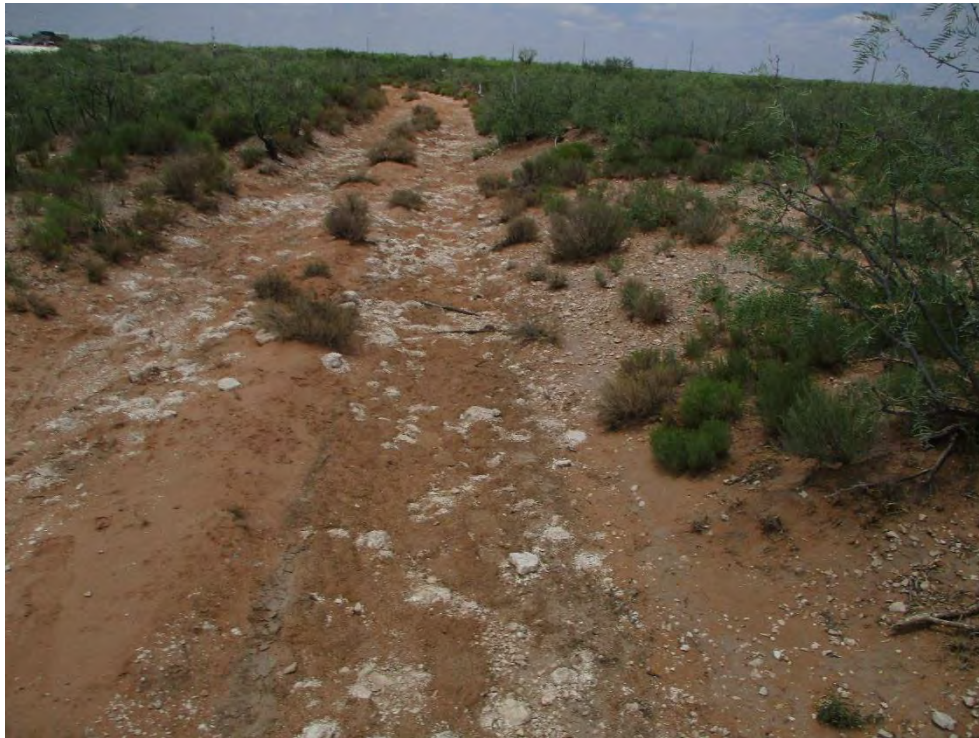
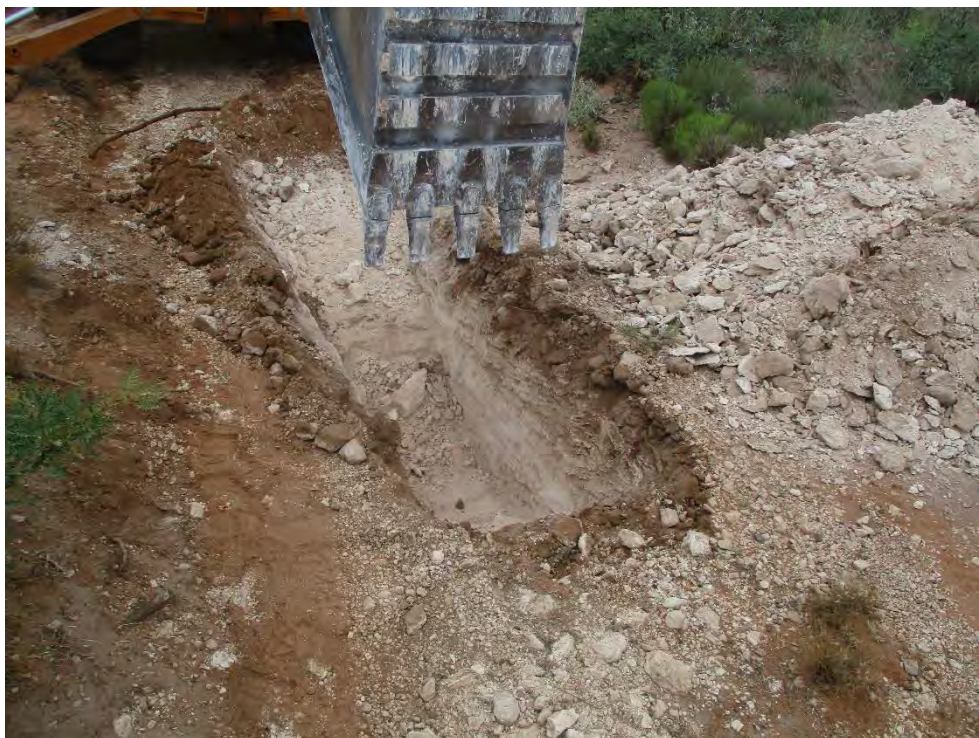
View West, Trench#7

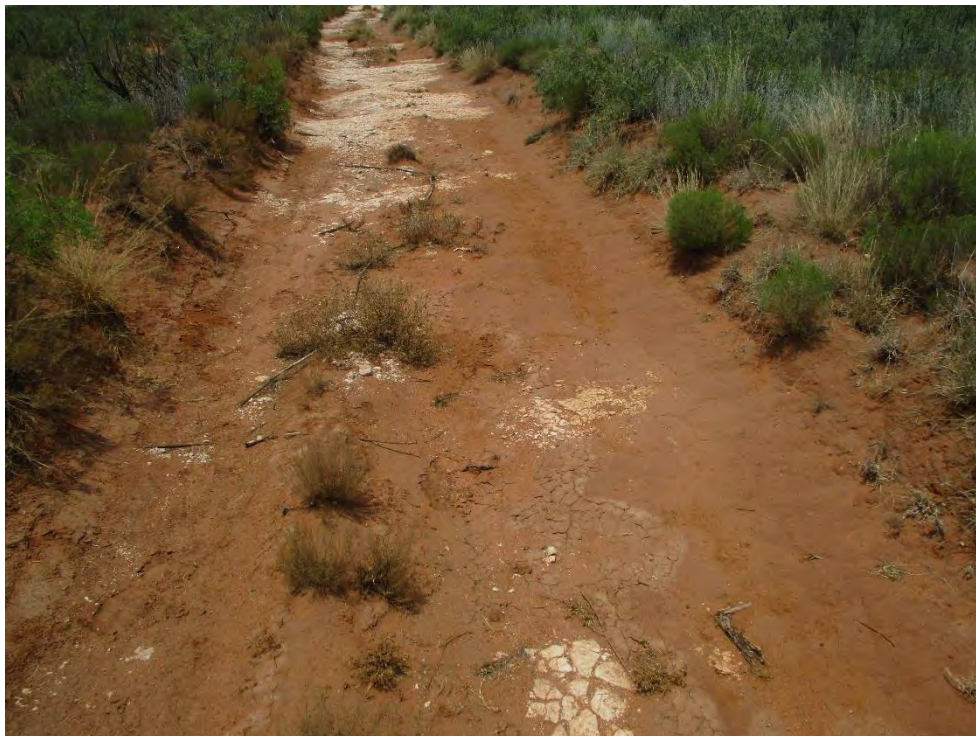
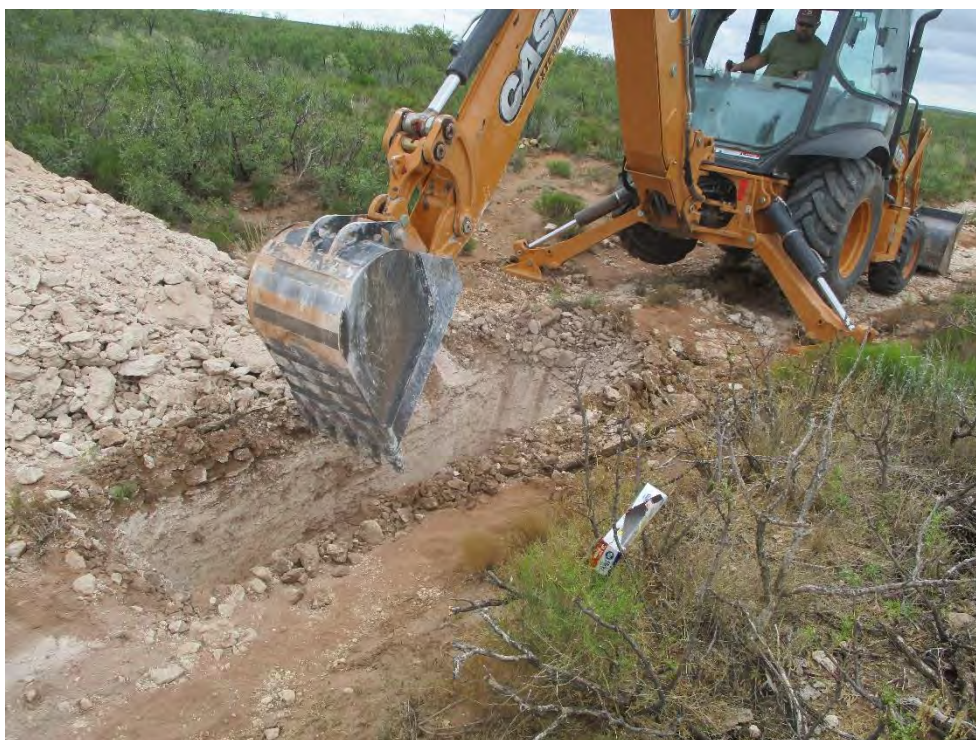
View West, Trench #8

View South West, Trench#8

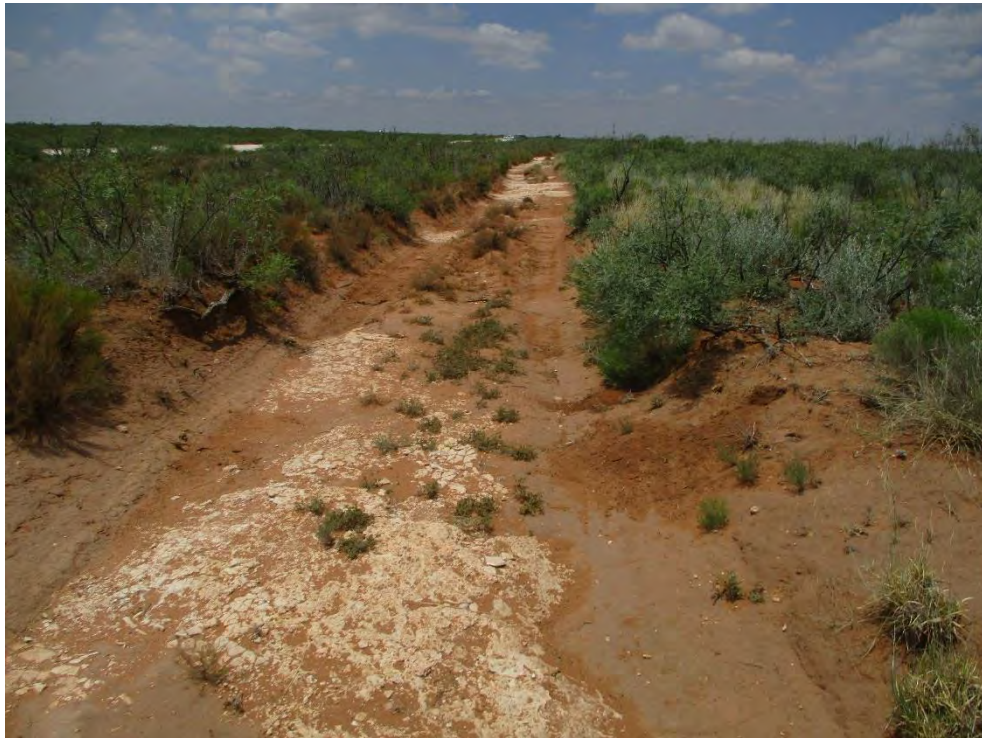
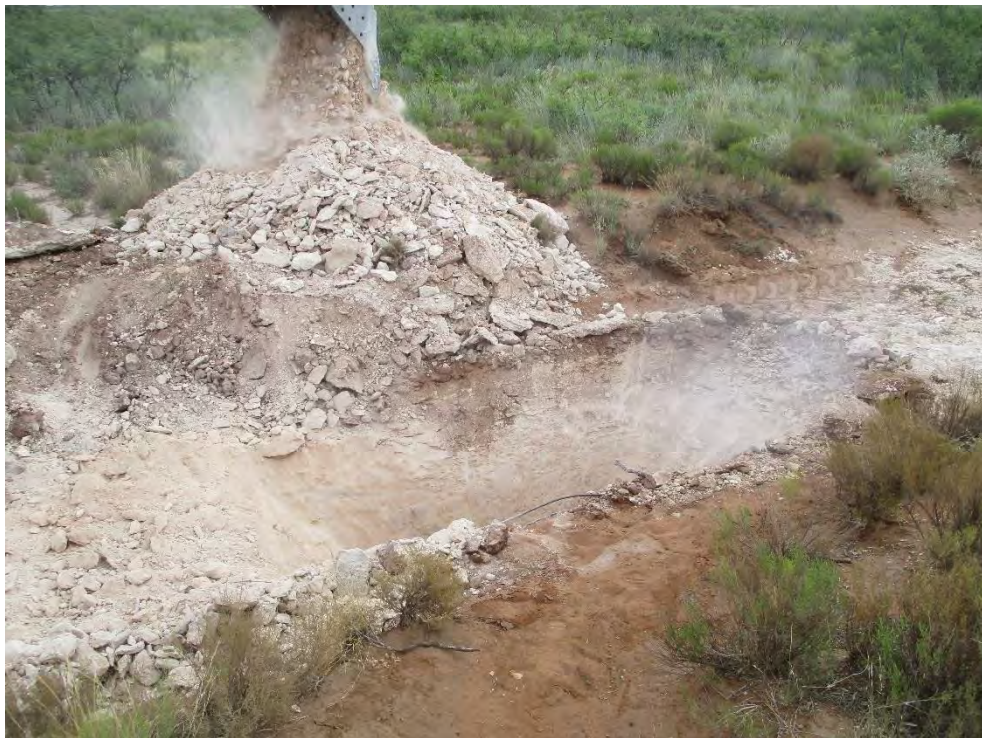
View West, Trench #9

View North, Trench#9

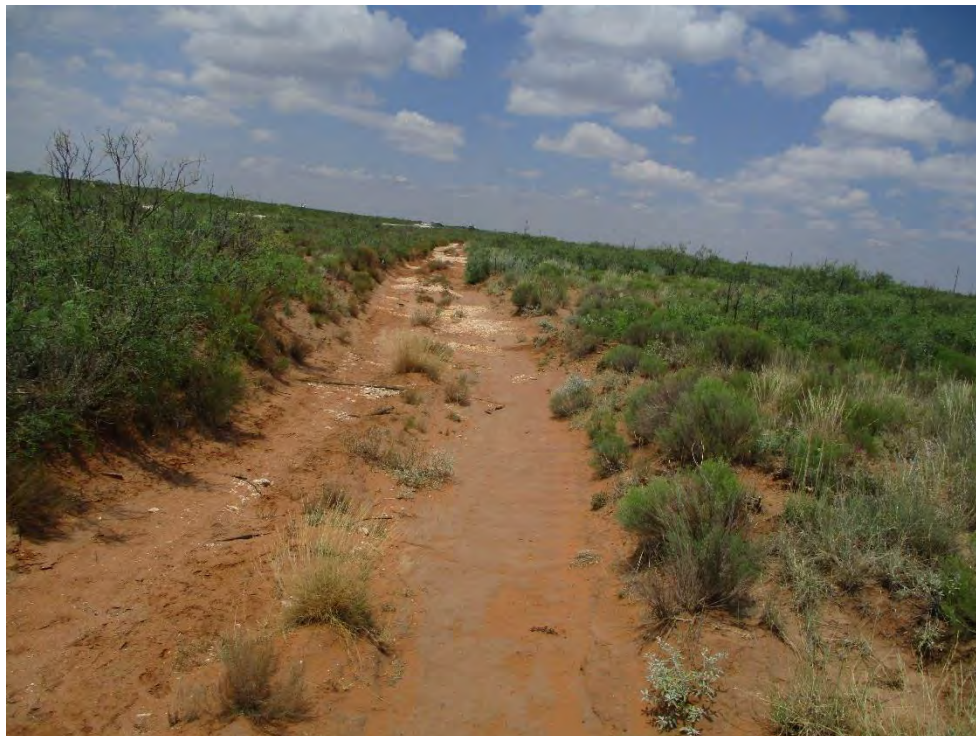
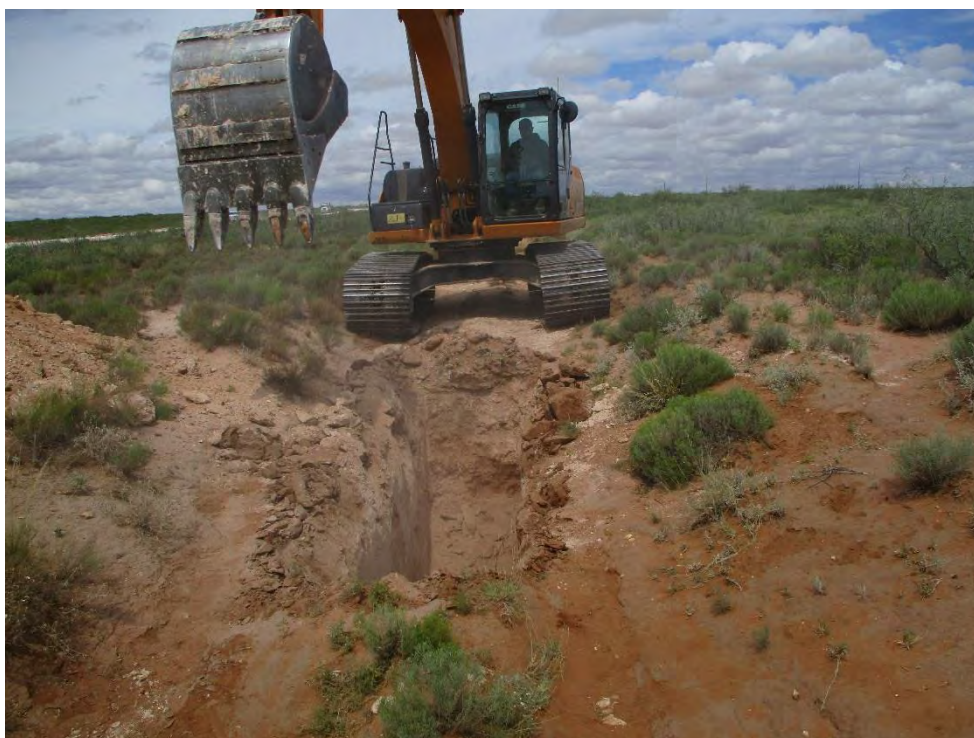
View West, Trench#10

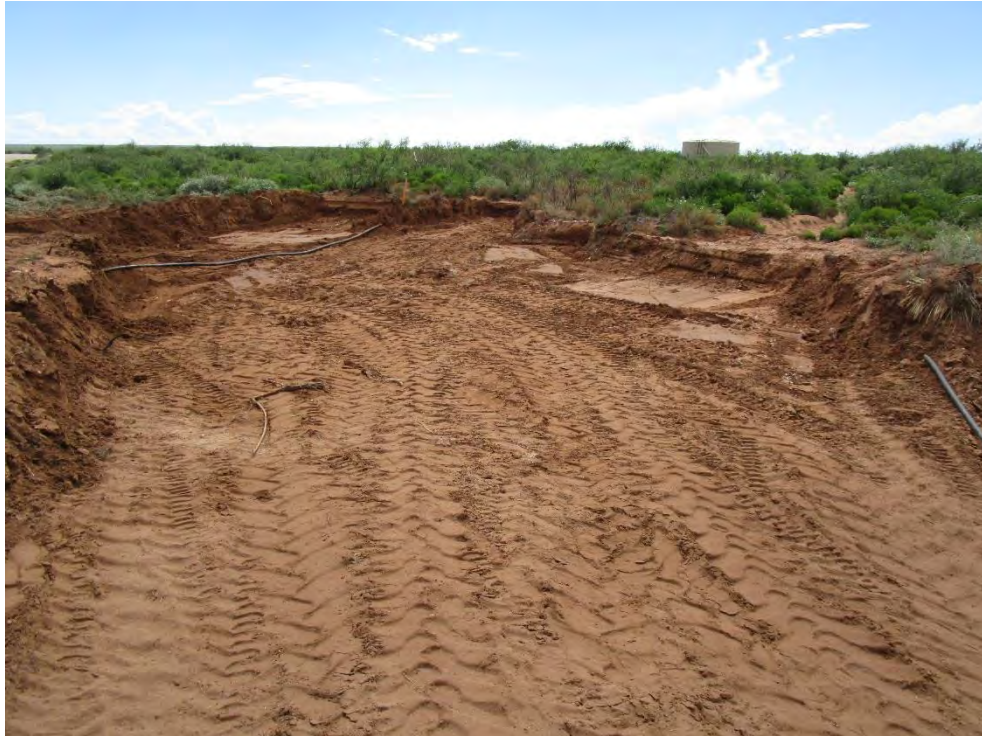
View West- Excavated Area T-1, T-2 and T-3

Based on the shallow impact and weather events at that time, EOG requested the impacted area be excavated immediately to prevent further leaching of the impact due to time and forecasted rain. On August 10 and 11, 2017, Tetra Tech personnel were onsite to supervise the excavation and remediation activities and collect confirmation samples. The excavation areas and depths are highlighted (green) in Table 1 and shown on Figure 4. The pasture area was excavated to a depth of 2.5'-3.0' below surface and 1.5'-2.0' in the area of the two track.

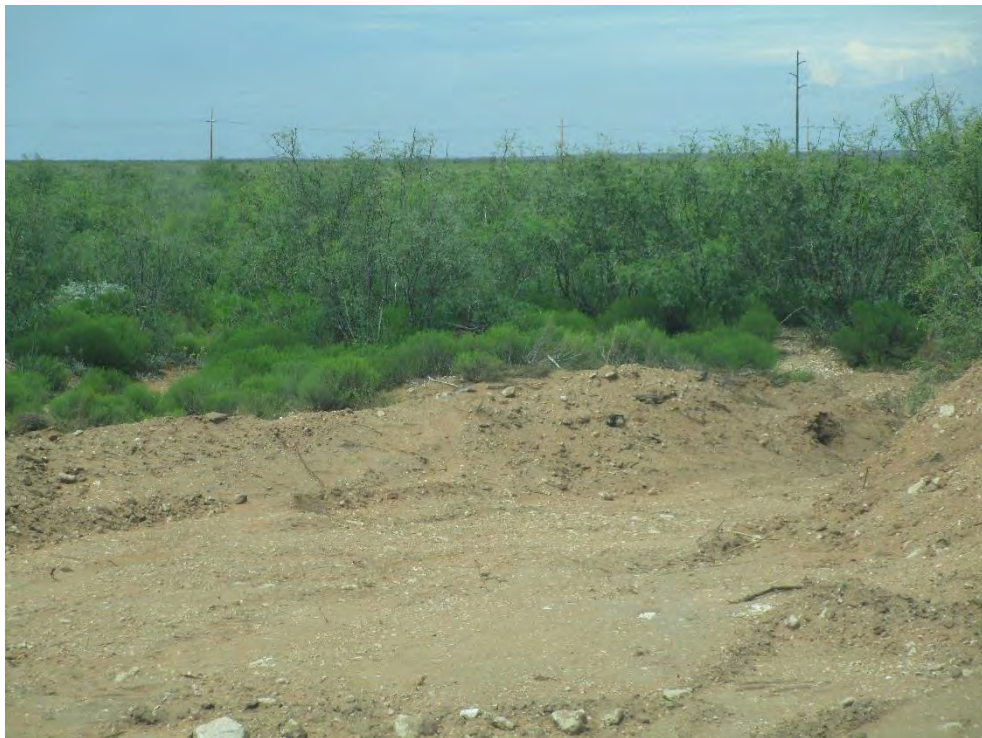
View North, Excavated Area Trench#4

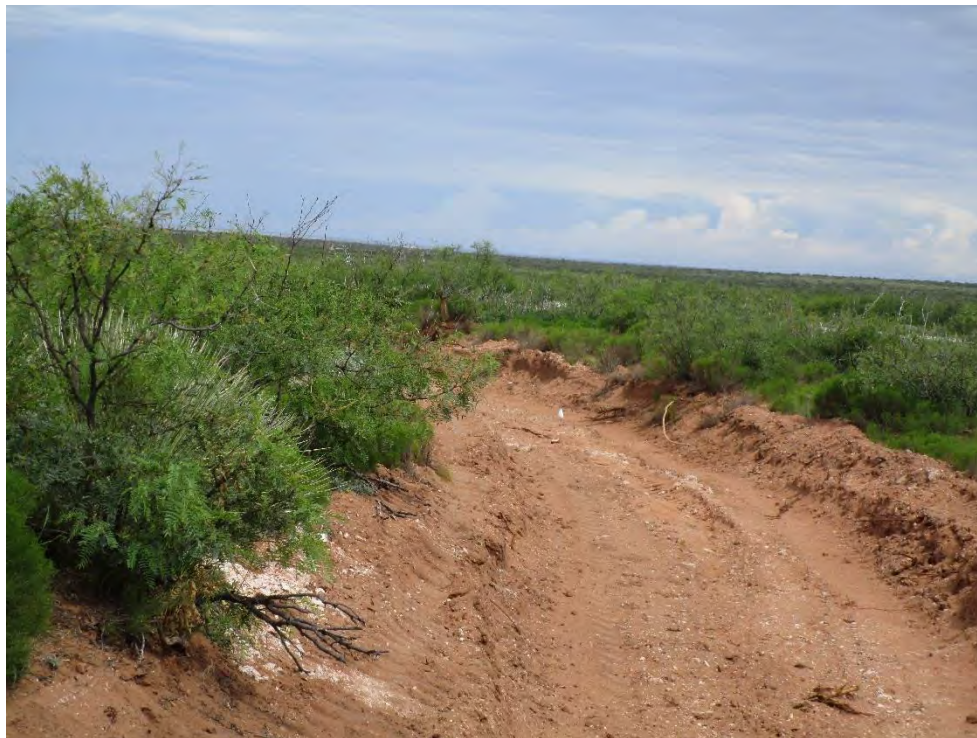
View East, Excavated Area Trench #5

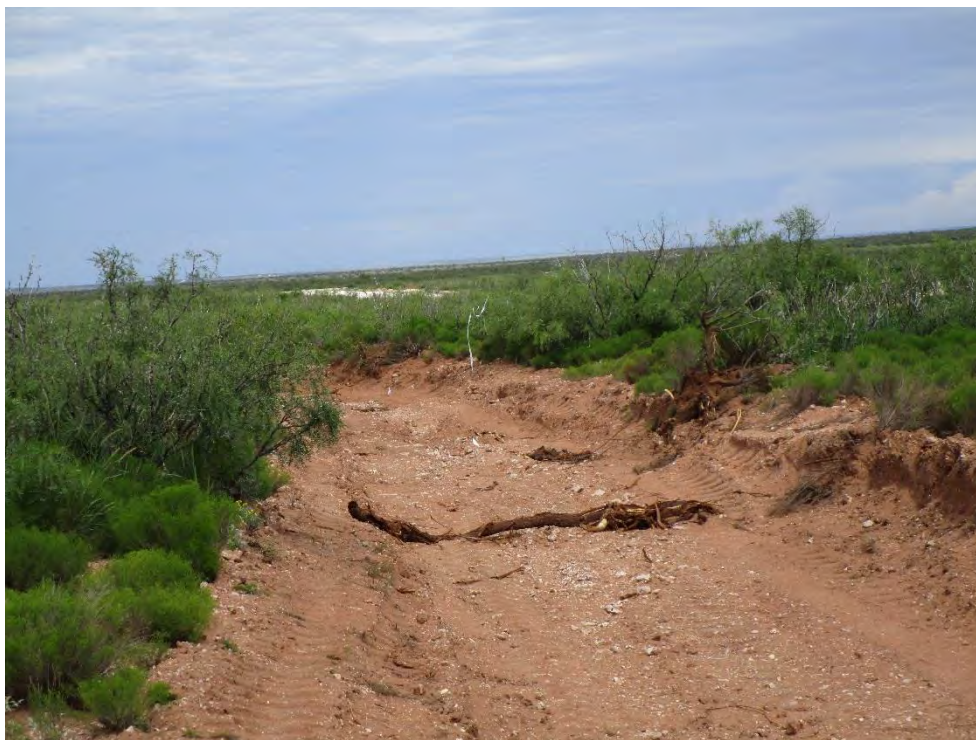
View East, Excavated Area Trench #6

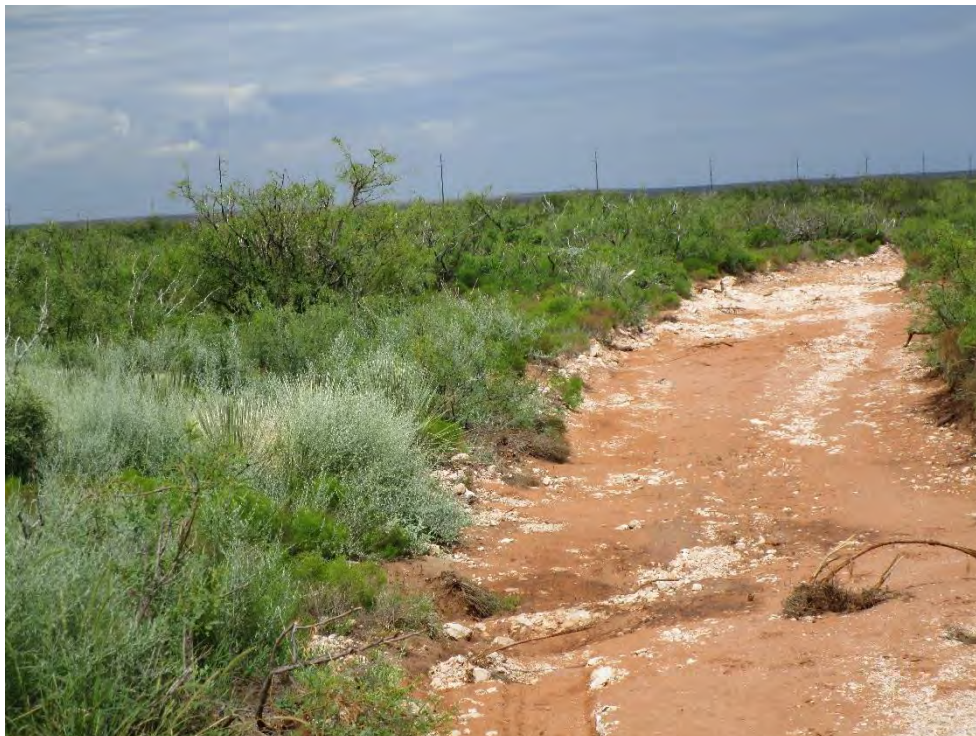
View West, Excavated Area Trench #7

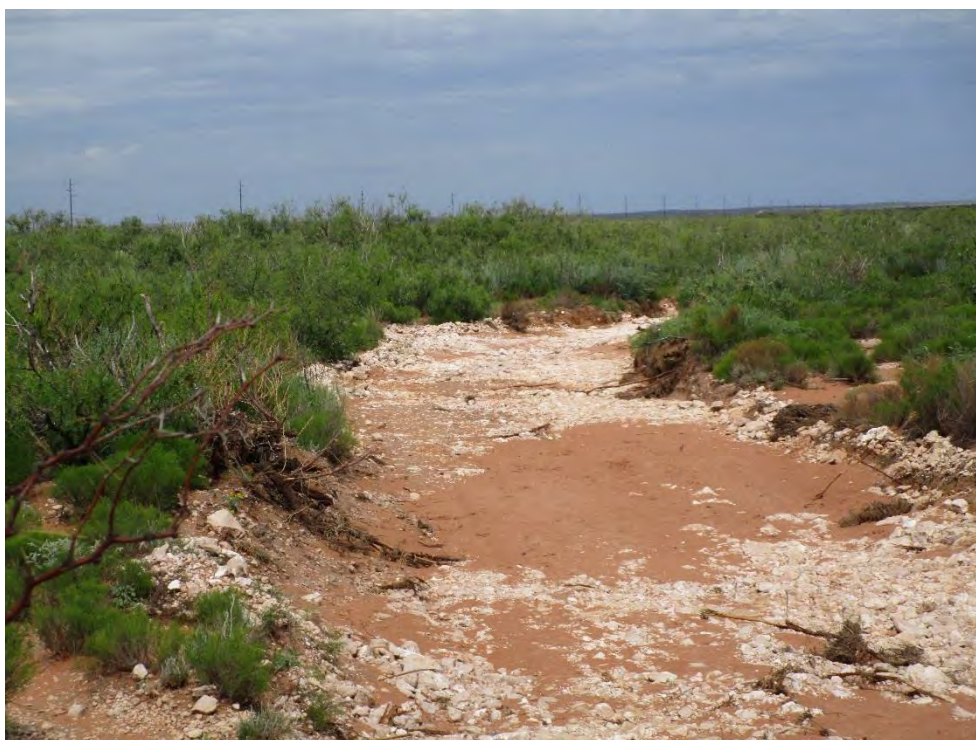
View West, Excavated Area Trench #8

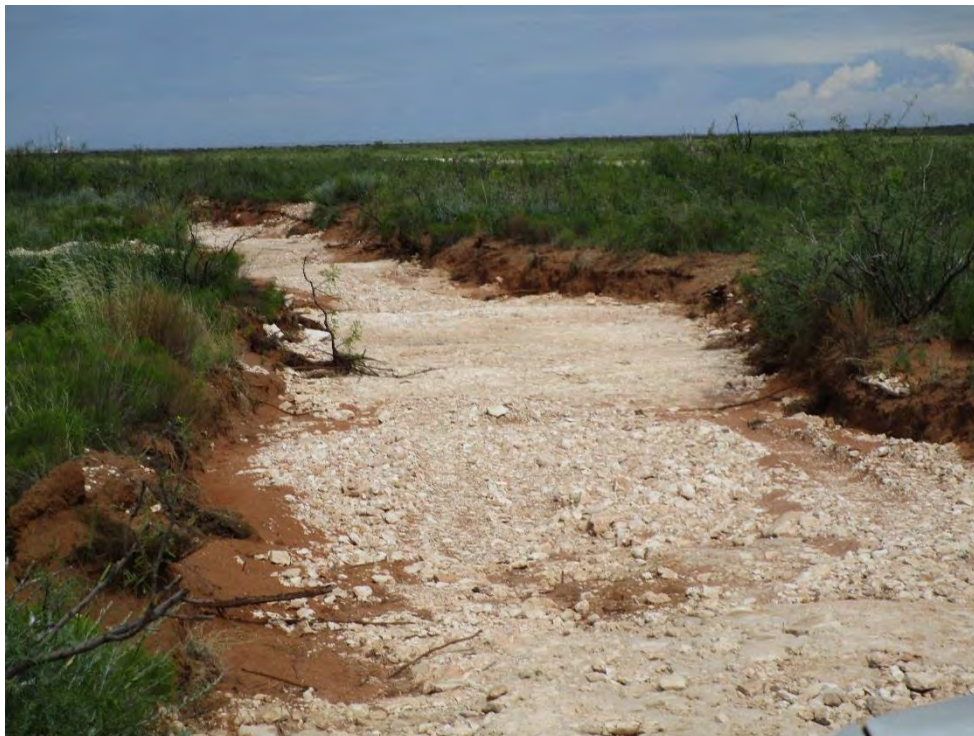
View West, Excavated Area Trench #9

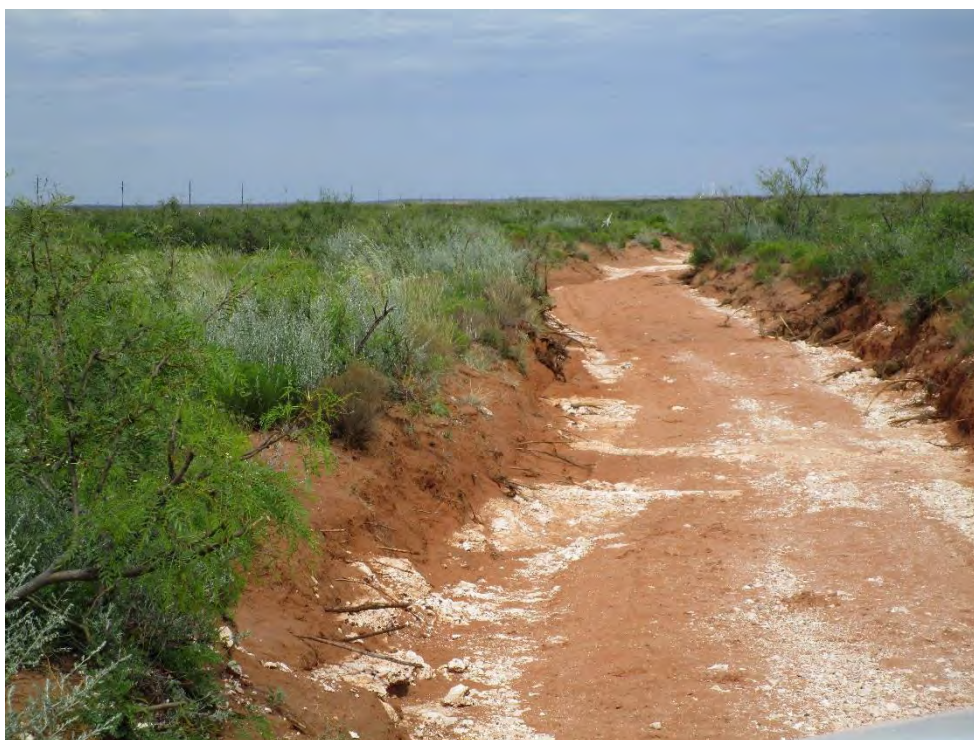
View West, Excavated Area Trench #10
