Reference No. 11135250-04

**Re: Closure and Deferral Request  
Trunk MC-16 (1RP-4524)  
ETC Field Services LLC  
Site Location: Unit O, Sec. 33, T 21-S, R 36-E  
(Lat 32.428160N°, Long -103.269760W°)  
Lea County, New Mexico**

**Re: Remediation Summary Report  
Trunk MC-16 inch  
ETC Field Services LLC  
1RP-4524  
Site Location: Unit O, Sec. 33, T 21-S, R 36-E  
(Lat 32.428160N°, Long -103.269760W°)  
Lea County, New Mexico**

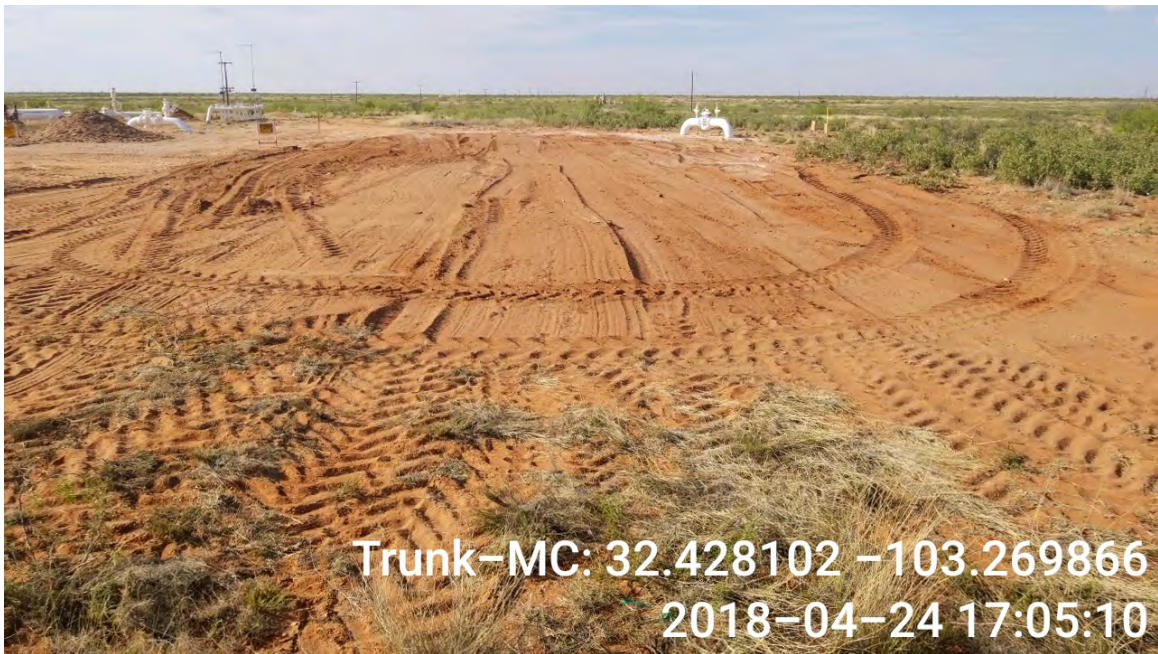
Photo 1 - Backfilled excavation

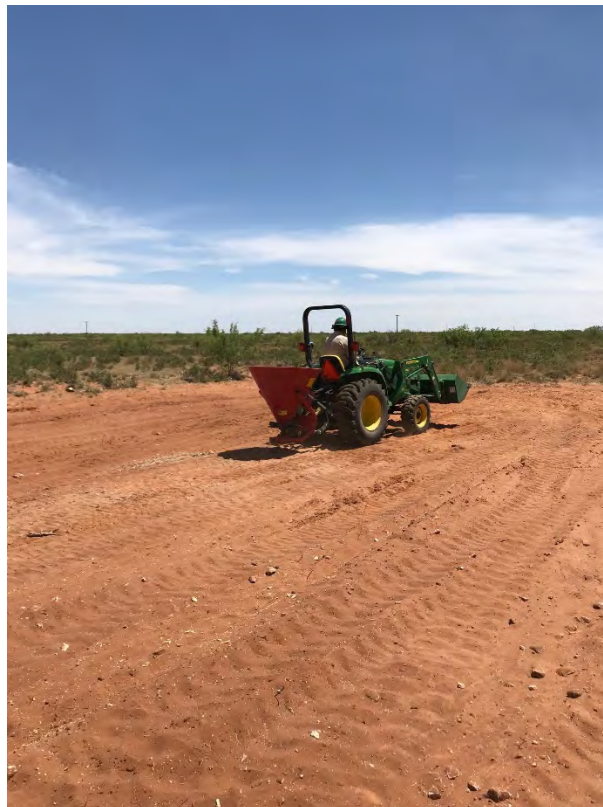
Photo 2 - Re-seeding

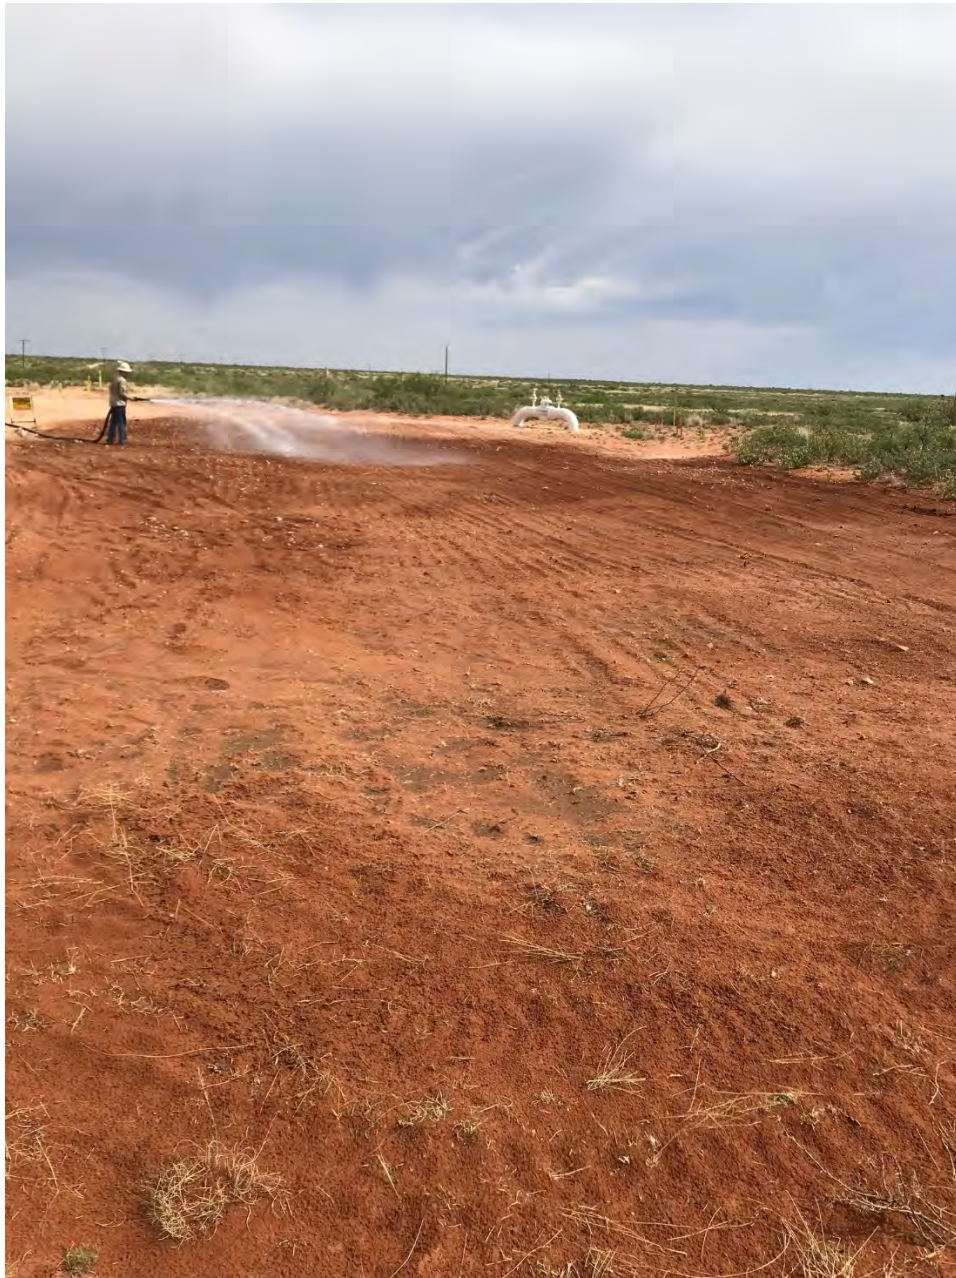
Photo 3 - Irrigating seeds

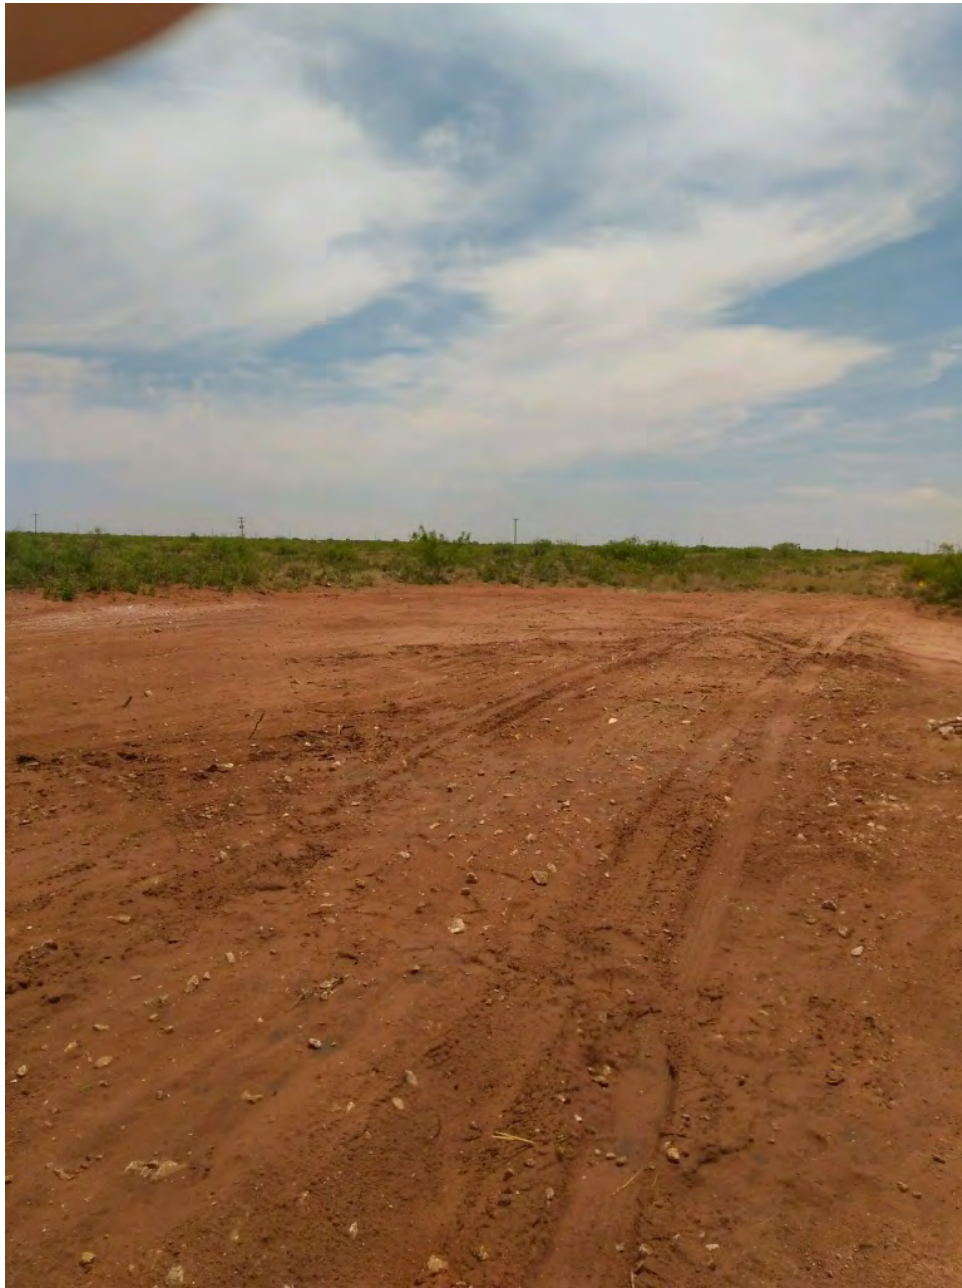
Photo 4 - Site completion
