R. T. HICKS CONSULTANTS, LTD.

RE: Advanced Energy Tomahawk SWD Facility
API: 30-025-33069. Unit L, 31, T21S. R33E. Lea County, NM
1RP- 4778

R.T. Hicks Consultants (Hicks Consultants) is pleased to submit this characterization and remediation plan on the behalf of Advanced Energy. This CAP relies on our

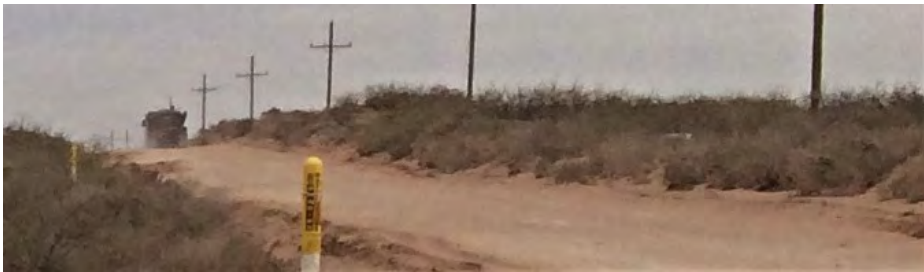
- - **Exhibit 1: Photograph viewing southwest across the north-south trending caliche access road. The road surface is cut into the surrounding natural grade at a depth of approximately 18-inches.**
 - **HA-250 South** - average chloride concentrations in the upper 3-feet is 401 mg/kg. At 6 feet bgs, chloride shows 2,006 mg/kg, below the 20,000 mg/kg chloride closure criteria. Hand auger refusal was encountered at 6 feet with the contact of caliche.
 - **Trench 350** - chloride is below 600 mg/kg from 1 foot to 8 feet bgs. No further delineation is required.

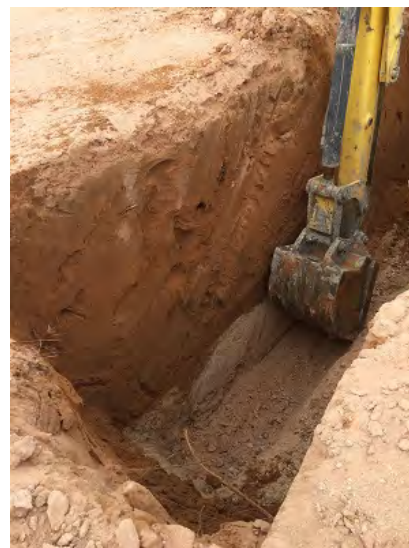
Exhibit B: Photo of lithology at Trench 2. Silty sand dominates the stratigraphic column from the surface to 5.5 feet. Very hard caliche was encountered at 5.5 feet.

Location HA-4 was placed near the location of the previous Trench 4. A recently installed surface pipeline prevented access with a backhoe. Therefore, we elected to hand auger the selected location. Trench 2 was relocated due to a subsurface pipeline paralleling the northern edge of the access road and per conversations with Storm Construction and Brad Blevins, ranch manger, regarding flow path and observed storm water surface flow that occurred with 24 hours of the release. Mr. Blevins and Storm Construction stated that release pooled in the location of the relocated Trench 2 (Exhibit B).
