R. T. HICKS CONSULTANTS, LTD.

August 30, 2018

RE: Operator: Pride Energy Company
NM 87 State #001 (Tank Battery)
API#: 30-025-23655
Section 33-14S-34E: Unit K
Lea County, New Mexico
Site Characterization Report and Remediation Plan 1

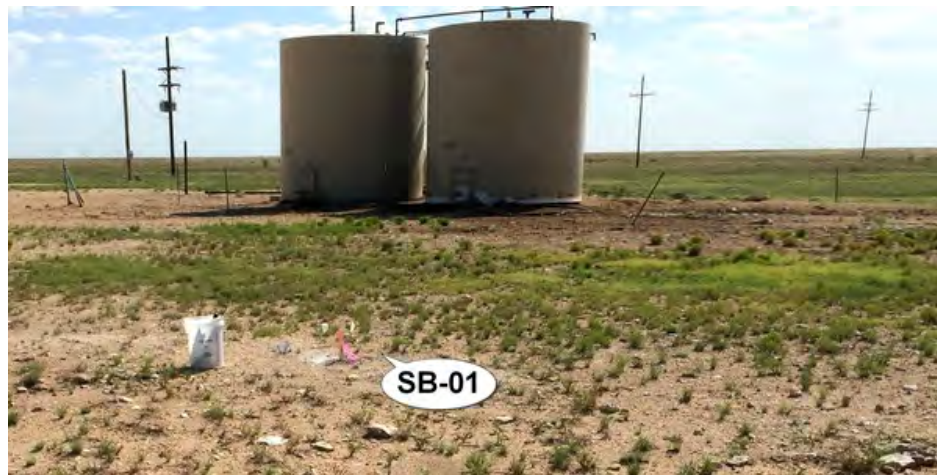
Chloride, Benzene, and BTEX concentrations shows no impairment. TPH (GRO+DRO+MRO) concentrations at 0-feet exhibit <1665 mg/kg, below the closure criteria of 2,500 mg/kg for areas still in-use. The two below photos show the area around SB-01 beginning to naturally revegetate. Any restoration efforts will negatively impact natural revegetation. Note the bright green vegetation growing in the area between and to the right of the tank battery and SB-01. This area was most heavily impacted by the release and shows the most productive natural revegetation.

Photo 1: Natural revegetation beginning to occur. July 19, 2018.

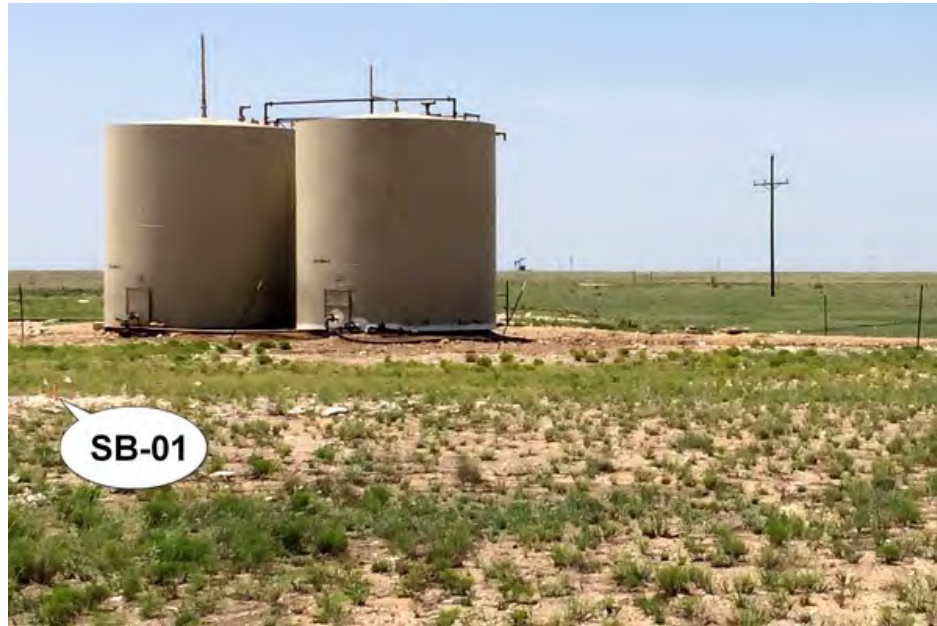
Photo 2: Photo of natural revegetation as of Aug. 15, 2018

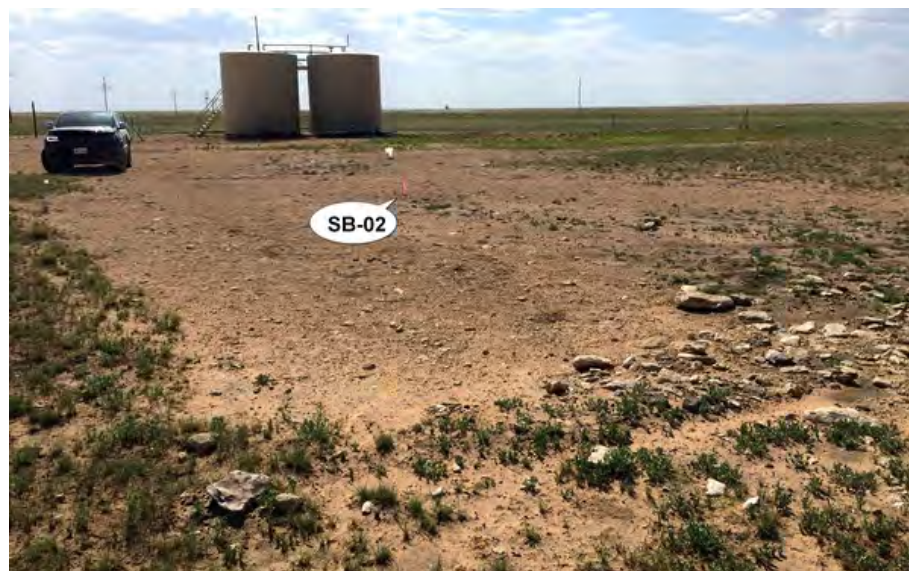
- SB-02
At the surface (0-feet) Chloride is 4,200 mg/kg. BTEX, Benzene, and TPH are below cleanup closure levels. Reclamation for chloride is necessary.

Photo 3: Photo of reclamation area at SB-02. Site condition as of July 19, 2018.

Location SB-02 Historic was not confined to the storage site and requires reclamation per NMAC 19.15.29.13.D as the area is no longer in use. Chloride concentration at the surface (0-feet) is 4,200 mg/kg and 404 mg/kg at 4-feet bgs.

Within 30-days of plan approval, remediation will include:

- Removal of materials to a depth of 4-feet or extent practical and to where chloride is below 600 mg/kg within the excavated depth; whichever is less. We estimate the extent practical at 2-foot, where trenching activities and boring logs demonstrate very hard caliche was encountered. Assuming a 2-foot removal depth, total volume of removed material will be approximately 140 cu. yds (=209 sq yds x 0.67 yds). Plate 13 shows the reclamation extent.

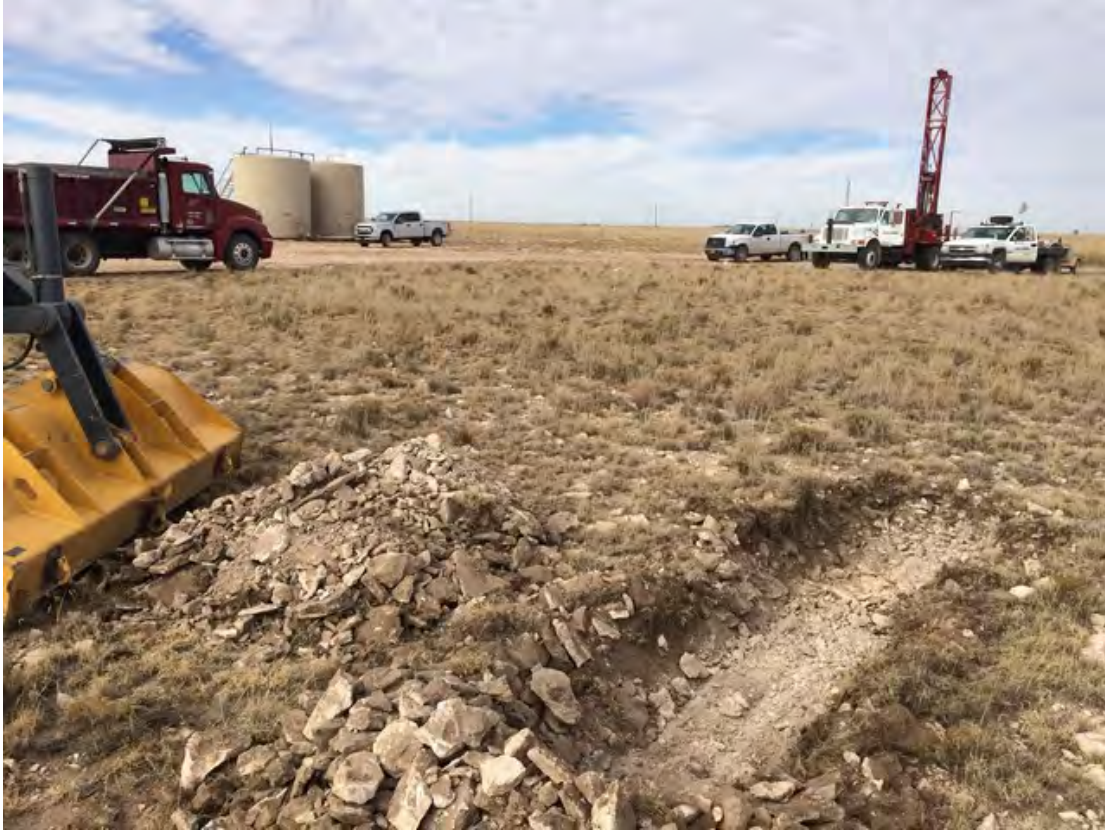
Exhibit B: Trench sample at Historic Southeast. Hard caliche encountered at 1-foot below ground surface. Land surface is undergoing natural restoration/re-vegetation. Drilling of SB-02 is visible in upper right of photo.

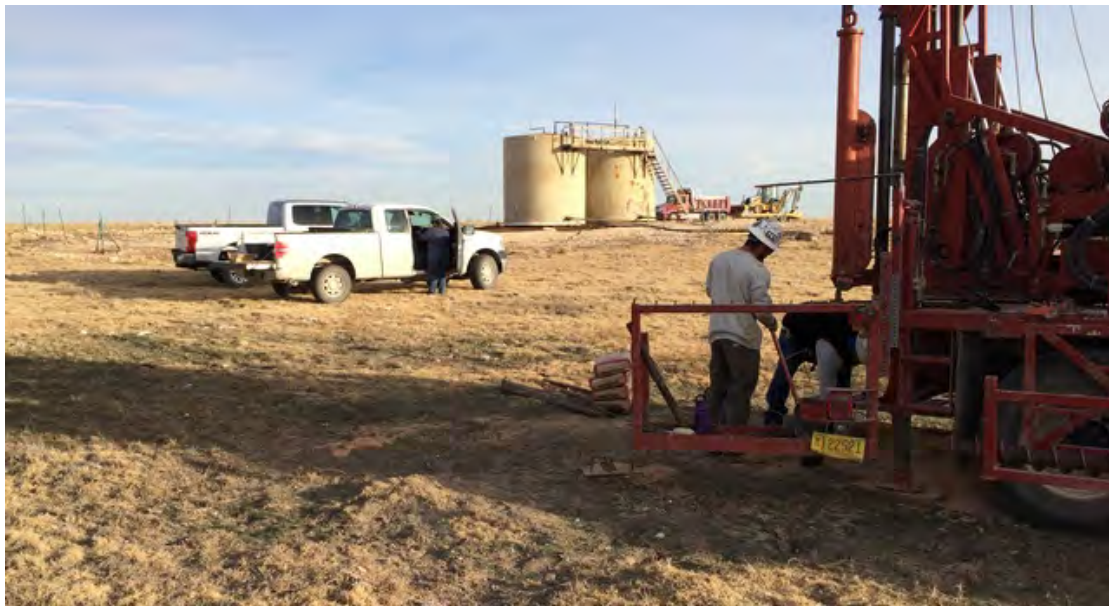
Exhibit C: Drilling of SB-03, within the natural depression (“playa”) west-northwest of the tank battery. Tank battery is visible in photo center.

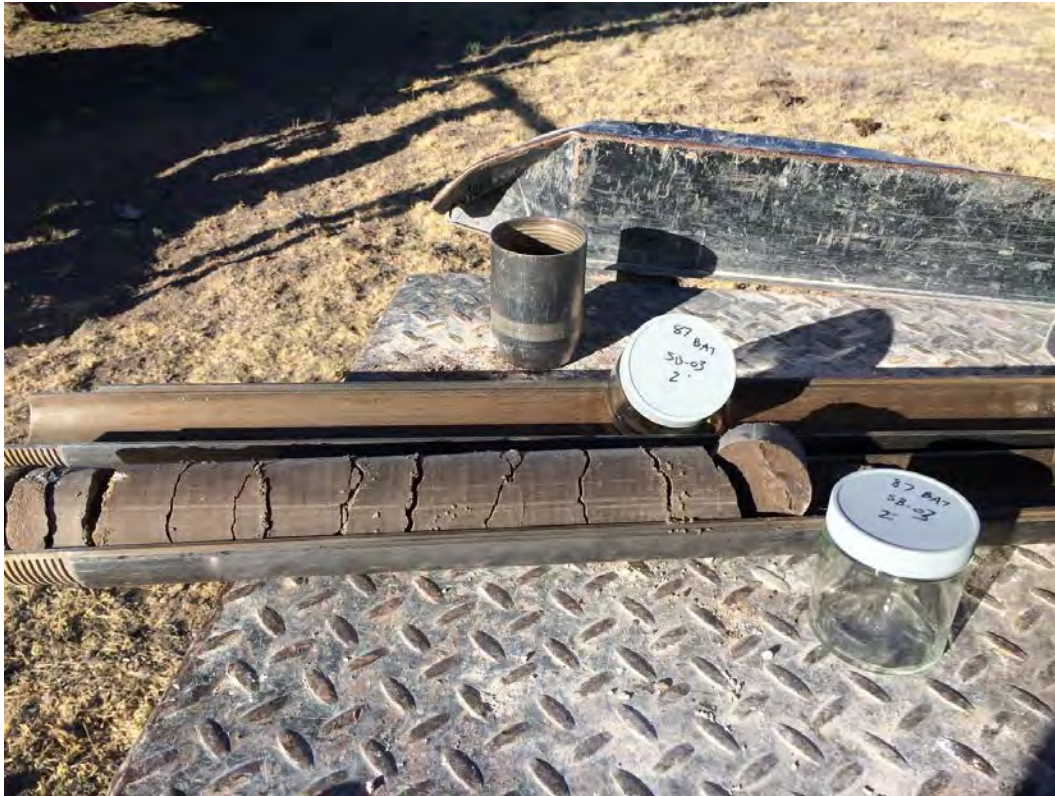
Exhibit D: Split spoon sample core at SB-03 Playa. 0-feet is at left. 2-feet is at right. Silty sand dominates the upper soil column from the surface to 6-feet.

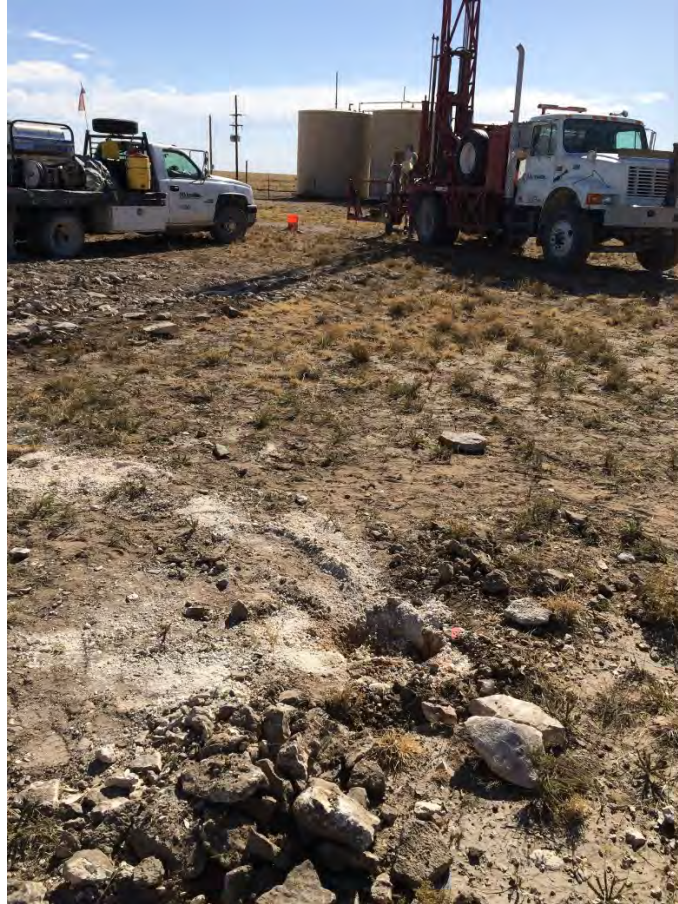
Exhibit E: Background photo is the drilling of SB-01 2017. Photo front center foreground is the borehole for Historic North. Re-vegetation is occurring in the area of Historic North.

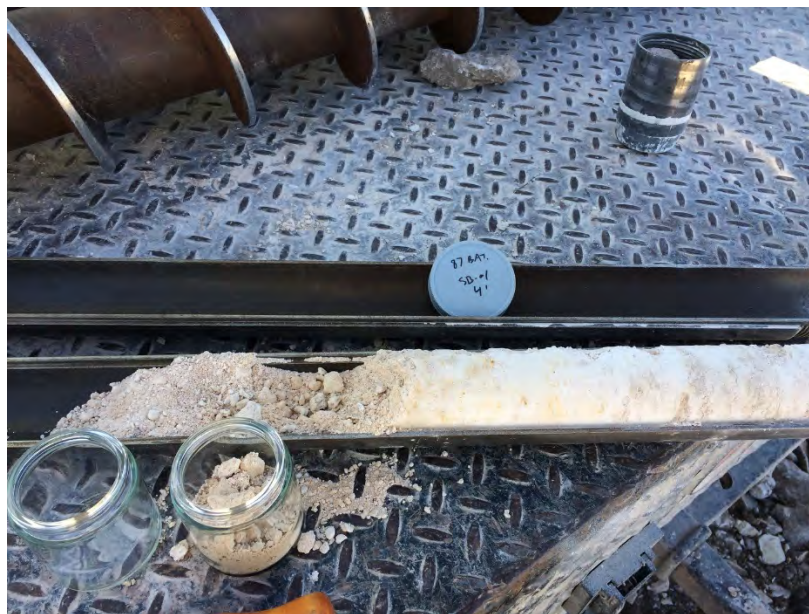
Exhibit F: SB-01 2017 split-spoon core sampling at 4-feet. Core sample is from 4-feet (left) to 6-feet (right). Caliche dominates the core sample.
