REMEDIATION PLAN

Abo Pump Water Station B-6

1RP- 5073

September 4, 2018

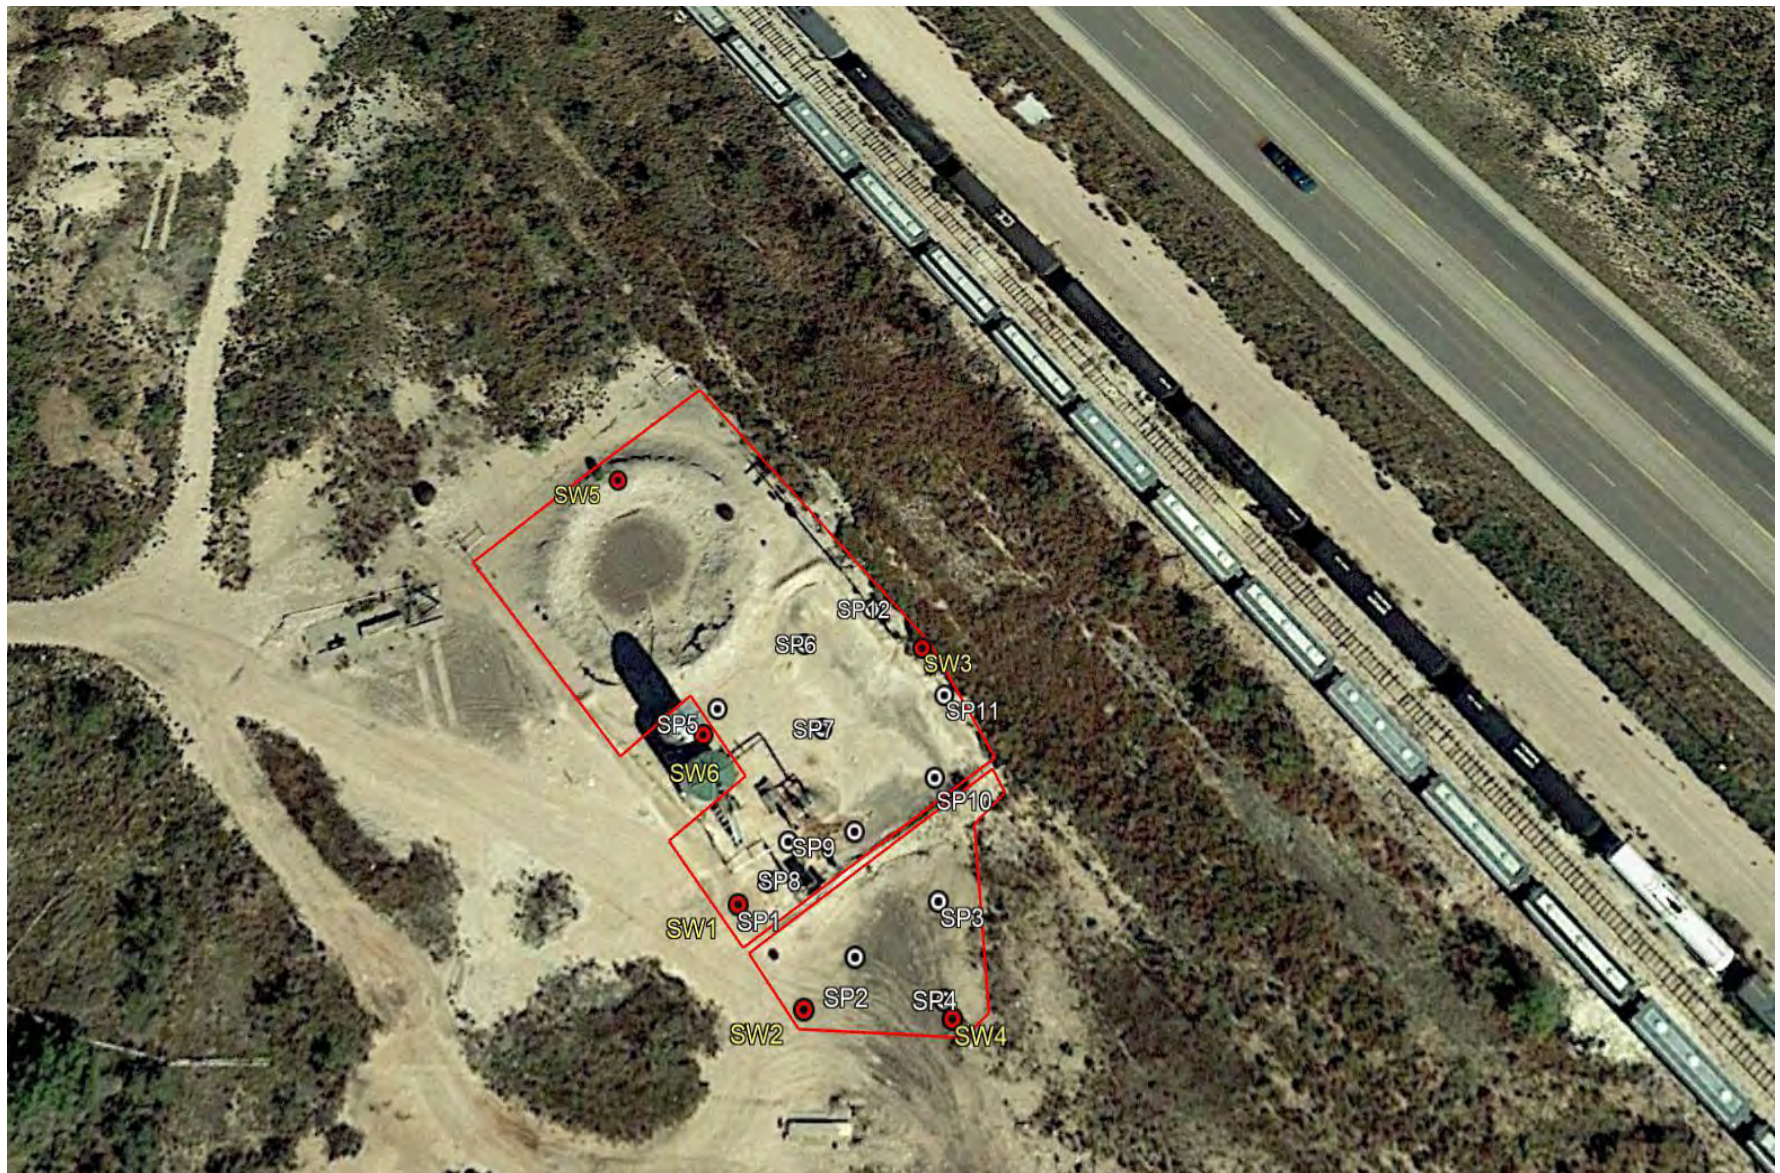
Vanguard Abo Pump Station B-6 1RP-5073

Excavate a total of 2'bgs, which will include the entire impacted area measuring 18,189.51 sq. ft. and haul the contaminated soil to an approved disposal. Final closure samples will be taken at each sample point and sidewall sample points as defined during the delineation process. These samples will be titrated in the field for chlorides, then taken to Cardinal Lab for closure confirmation. Further sidewall closure samples will be taken in the area of the old overflow pit area when delineation takes place. Once closure lab confirmation is received, WBE will backfill the entire site excavation with clean caliche and the disturbed area will be then contoured back to its natural state. Berms will be constructed around the facility following SPCC Guidelines and the berms around the location pad will be rebuilt to ensure that fluids would not escape the site if another release occurred at this site. A final closure report will be then sent to the NMOCD for closure of this release herein.
