**Re: Chevron Central Vacuum Unit No. 266
2017 Soil Assessment Report
Case No. RP-3948
Lea County, New Mexico**

2017 Soil Assessment Report

Central Vacuum Unit No. 266

RP-3948

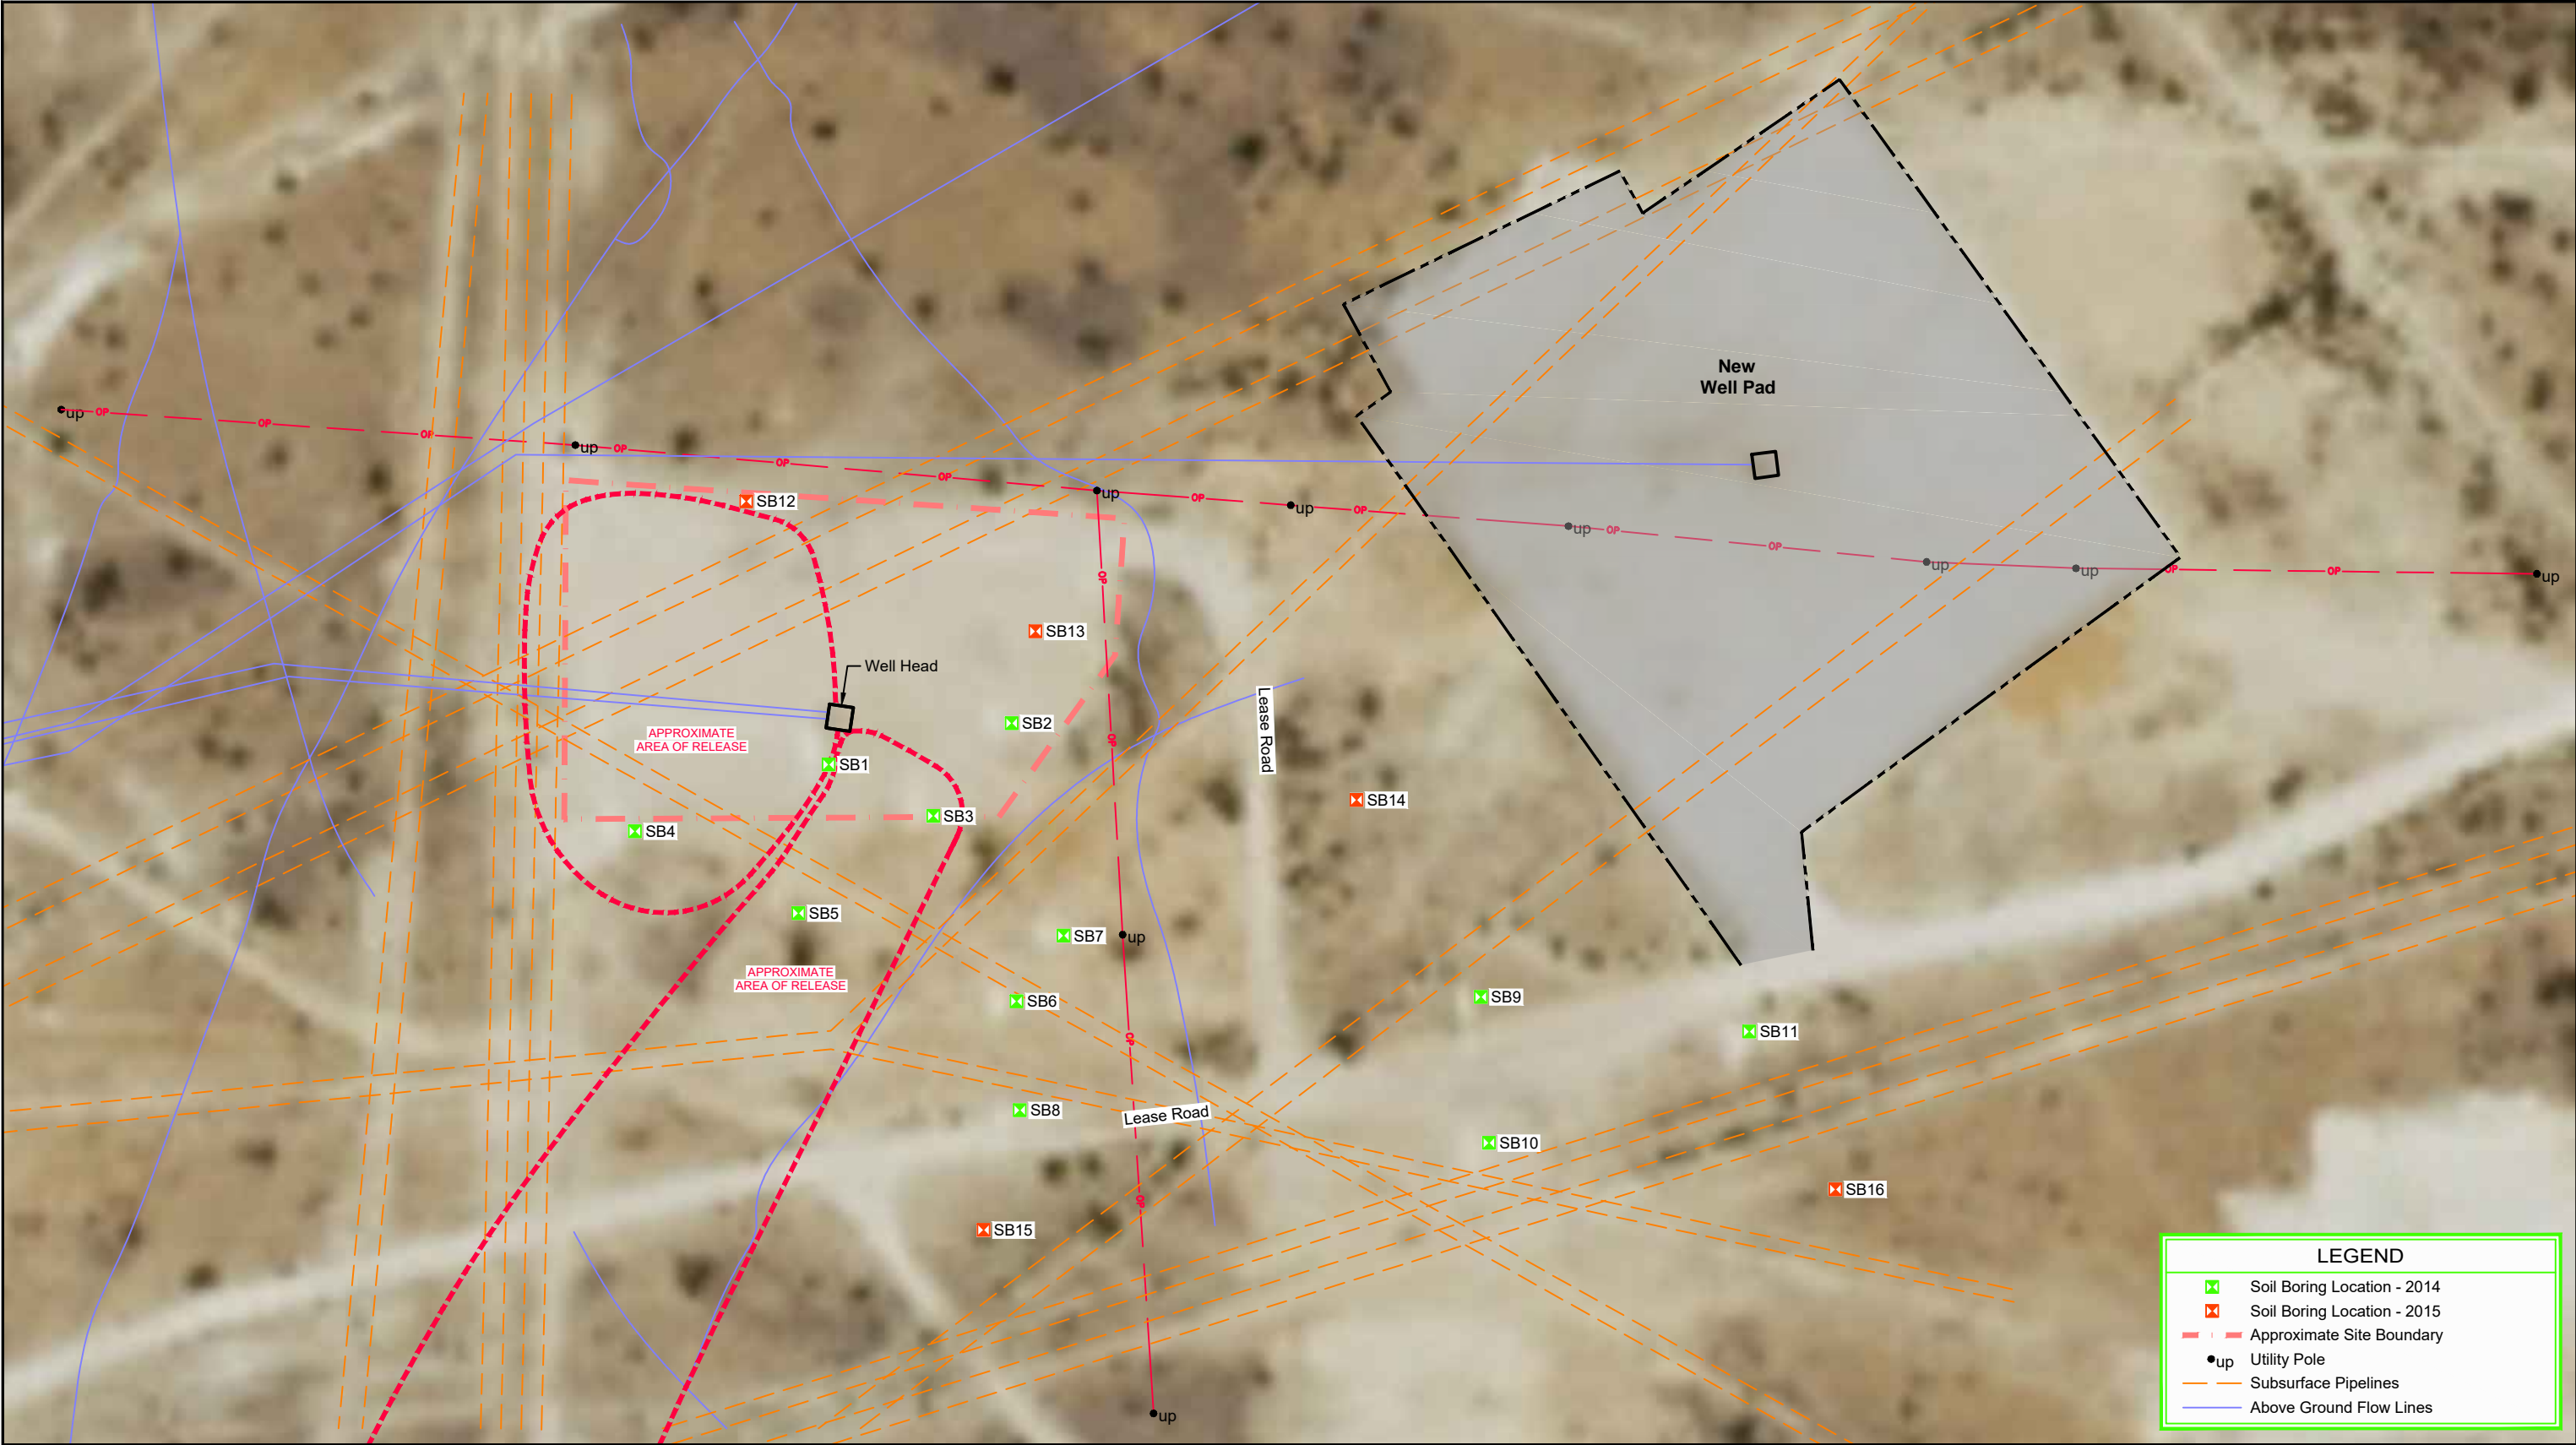
FIGURE 2

In 2014, Chevron contracted GHD to perform a comprehensive soil assessment at the Site by implementing a soil boring program. A Site visit was performed on April 8, 2014 by GHD. During the Site visit, boring locations were flagged for utility locating purposes. In addition, the Site was walked to observe Site features; which included oversight of a geophysical Site survey by way of ground penetrating radar (GPR) to assess the presence of subsurface utility hazards. Multiple surface and subsurface hazards were identified at the Site. A Site details and utility map is presented as Figure 2.

SITE DETAILS AND UTILITIES MAP

Two areas observed to be lacking natural vegetation both in the field and on aerial photography (Figure 2 and Figure 3) exhibited elevated and peak responses ranging from approximately 40 to 200 mS/m. Due to the lack of natural vegetation, the elevated EM responses, and previously collected analytical soil data from near or within the areas, it is assumed that these areas are likely former pits associated with oil and gas production.

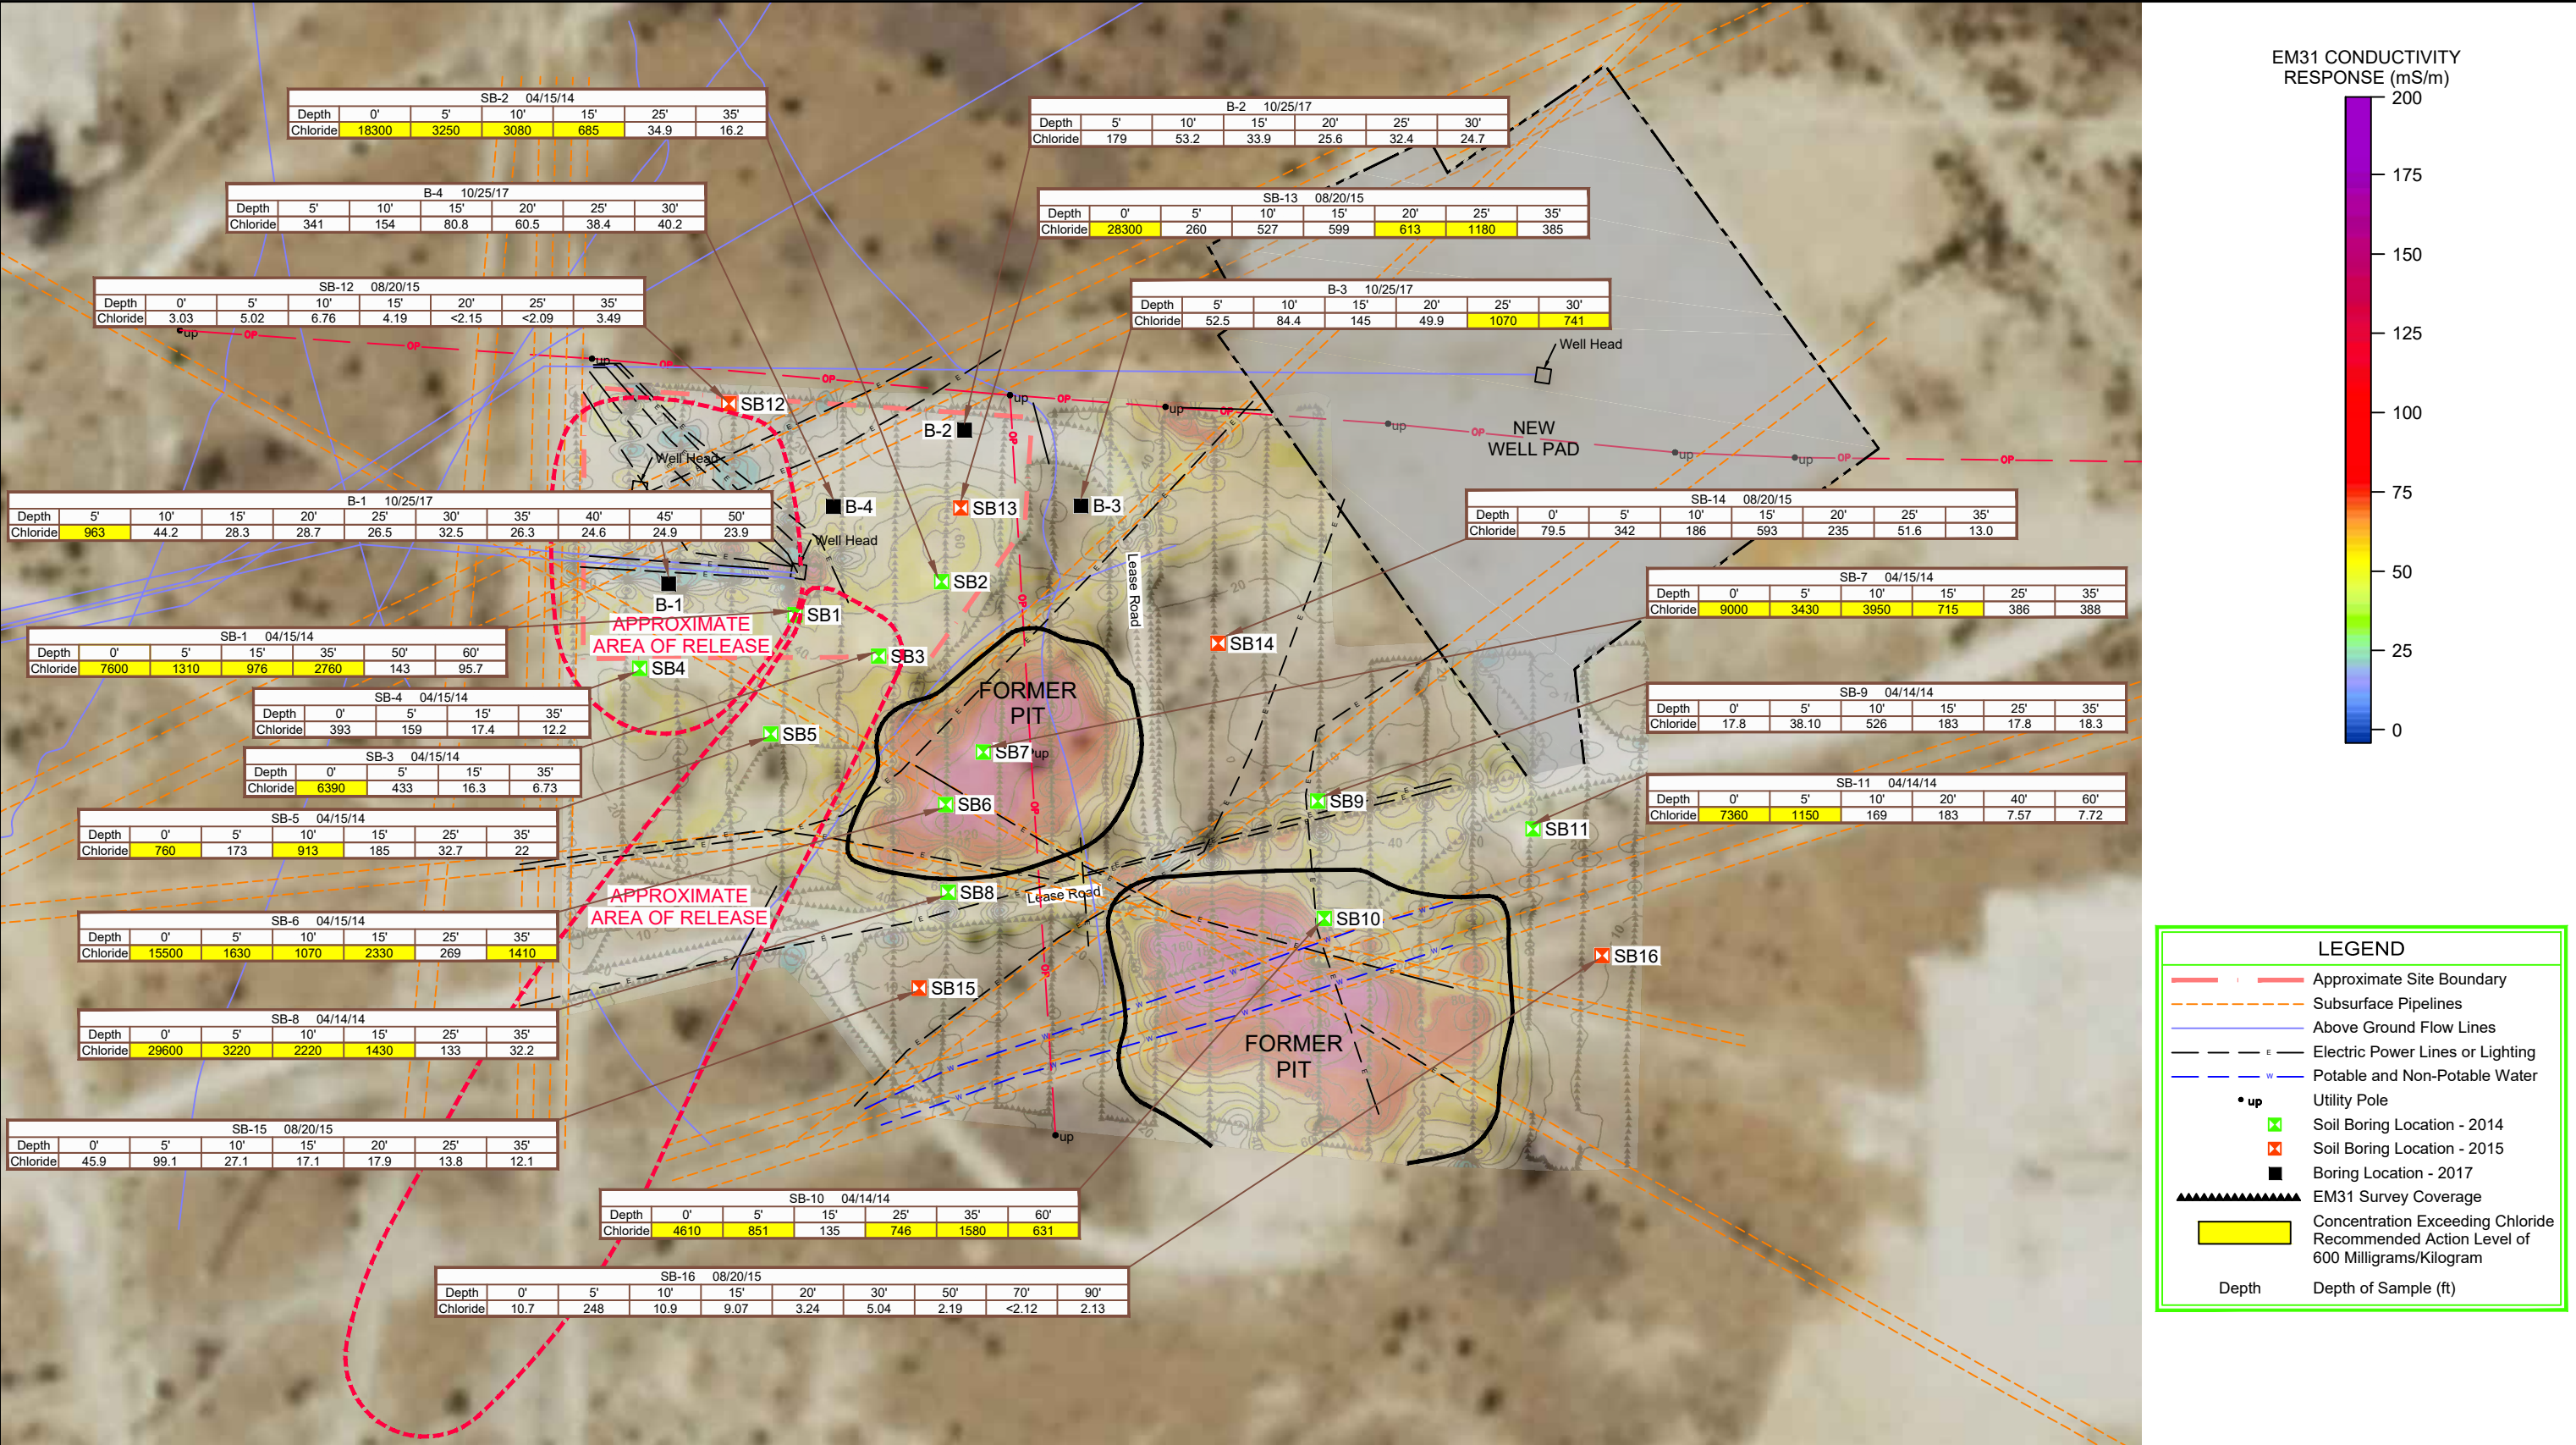
Upon return from the Site, the EM31 data were downloaded to a computer and compiled for data processing and plotting. The data for the EM31 survey were then processed as a colored contour plot. The plot was superimposed on an aerial image of the Site plan, and was used to locate elevated conductivity responses indicative of chloride-impacted areas relative to the Site features. Figure 3 depicts the EM31 survey results.

The colored contour conductivity plot presented on Figure 3 reveals that the highest intensity conductivity responses are colored red to purple, while areas of low response are colored blue. All remaining intermediate responses correspond to the color scale presented on the figure. Results from non-impacted areas within the survey coverage indicate that background conductivity responses were approximately 20 milliSiemens/meter (mS/m). Anomalous responses relative to background were generally 1.5 to 10 times higher, and ranged from approximately 30 to 200 mS/m.

As seen on Figure 3, the survey was completed southwest of the new well pad. Naturally vegetated areas generally yielded background responses of 20 mS/m. Several linear features were evident on the well pad, detected to the west of the new well pad, and detected along the lease road that dissects what appears to be former pits (see Figure 3). These linear features were shown as either negative or moderately elevated responses. As previously indicated, these responses indicate the location of metal pipes on or beneath the ground surface, which typically extended from pump jacks in the oil field as flow lines.

The survey coverage is presented on Figure 3. Ground cover for most of the survey area consisted of grasses and mesquite trees and shrubs. Exceptions included access roads and crushed aggregate caliche pad(s). Survey lines were spaced approximately 30 feet apart.

Drill cuttings were used for logging the soil type in each of the locations. Boring locations are shown on Figure 3. Soil observed during drilling activities consisted primarily of silty sands with secondary cementation (caliche). Boring logs are included as Appendix C.

- The data obtained from the geophysical survey indicated the following: the EM-31 indicated the presence of two drilling pits within the area of assessment. The northern-most drilling pit is likely associated with CVU-266. However, the southern-most drilling pit is likely associated with a well located to the south of the site (Vacuum Glorieta West Unit No. 075).
