### Report Type: Closure Report 1RP-4886

Site:	Chili Parlor 17 Federal 03H					
Company:	Marathon Oil Permian, LLC					
Section, Township and Range	Unit O	Sec. 08	T 22S	R 33E		
Lease Number:	API No. 30-025-43138					
County:	Lea County					
GPS:	32.3997481			-103.593154		
Surface Owner:	State					
Mineral Owner:	Federal					
Directions:	From the intersection of Hwy 176 and CR 27 A in rural Lea County, travel east on HWY 176 for 2.2 mi, turn southwest onto lease road and go 1.44 mi, turn south and go 0.66 mi, turn southeast and go 1.62 mi, turn southwest and go 6.77 mi, turn south and go 1.16 mi, turn west and go 0.27 mi, turn south and go 1.25 mi, turn east and go 0.91 mi, turn south and go 0.13 mi, turn southwest and go 200 ft to location.

**Re: Closure Report for the Marathon Oil, Chili Parlor 17 Federal #3H, Unit O, Section 08, Township 22 South, Range 33 East, Lea County, New Mexico. 1RP-4886.**

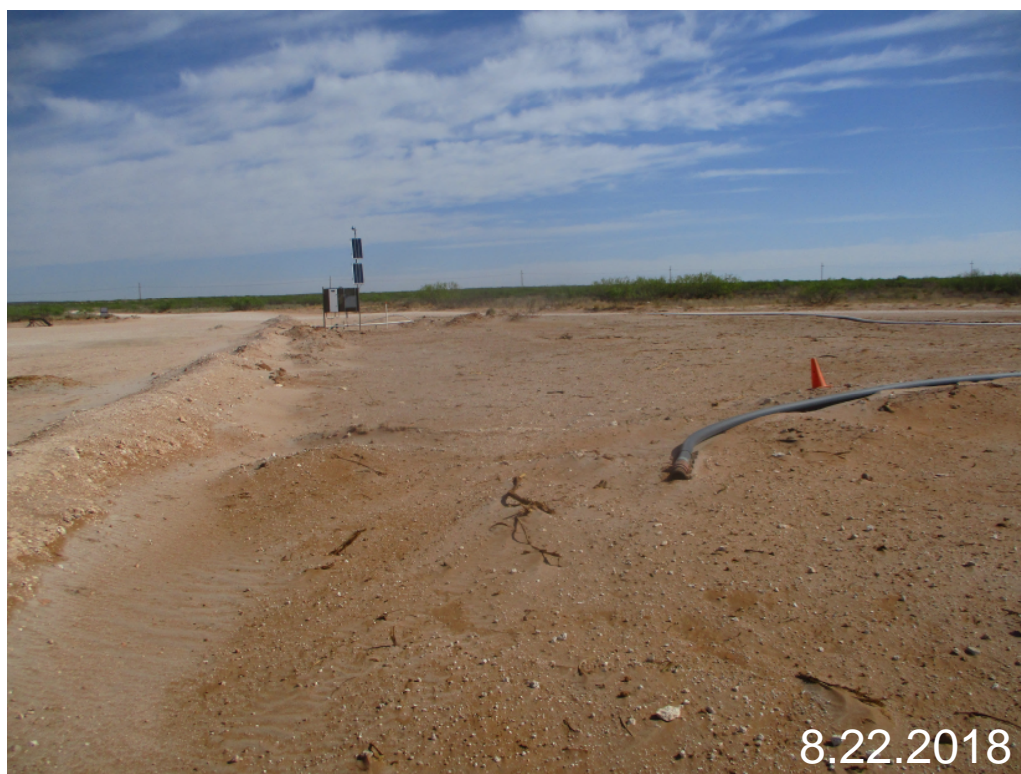
View North – Area of release point.

According to the State of New Mexico C-141 Initial Report, the leak was discovered on November 3, 2017, and released approximately four (4) barrels of water due to the disconnection of a transfer line by a contractor. No fluids were recovered. The release occurred to the southeast and adjacent to the location. The spill measured approximately 50' x 150'. The initial C-141 form is included in Appendix A. As part of the emergency response, Marathon personnel excavated the area to approximately 2' to address the surficial impact. The excavated material was hauled for proper disposal and the area was backfilled.

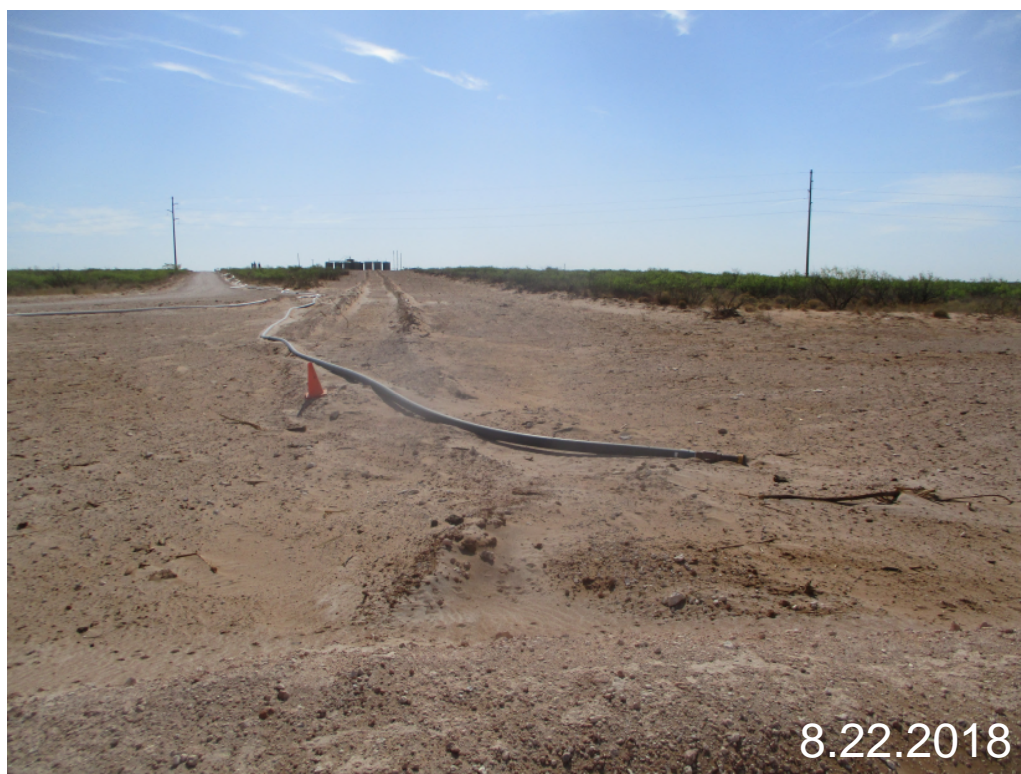
View East – Area of release.
