**Devon Energy Production Co LP
Bilbrey 27A Federal 1**

Closure Report

**Unit Letter F, Section 27, T21S, R32E
Lea County, New Mexico**

30-025-31095

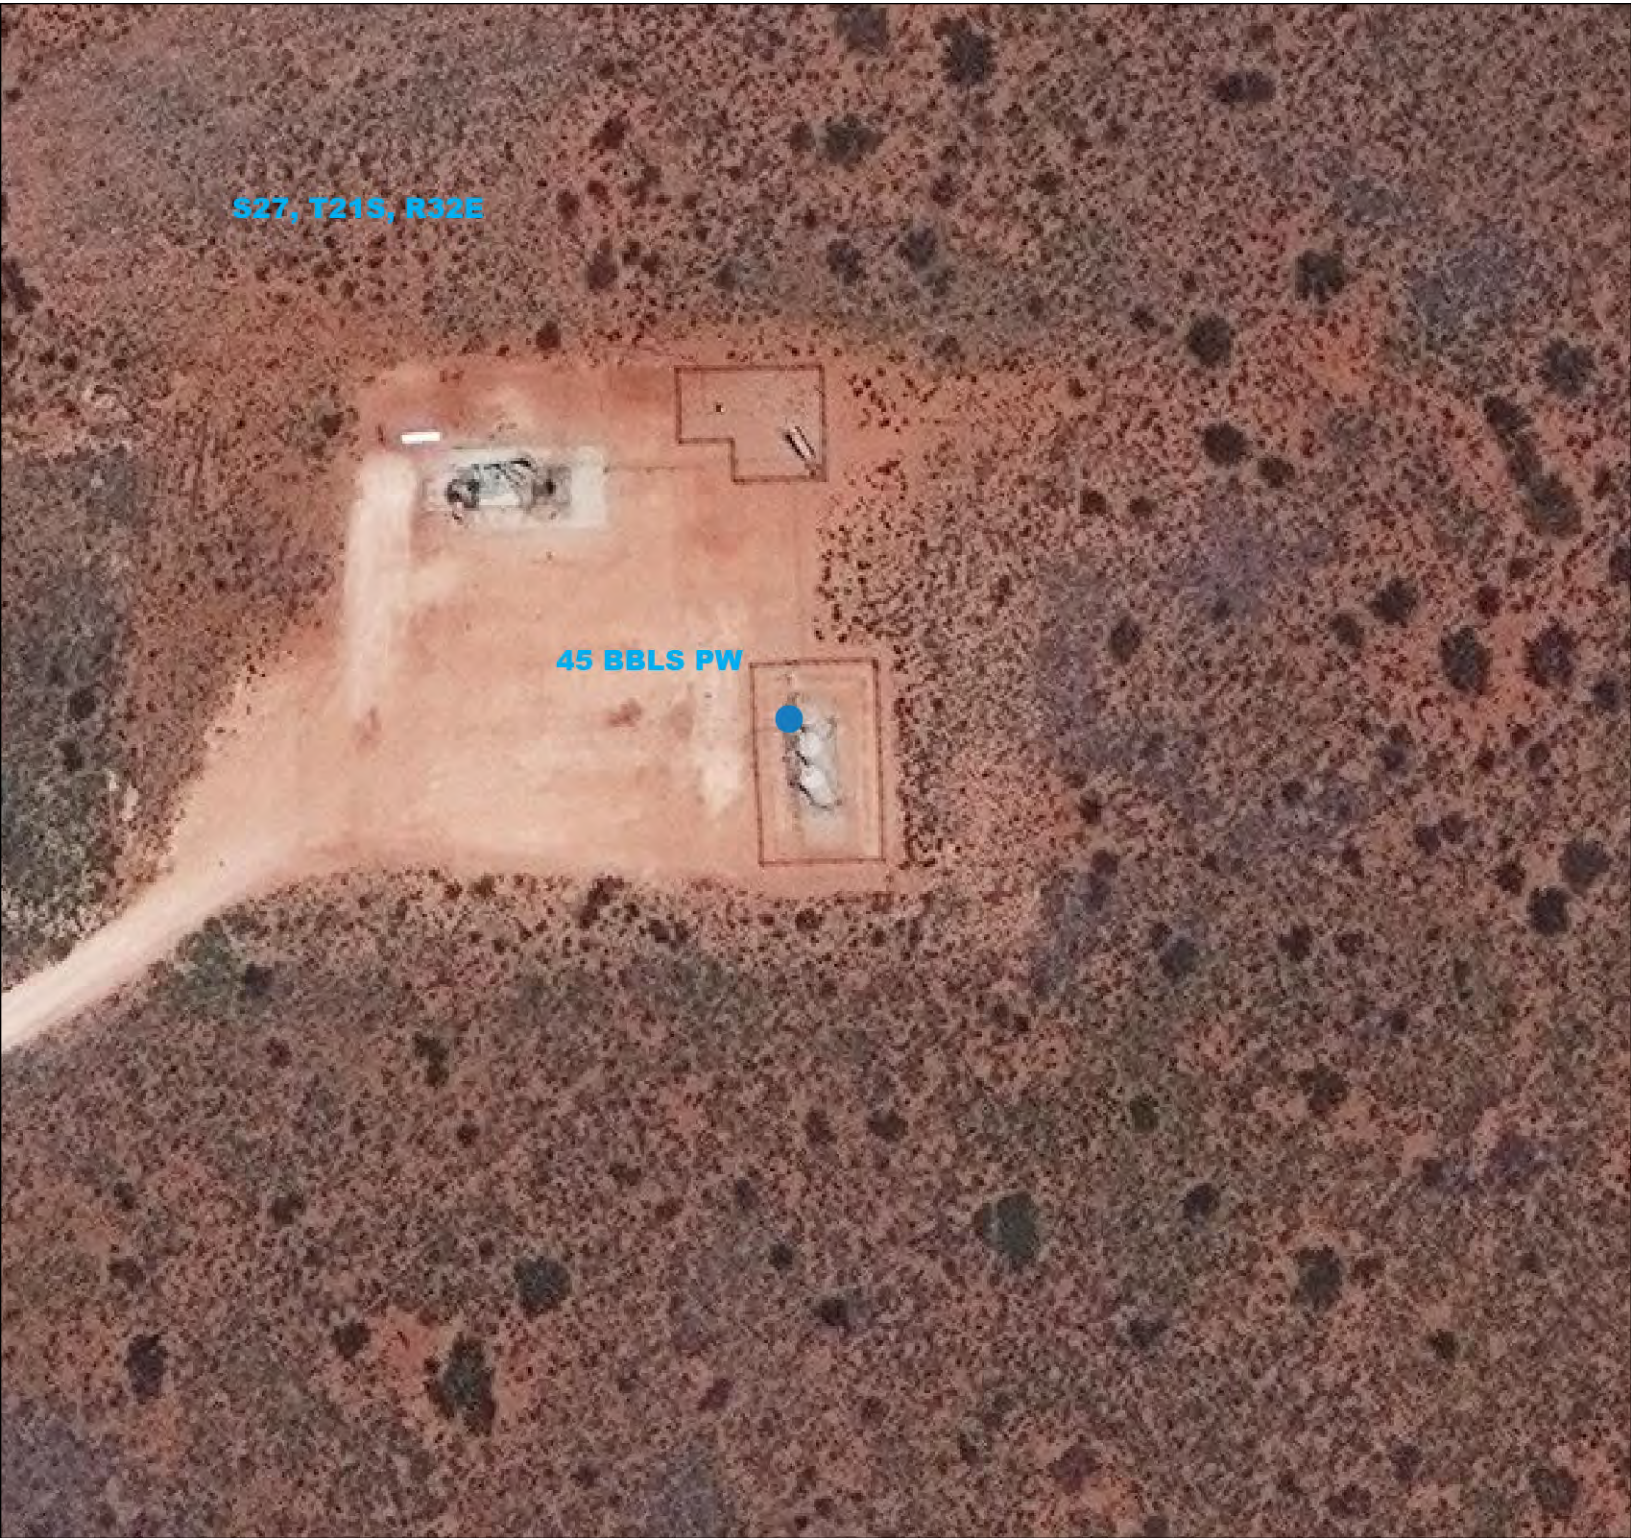
Figure 1

Vicinity Map

Bilbrey 27 A Federal #1
45 BBLS PW 2-15-16

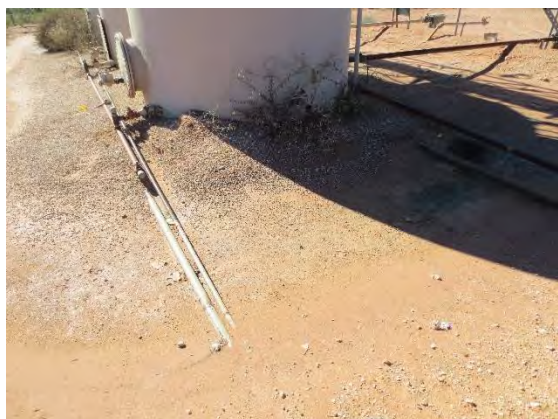
North end of the battery

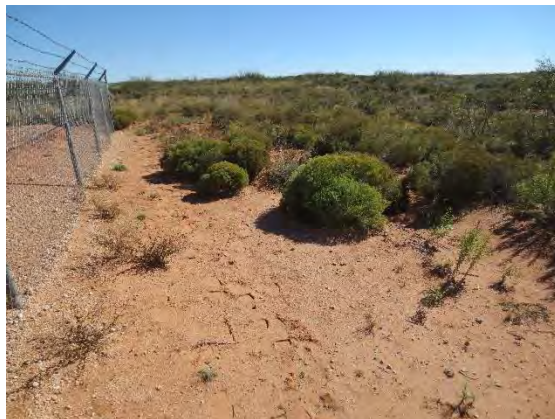
Area South of the battery

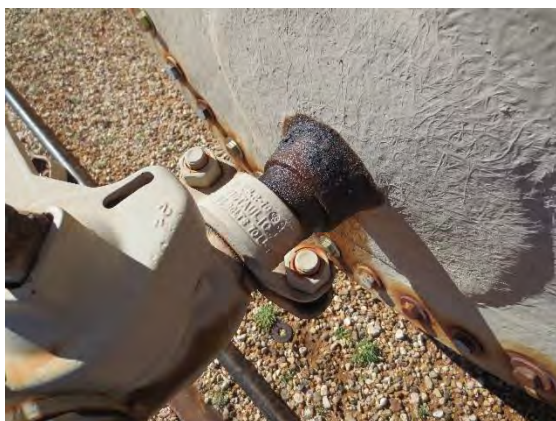
Fitting on the tank

According to the C-141: A water hauler backed into the water load line, broke the fiber glass collar, and 45 bbl. of produced water released from the water load line. The well was immediately shut in and all dump lines were closed going to the tank to prevent further release. The water released into an unlined bermed secondary containment. The approximate area affected was 25ft X 20ft within the bermed containment. All 45 bbl. of the produced water released remained in the bermed containment. None of the released fluid left location. A vacuum truck recovered approximately 40 bbl. of the released produced water. The trucking company contacted SESI to assess the area for remediation. The NMOCD and BLM were notified on February 15, 2016.

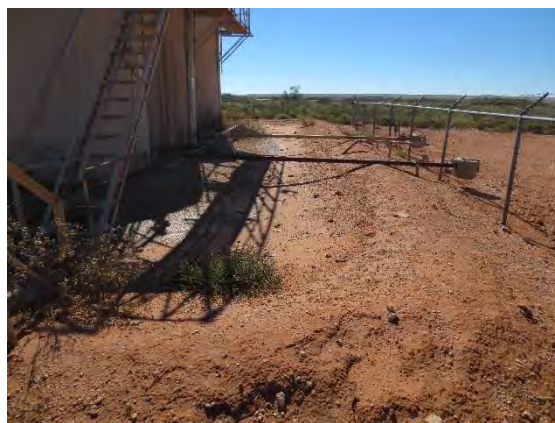
West side of the battery
