**Devon Energy Production Co LP
Bell Lake 24 Federal 1H**

Work Plan

**Unit Letter M, Section 24, T24S, R32E
Lea County, New Mexico**

December 13, 2016

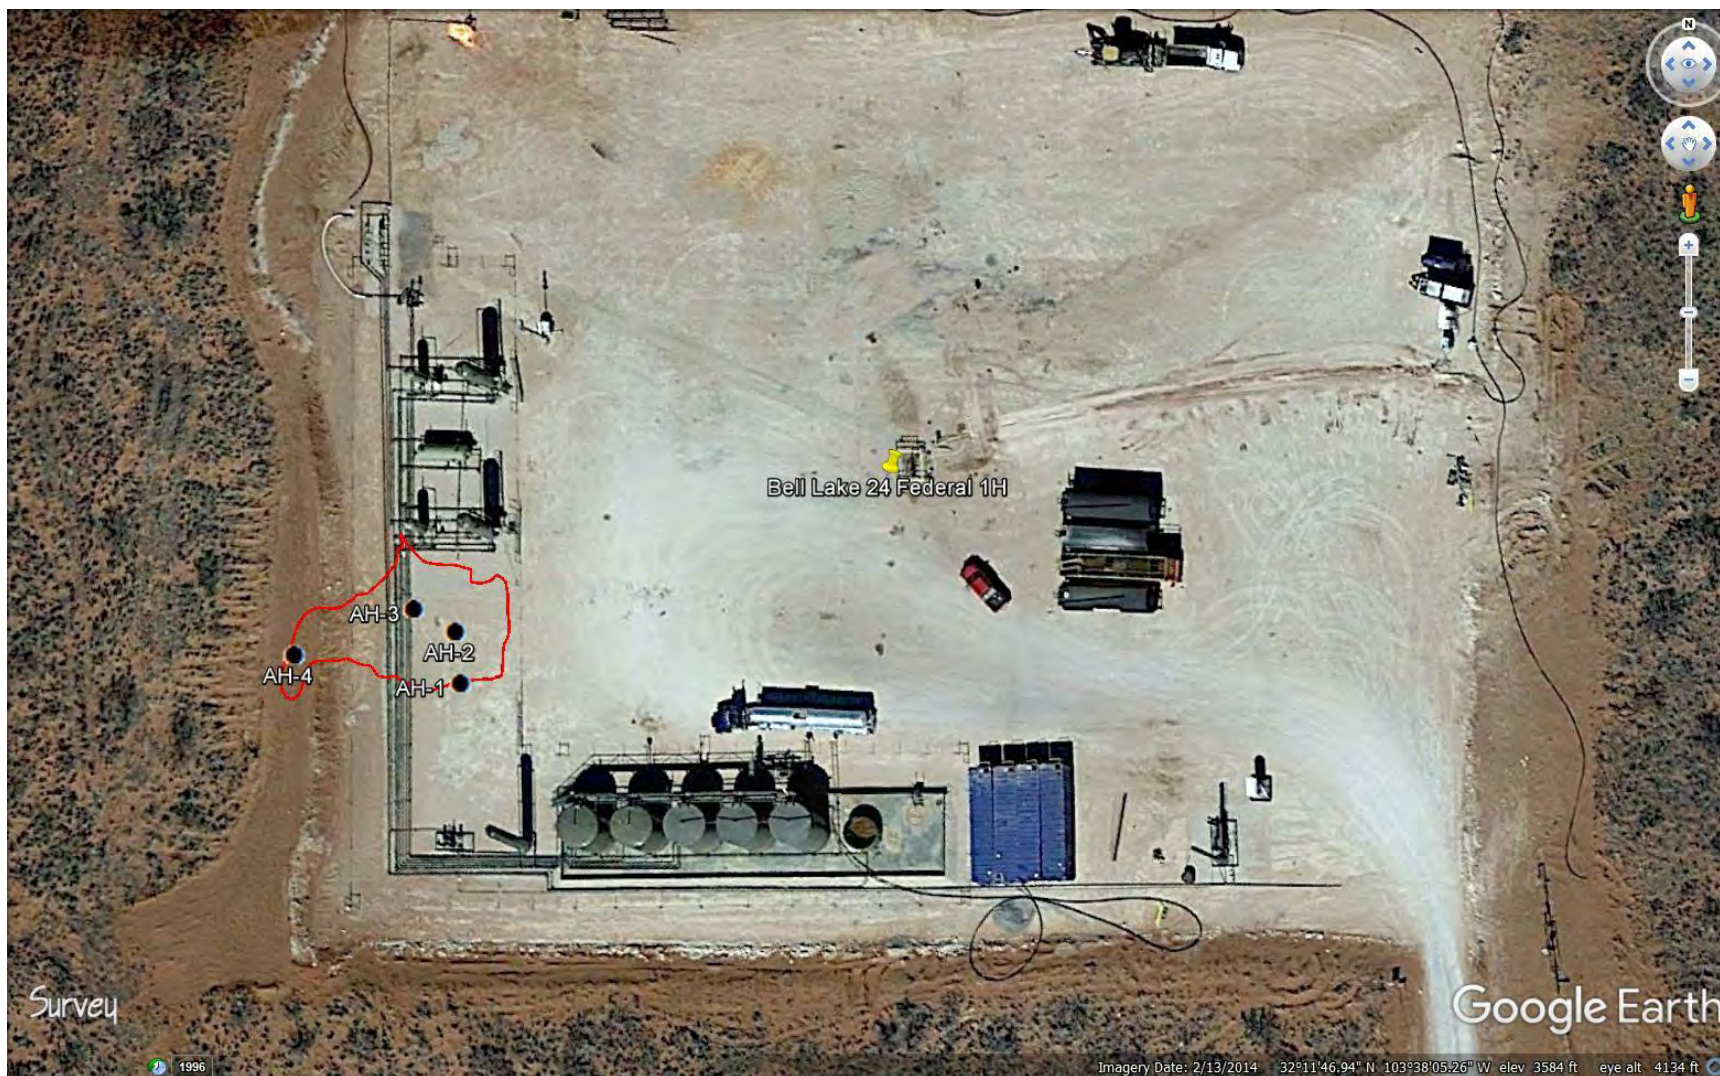
Figure 2

Site Plan

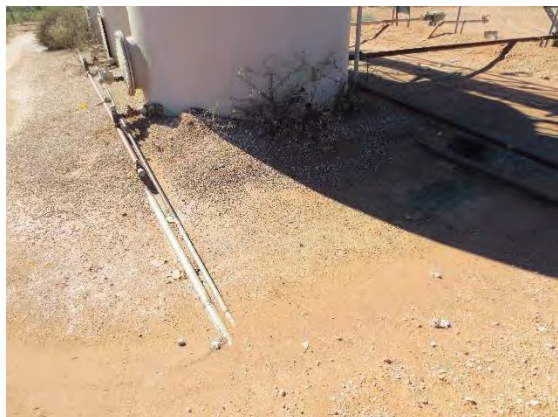
North end of the battery

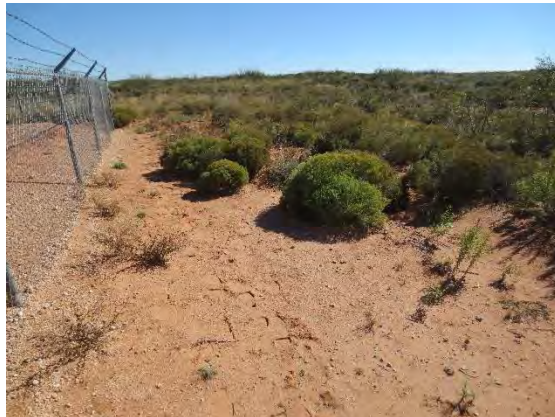
Area South of the battery

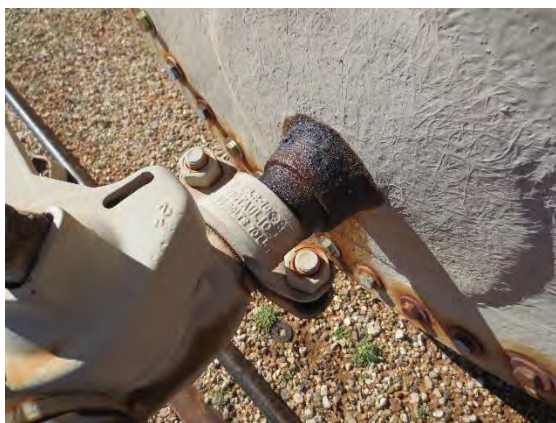
Fitting on the tank

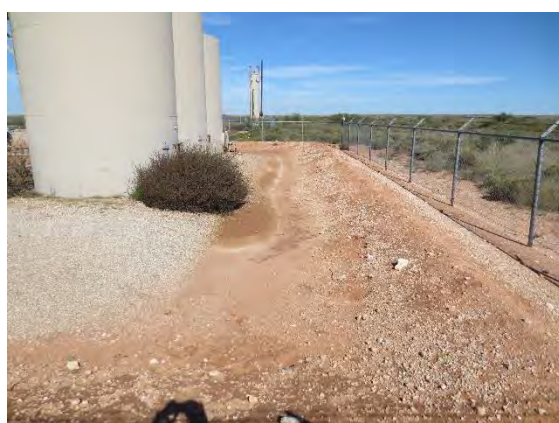
East side of the battery

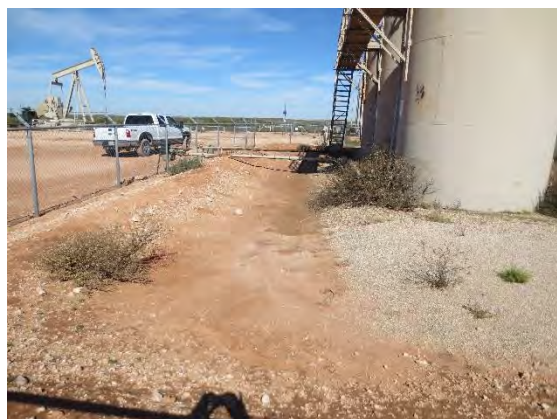
West side of the battery

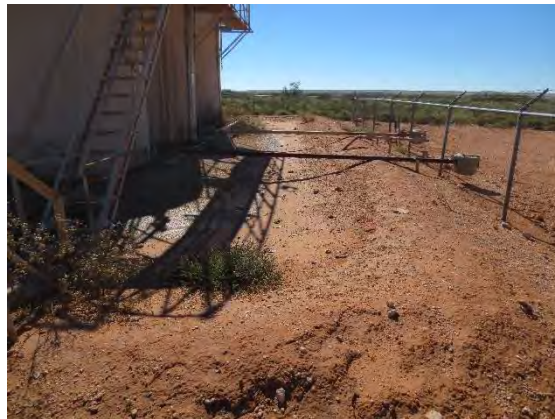
West side of the battery
