# Closure Report

NMOCD grants  
closure to 1RP-4520.

Site Name:	Macho Nacho State #002H
Company:	COG Operating LLC
Legal Description:	U/L H, Section 7, T24S, R33E
County:	Lea County, NM
GPS Coordinates:	N 32.23388° W 103.60349°

Date of Release:	11/18/2016
Type of Release:	Oil
Source of Release:	Well head
Volume of Release:	50 bbls
Volume Recovered:	45 bbls

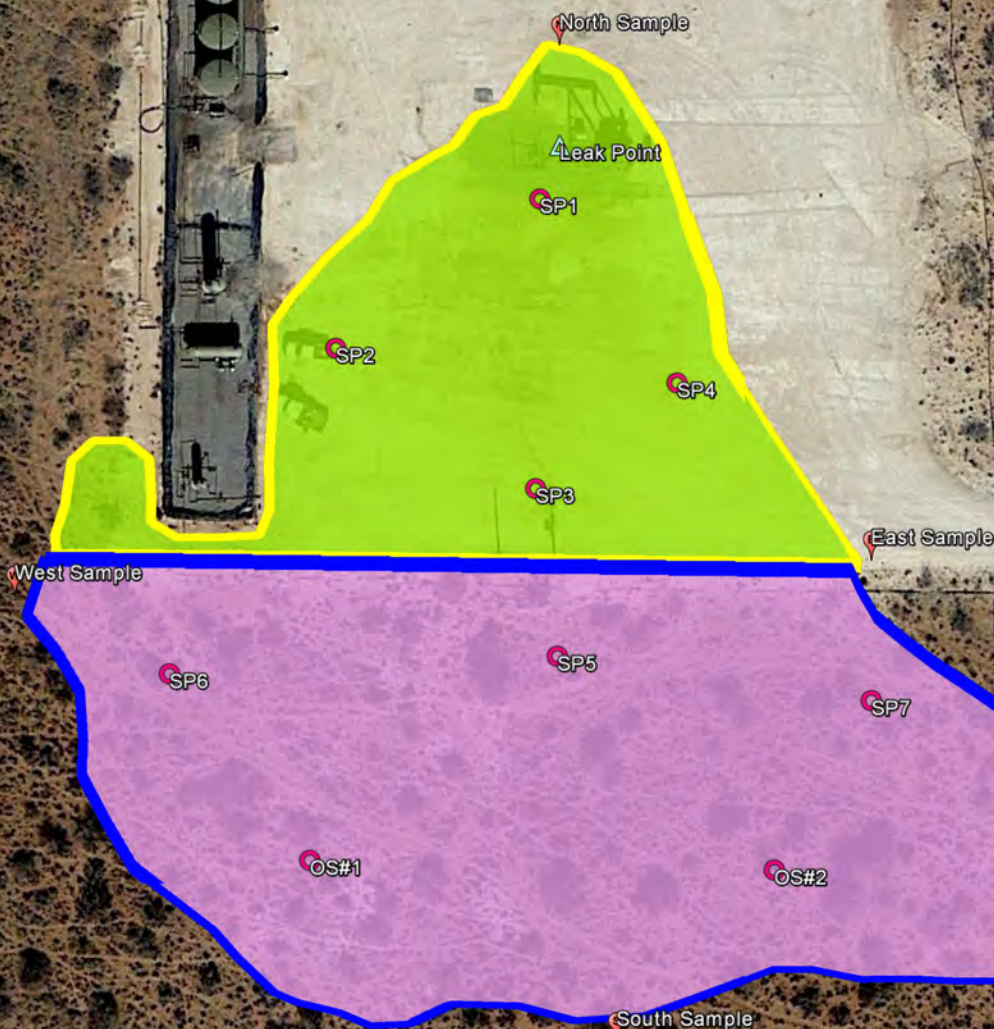
Leak Date: 11/18/2016  
Lea County, NM  
API# 30-025-39883  
RP# 1RP-4520

-   East Sample
-   Sample Points, Hand Auger
-   Leak Point
-   North Sample
-   Overspray, Rake or Mow
-   South Sample
-   Spill Area, 6 Inch
-   Excavation West Sample

Remediation Parameters:	Excavate the areas around SP1-SP4, SP8, SP9, & SP12 to a depth of 6 inches. Obtain sidewall confirmation samples for TPH and CI for SP1-SP4. If permissible levels are exceeded, excavate to 1 foot and go additional confirmation sampling. The overspray areas of SP5-SP7, SP10, SP11, OS #1 & #2, will be raked or mowed. Backfill with clean soil.	
Remediation Activities:	09/25/2017 to 10/04/2017	
Plan Sent to OCD:	03/24/2017	Email from Cliff Brunson to Olivia Yu
OCD Approval of Plan:	06/30/2017	Email from Olivia Yu to Cliff Brunson
Plan Sent to SLO:	03/24/2017	Email from Cliff Brunson to Amber Groves
SLO Approval of Plan:	07/06/2017	Email from Amber Groves to Cliff Brunson
