SITE INFORMATION												
Report Type: Soil Remediation Closure Request 1RP-3960												
General Site Information:												
Site:	Eunice Yard											
Company:	Globe Energy Services											
Section, Township and Range	Unit I	Sec. 34	T 21S R 37E									
Lease Number:												
County:	Lea County											
GPS:	32.433563° N		103.144684° W									
Surface Owner:	Chevron USA, Inc.											
Mineral Owner:												
Directions:	From intersection of Texas Ave & 4th St in Eunice, NM travel SOUTH on 4th St for approx 0.25 mi, turn EAST onto lease road for approx 0.15 mi. SW Corner of Globe Energy Yard is approx 125 feet north of lease road.											
Release Data:												
Date Released:	Unknown											
Type Release:	Produced Water											
Source of Contamination:	Frac Tank Failure											
Fluid Released:	Unknown											
Fluids Recovered:	None											
Official Communication:												
Name:	Tommy Morris		Ike Tavaréz									
Company:	Globe Energy Services		Tetra Tech									
Address:	113 Texas Ave.		4000 N. Big Spring									
			Ste 401									
City:	Eunice, NM 88231		Midland, Texas									
Phone number:	(325) 207-7775		(432) 687-8110

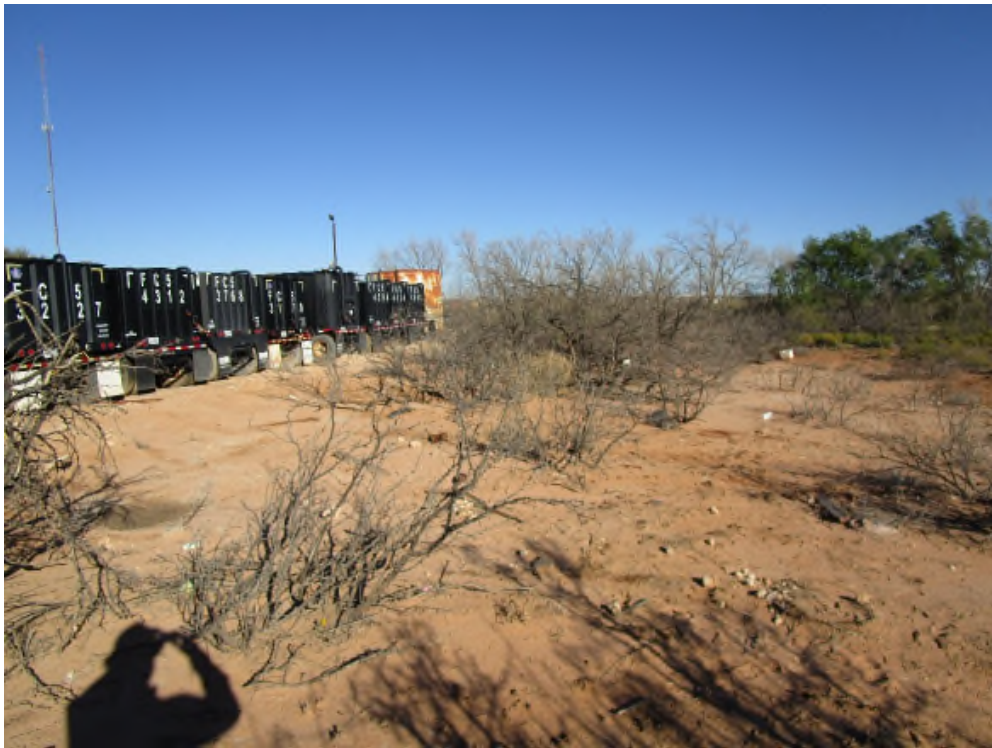
View West – Area of AH-1 and AH-2

Referring to Table 1, all of the auger hole samples selected for BTEX analysis were below the RRAL. The areas of AH-1, AH-16 and AH-21 showed TPH concentrations above the RRAL with concentrations of 350 mg/kg, 387 mg/kg and 320 mg/kg, respectively. However, the impact in these areas were vertically defined in the shallow soils at a depth of approximately 1-1.5' below surface. In addition, auger holes (AH-3, AH-4, AH-8, AH-15, AH-17, AH-19, AH-20 and AH-22) exceeded the TPH RRAL and were not vertically defined. The remaining auger holes (AH-2, AH-5, AH-6, AH-7, AH-9, AH-10, AH-11, AH-12, AH-13, AH-14, AH-18, AH-23 and AH-24) did not show any TPH concentrations above the RRAL.

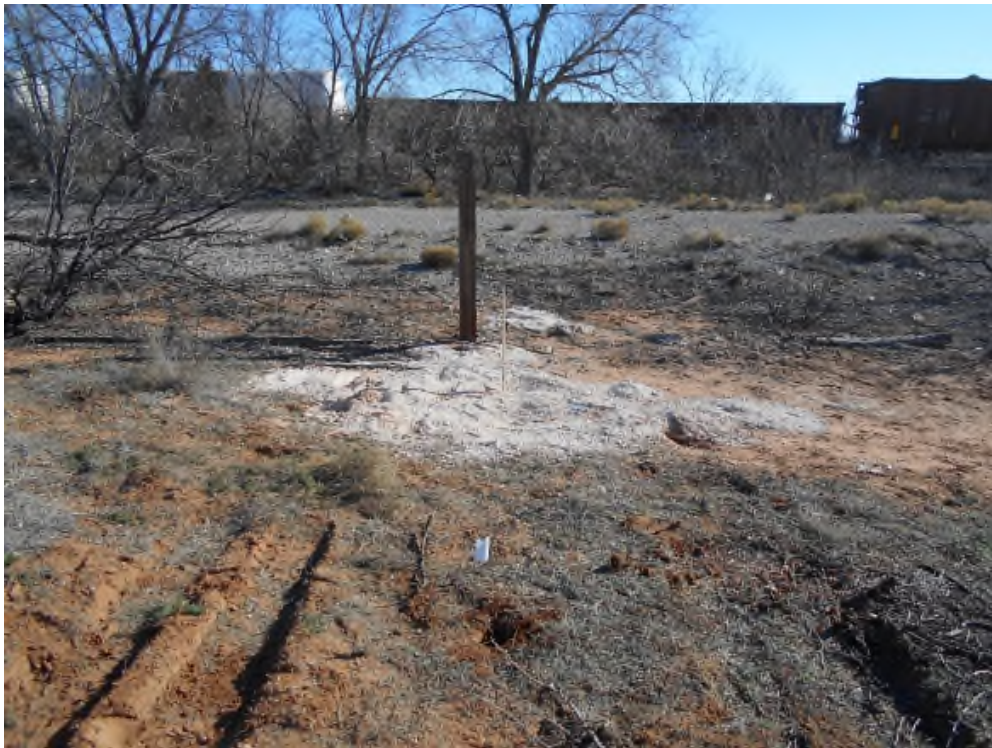
View East – Area of BH-1

The remaining boreholes; BH-1 (AH-6), BH-2 (AH-7), BH-4 (AH-4), BH-5 (AH-3), and BH-6 (AH-1) did not show chloride concentrations decline below 250 mg/kg at a depth of 24'-25', with concentrations of 286 mg/kg, 455 mg/kg, 1,320 mg/kg, 426 mg/kg, and 370 mg/kg, respectively. Due to shallow groundwater in the area, no samples were collected deeper than 24'-25' below surface.

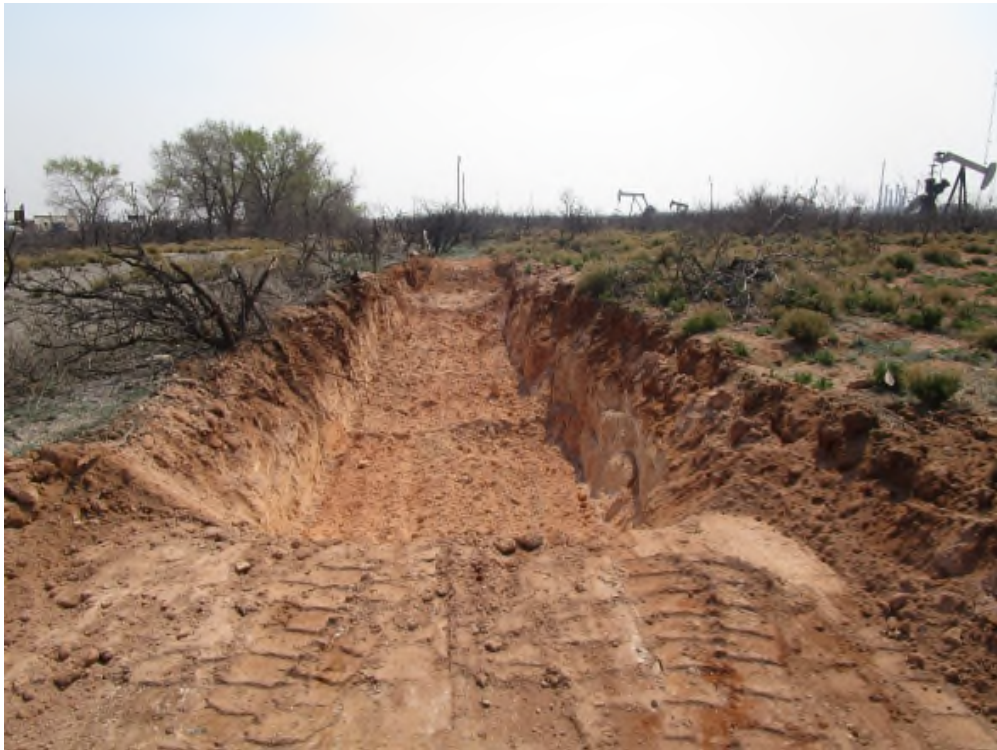
View South – Excavated Area of BH-1

The areas of auger holes (AH-1, AH-2, AH-3, AH-7, AH-13, and AH-14) were excavated to depth of 5.0'-5.5' below surface and the area of auger hole (AH-6) was excavated to a depth of 6.0' below surface. In the area of auger hole (AH-4), which showed deeper chloride impact to the soils, the area was excavated to 19.0' below surface. Additionally, the areas of auger holes (AH-8, AH-9, and AH-12) were excavated to a depth of 1.5'-2.0' below surface. In addition, a total of seventeen (17) sidewall samples were collected in the south area of the Globe facility. Figure 5a shows the sample locations and Table 3 summarizes the sampling results.

the sidewall samples collected to the east of the excavation, along the adjoining property line (BH-1 ESW and BH-2 ESW) showed chloride concentrations of 4,160 mg/kg and 5,840 mg/kg, respectively. Additionally, two (2) bottom hole samples (BH-7 NBH and BH-7 SBH) were collected in the area of borehole (BH-7), which showed chloride concentrations of 54.4 mg/kg and 144 mg/kg, respectively.

Tetra Tech will investigate the impacted soils along the east property line in the area of (BH-1 ESW) and (BH-2 ESW), which were identified during the excavation when the east sidewall samples were collected along the east property line. The property owner will be contacted to collect soil samples for proper removal of the impacted soils. Soil samples will be collected from the area to assess the soil for chlorides. Once the area is assessed, a work plan will be submitted to the NMOCD for review and approval.

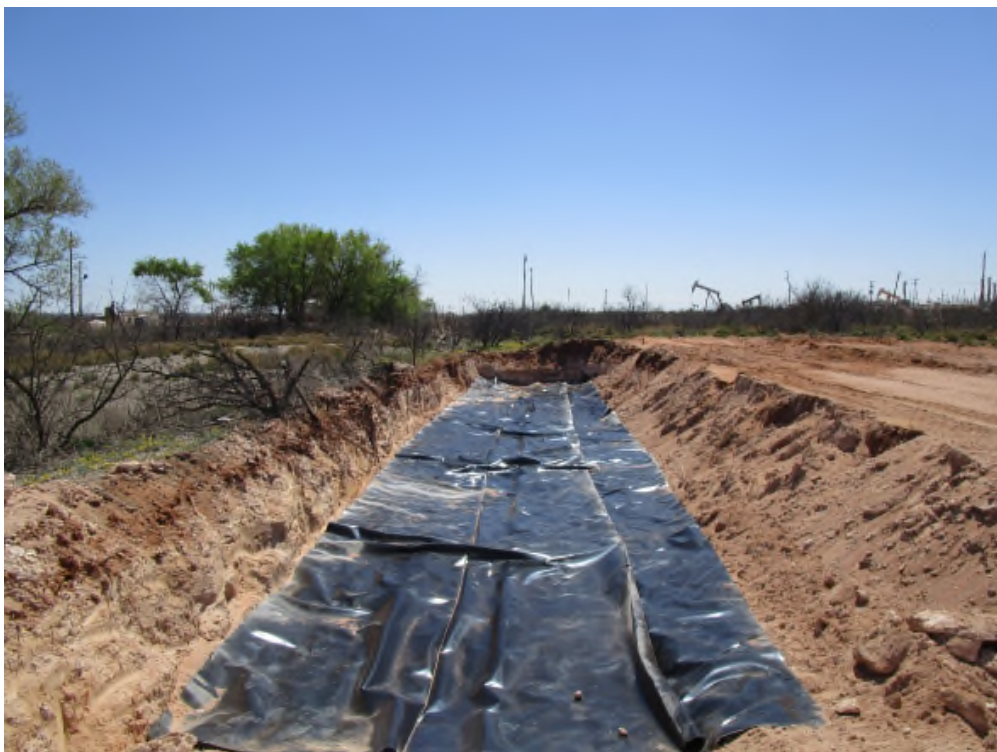
View South – Lined Area of BH-1 and BH-2

Approximately 4,800 cubic yards were removed and hauled to Sundance Disposal located in Eunice, New Mexico. All of the impacted soils on Chevron property have been properly removed to the appropriate or proposed depths, including the spill footprint. In addition, the areas of auger holes (AH-1, AH-2, AH-3, AH-4, AH-6, and AH-7) were capped with a 40 mil liner to prevent vertical migration of the deeper impact.

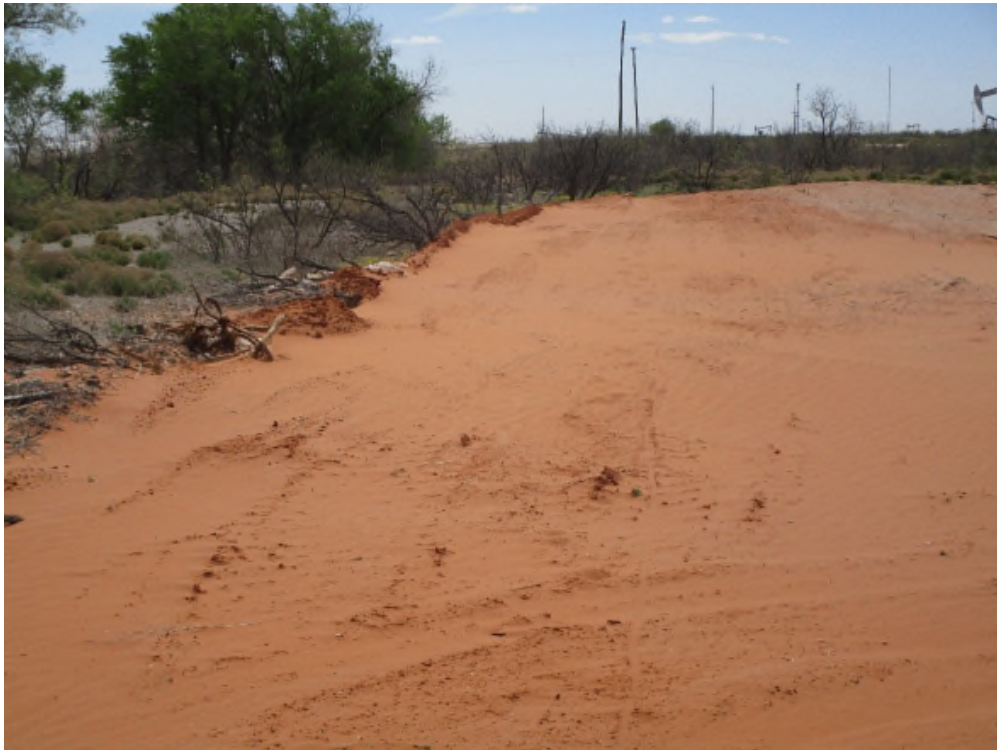
View South – Backfilled Area of BH-1, BH-2, and BH-3

Once excavated to the appropriate depth, the areas were backfilled with clean soil to grade. The excavated areas and depths highlighted (green) in Table 1 and shown on Figure 5. The soil remediation details were divided into two areas for simplicity. The South Release Area included the areas of auger holes (AH-1 through AH-14) and the West Release area included the areas of auger holes (AH-15 through AH-24).

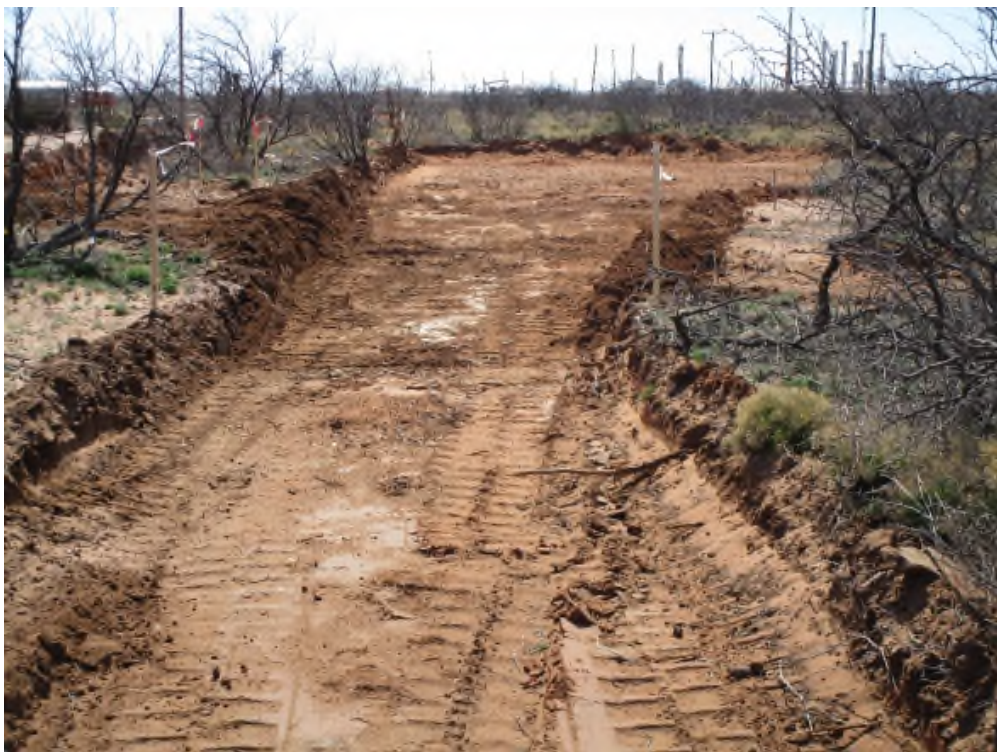
View South – Excavated Area of AH-17 and AH-21

The areas of auger holes (AH-19 and AH-20) were excavated to a depth of 6" below surface, the areas of auger holes (AH-15, AH-16, AH-17, AH-22, and AH-23) were excavated to a depth of 1.5'-2.0' below surface. In addition, the area of auger hole (AH-21) was excavated to depth of 3.0' below surface. A total of ten (10) sidewall samples were collected during the excavation of the soils in the west area of the Globe facility. Figure 5b shows the samples and Table 3 summarizes the sampling results.

Referring to Table 3, the sidewall sample collected at (AH-17 WSW) showed a chloride concentration of 152 mg/kg. The samples collected at (BH-8 SSW, BH-8 WSW, BH-8 NSW, AH-17 WSW, AH-20 SSW, AH-20 NSW, BH-12 WSW, AH-22 NWSW, and BH-12 NSW) showed TPH concentrations ranging between <10.0 mg/kg and 106 mg/kg. In the area of (AH-19 WSW) elevated TPH concentrations were detected at the original sidewall location and was then expanded an additional 5', which then showed a sidewall concentration of 275 mg/kg. However, after the area was expanded further, a TPH concentration of 548 mg/kg was detected. Further excavation was not performed in this area due to the area sloping uphill and the impact does not appear to be related to the release.

Additionally, two (2) bottom hole samples (AH-17 BH and BH-11 BH) were collected in the areas of AH-17 and BH-11 to confirm the impacted materials were properly removed. The sample collected at (AH-17 BH) showed a chloride concentration of 76.2 mg/kg and the sample collected at (BH-11 BH) showed a TPH concentration of <10.0 mg/kg.
