# Closure Report

Site Name:	State AR #003 Battery
Company:	Oxy Permian Ltd.
Legal Description:	U/L L, Section 2, T20S, R37E
County:	Lea County, NM
GPS Coordinates:	N 32.59991° W 103.22853°

Date of Release:	11/02/2016
Type of Release:	Oil and produced water
Source of Release:	Lightning caused a fire which resulted in a burn off
Volume of Release:	162 bbls oil, unknown amount of produced water
Volume Recovered:	0 bbls

# Oxy, State AR #003 Battery

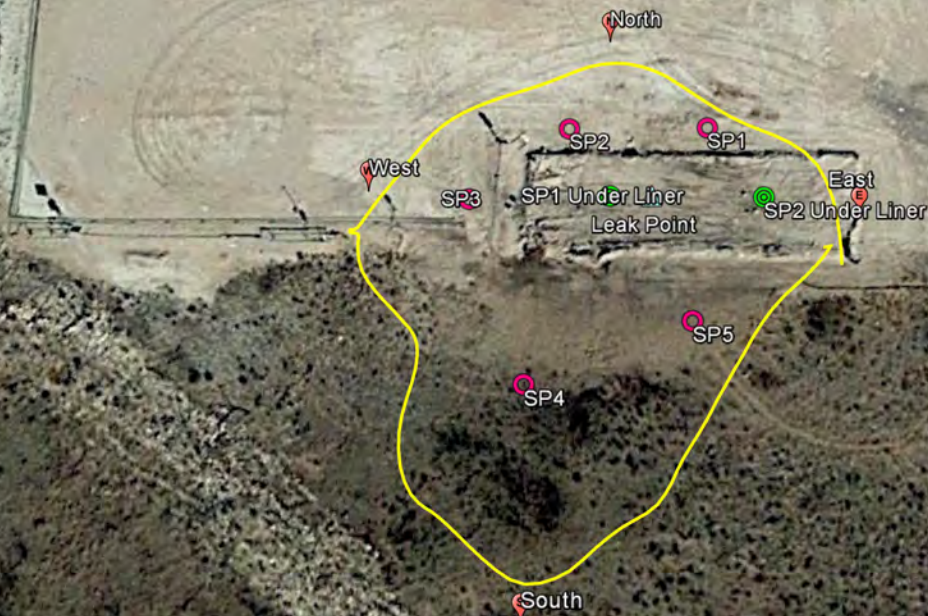
Leak date: 11/03/2016  
Lea County, NM  
API# 30-025-37155  
RP# 1RP-4518

- E East Sample, hand auger
- △ Leak Point
- N North Sample, hand auger
- Sample points, hand auger
- Sample points, Under liner, hand auger
- S South Sample, hand auger
- ⬢ Spill area, Surface scrape the entire area
- W West Sample, hand auger

Remediation Parameters:	Remove impacted material from within the lined battery. Surface scrape the rest of the leak area. Collect two samples within the battery for vertical delineation. Backfill the site with clean soil.	
Remediation Activities:	04/14/2017 to 04/18/2017	
Plan Sent to OCD:	01/28/2017	Email from Cliff Brunson to Kristen Lynch
OCD Approval of Plan:	03/07/2017	Email from Olivia Yu to Cliff Brunson
Plan Sent to BLM:	n/a	n/a
BLM Approval of Plan:	n/a	n/a
