RE: **Response to NMOCD's October 4th and 7th, 2018 email**

Operator: Pride Energy Company
NM 87 State #001 **(Tank Battery)**
API#: 30-025-23655
Section 33-14S-34E: Unit K
Lea County, New Mexico
Site Characterization Report and Remediation Plan 1RP-4624

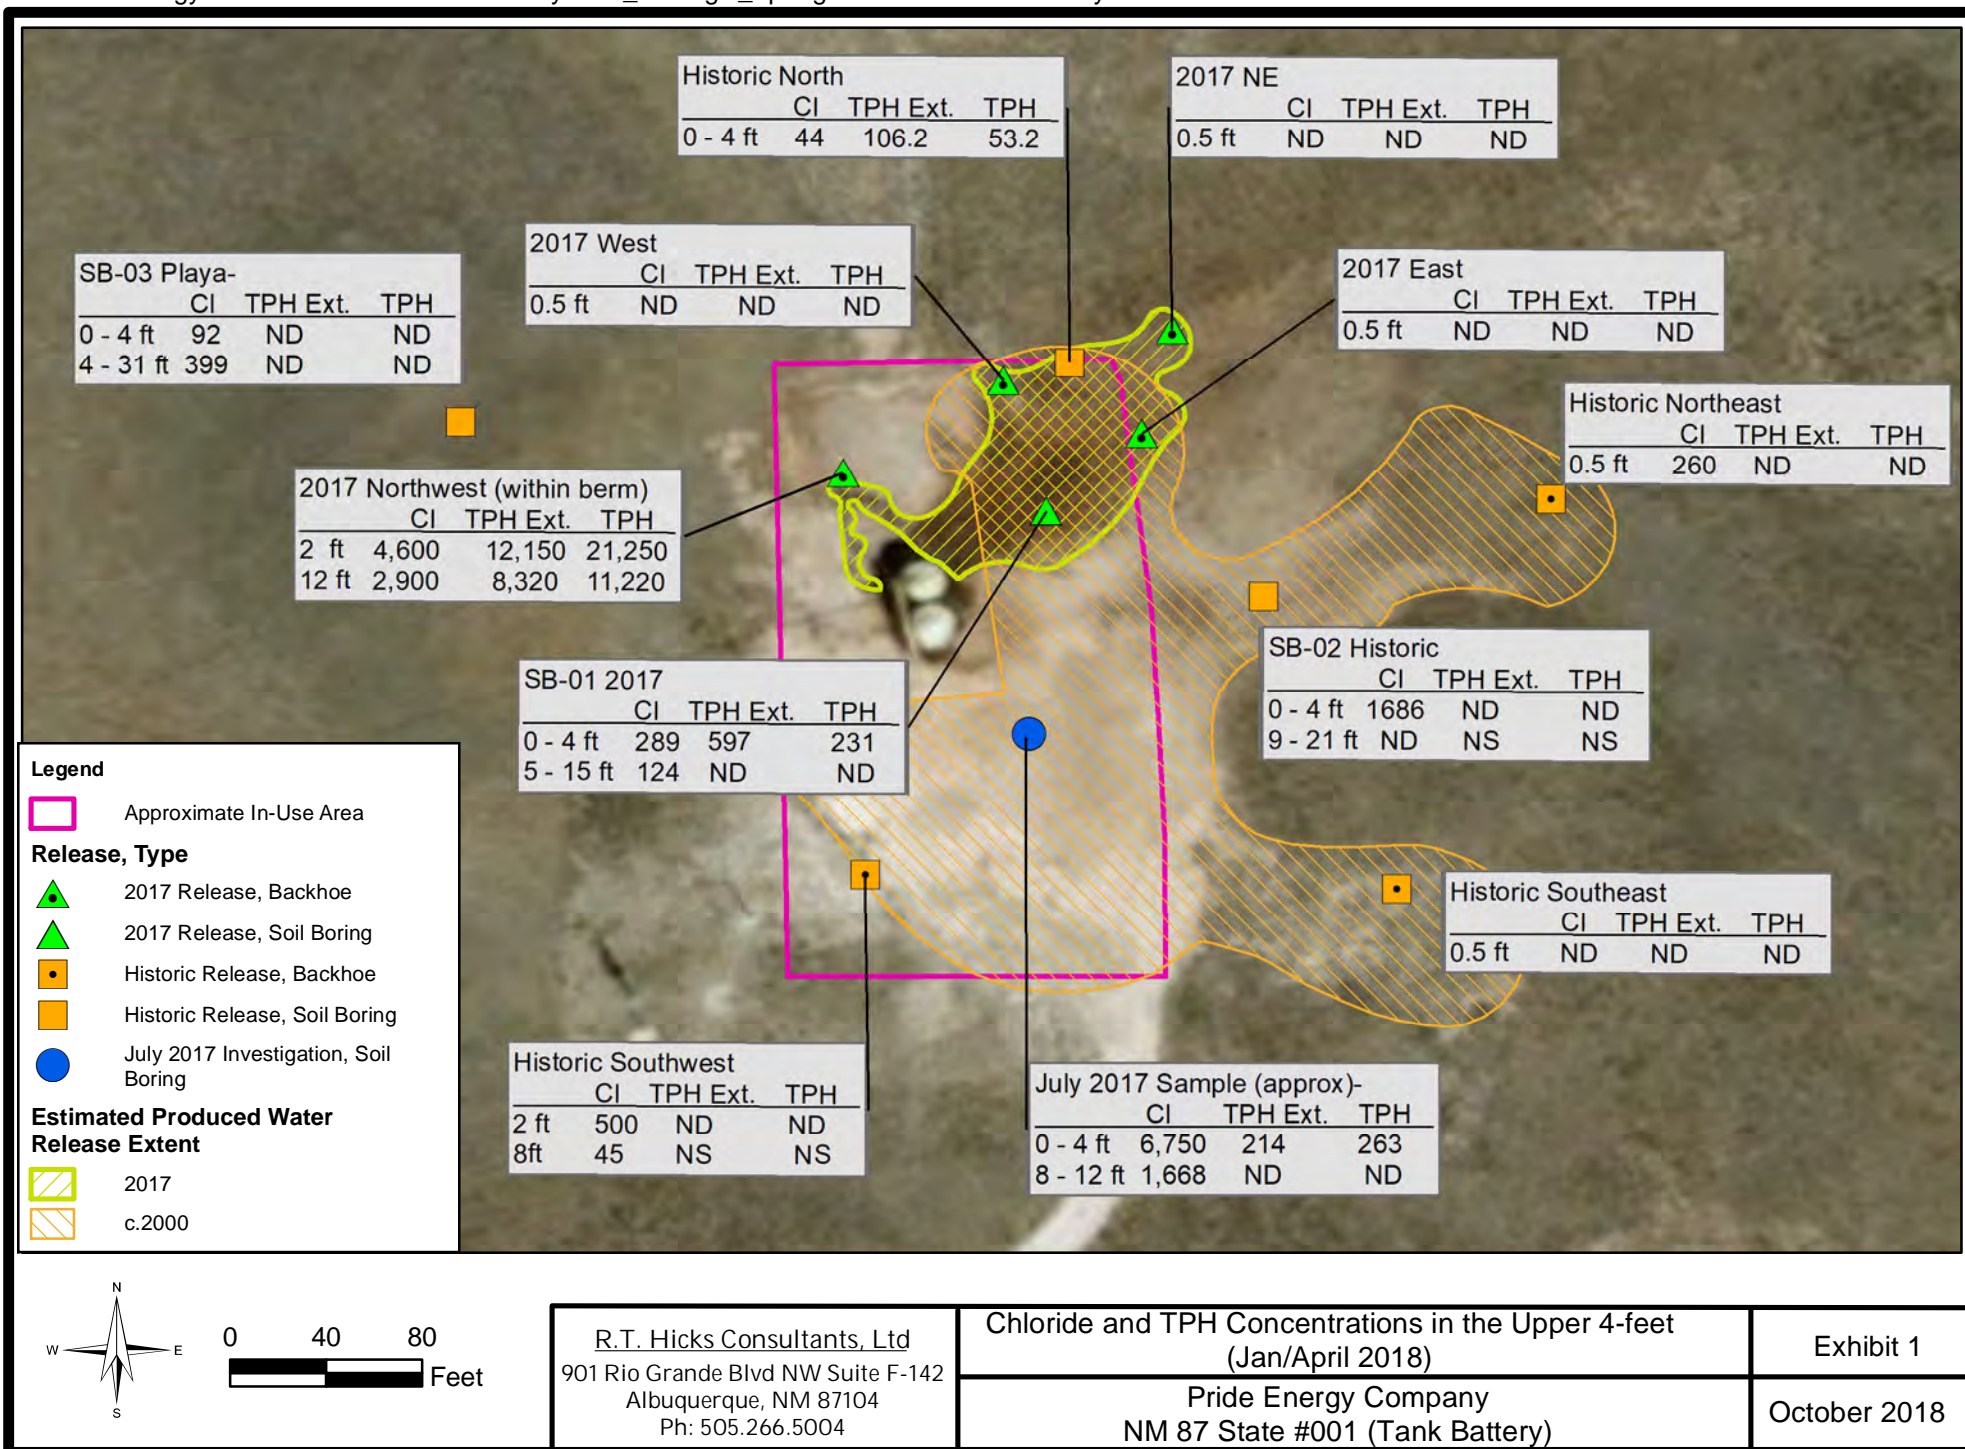
As shown on Exhibit 1, attached, the pink outline defines the "in-use" area based upon historic aerial photos, a current aerial photo, and site reconnaissance of the active tank battery. Pride Energy acquired the former salt water disposal location in February 2007 and has no survey plats in their files. The former well was first spudded in 1970. No site specific survey exists in NMOCD's online files. Mr. Mann with the State Land Office has not survey plats showing lease extents.

Included on Exhibit 1 are chloride and TPH concentrations in mg/kg. Sample depths showing a range were averaged from discrete samples. Discrete sample depths are noted

was omitted from further vertical delineation. The two exceptions were SB-03 Playa and SB-02 Historic. SB-03 Playa was vertically delineated at the request of the State Land Office. SB-03 Playa is below Table 1 limits including chloride <600 mg/kg in the upper 4-feet. Vertical delineation showed that SB-02 Historic requires reclamation for areas “no longer in-use” per 19.15.29.13.D and concurrence with the State Land Office.

For sampling locations within areas “in-use” only the 2017 Northwest (within berm) location shows TPH above Table 1 limits. As shown in Exhibit 2, the area is most likely within a former reserve pit. In the 1970s, when wells were originally drilled, a reserve pit was commonly constructed north of the wellhead and unlined. The left panel on Exhibit 2 is an example of a reserve pit captured in a December 1971 aerial photograph - 1.7 miles northwest of the tank battery location.
