Report Type: Closure Report 1RP-4845

Site:	Cochise 2 State 4					
Company:	Saber Oil & Gas Ventures, LLC.					
Section, Township and Range	Unit G	Sec. 02	T 19S	R 32E		
Lease Number:	API No. 30-025-31670					
County:	Lea County					
GPS:	32.692152° N			103.7347785° W		
Surface Owner:	State					
Mineral Owner:						
Directions:	From the intersection of 126A and Dry Lake Rd in rural Lea County, travel east on Dry Lake Rd for approximately 5.10 mi, turn north onto lease road and continue for 2.25 mi, turn west onto lease road and continue for 1.20 mi to the location.

Re: Closure Report for the Saber Oil & Gas Ventures, LLC., Cochise 2 State 4, Unit G, Section 02, Township 19 South, Range 32 East, Lea County, New Mexico. 1RP-4845

Spill Assessment Map

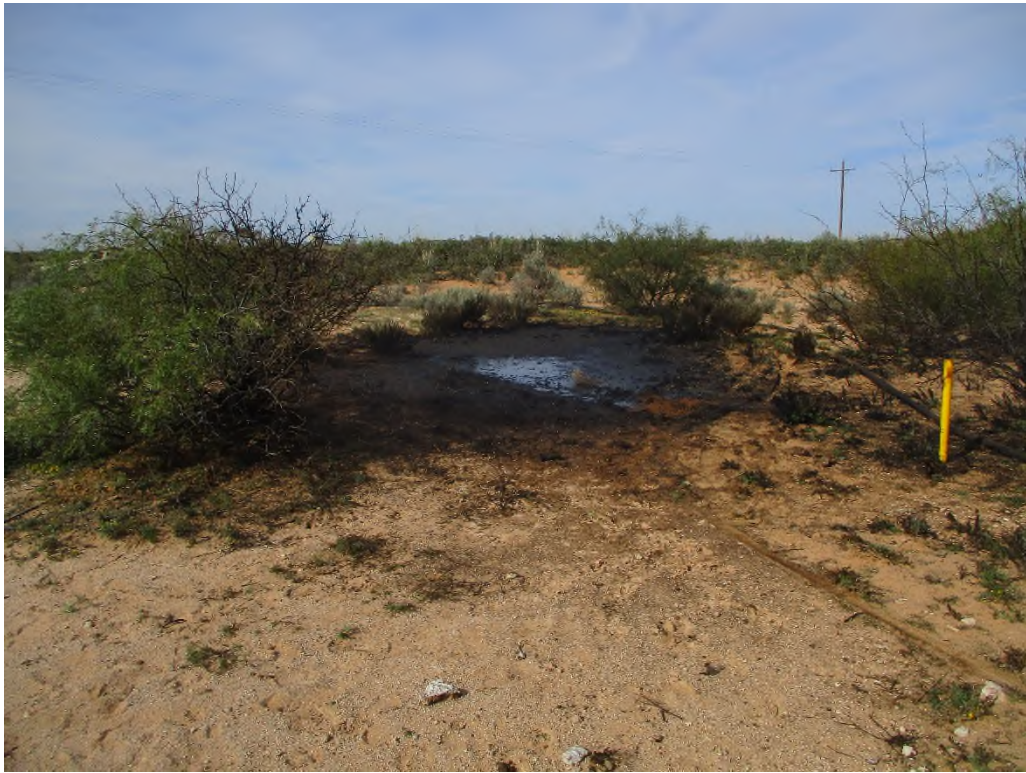
View Northwest – Release Area

According to the State of New Mexico C-141 Initial Report, the leak was discovered on October 12, 2017, and released an unknown amount of oil and produced water due to a ruptured flowline. The release occurred in the pasture adjacent to the pad and measured approximately 25' x 50'. As part of an emergency response, the release area was excavated to a depth of 1.0' below surface on October 18, 2017. The excavation was performed to remove the saturated soils and prevent vertical migration of the fluids. Approximately 40 cubic yards of excavated material was hauled for proper disposal. The initial C-141 form is included in Appendix A.

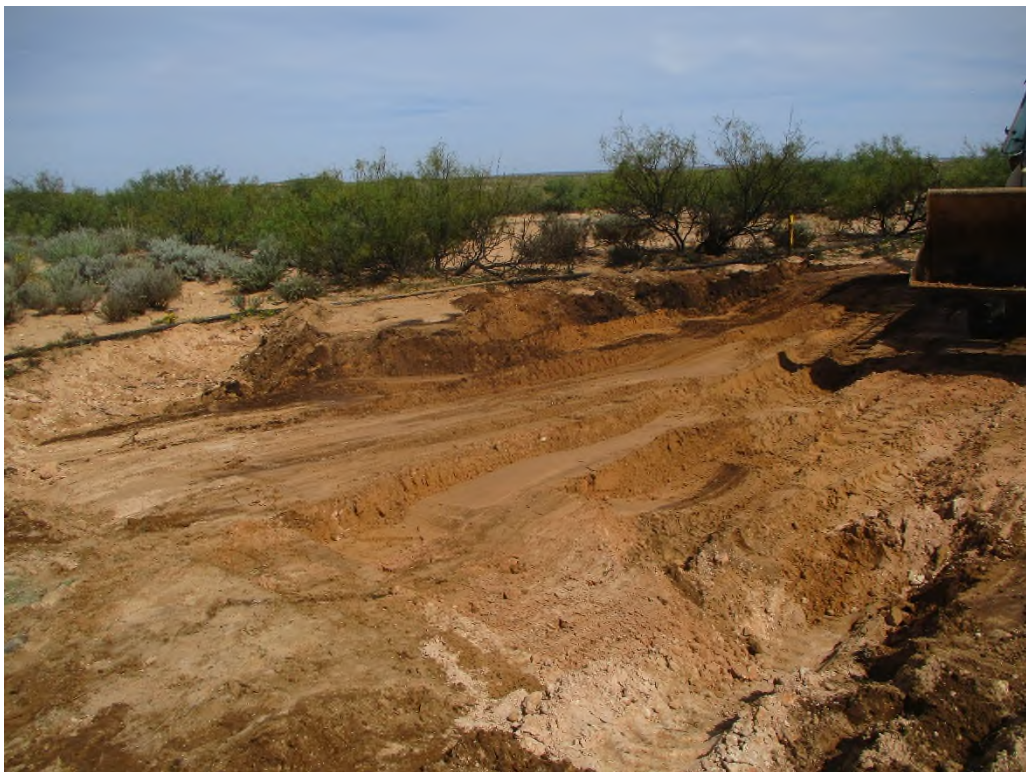
View Northeast – Excavated Release Area

On October 18, 2017, Tetra Tech personnel were onsite to supervise the excavation and to sample the release area. Once the area was excavated to a depth of 1.0' below surface, one backhoe trench (T-1) was installed in the release area to a total depth of 6.0' below excavation bottom (BEB). All of the samples collected were analyzed for TPH analysis by EPA Method 8015 modified, BTEX by EPA Method 8021B and chloride by EPA method 300.0. Copies of laboratory analysis and chain-of-custody documentation are included in Appendix C. The sampling results are summarized in Table 1. The trench location is shown on Figure 3.

None of the samples exceeded the RRALs for TPH, benzene or Total BTEX. Based on the laboratory results, Saber requests closure of this spill issue. The excavated area will be backfilled with clean material to surface grade. The final C-141 is enclosed in Appendix A. If you have any questions or comments concerning the assessment and remediation activities for this site, please call at (432) 682-4559.

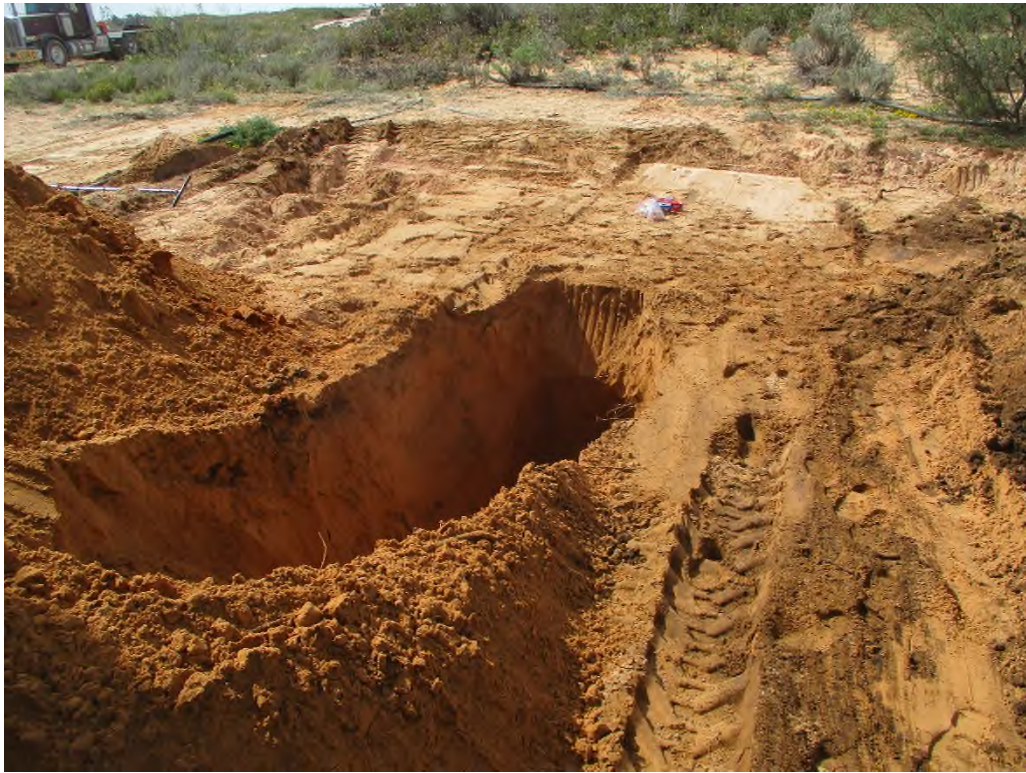
View West – Area of T-1

Referring to Table 1, none of the samples showed TPH, benzene, or total BTEX concentrations above the RRALs. A TPH high of 4,157 mg/kg was detected at 2.0' BEB, which declined with depth to 106 mg/kg at 6.0' BEB. The sample collected at 1.0' BEB showed a benzene concentration of 0.0145 mg/kg and a total BTEX concentration of 1.83 mg/kg. The benzene and total BTEX concentrations declined with depth and showed bottom trench concentrations below the laboratory reporting limits.
