**Re: Supplemental Site Assessment and Site Closure Request  
Phillips66 McGowan Station Crude Release  
NMOCD #1RP-5152  
Unit Letter J, S35, T17S, R34E  
Lea County, New Mexico**

PHILLIPS 66  
MCGOWAN STATION CRUDE OIL RELEASE  
BUCKEYE, LEA COUNTY, NEW MEXICO

PHILLIPS 66  
MCGOWAN STATION CRUDE OIL RELEASE  
BUCKEYE, LEA COUNTY, NEW MEXICO  
**SAMPLE LOCATION AND  
ANALYTICAL RESULTS MAP**

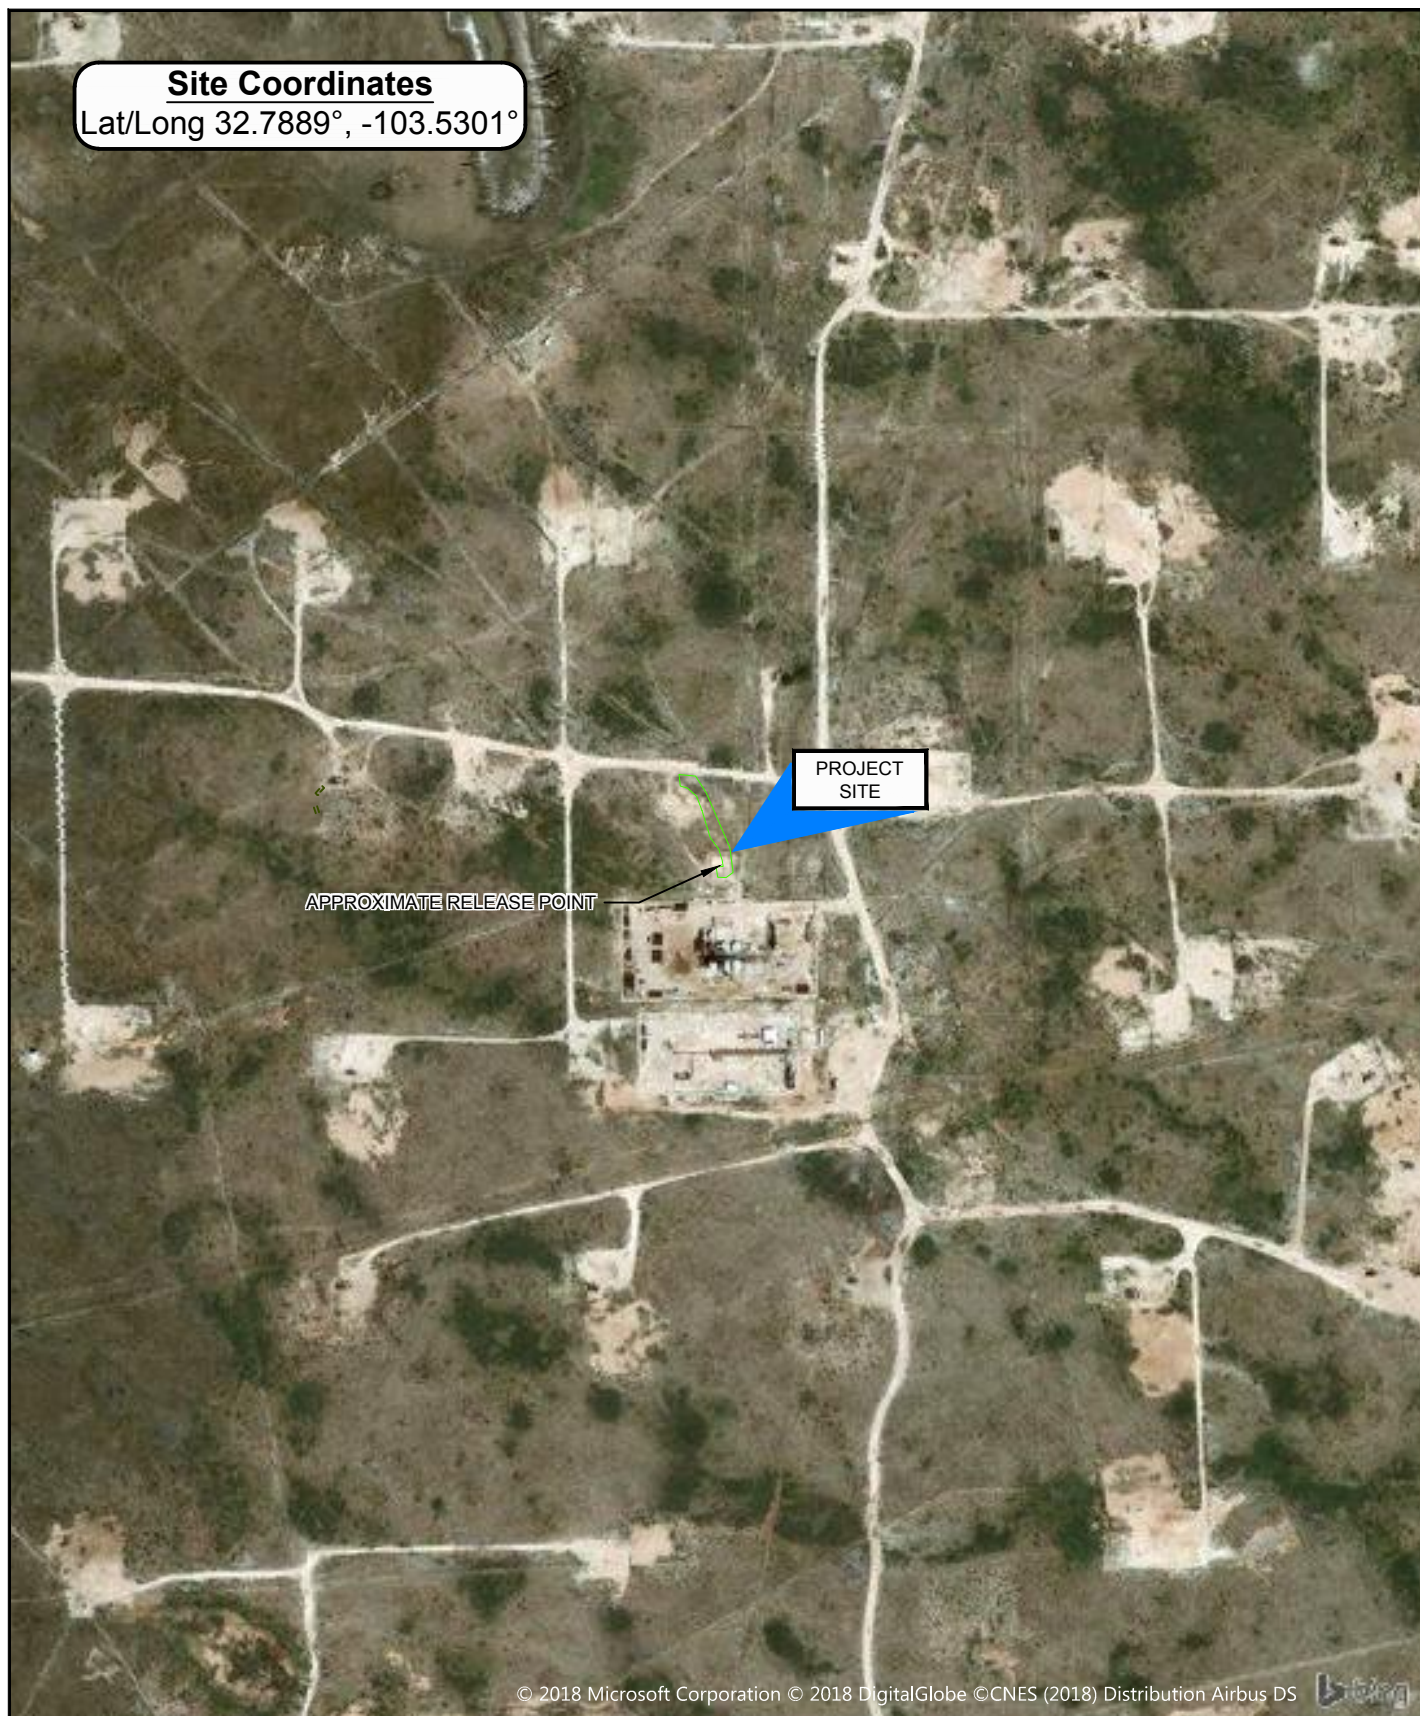
FIGURE 2

SITE AERIAL PHOTOGRAPH

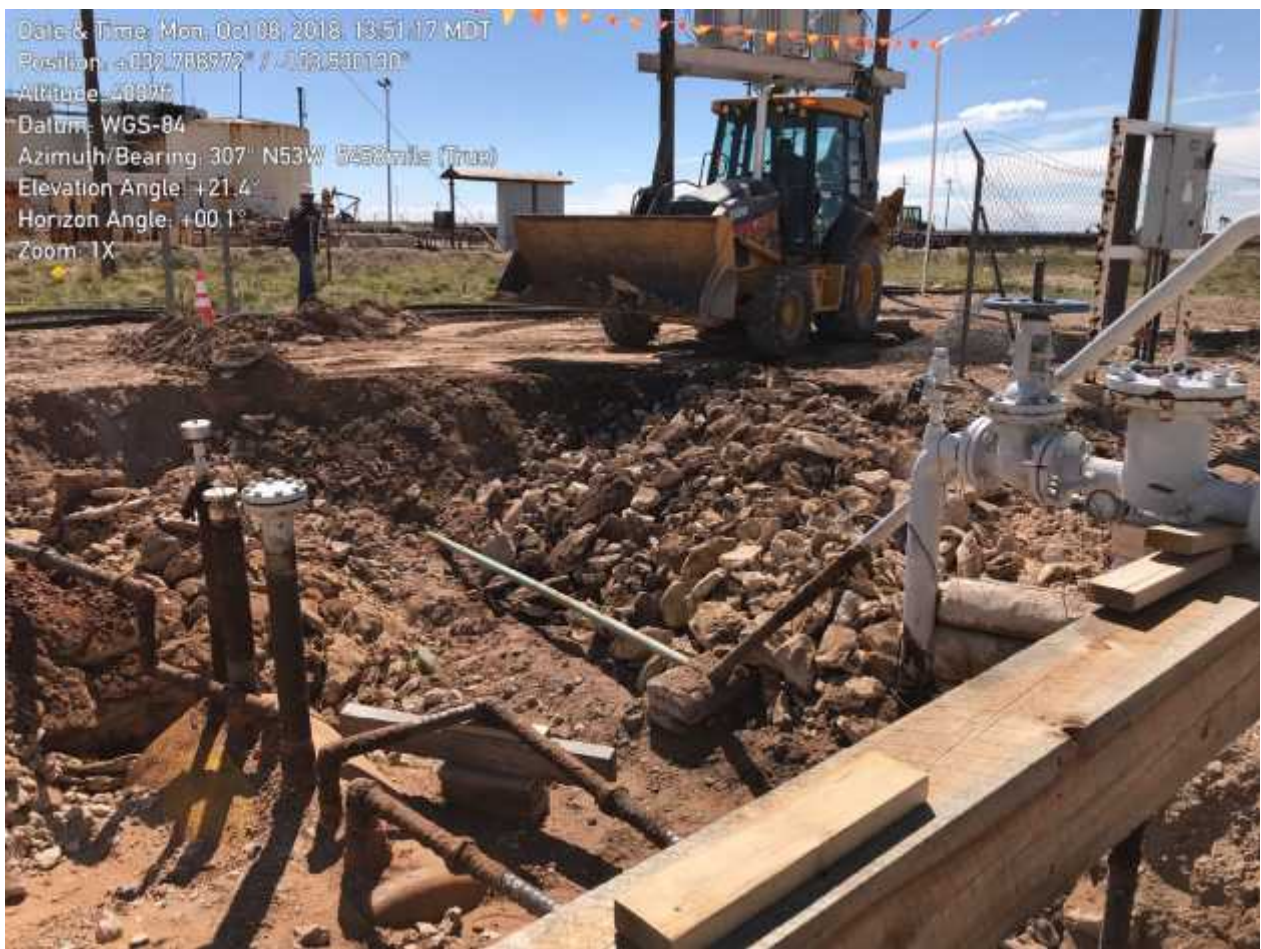
The sump area was further excavated to the south and west by hand and by limited backhoe use due to associated piping and equipment (see Photo 1). Soils and caliche were excavated laterally in these areas using field screening with a PetroFlag® test kit to guide the excavation. Soils were excavated in these areas an additional distance of approximately 4 feet (ft) back from the original excavation boundaries (Fig 2). Once field screening results indicated soils were below prescribed closure criteria concentrations samples were collected for laboratory confirmation analyses (see Photo 2). Samples were submitted to Cardinal Laboratories in Hobbs, New Mexico, for analysis of BTEX, TPH and chlorides. Laboratory results indicate concentrations of BTEX and TPH were below laboratory reporting limits (LRL-non-detect). Chloride concentrations ranged from non-detect to 16 milligrams per kilogram (mg/kg).

Photo 1: Additional excavation at sump/pipeline pumping unit.

- ) The sump area, at the source of the release, was further excavated to the south and west, guided by field screening data. An additional 4-5 ft was excavated horizontally from the existing excavation. Collected confirmation sidewall samples SumpS2 and SumpW2 were non-detect for BTEX and TPH constituents and chloride concentrations were below Table 1 closure criteria.

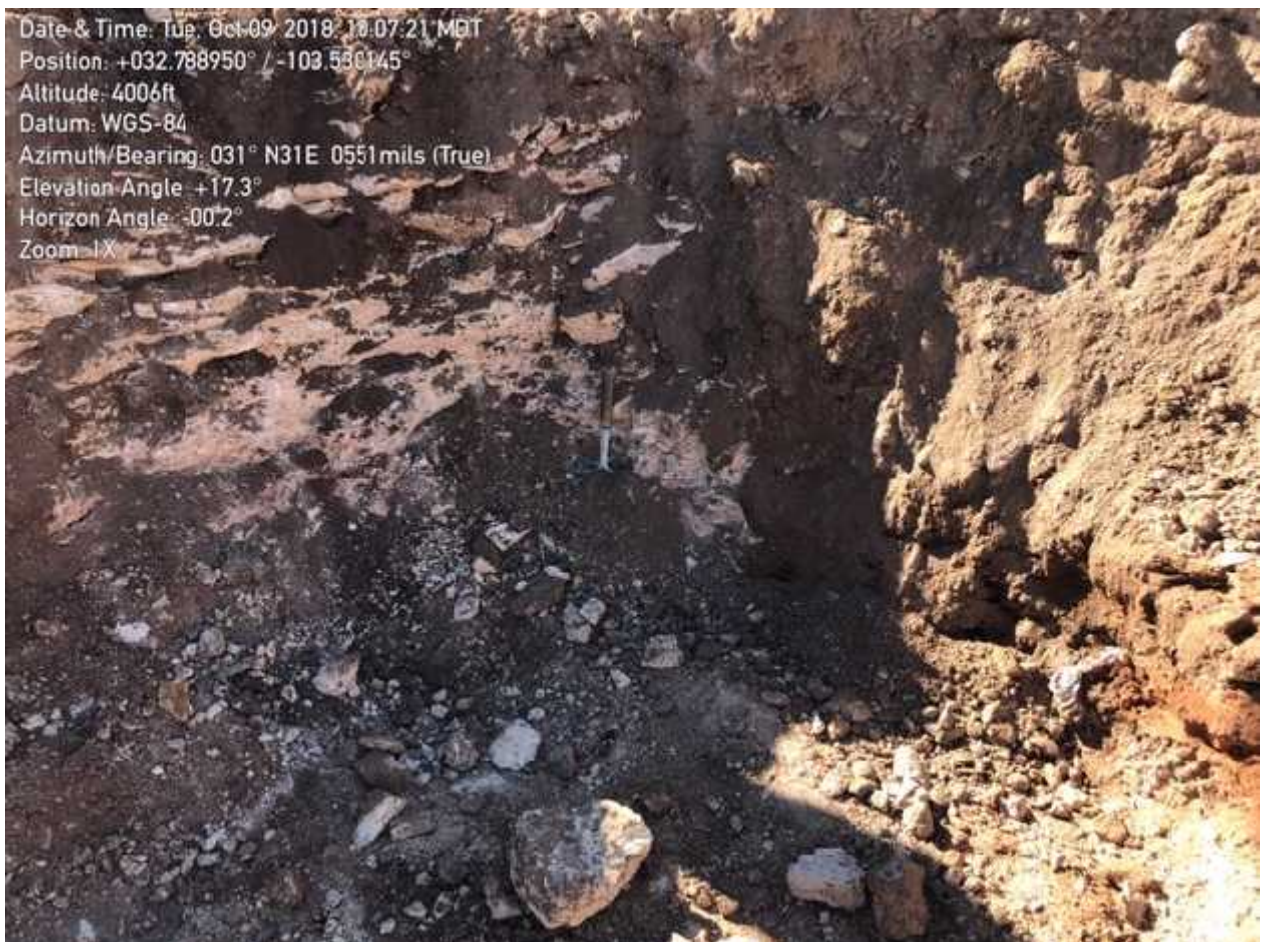
Photo 2: SumpS2 sample location. Note: dark soil coloration due to naturally occurring organic material.

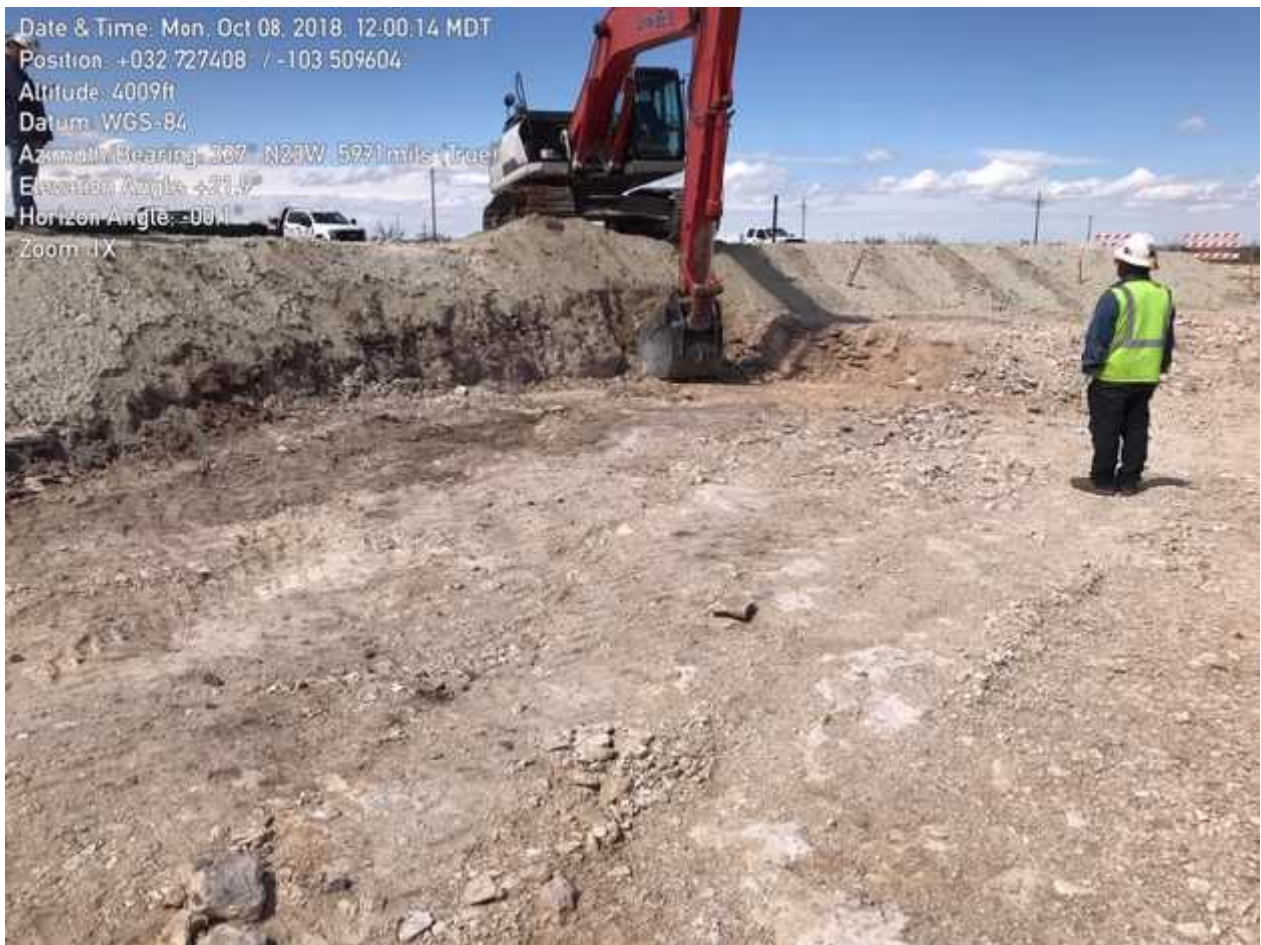
An area to the west of initial assessment sample location SW-6 was excavated approximately 7 ft laterally to assess limits of crude oil impacts in this area (see Photo 3). Excavation by backhoe was guided by field screening and a confirmation sample collected (SW-8-3) and submitted as described above (see Photos 3 and 4). Concentrations of BTEX and TPH were below LRL and the chloride concentration for this sample was 336 mg/kg.

Photo 3: Additional westward excavation at SW-6 location.

- ) The existing excavation was widened approximately 7 ft to the west of where sample SW6 was collected August 10, 2018. A confirmation sidewall sample (SW-8) was collected at this location. Results were non-detect for BTEX and TPH constituents and the chloride concentration was below Table 1 closure criteria.

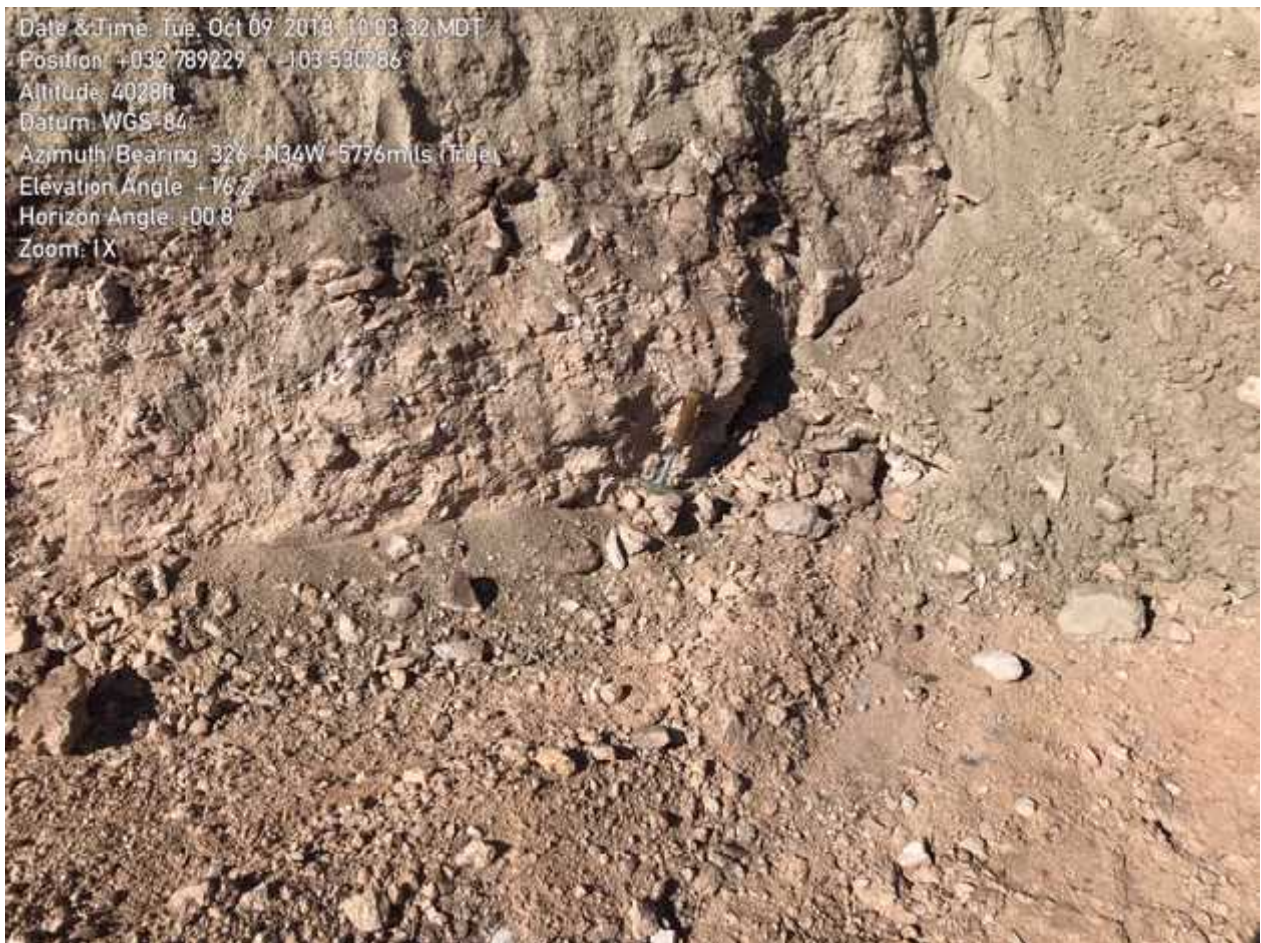
Photo 4: SW-8 sample location.

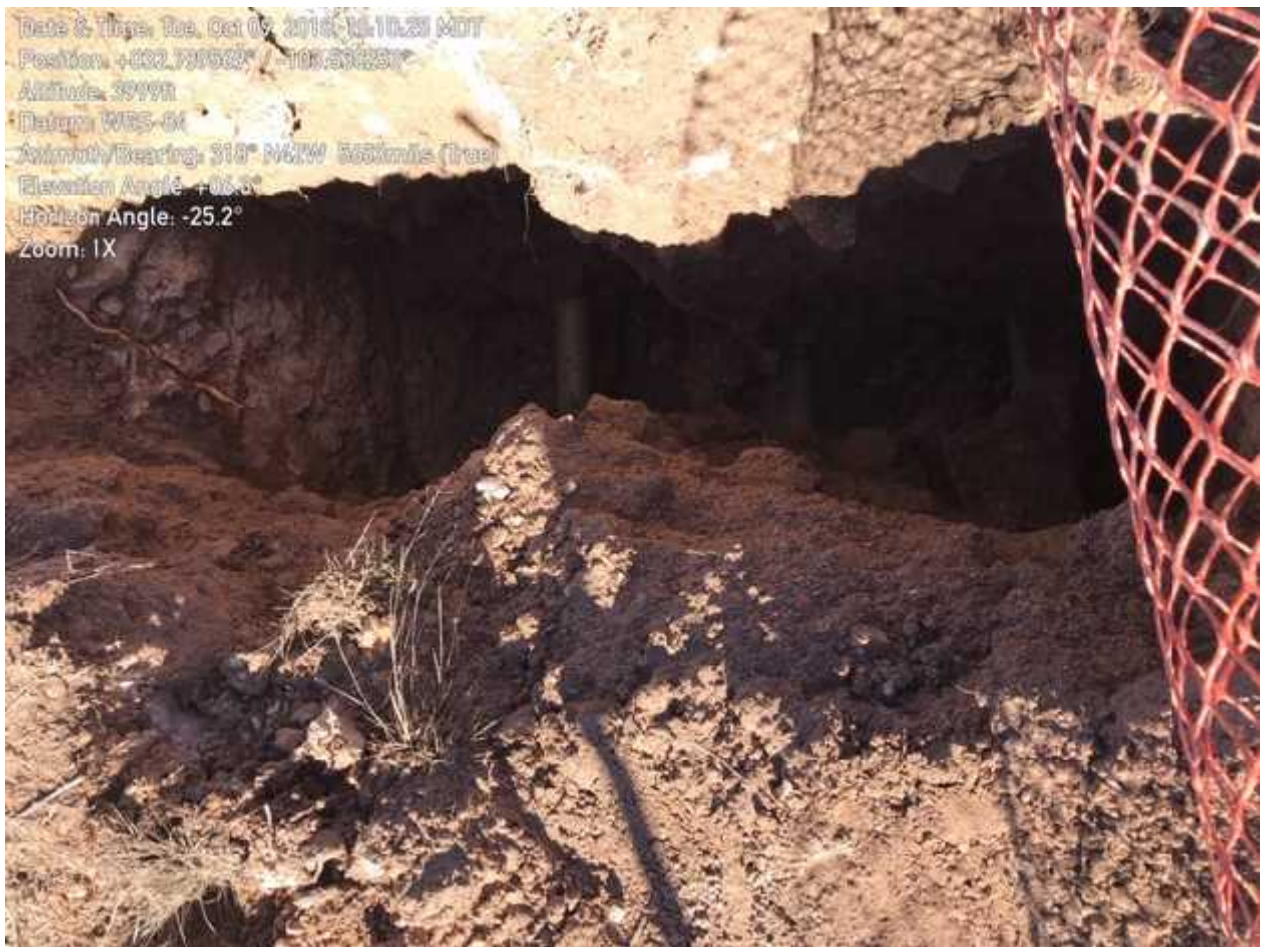
The NMOCD in the August 28, 2018 correspondence granted the requested deferral to excavation beyond the eastern edge of current excavation limits, but requested delineation to the east of the high pressure water pipelines that limited further digging near the SW-3 sample location. Hydroexcavation was employed to reach a depth of 4 ft deep (SW-9-4) between the high pressure water lines east of SW-3 and the Phillips 66 crude line. A sample was collected at this location (see Photo 5) and submitted for confirmation analyses as described above. Concentrations of BTEX and TPH were below LRLs and the chloride concentration was 48 mg/kg. A summary of field screening data for this event is included as an attachment to this report. The summary table of soils analytical data is attached to this report and has been updated with supplemental laboratory results. Figure 2 has also been updated with all current data and the complete Cardinal Laboratories report is also attached.

Photo 5: Hydroexcavated hole east of high pressure pipelines. Sample SW-9 location.

- ) Hydroexcavation was utilized to bore down to 4 ft deep east of the high pressure water lines, east of the sample SW3 location, to assess impacts east of existing excavation. A confirmation sample (SW-9) was collected at this location. Results were non-detect for BTEX and TPH constituents and the chloride concentration was below Table 1 closure criteria.

- ) In accordance with 19.15.29.12.C.(2), request is made to defer remediation and restoration of the eastern boundary of the excavation due to buried pipelines directly adjacent to the excavation. Visual observations of hydroexcavated trenches of the pipeline made during the August 6-10, 2018 Site assessment, and SW-9 sample results indicated that the eastern extent of the crude release impacts end essentially at the pipeline and do not go eastward from this area.
- ) With respect to the remainder of the impacted area, including the sump area, based on delineation and confirmation sample results, Site closure and permission to backfill the excavation is requested.
