# On-Site Soil Remediation Project

Ruth Co SWD  
1RP-4572-0  
32°41'49.94"N 103° 5'33.15"W

## Closure Report – Amendment for:

October 19, 2017

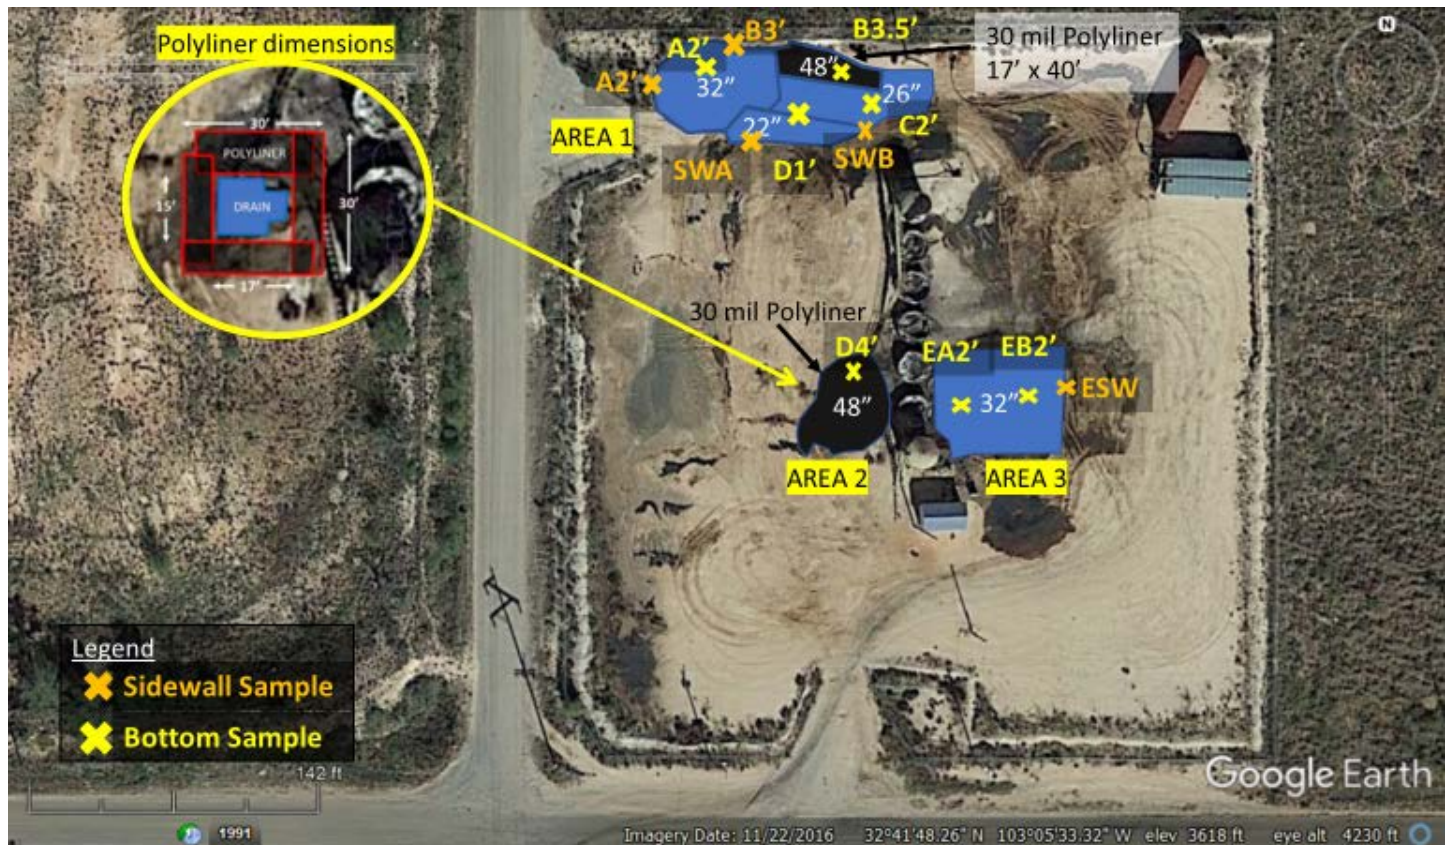
1. One Google Earth image with these annotations:
  - a. Scale and compass
  - b. Area 1, 2, & 3 outlined and labelled.
  - c. Depths of excavation noted in one measurement unit, either inches or feet.
  - d. Locations of the confirmation soil samples with the corresponding Sample ID demarcated.
  - e. Outlines, dimensions, and depths at which liners were placed.

In **Area 2**, two sidewalls and one bottom laboratory samples were requested. Excavation began on the north and east sides of the drain. Bottom samples were field tested as a guideline. Once depth reached four feet, field samples still tested high, so that sample was sent to the lab. It was determined here that a polyliner would be required. A large concrete slab on the east side of this excavated area prevented sampling from that wall.

The previously delineated area was then excavated beyond the initial perimeter. I, Zach Robbins, was on site and responsible for collecting samples. When the remainder of the material was removed, this drain appeared to shift from when it was supported by adjacent soil. Being a large concrete block, I did not feel comfortable safely getting back in the excavated area and failed to get the remainder of the samples. In the future, this should be communicated at the time it happens to find a solution.

In **Area 3**, two sidewalls and two bottom laboratory samples were requested. The plan was to sample from west to east along the center of the area. A sidewall was taken on the east side. Two bottom samples were taken equidistant from the east and west walls. As stated above, the large tank in the middle of the pad was supported by a concrete slab. This prevented the final sample on the west wall from being taken.
