### Report Type: Closure Report 1RP-4997

Site:	BTA Vaca Draw 9418 10 Fed. Flowline Leak					
Company:	EOG Resources					
Section, Township and Range	Unit B	Sec. 10	T 25S	R 33 E		
Lease Number:	API No. 30-025-43611					
County:	Lea County					
GPS:	32.151400° N			103.561570° W		
Surface Owner:	Federal					
Mineral Owner:	Federal					
Directions:	From the intersection of Hwy 128 and County Rd. 2 Head South on Cr-2 approx. 4.2 miles Location is on West side of lease Road.

**Re: Closure Request for the EOG Resources, BTA Vaca Draw 9418 10 Fed, Unit B, Section 10, Township 25 South, Range 33 East, Lea County, New Mexico. 1RP-4997**

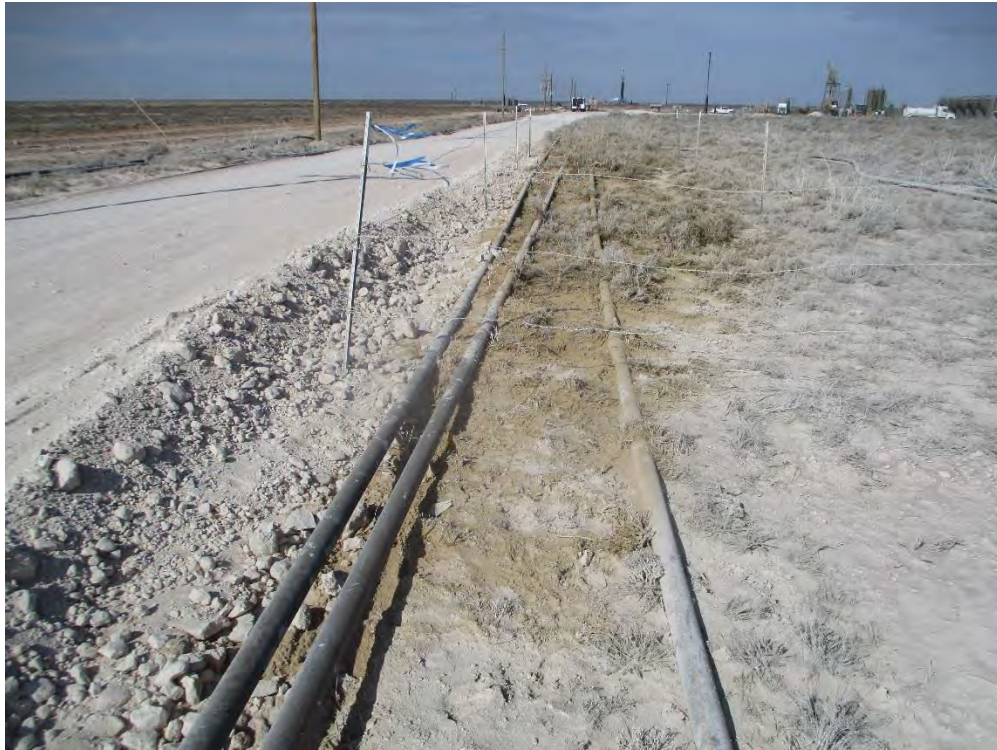
View East of AH-1

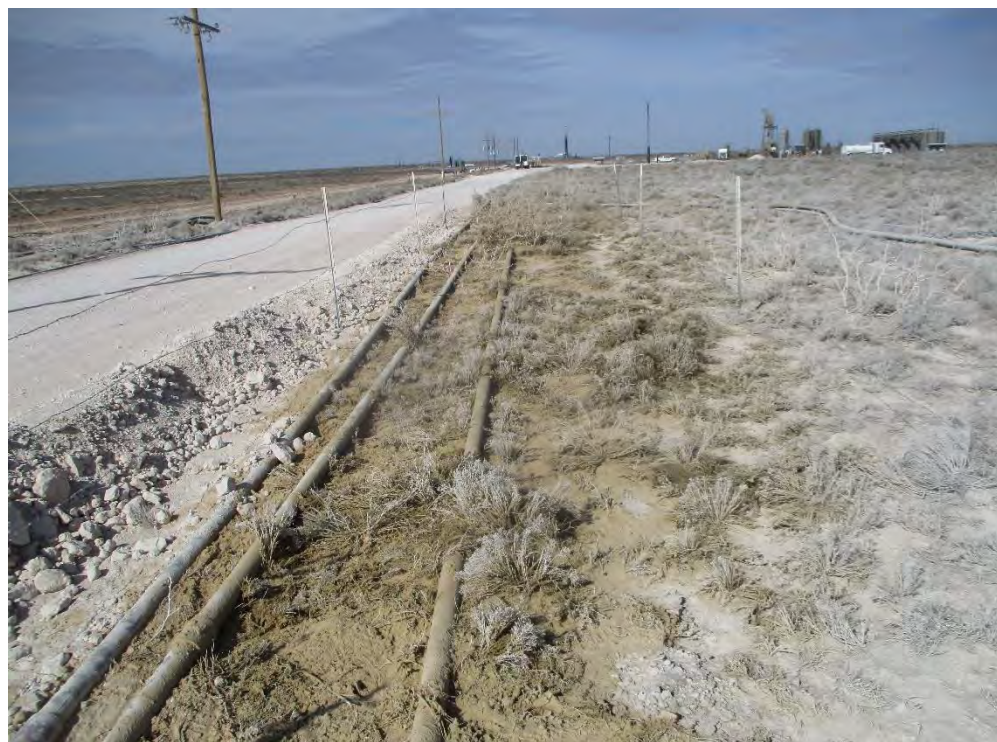
View East of AH-2

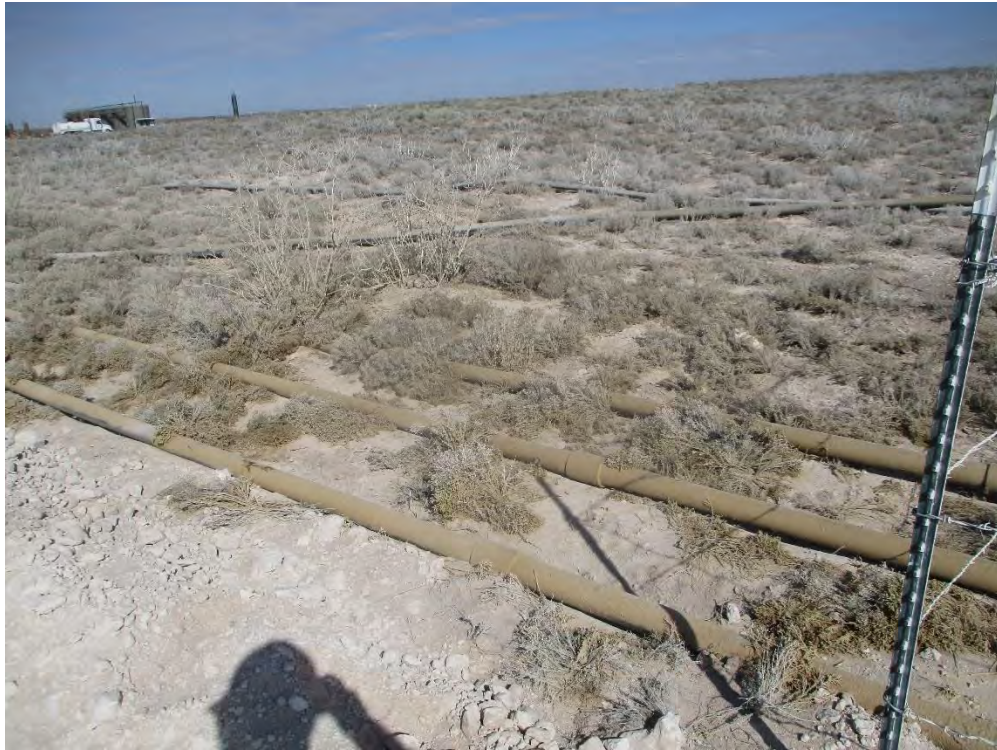
View Southeast of AH-3

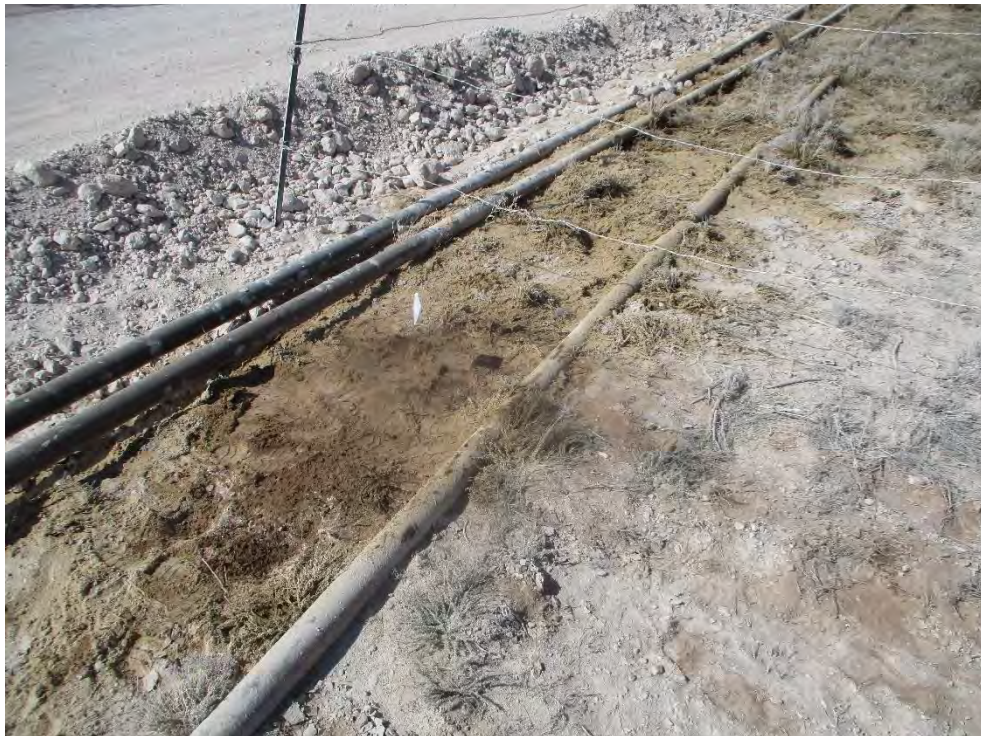
View Northeast of AH-1

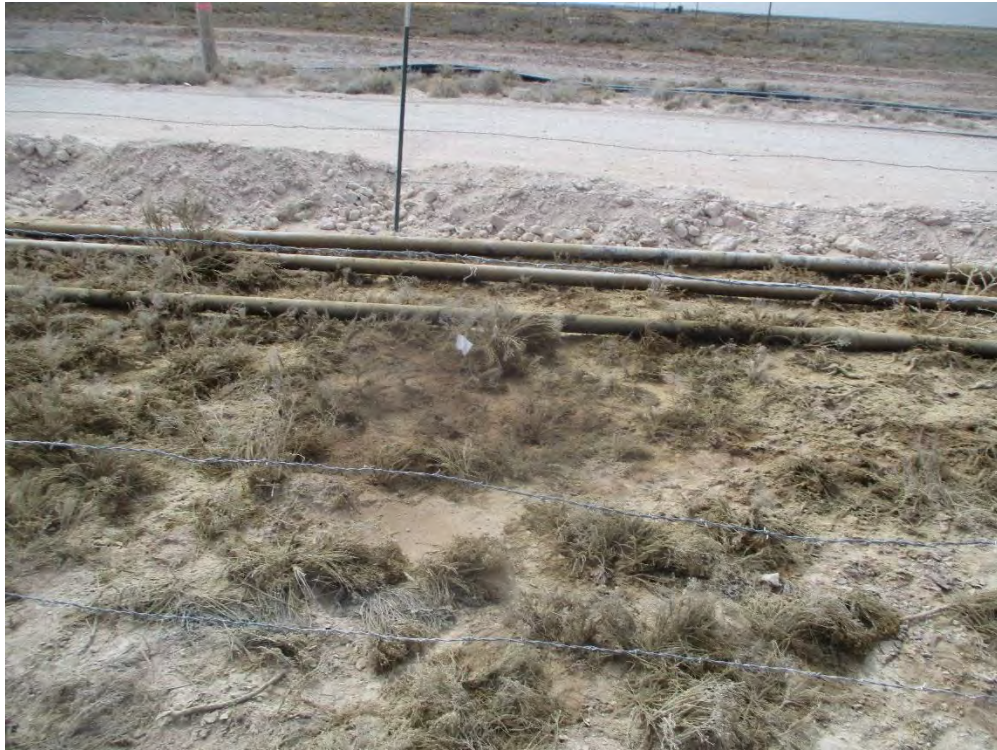
View North of AH-2

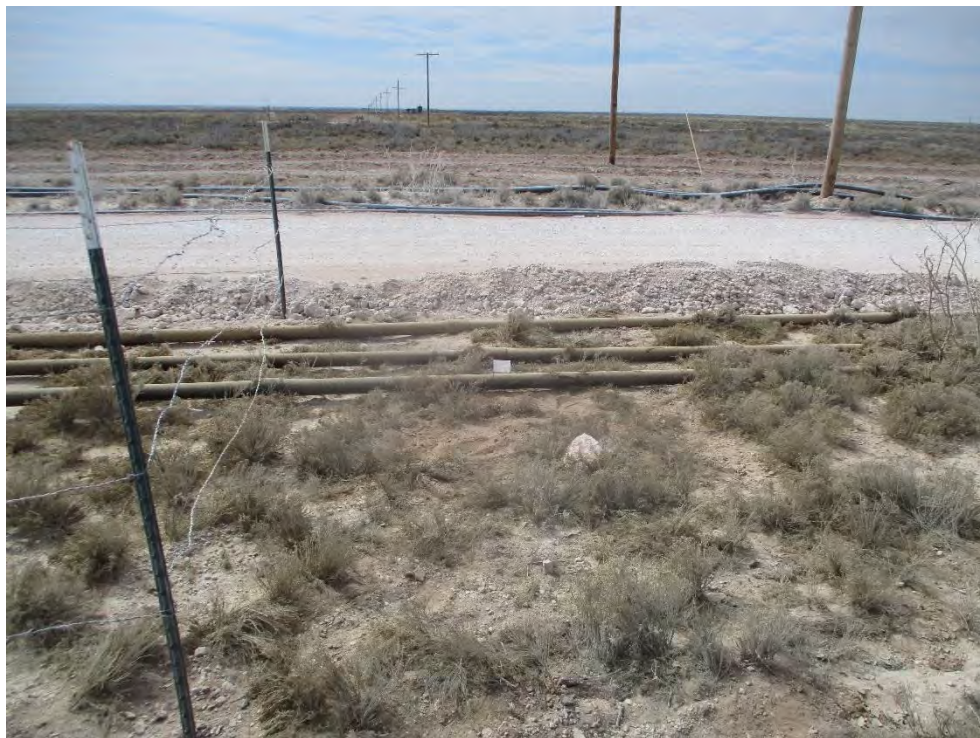
View North of AH-3

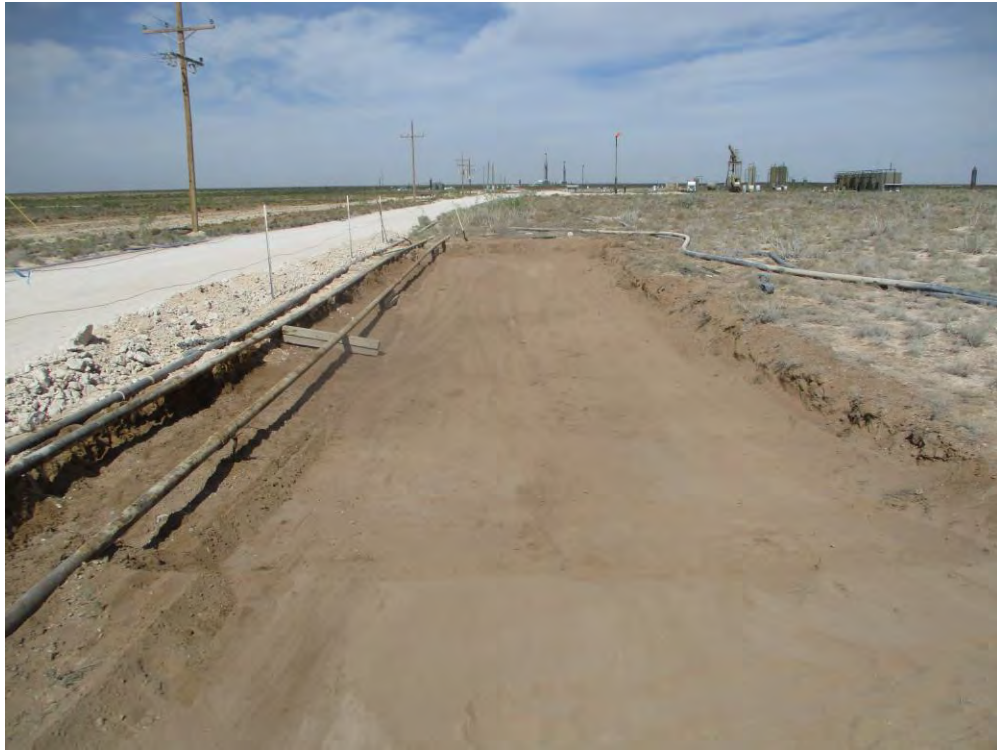
View West – Excavated areas of AH-1 and AH-2

On April 30, 2018, Tetra Tech personnel were onsite to supervise the excavation and remediation activities. The remediation was performed in accordance with the approved work plan. The excavated areas and depths are shown on Figure 4 and highlighted (green) in Table 1. The areas of auger holes (AH-1 and AH-2) were excavated to 1.0'-1.5' below surface.

Referring to Table 1, all of the confirmation samples collected shown chloride concentrations below the laboratory reporting limits. Approximately 80 cubic yards of material hauled to proper disposal. The excavated areas will be backfilled to surface grade.

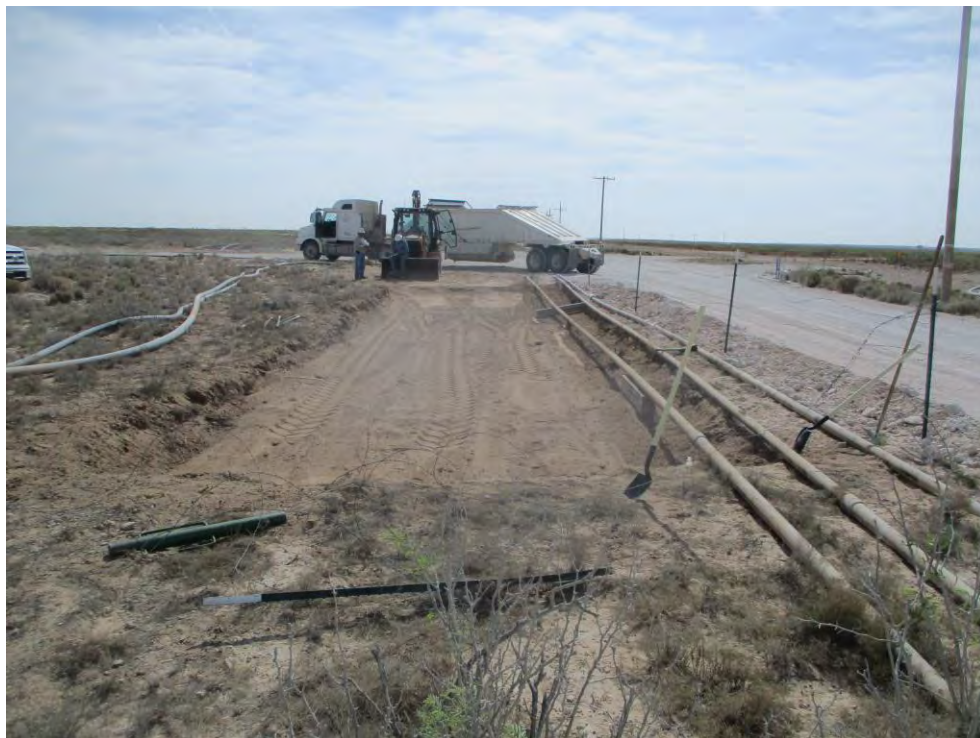
View East – Excavated areas of AH-1 and AH-2
