Re: Site Assessment Report and Proposed Remediation Plan
Site Name: Cotton Draw Pipeline
GPS: Latitude: 32.10952 Longitude: -103.71871
Legals: UL "N", Sec. 19, T25S, R32E
Lea County, New Mexico
NMOCD Ref. No. 1RP-5234

Lowry Environmental & Associates, LLC (LEA), on behalf of ETC Texas Pipeline, Ltd. , has prepared this Site Assessment Report and Proposed Remediation Plan for the Release Site known as the Cotton Draw Pipeline. Details of the release are summarized on the table below:

INITIAL SITE ASSESSMENT

PROPOSED REMEDIATION PLAN

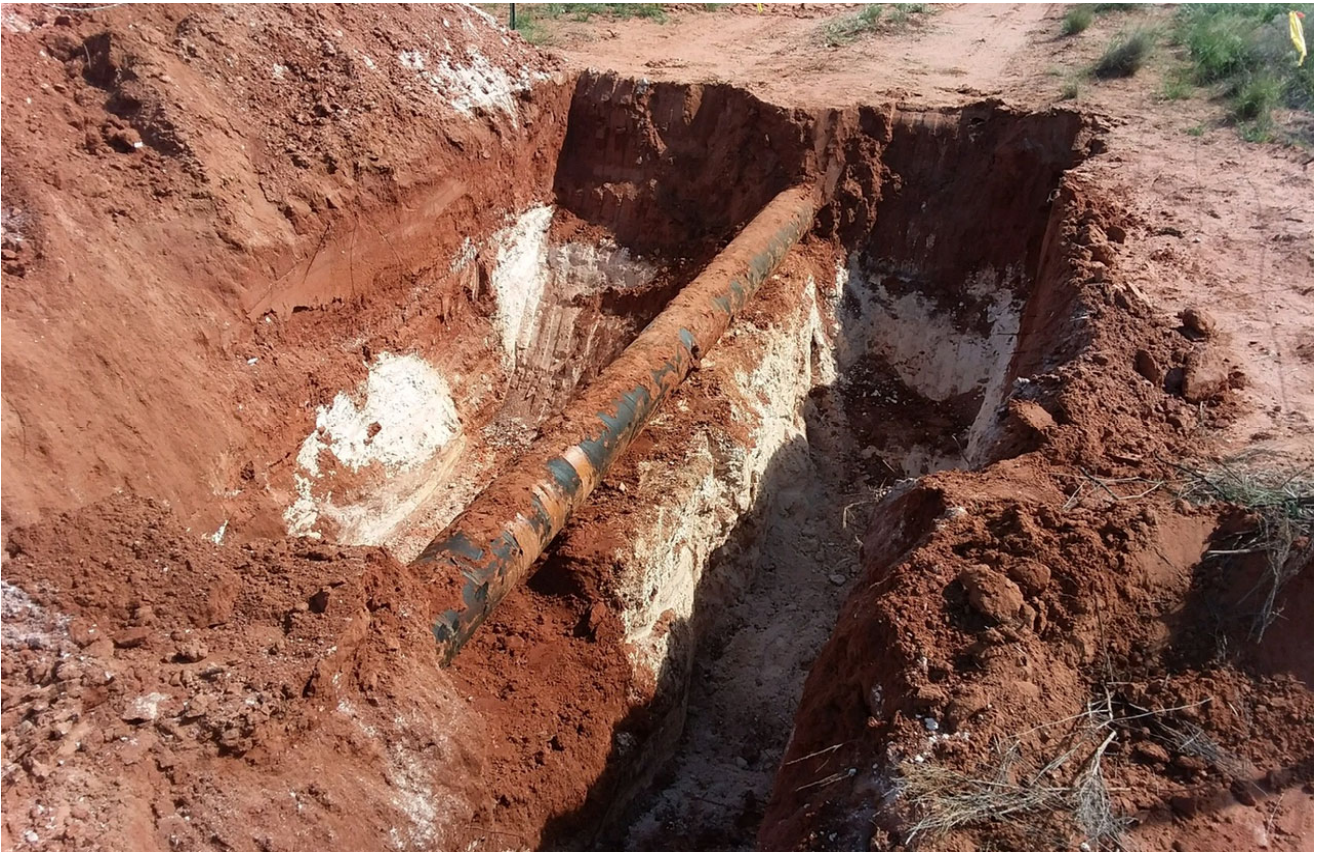
Photo 1: View of the affected area and immediate response activities ,facing North.

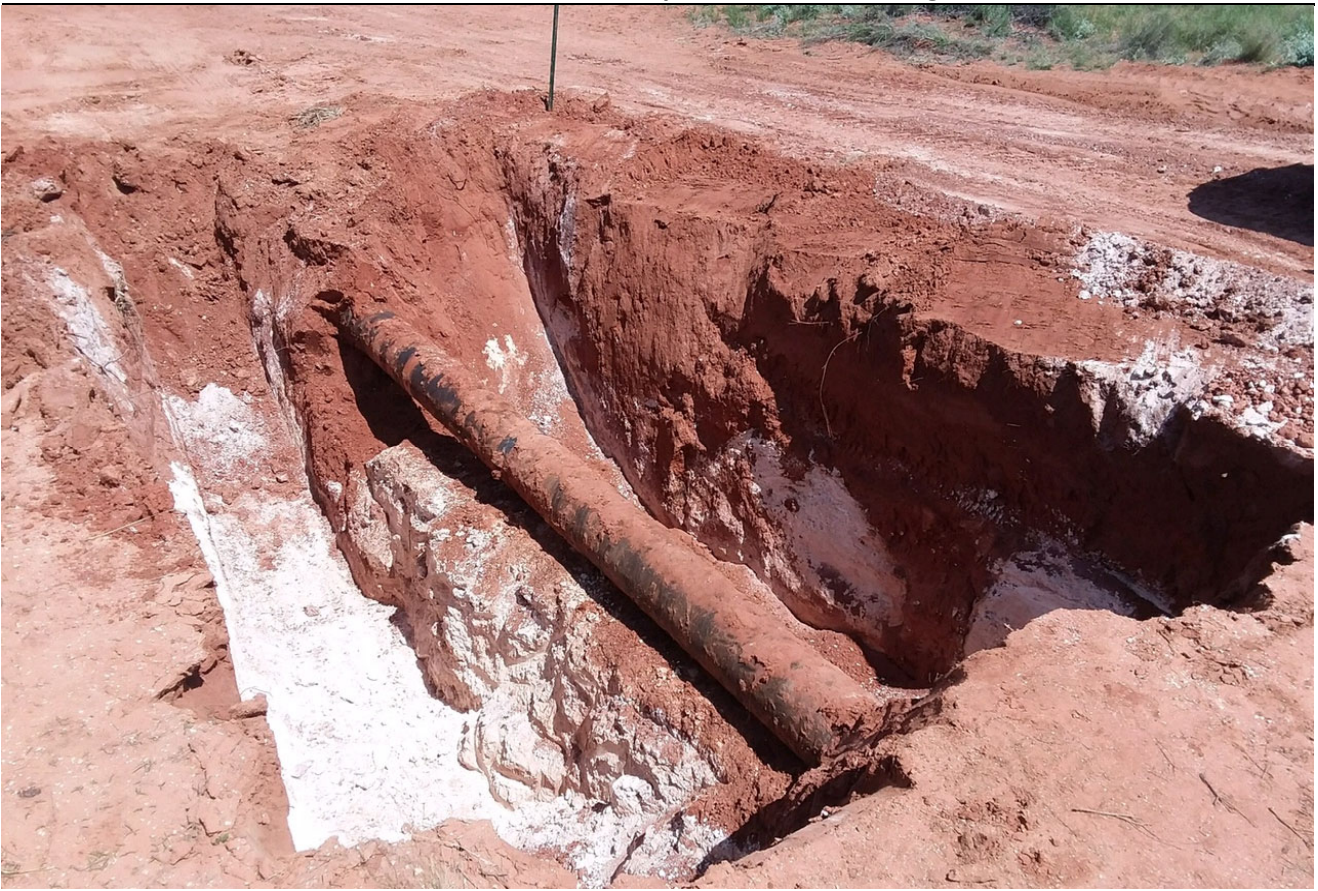
Photo 2: View of the affected area and immediate response activities ,facing Southwest.

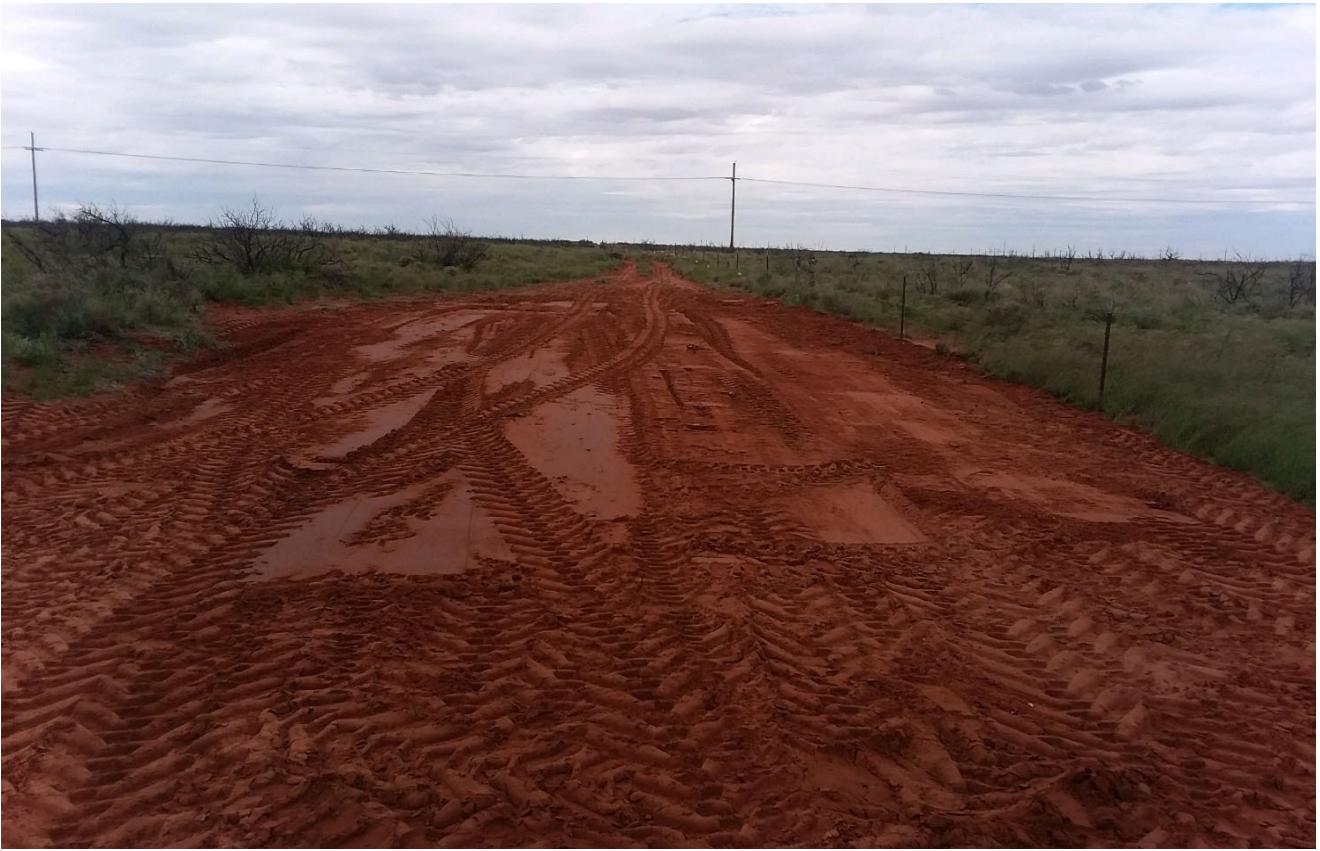
Photo 3: View of the affected area after initial response activities, facing South.

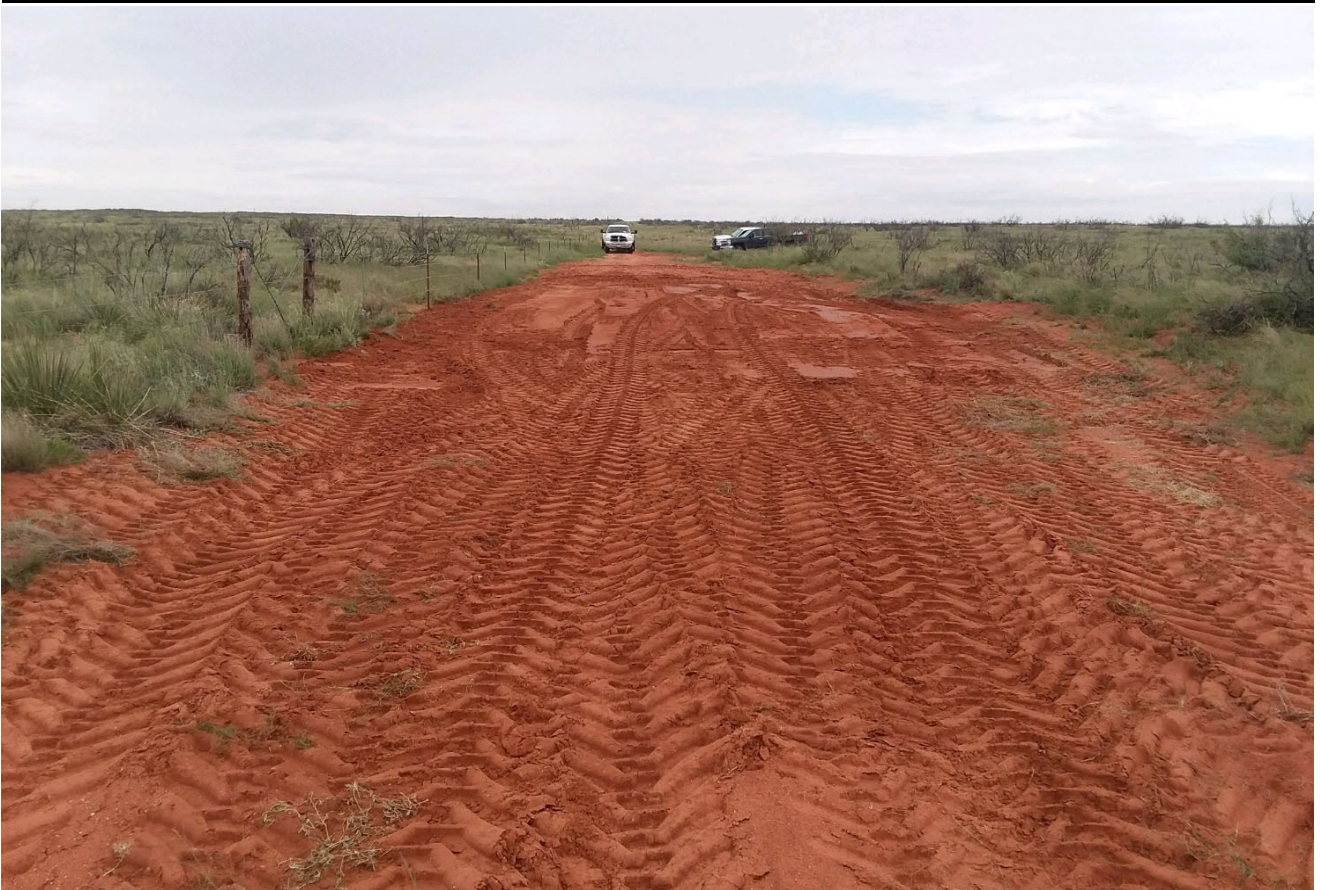
Photo 4: View of the affected area after initial response activities, facing North.
