REMEDIATION SUMMARY & SITE CLOSURE REQUEST

**Goodnight Midstream Permian, LLC
SERRANO
Lea County, New Mexico
Unit Letter "C", Section 28, Township 23 South, Range 35 East
Latitude 32.280010° North, Longitude 103.373311° West
NMOCD Reference #1RP-5451**

July 2019

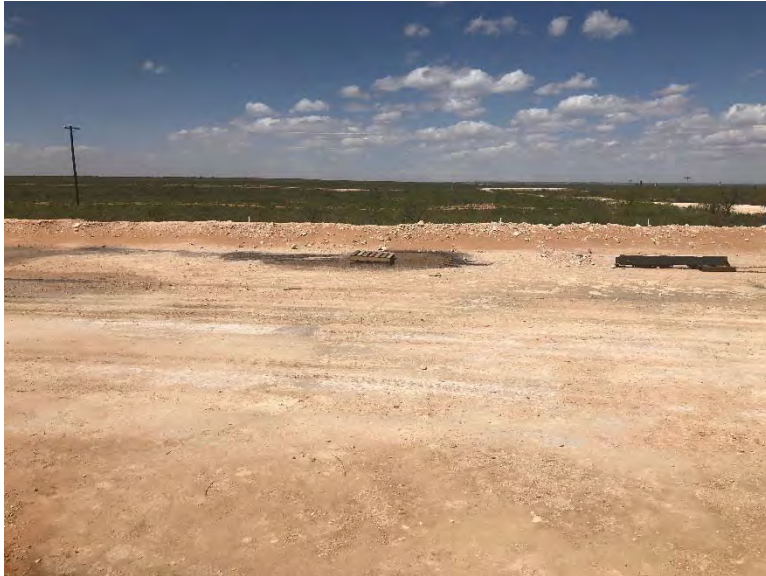
Release area, facing west

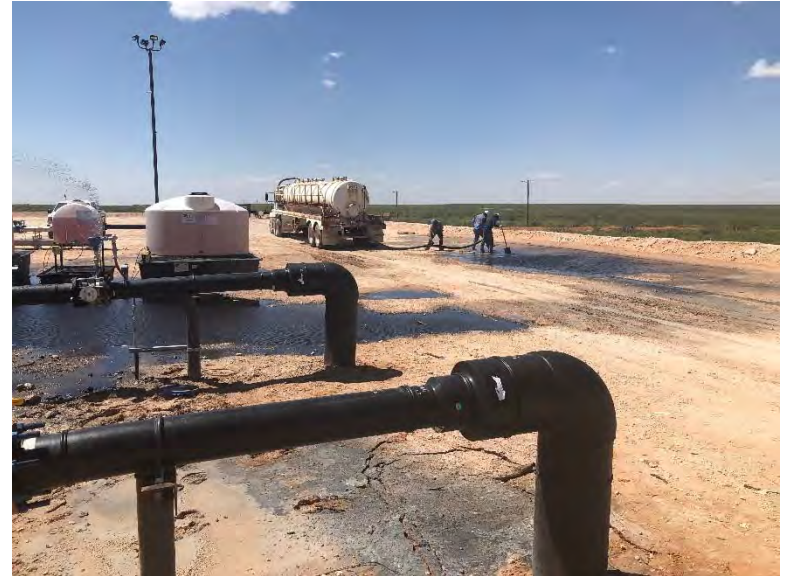
Release area, facing southwest

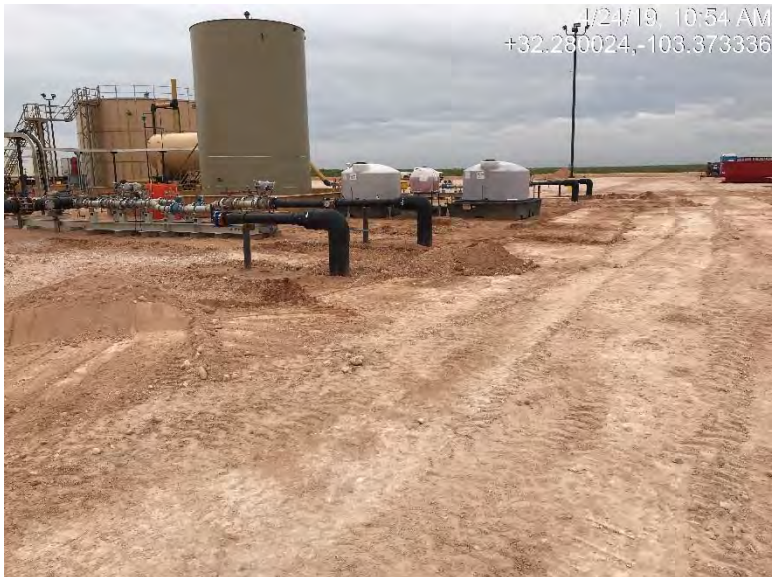
Excavation, facing south

On April 18, 2019, Etech began remediation activities. The entire release area was excavated to approximately one-foot bgs with contaminated soil hauled to a state approved facility for disposal.

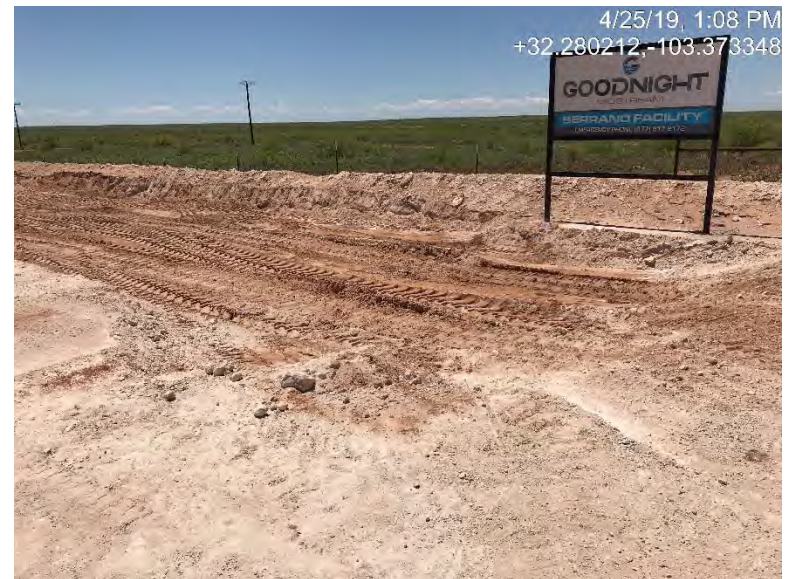
Excavation, facing southwest

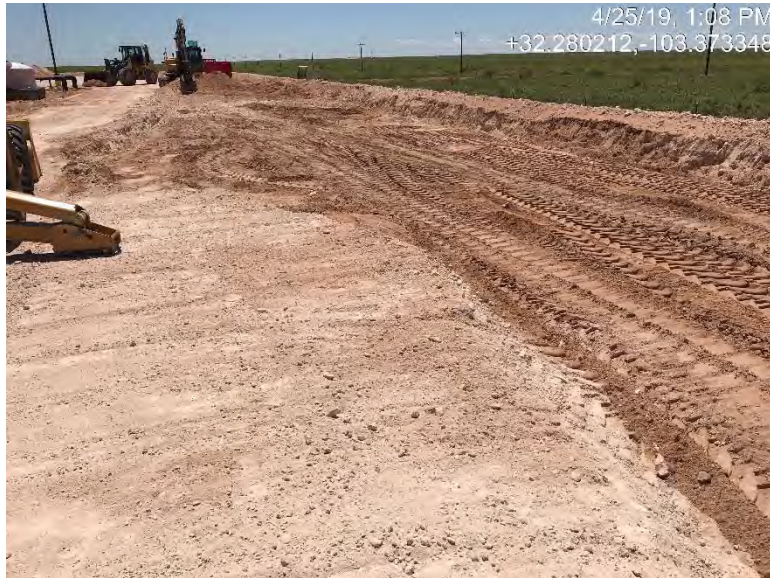
Excavation, facing southwest

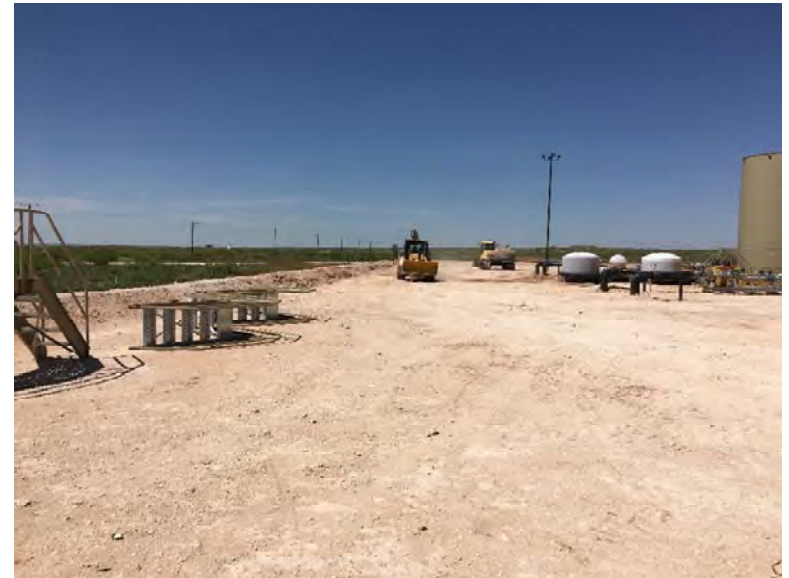
Backfilling, facing north

Final samples for the location began to be retrieved on April 26th, 2019, at a depth of approximately one-foot bgs. Laboratory results confirm that delineation was achieved (reference Figure 3 and Table 1). Laboratory analytical reports are provided as Attachment III. The excavation was then backfilled with imported, non-impacted soils, compacted and contoured to the surrounding pad area.

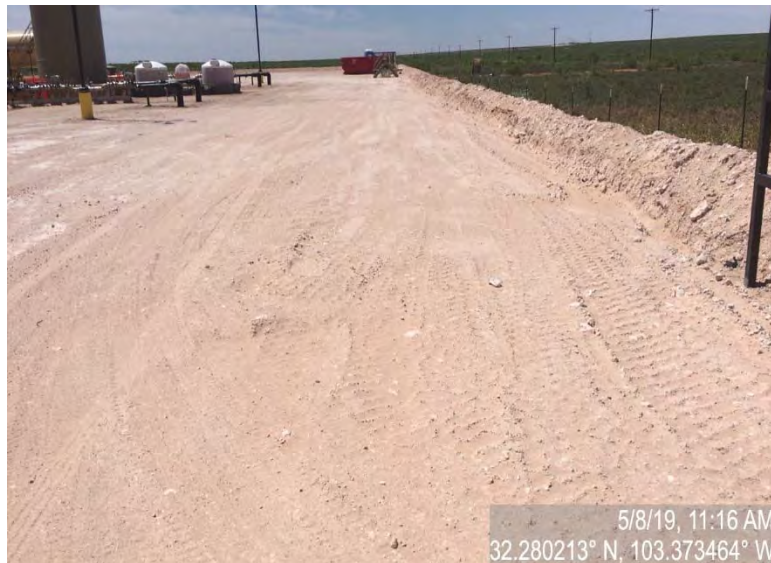
Backfilled, facing south

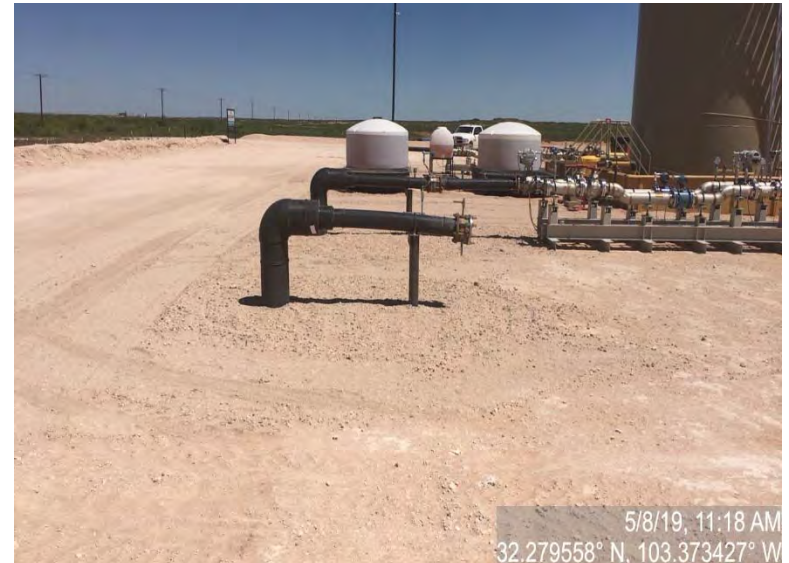
Backfilled, facing north
