MGU #002

CLOSURE REPORT

API No. 30-025-42628

Release Date: October 25, 2015

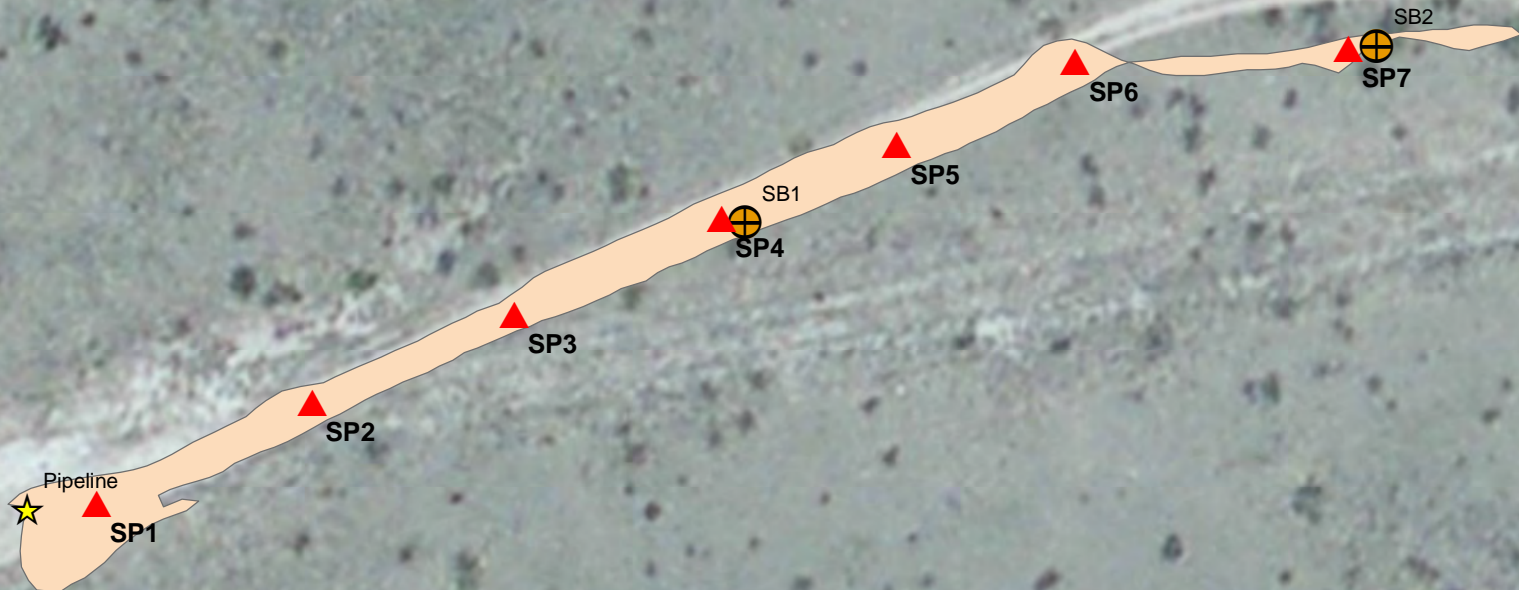
Soil Delineation

SP1										SP2										SP3									
Depth	CI-	PID	Lab CI-	GRO	DRO	B	T	E	X	Depth	CI-	PID	Lab CI-	GRO	DRO	B	T	E	X	Depth	CI-	PID	Lab CI-	GRO	DRO	B	T	E	X
SS	2,196	58.6								SS	88	0.4								SS	110	0.4							
1.5'	678	0	848	<10	<10	<0.05	<0.05	<0.05	<0.15	1'	209	10.7	256	<10	12.6	<0.05	<0.05	<0.05	<0.15	1'	173	0	176	<10	<10	<0.05	<0.05	<0.05	<0.15

SP4										SP5										SP6									
Depth	CI-	PID	Lab CI-	GRO	DRO	B	T	E	X	Depth	CI-	PID	Lab CI-	GRO	DRO	B	T	E	X	Depth	CI-	PID	Lab CI-	GRO	DRO	B	T	E	X
SS	7,062	35.4								SS	7,137	5								SS	174	1.5							
1'	117	0	48	<10	<10	<0.05	<0.05	<0.05	<0.15	1'	112	0	48	<10	<10	<0.05	<0.05	<0.05	<0.15	1'	266	0	160	<10	<10	<0.05	<0.05	<0.05	<0.15

SP7										SB1										SB2									
Depth	CI-	PID	Lab CI-	GRO	DRO	B	T	E	X	Depth	CI-	PID	Lab CI-	GRO	DRO	B	T	E	X	Depth	CI-	PID	Lab CI-	GRO	DRO	B	T	E	X
SS	8,995	115								SS	7,000	25.3								SS	8,500	15.5							
1'	87	0	<16	<10	<10	<0.05	<0.05	<0.05	<0.15	1'	570	0.5	576	<10	<10	<0.05	<0.05	<0.05	<0.15	1'	224	1.1	<16	<10	<10	<0.05	<0.05	<0.05	<0.15
										2'	503	0.8	448	<10	<10	<0.05	<0.05	<0.05	<0.15	2'	213	0.5	64	<10	<10	<0.05	<0.05	<0.05	<0.15

- ▲ Sample Points
- Soil Bores
- ★ Source
- Oil and Produced Water (4893 sq ft)

On October 29, 2015, DFSI personnel were on site to scrape the visibly impacted area. On November 6, 2015, DFSI personnel returned to the site to obtain samples within the leak area (Figure 1). Seven samples were obtained and field sampled for chloride levels, as well as BTEX. The BTEX samples were performed using a Mini Rae Photoionization Detector (PID).

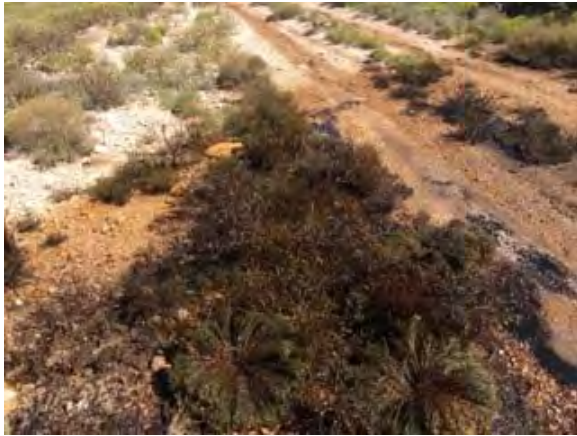
Site prior

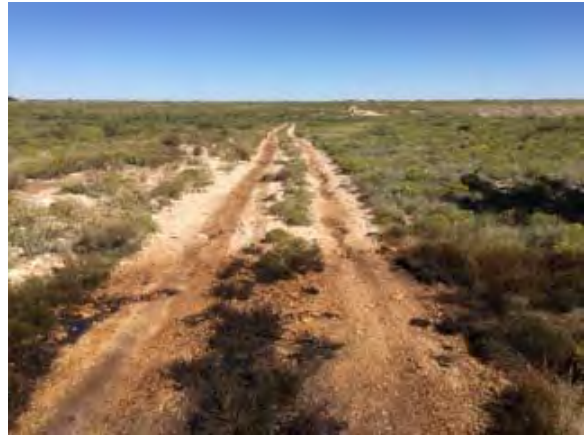
Site prior

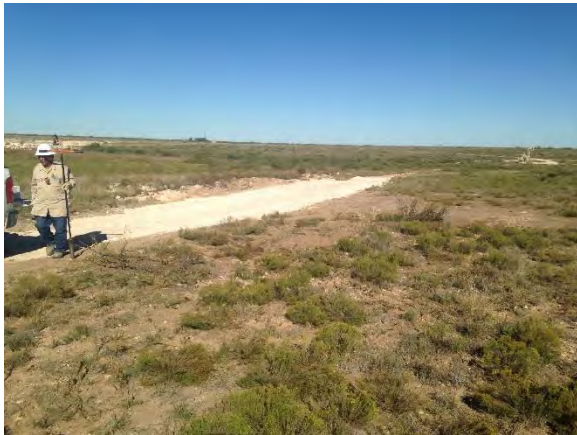
Collecting samples

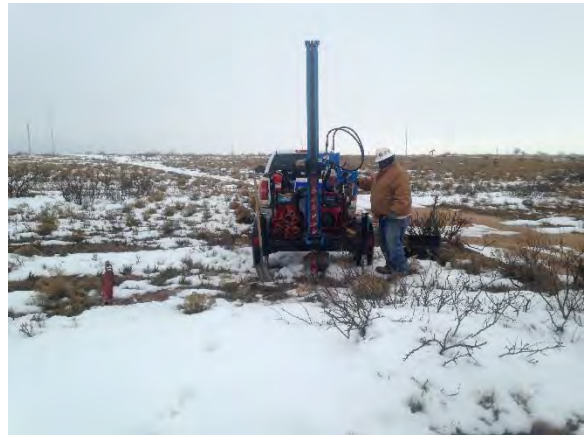
Installing soil bore

To further delineate the site, on November 19, 2015, DFSI personnel installed two soil bores to obtain confirmation samples. All clean field samples under NMOCD and BLM regulatory guidelines were submitted for laboratory analysis at Cardinal Laboratories of Hobbs, NM to obtain confirmation (Appendix II).

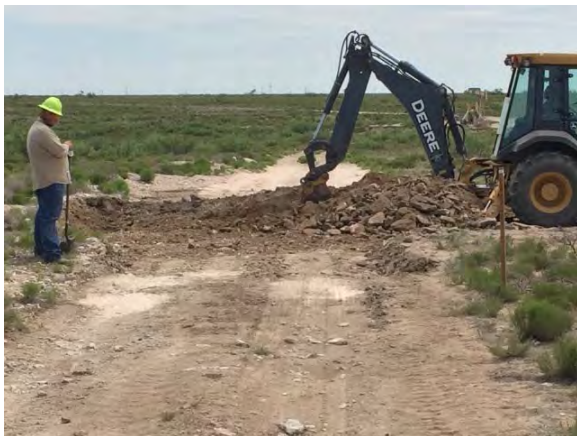
Excavating site

A work plan was submitted to BLM on January 19, 2016, and approved by BLM on January 20, 2016, with stipulations. Beginning June 9, 2016, DFSI personnel were on site to excavate the release area. Prior to backfilling, confirmatory samples taken at 1.5 ft at SP1 and 1 ft at the remaining six samples were submitted for analysis at Cardinal Laboratories of Hobbs, NM to obtain confirmation (Appendix III). The excavation was backfilled with clean, imported topsoil on the pasture area and caliche within the road to ground surface and contoured to the surrounding area (Appendix IV). Contaminated soil was properly disposed of at an NMOCD approved facility.

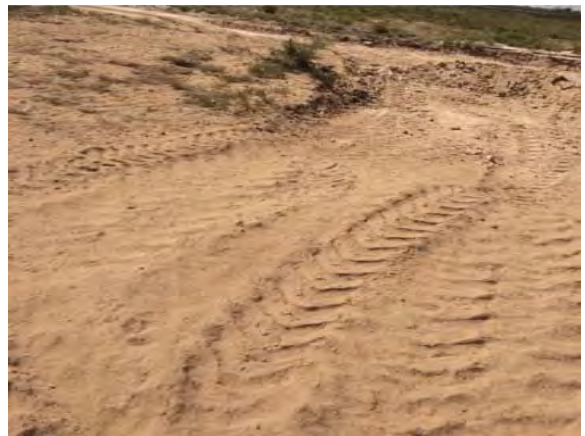
Backfill completed
