**Pit or Below-Grade Tank Registration or Closure**

Re: Final C-144  
Chevron USA (O-Grid #4323)  
CDU #112 (Ref. #200103)  
UL-H, Section 28, Township 21 South, Range 37 East

Figure 1  
 Area Map  
 Chevron Corporation  
 CDU #112

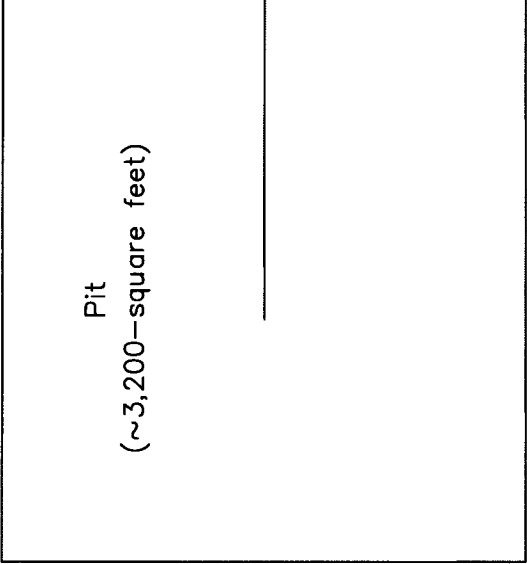
Figure 3  
Site Map  
Chevron Corporation  
CDU #112

Pit  
(~3,200-square feet)

Flowline

Well Pad

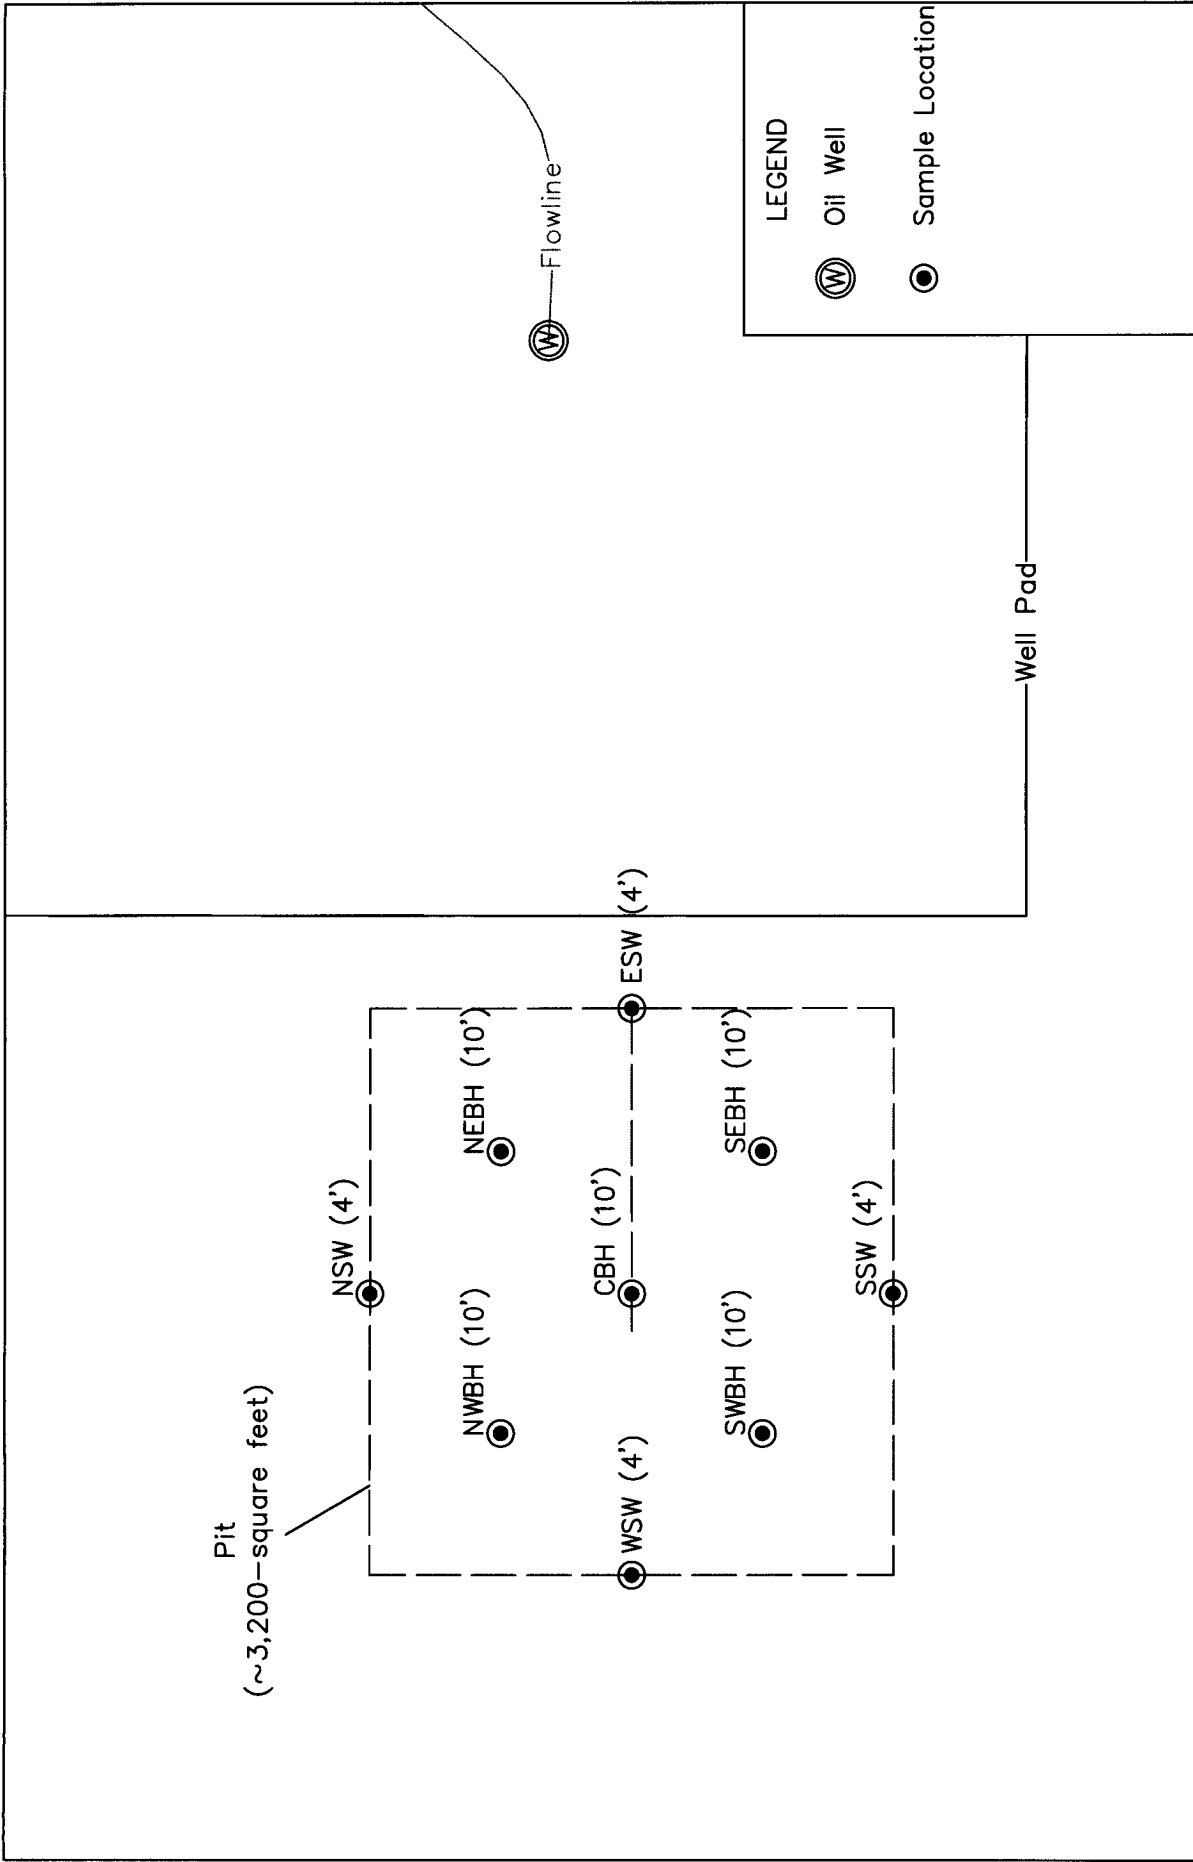
<p>Figure 3a Sample Location Map Chevron Corporation CDU #112</p>	<p>Lea County, New Mexico SE 1/4 of the NE 1/4, Sec. 28, T21S, R37E N 32° 27' 7.60" W 103° 09' 45.8" Elevation: 3,429 feet amsl</p>		<p>DWG By: Daniel Dominguez October 2006</p>	<p>REVISID: Dec 2006</p>

Sample Location
