**OIL AND GAS SERVICE INDUSTRIES
COMPLIANCE EVALUATION INSPECTION
FINAL - REPORT**

**KNOX SERVICES, INC.
HOBBS, NEW MEXICO**

March 10, 1997

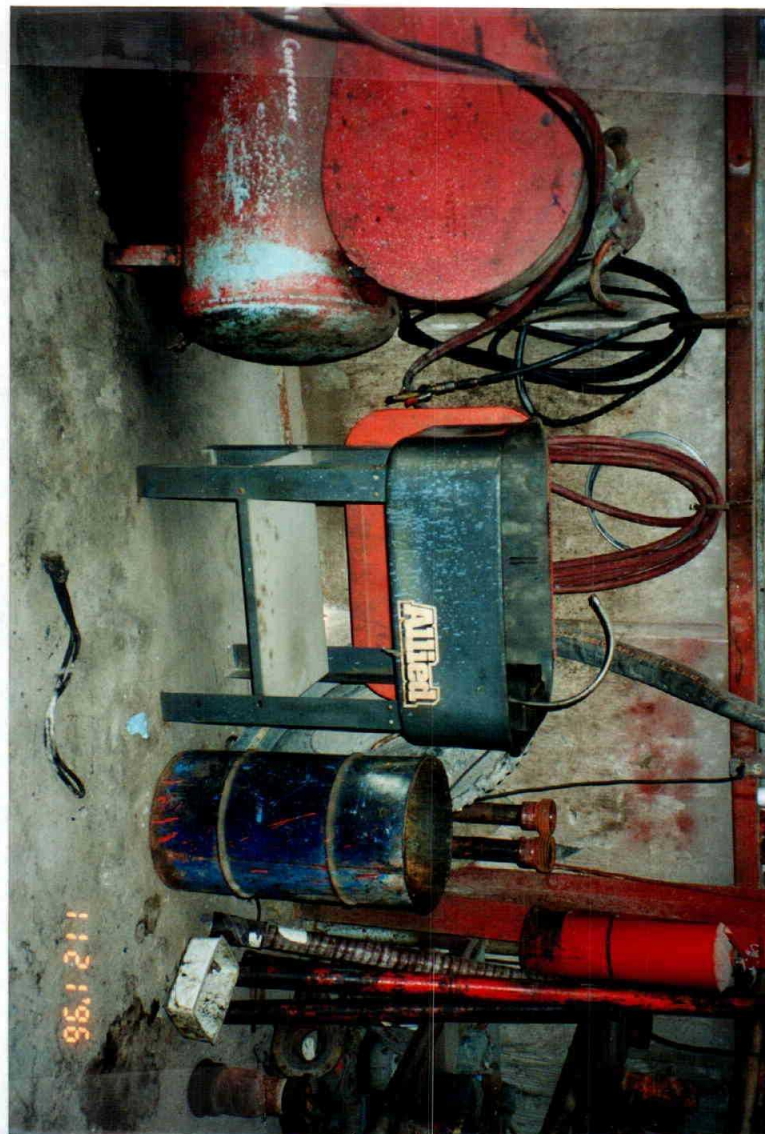
Photo# 1-2

Spent parts washer solvent (Varsol) is generated from a parts washer unit located in the garage area (see photograph 1-2). The parts washer consists of an approximately 30-gallon barrel with an attached plastic washing basin. The parts washer is located on the garage concrete floor. According to Mr. Ramriez, the parts washer solvent is combined with the used oil generated on-site prior to being collected by E&E Environmental. A review of a MSDS for the parts washer solvent indicated that the solvent may be ignitable.

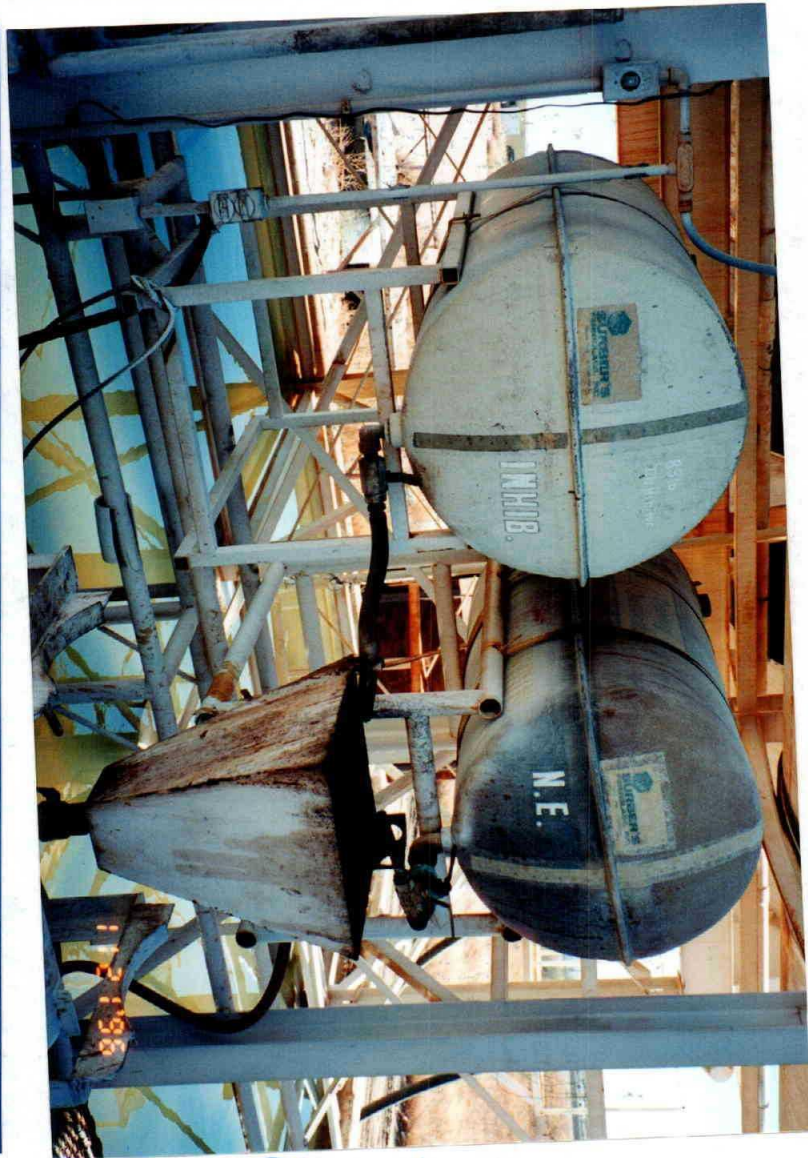
Photo #
1-14

Southwest side of HCl/Freshwater tanks and drum storage area.

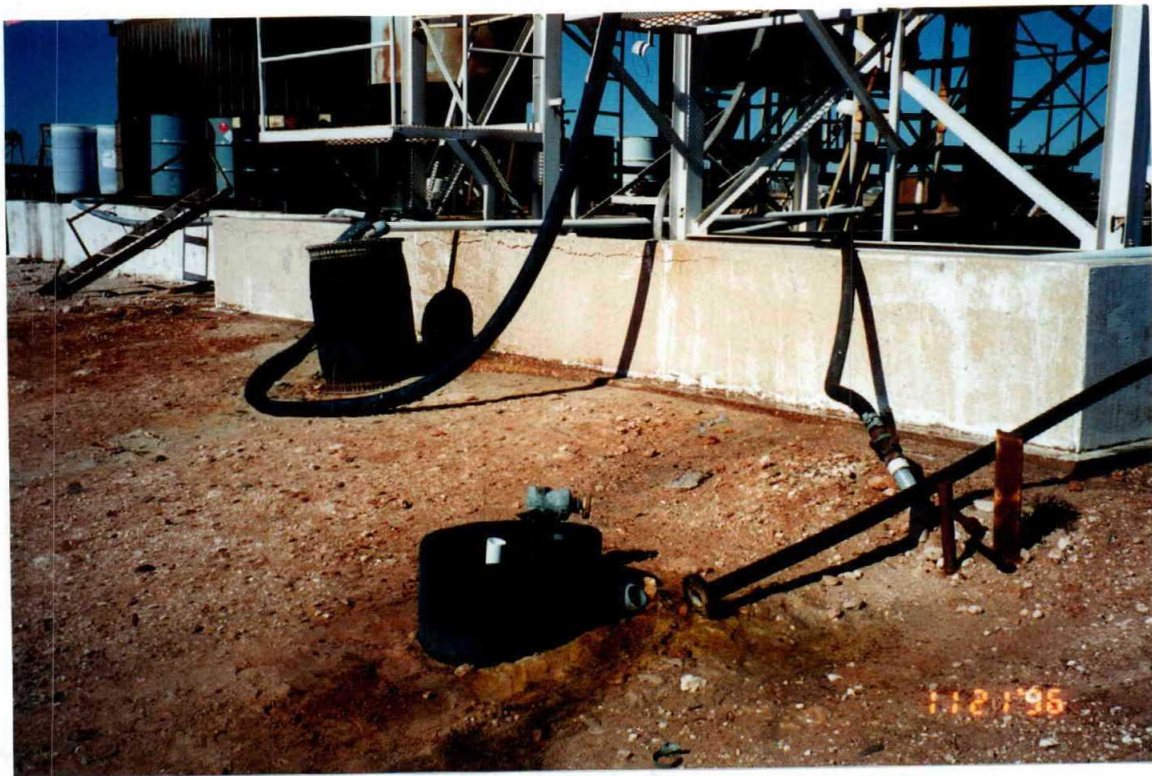
Photo
#1-16

Other observations included the stained soil around the HCL sump next to the HCL/Freshwater tanks. According to Mr. Ramirez, the stained soil was the result of the HCL supplier recently breaking the connectors to the HCL tank used to pump the HCL from the suppliers tanker truck to the Knox tank. Mr. Ramirez indicated that he was in the process of fixing the pump connector.

Unloading area on southwest side of the HCL/Freshwater tanks. Ground around line connector is stained yellow.

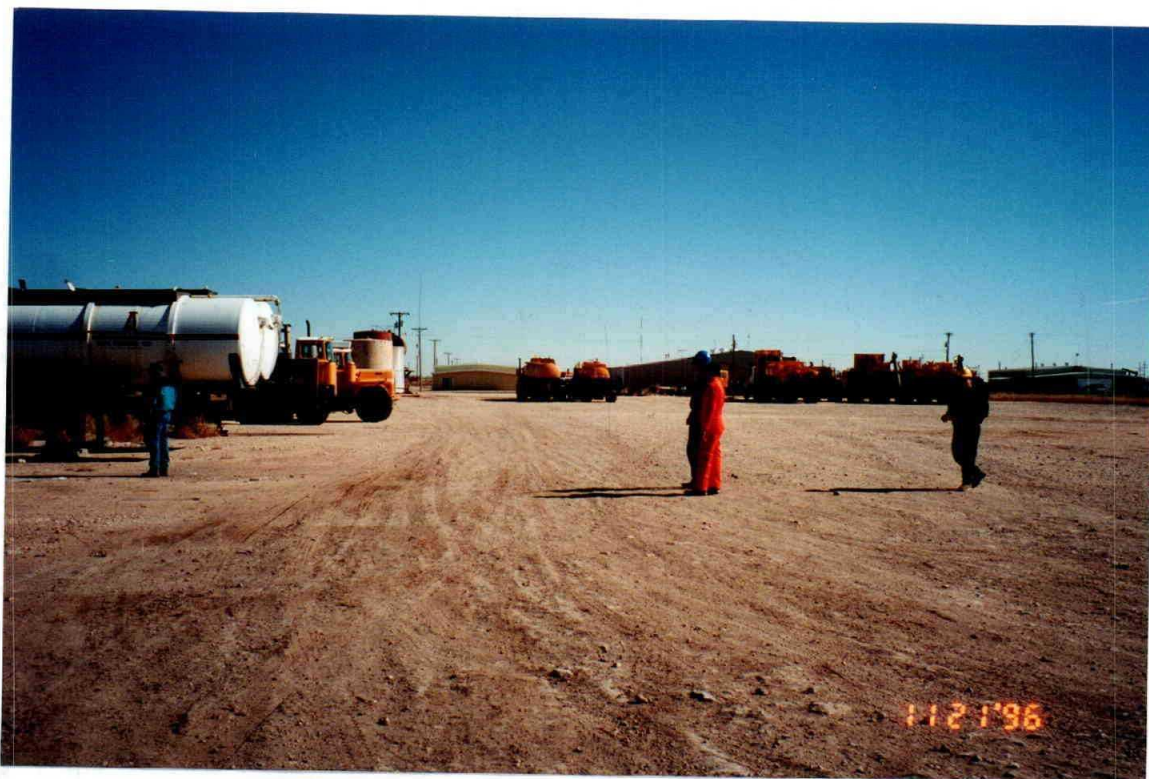
Photo#
1-19

Photo 4 of a panoramic view of the facility taken from the north part of the facility. Looking from east to west.
