**PIT
REMEDIATION
PLAN
AND
CLOSURE
REPORT**

APACHE CORPORATION PIT REMEDIATION AND CLOSURE REPORT									
Routing									
OCD Dist. I, P.O. Box 1980 Hobbs, New Mexico 87410				x		OCD Santa Fe, P.O. Box 2088 Santa Fe, New Mexico 87504-2088			x
APACHE CORPORATION EH&S GRP. 2000 Post Oak Blvd. Houston, Texas 77056				x					
Operator: APACHE CORPORATION						Telephone: (915) 527-3311			
Address: P.O. Box 848 Wink, Texas 79789									
Facility or Well Name: New Mexico BZ State									
Location: Unit or Qtr/Qtr Sec.				Sec 16		T 23S		R 37E County Lea	
Pit Type:		Separator		Dehydrator		Other: Overflow			
Land Type:		BLM		State		x		Fee Other:	
PIT LOCATION (Diagram Attached)									
Pit Dimensions:		Length: 40'		Width: 40'		Depth: 12'			
Reference:		Wellhead		Other: SE Corner					
Footage From Reference:		1'							
Direction From Reference:		25 Degrees				East		North x	
						West		South x	
Depth to Ground Water: (Vertical distance from contaminants to seasonal high water elevation of ground water)		Less than 50 feet 50 feet to 99 feet Greater than 100 feet				(20 Points) (10 Points) (0 Points)		0

TO: File of Apache Corporation.
From: Wayne Price-Environmental Engineer
Date: June 26

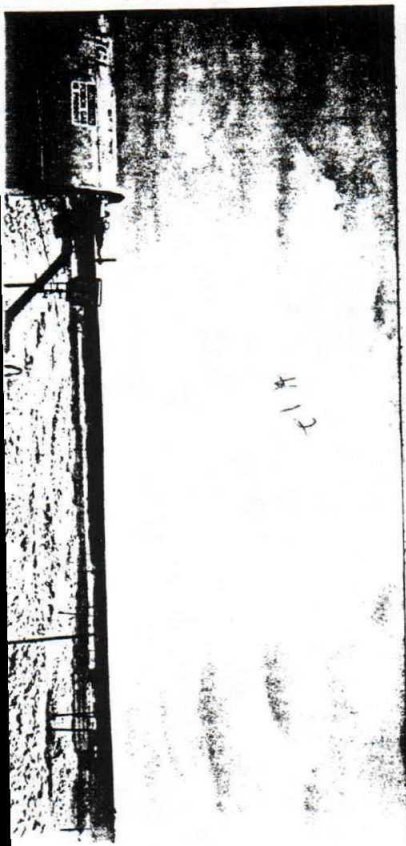
The legal description on the pit closure is wrong location, actual is above. Took bottom sample PID (BTEX) approx. 12 ppm, wet soil due to recent rain. Discharge pipe still in place. Soil has no hydrocarbon odor. NM St. Engr. office indicated ground water at 55-65 feet. Windmills and Jal country club fresh water well nearby area located to east and south approx. 400 yards.

- #9. Looking Southeast.
- #10 Looking south.

Took bottom sample of pit PID (BTEX) approx. 140-160 ppm, wet soil due to recent rain. Roadway where condensate and water was being discharged by Amoco PID (BTEX) 45 ppm. Pit has mild to moderate condensate smell. NM St. Engr. office indicated ground water at 107-124 feet.

- #11. Looking East. Shows pit and to right where tank water had been discharged into road.
- #12. Looking North show remediation area.

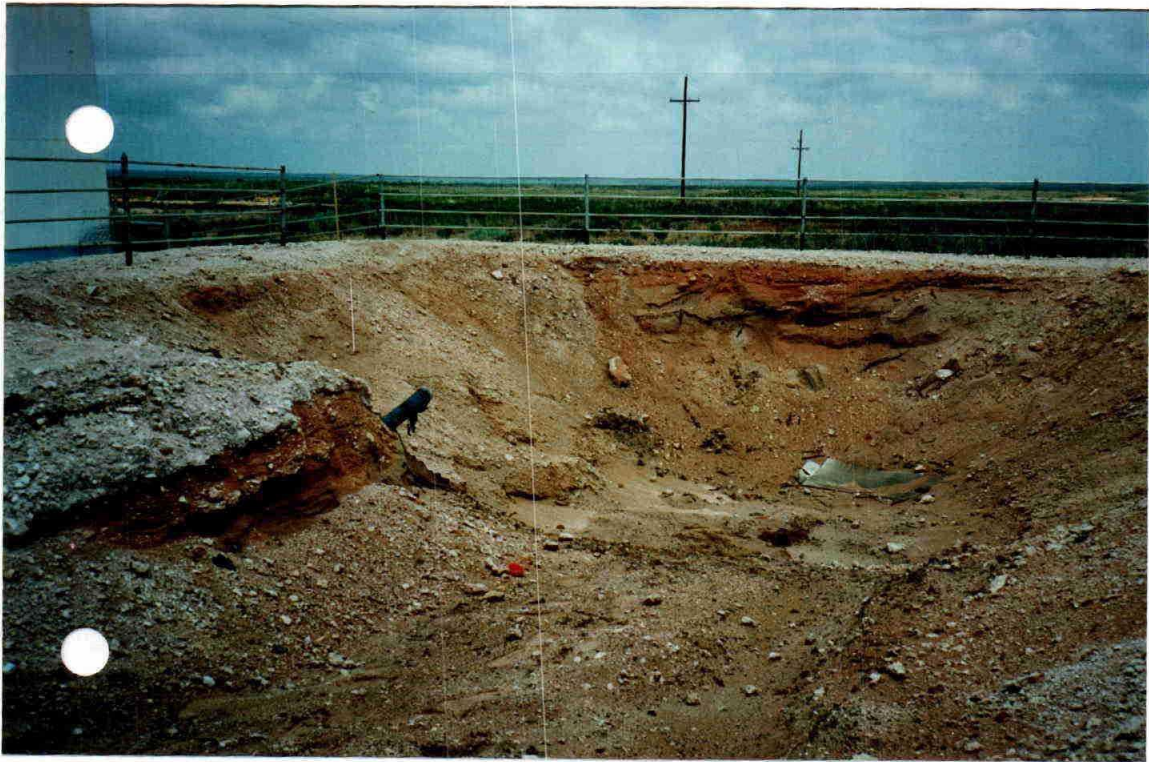
APACHE-NM ST BZ 16-23S-37E #7

Took bottom sample PID (BTEX) approx. 84 ppm, wet soil due to recent rain. Discharge pipe still in place. Apache will remove. Apache discovered that this pit had liner on sides only, pit bottom had no liner. Soil has mild hydrocarbon odor. NM St. Engr. office indicated ground water at 65-75 feet. Windmills nearby area located to southeast approx. 400 yards.

- #7. Looking east.
- #8. looking north- show remediation area.
