**RE: Closure Report – Ballard Ponds
Chaco Gas Plant
Enterprise Field Services, LLC
San Juan County, NM
NE ¼ of SW ¼, S16 T26N R12W
OCD Discharge Permit GW-071**

CLOSURE REPORT - BALLARD PONDS
OCD Discharge Plan (GW-071)

CHACO GAS PLANT
895 County Road 7100
Section 16, Township 26N, Range 12W
San Juan County, New Mexico

September 17, 2012
SWG Project No. 0410001A

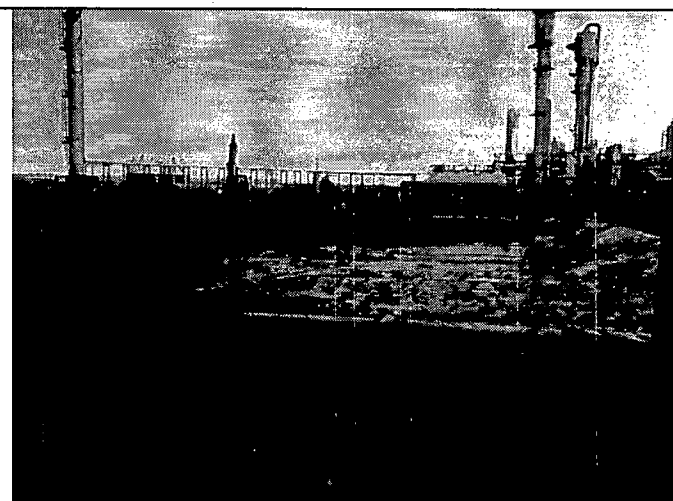
2.) West Pond during content removal.

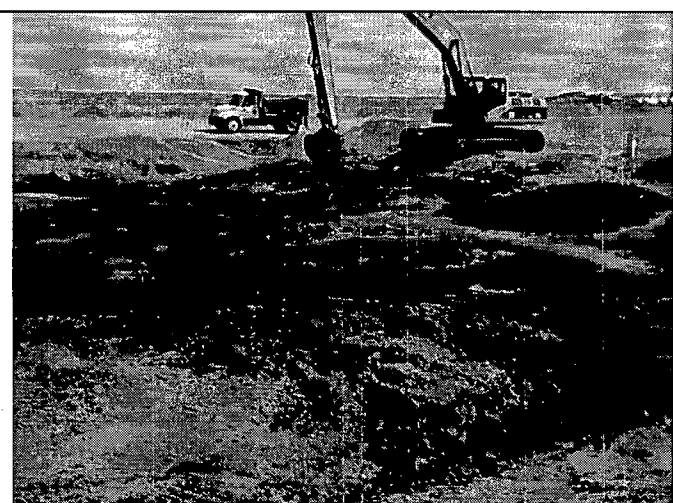
6.) Early stages of solidification in East Pond.

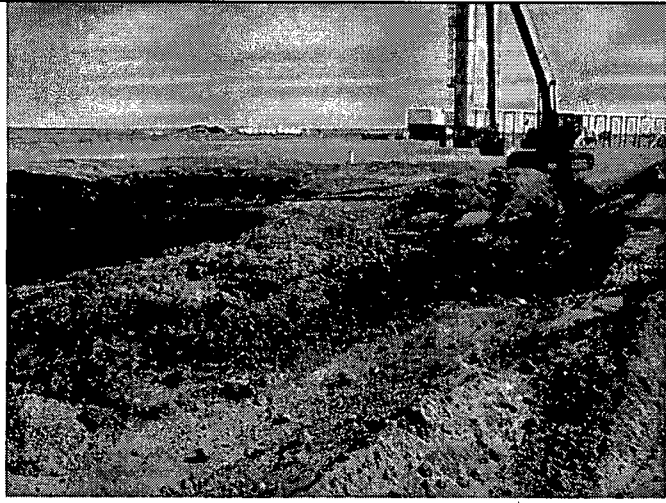
7.) Solidification of East Pond material utilizing blow sand.

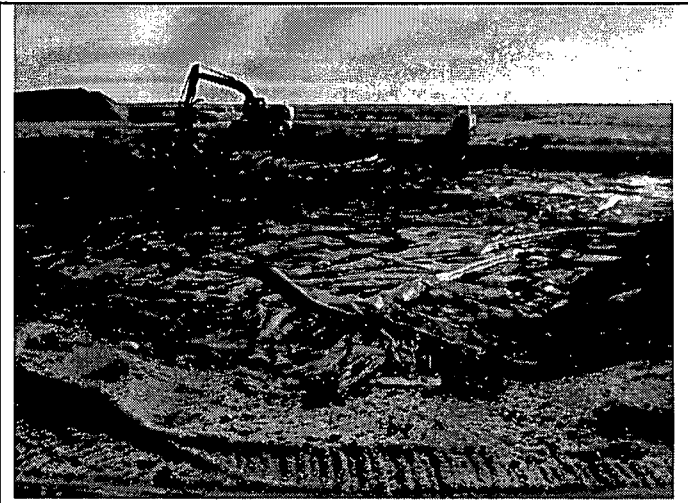
8.) Removal of solidified material in East Pond.

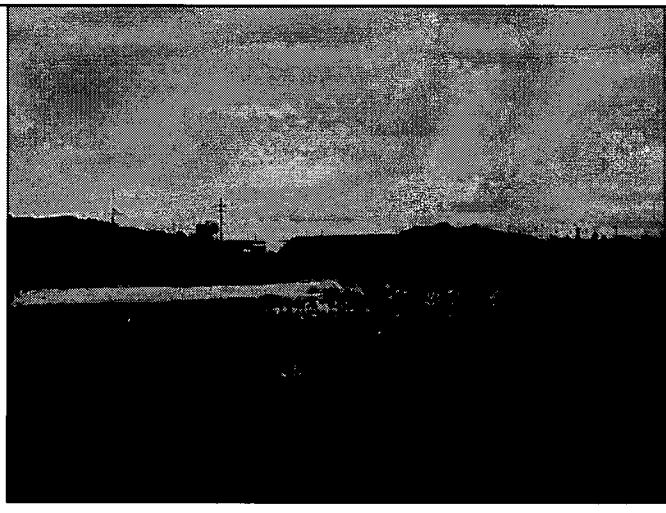
9.) Stockpiled material awaiting land farm acceptance.

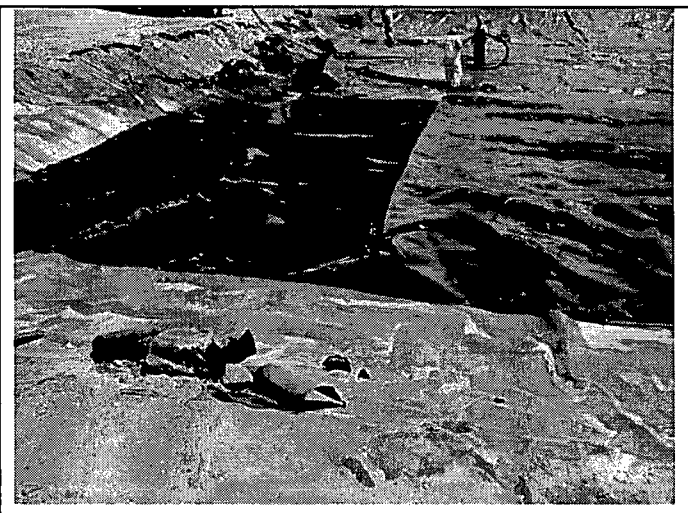
10.) Pressure washing and removing upper liner at East Pond.

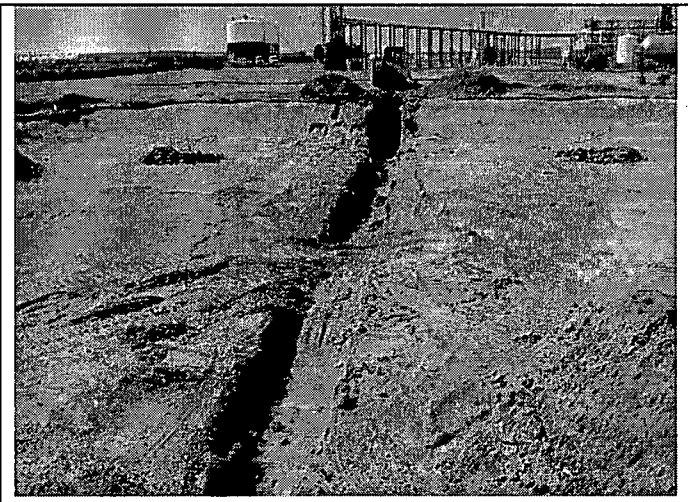
12.) Leak detection system removed from East Pond.

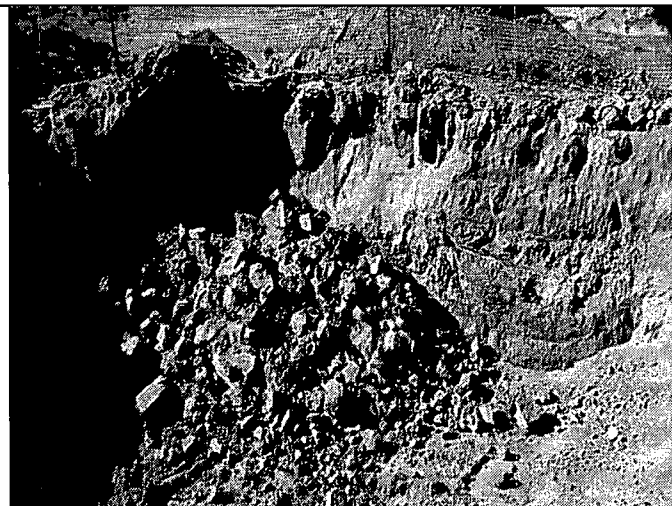
14.) General view of the over-excavation at south wall of East Pond. Minor slough occurred overnight. White/gray areas are clays.

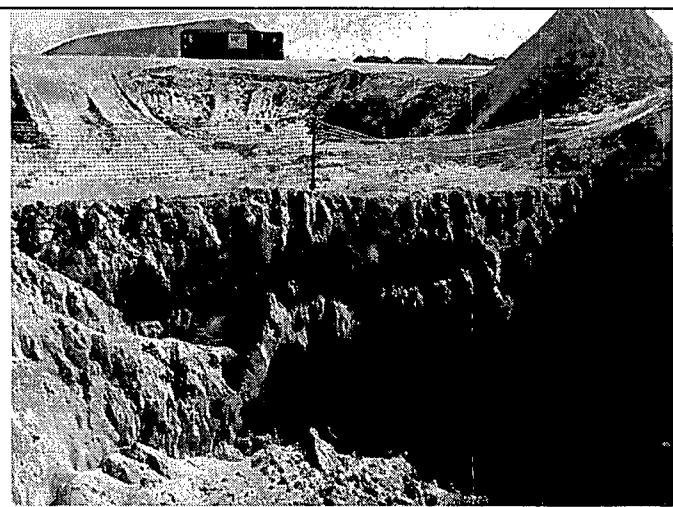
15.) General view of the final excavation at north wall of East Pond.
