**RE: Corrective Action Plan (CAP) Report & Termination Request
Rice Operating Company – EME SWD System
EME C-33 EOL (1R427-405): UL/C, Sec. 33, T20S, R36E**

Corrective Action Plan Report

EME C-33 EOL (1R427-405)
Unit Letter C, Section 33, T20S, R36E

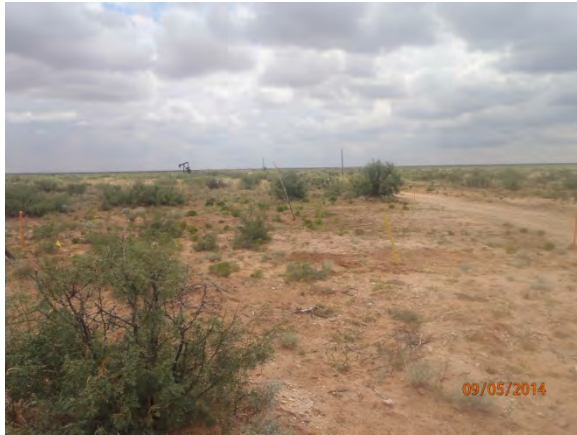
Site prior to excavation,
Facing south 9/5/2014

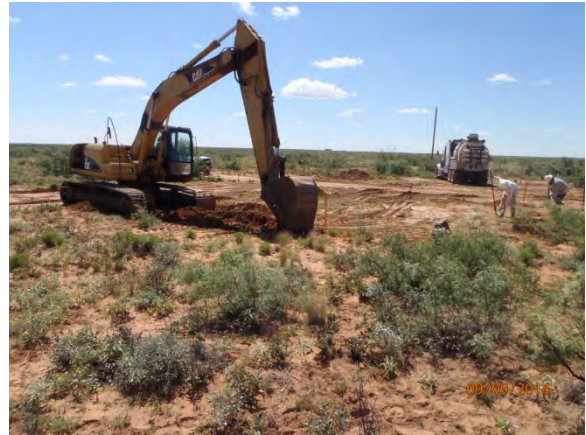
Digging excavation,
Facing southwest 9/9/2014

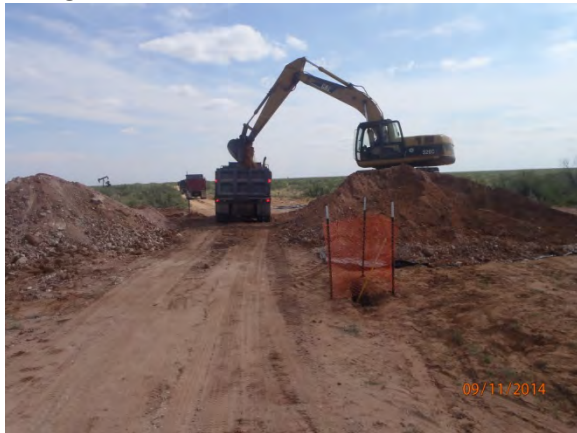
Exporting the spoil pile,
Facing south 9/11/2014

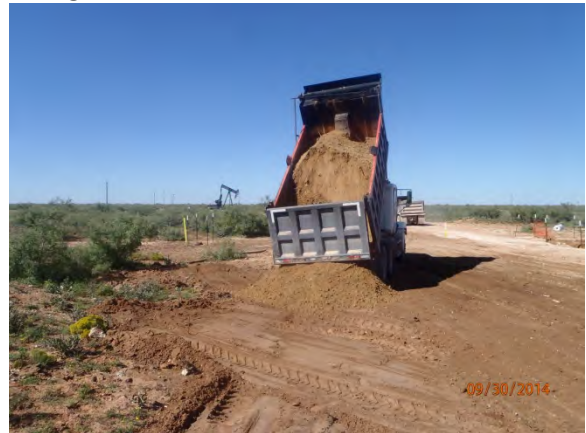
Importing soil,
Facing north 9/30/2014

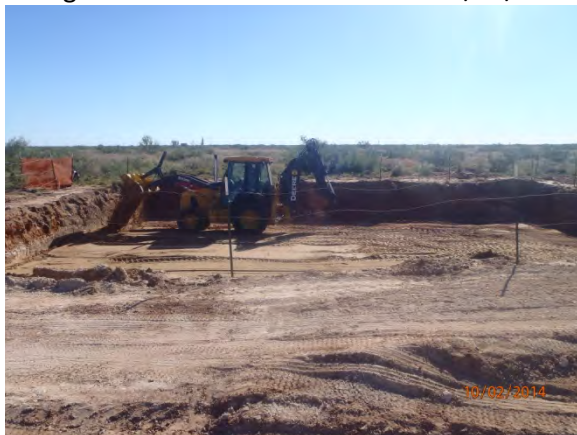
Padding excavation with 6" of topsoil,
facing east 10/2/2014

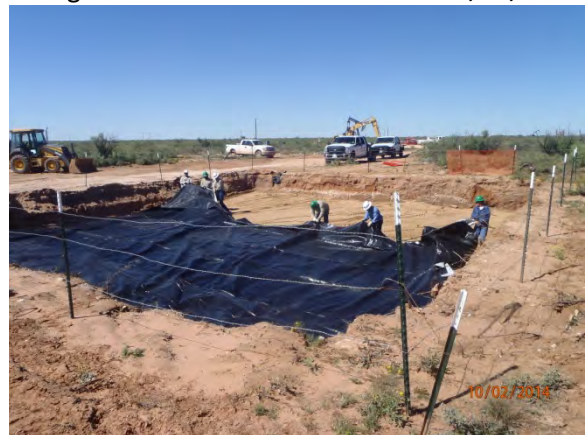
Installing 20-mil liner at 4.5 ft gs,
facing northwest 10/2/2014

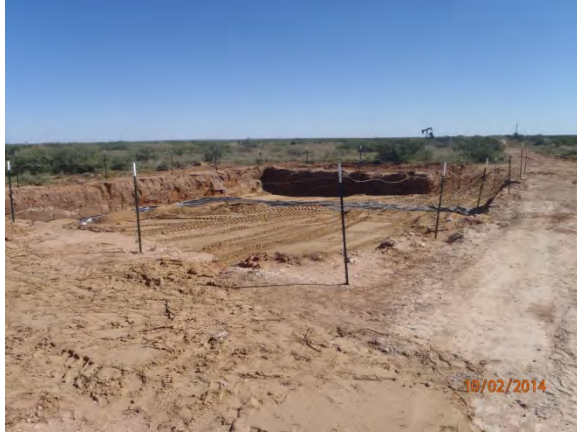
47x48-ft liner installed with 6 inch top soil pad, facing southeast 10/2/2014

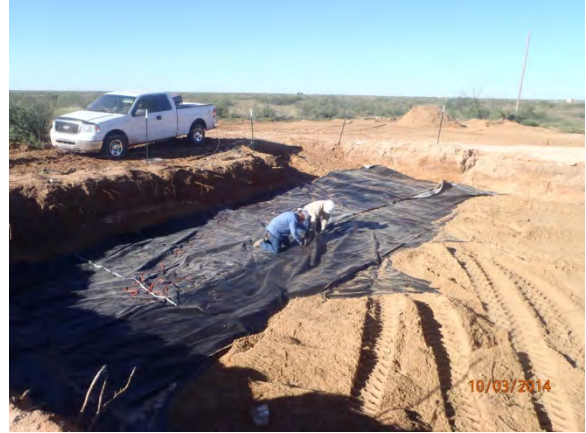
Installing and seaming the 47x12-ft liner with the 47x48-ft liner, facing southwest 10/3/2014

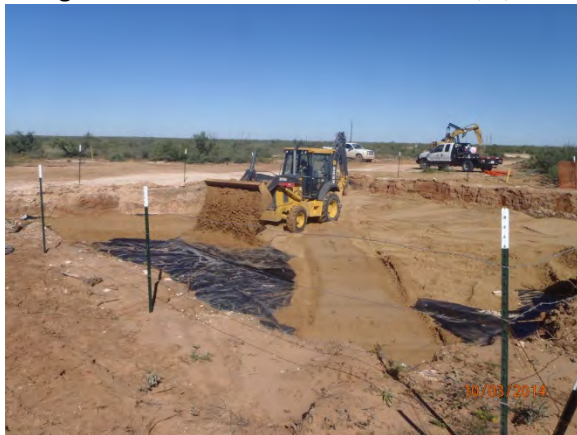
Padding above the liner with 6 inches of top soil, facing north west 10/3/2014

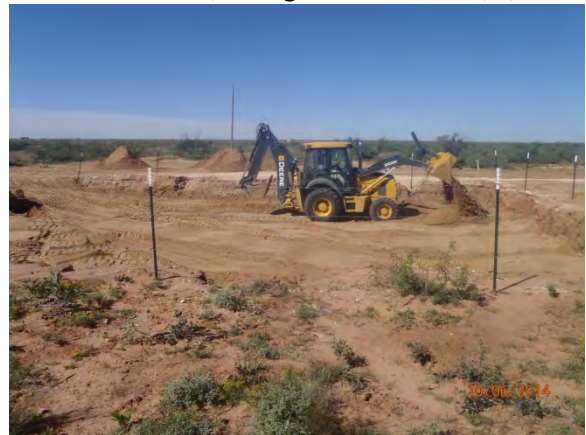
Backfilling above liner, facing west 10/6/2014

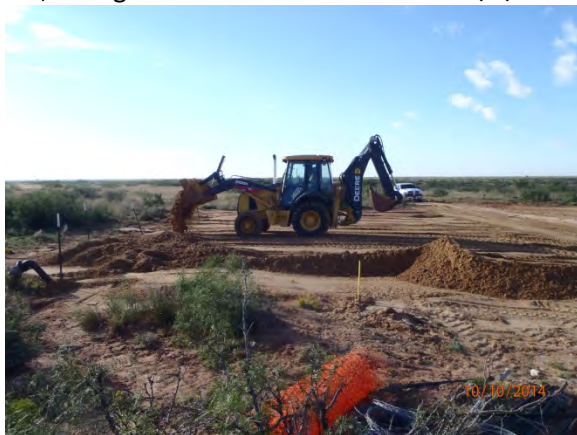
Contouring the site with imported soil, facing south 10/10/2014

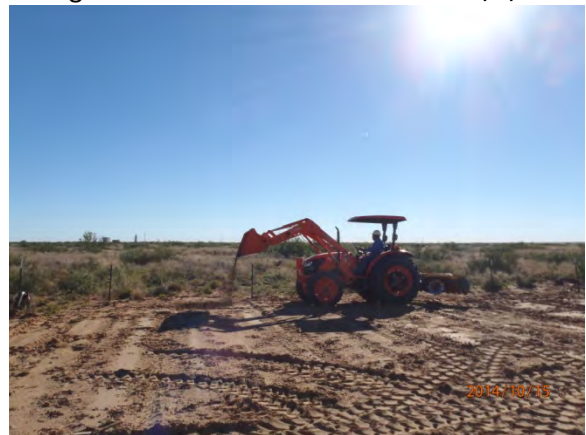
Spreading amendments, facing east 10/15/2014

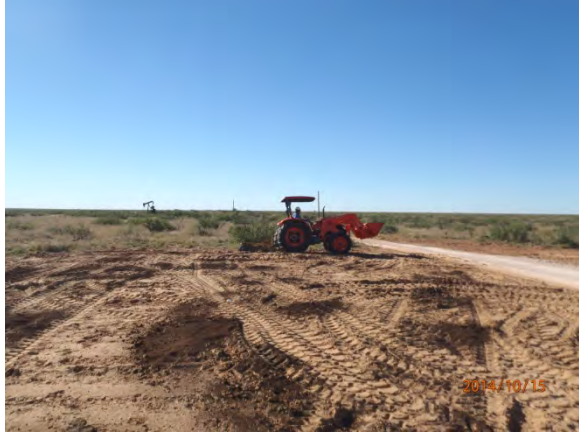
Discing location,
facing south 10/15/2014

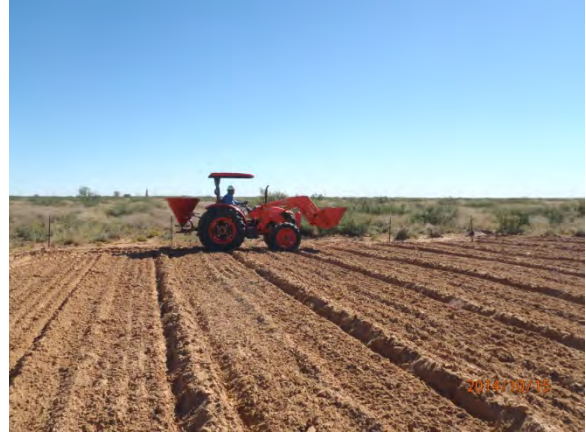
Seeding site,
facing east 10/15/2014

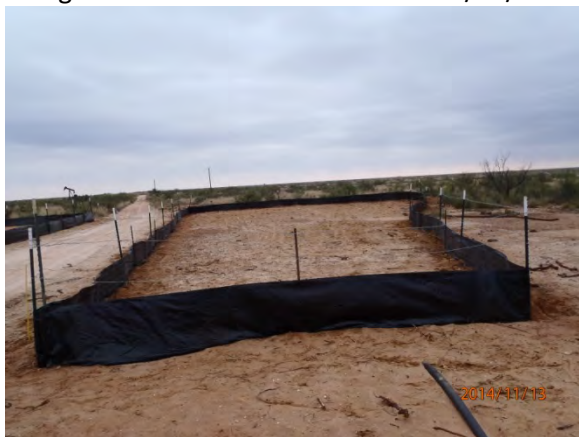
Site complete, facing south 11/13/2014

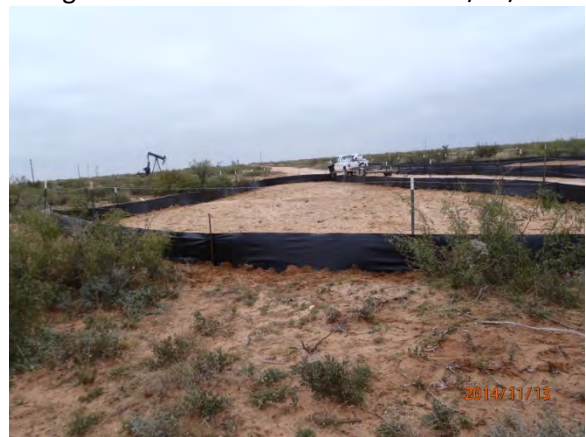
Site complete, facing north 11/13/2014
