**RE: Corrective Action Plan (CAP) Report & Termination Request
Rice Operating Company – EME SWD System
EME Jct. F-32 (1R427-407): UL/F, Sec. 32, T19S, R37E**

Corrective Action Plan Report

EME Jct. F-32 (1R427-407)
Unit Letter F, Section 32, T19S, R37E

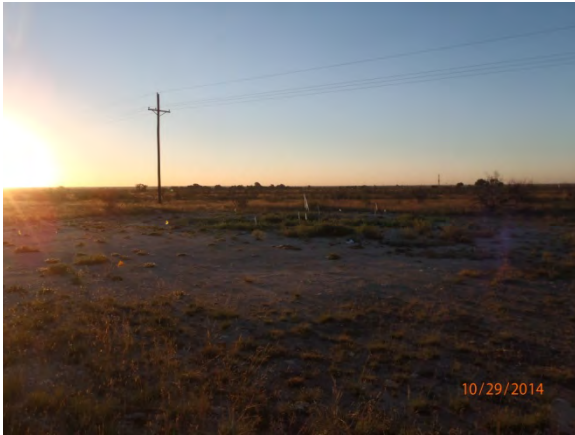
Site prior,
facing southeast 10/29/2014

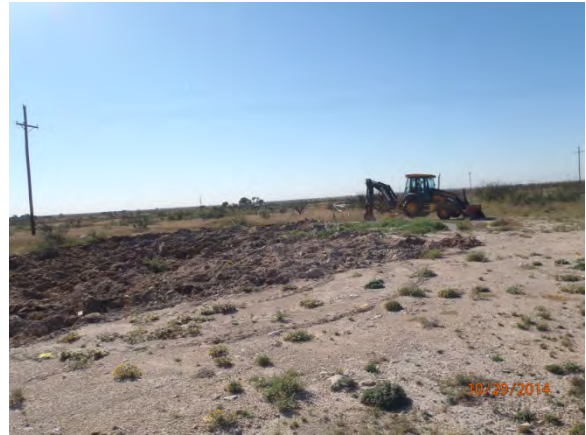
Breaking up the location,
facing south 10/29/2014

On October 29th, 2014, RECS personnel began scraping the site to a depth of 6 inches. An area of approximately 6,407 ft² was scraped, and a total of 128 yards of excavated material were taken to a NMOCD approved facility for disposal. A total of 274 yards of clean soil were imported and a sample of this imported soil was tested for hydrocarbons using a PID and was sent to a commercial laboratory for analysis of chloride. The sample resulted in a chloride concentration below detectable limit and field PID reading of 0.1 ppm. The site was then seeded with a native seed blend and a silt net fence was placed around the site to maintain seed integrity. Documentation of all site activities can be found in Appendix A.

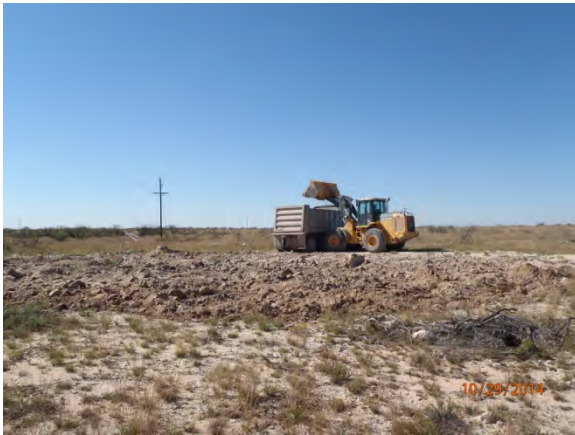
Exporting spoiled material,
facing west 10/29/2014

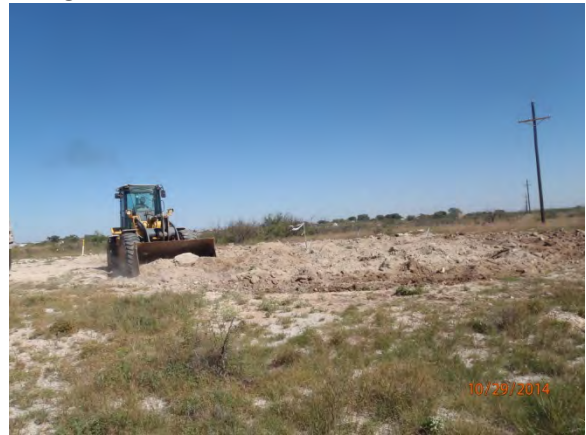
Scraping location,
facing northwest 10/29/2014

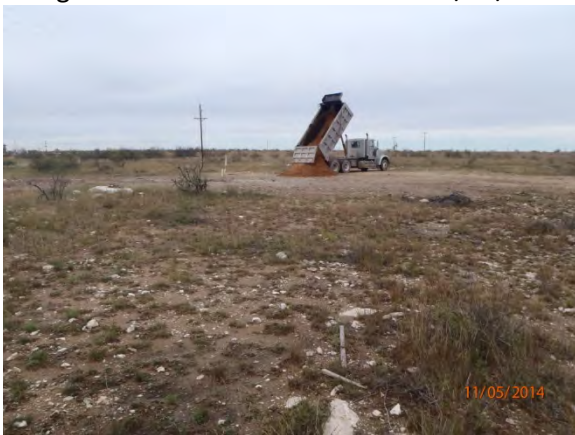
Importing topsoil,
facing west, 11/5/2014

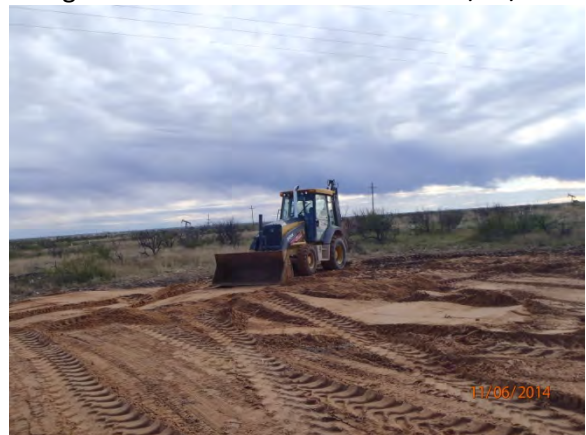
Backfilling scrape,
facing south 11/6/2014

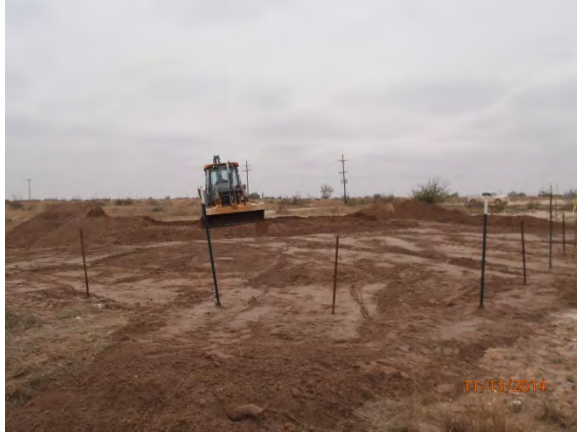
Spreading topsoil,
facing northwest 11/11/2013

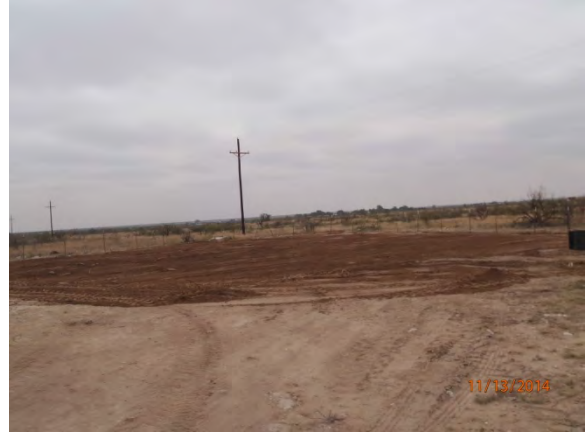
Backfill complete,
facing southeast 11/13/2014

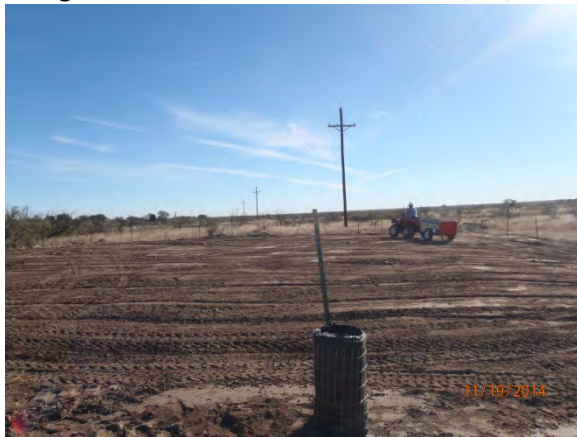
Spreading amendments,
facing east 11/19/2014

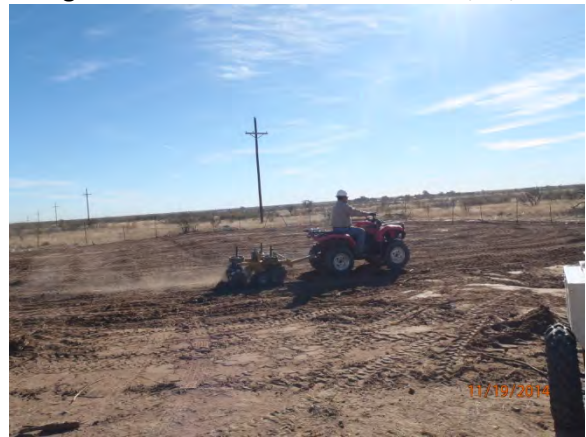
Discing in amendments,
facing southeast 11/19/2014

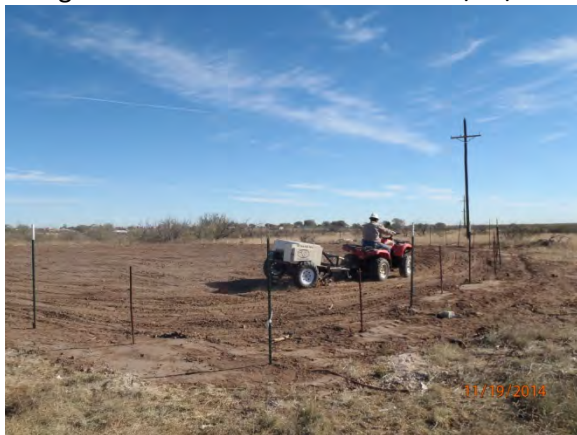
Seeding location,
facing northeast 11/19/2014

Custom seed mix <input checked="" type="checkbox"/>	Prescribed mix <input type="checkbox"/>	Seed mix name: 7 lbs. Black Gramma and 7lbs. Winter Wheat	Seeding date: 11/19/2014
Broadcast <input checked="" type="checkbox"/>			
Method: Used the dew drop drill seeder to seed the site.			
Soil conditions during seeding: Dry <input checked="" type="checkbox"/> Damp <input type="checkbox"/> Wet <input type="checkbox"/>			
Photos attached <input type="checkbox"/>	Observations: The seed was tilled into the soil.		
Number of photos:

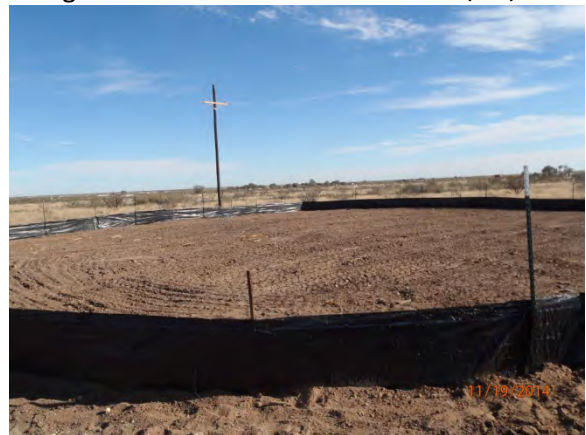
Site complete,
facing southeast 11/19/2014
