CLOSURE REPORT

BRUNSON ARGO TANK BATTERY #6

NMOCD REF. #1RP1304

RE: **Final Closure Report**
 Chevron USA
 Brunson Argo Tank Battery #6
 UL-F (SE ¼ of the NW ¼) of Section 10, T 22 S, R 37 E
 Latitude: 32° 24' 32.09"; Longitude: 103° 09' 13.11"
 NMOCD Ref. #1RP-1304; EPI Ref. #200131

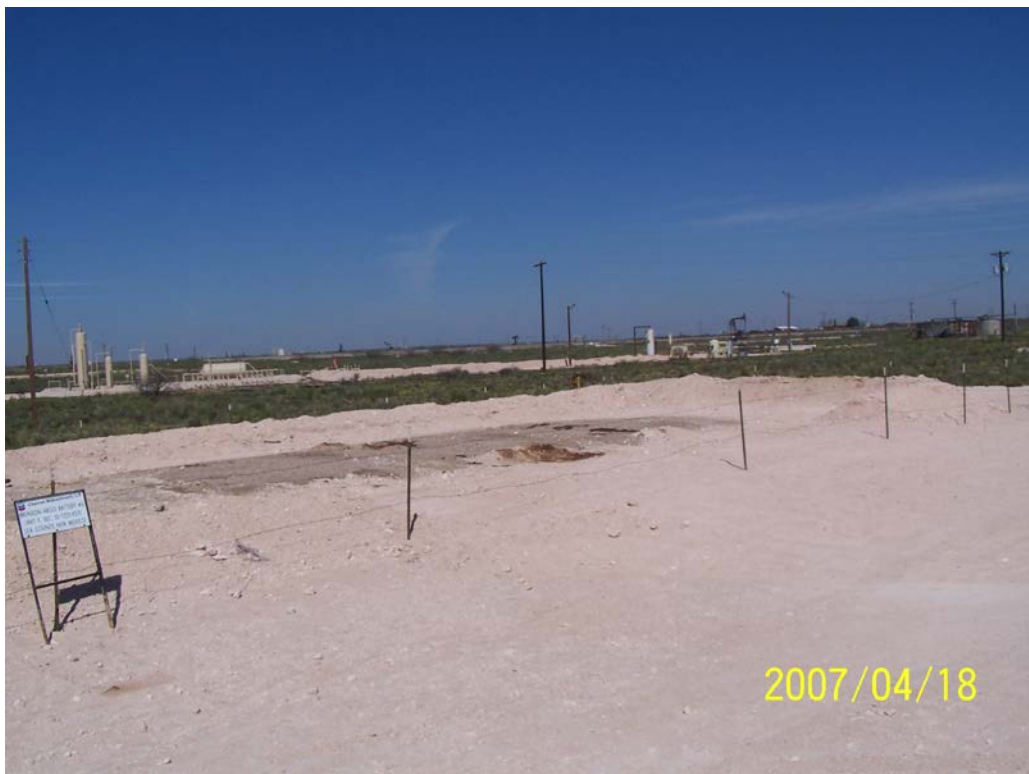
Photograph No. 2 – Looking northwest at tank battery bermed area (north end).

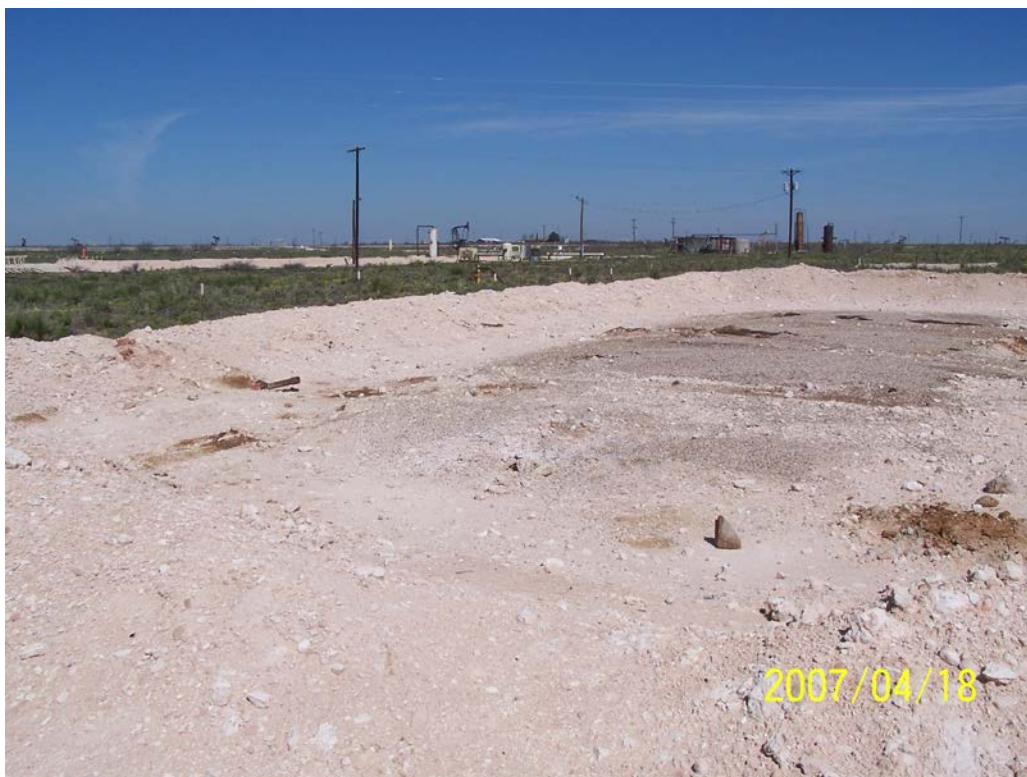
Photograph No. 3 – Looking northwesterly at tank battery bermed area (north end).

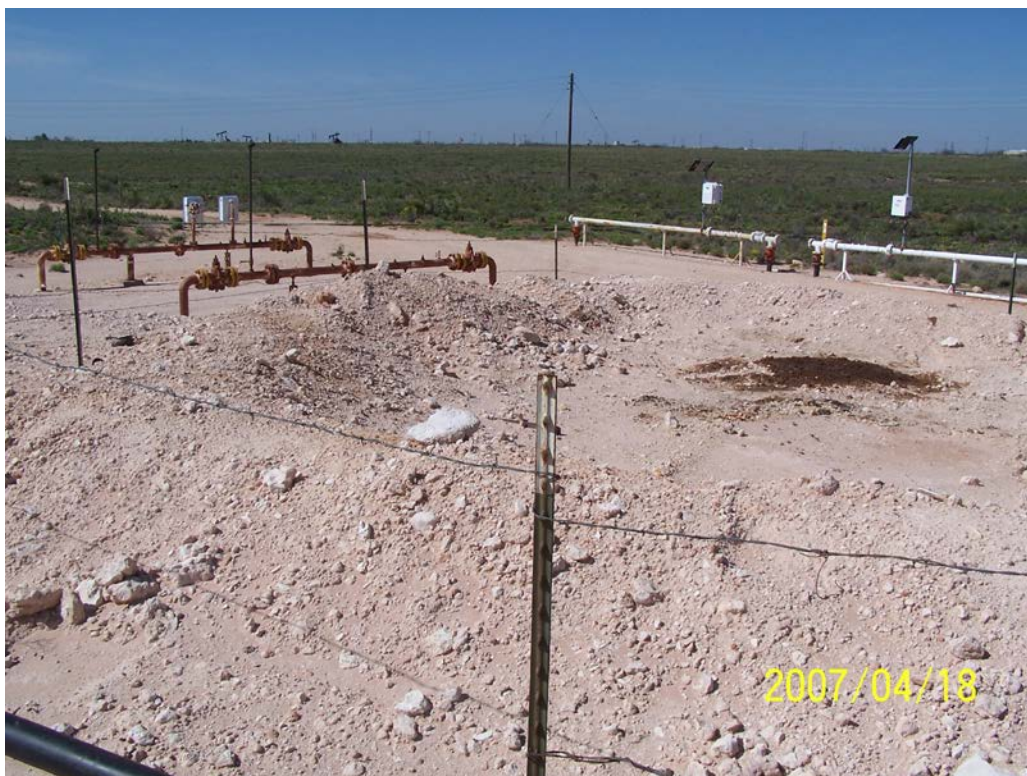
Photograph No. 4 – Looking south at tank battery bermed area (south end) and meter runs.

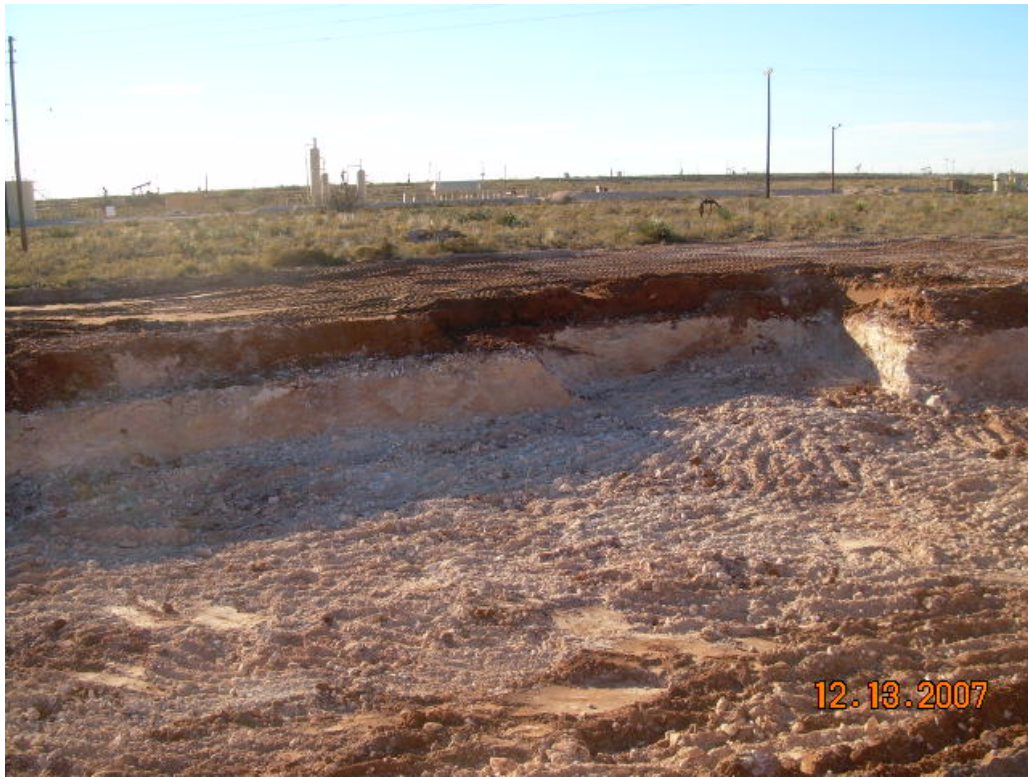
Photograph No. 5 – Looking westerly across Excavation II.

- B. **Remediation Activities** – From December 3 to December 18, 2007 approximately 3,556 yds³ of impacted soil were excavated from a combined surface area of 7,284-ft² at depths ranging from 1- to 8-ft bgs. Caliche from the production well and tank battery pad was excavated to existing ground surface (~3.5-ft bgs). Impacted soil was transported to Sundance Services Inc., located in Eunice, New Mexico, for disposal. Excavation I was excavated to a depth of ±7-ft bgs and Excavation II to a

depth of ± 8 -ft bgs. Although chloride impacted soil above remedial threshold goals exist in the bottom and sidewalls of the excavations, removal of additional impacted soil may not be performance or cost effective. In Excavation I, the easterly sidewall contains impacted soil greater than remedial threshold goals. However, the east sidewall abuts the existing caliche production pad and is considered an integral part of it. Remediation will be addressed whenever the production well is plugged/abandoned and the caliche pad reclaimed. Similarly, the east and south sidewalls in Excavation II have chloride concentration above remedial threshold goals. However, the west sidewall abuts against an existing pipeline and the south sidewall against a meter run. Upon completion of excavation activities, the bottom of both excavations was A 20-mil polyethylene liner sandwiched between one-foot layers of cushion material was installed across the bottom of Excavation I and Excavation II. The remainder of Excavations I was backfilled with clean topsoil ($\sim 2,078$ yds³) to original ground surface. The west side of the production well pad was backfilled with clean caliche (~ 582 yds³) and sloped (3:1) to prevent erosion of caliche material onto the remedial area. Disturbed areas were contoured to allow natural drainage.

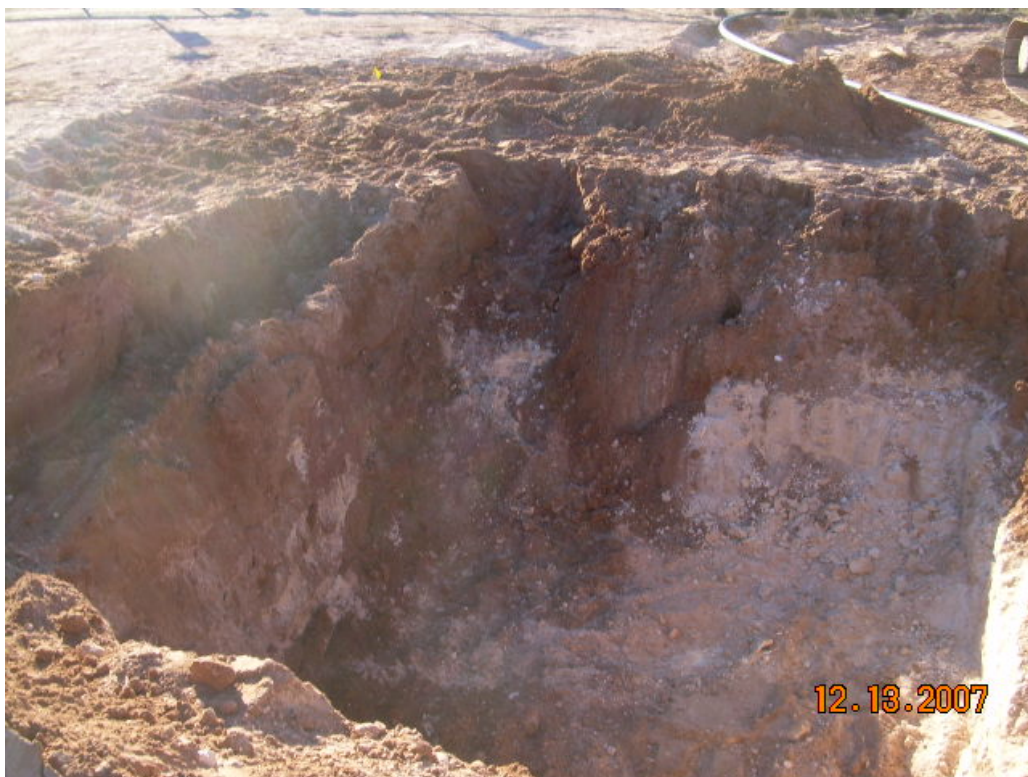
Photograph No. 6 – Looking southerly excavation II.

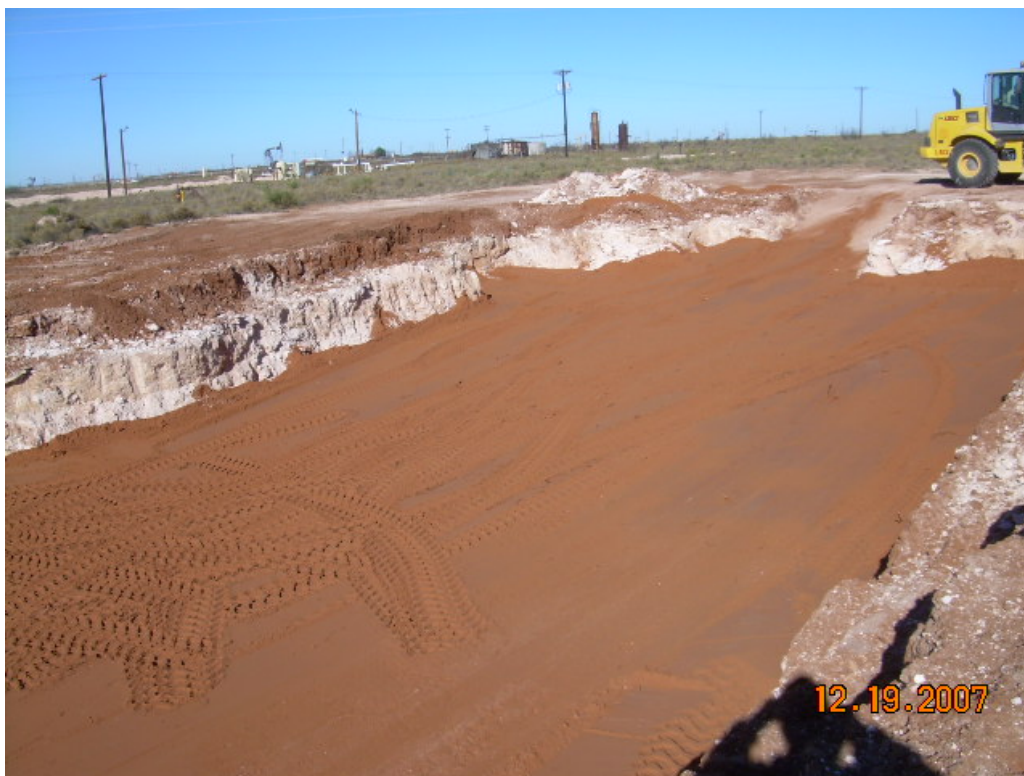
Photograph No. 7 – Looking northwesterly across excavation I with cushion material.

- C. **Conclusion** – A review of *Table 2 Soil Boring Soil Sample Field Analyses and Laboratory Analytical Results* indicates residual chloride concentrations in soils to 25-ft bgs may pose risks to local groundwater. However, these risks are considered manageable for the following reasons:
1. Vertical distance between groundwater (~ 66 -ft bgs) and the lowest point of known chloride impacted soil (~ 25 -ft bgs) is approximately 41 feet. With chloride impacts confined to one general area, natural attenuation will deplete concentrations significantly during migration. Hence, in-situ chloride residuals should not be capable of impacting groundwater above NMWQCC Ground Water Standards of 250 mg/L.
 2. Vertical migration of in-situ chloride residual concentrations have been impeded with installation of a 20-mil polyethylene liner across the bottom of Excavations I and Excavation II.

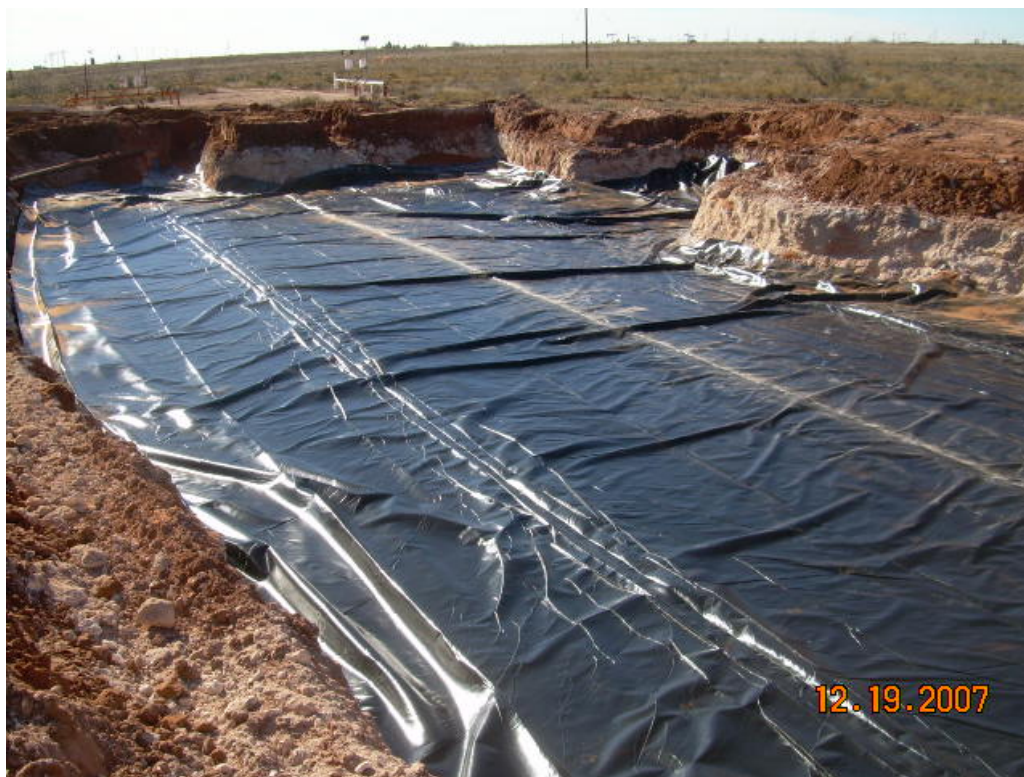
Photograph No. 8 – Looking southwest across Excavation I and installation of liner.

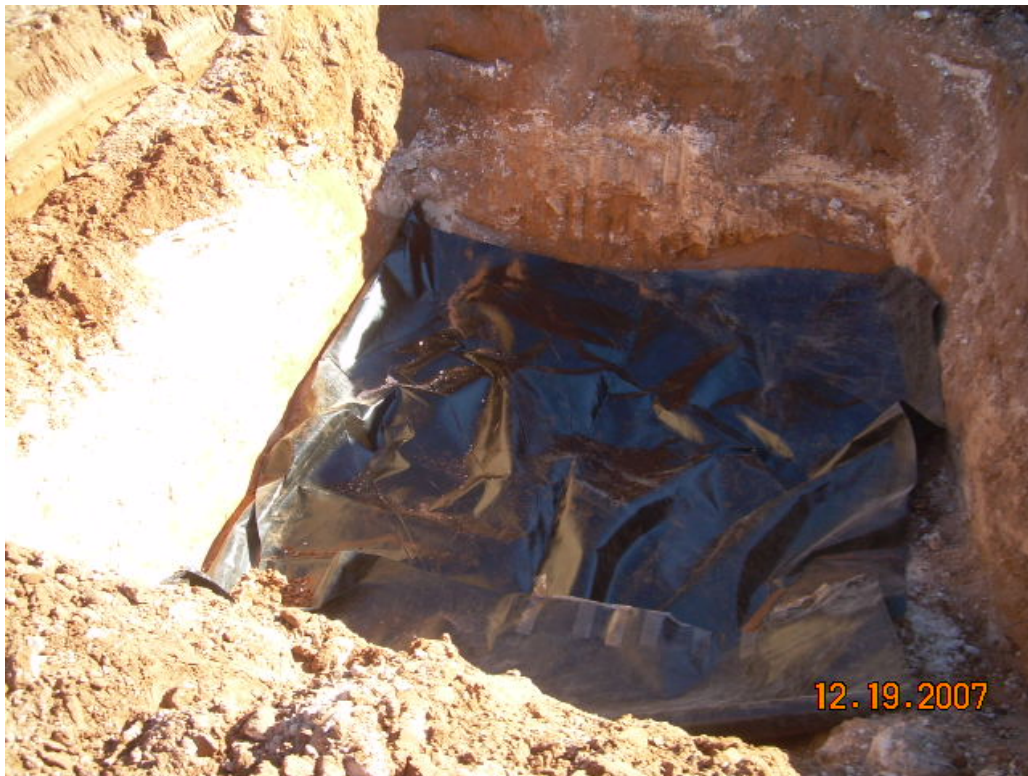
Photograph No. 9 – Looking southerly across excavation II and installation of liner.

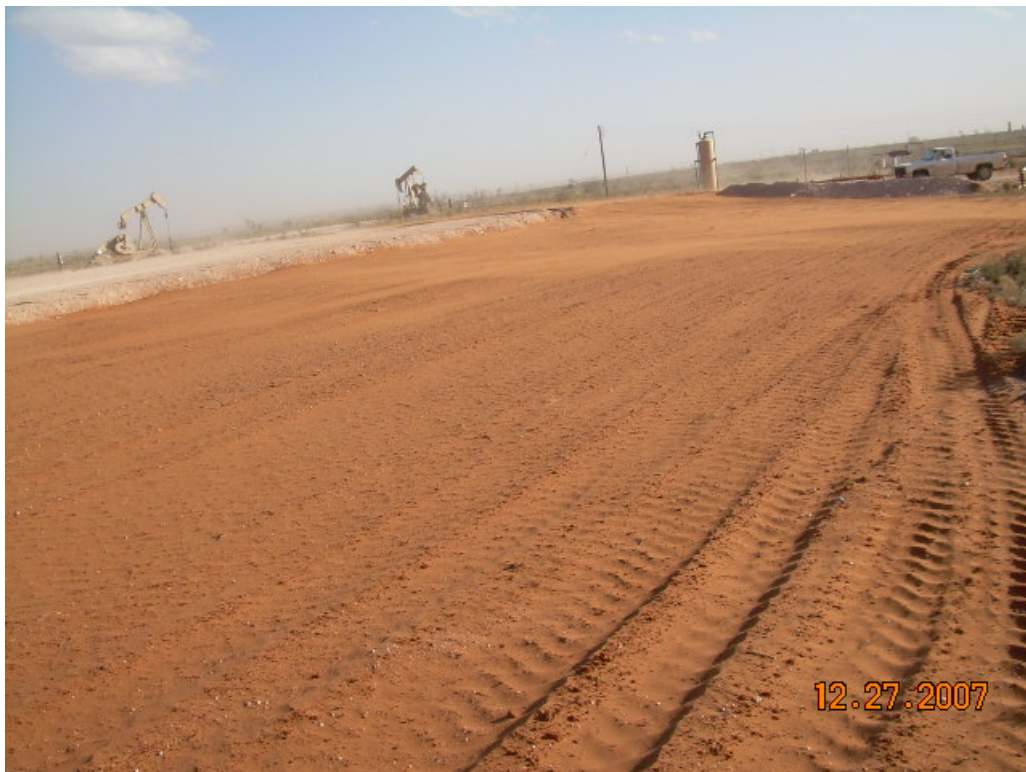
Photograph No. 10 – Remediated site.
