## Release Notification and Corrective Action

Name of Company BOPCO, L.P. 260731 Contact Tony Savoie  
Address 522 W. Mermod, Suite 704 Carlsbad, N.M. 88220 Telephone No. 432-556-8730  
Facility Name: Golden 8 Federal Battery #1 Facility Type E&P

Site Name Golden 8 Federal Battery #1	Site Type Exploration and Production
Date Release Discovered 06/14/2010	API# (if applicable) 30-015-26931

Project: 012918065	XTO Energy, Inc. Golden 8 Federal Battery #1

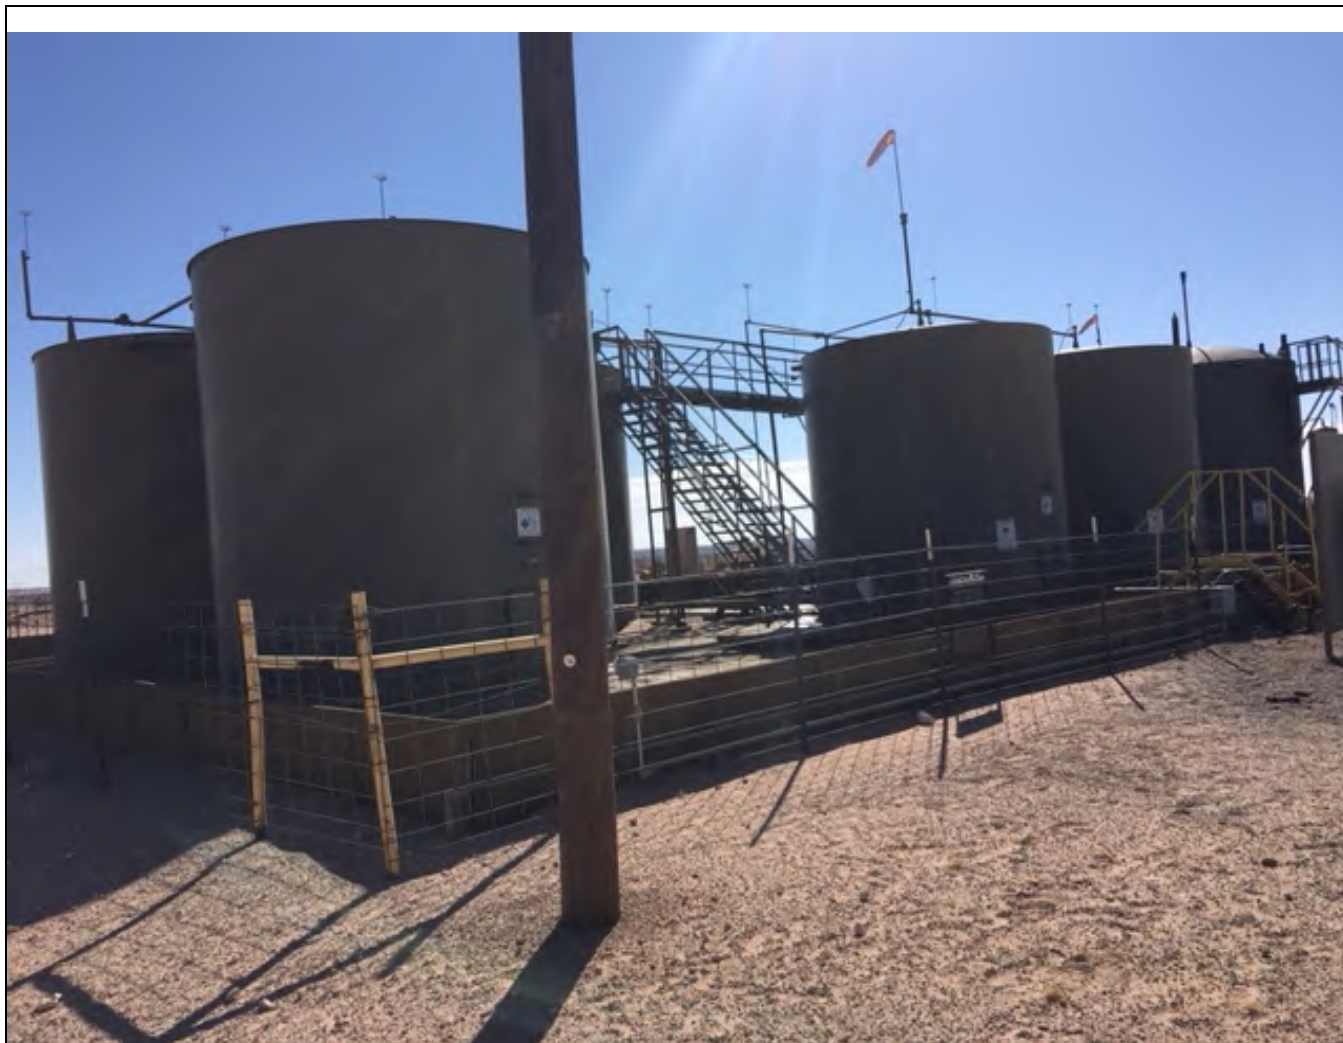
**Western view of lined tank battery containment.**

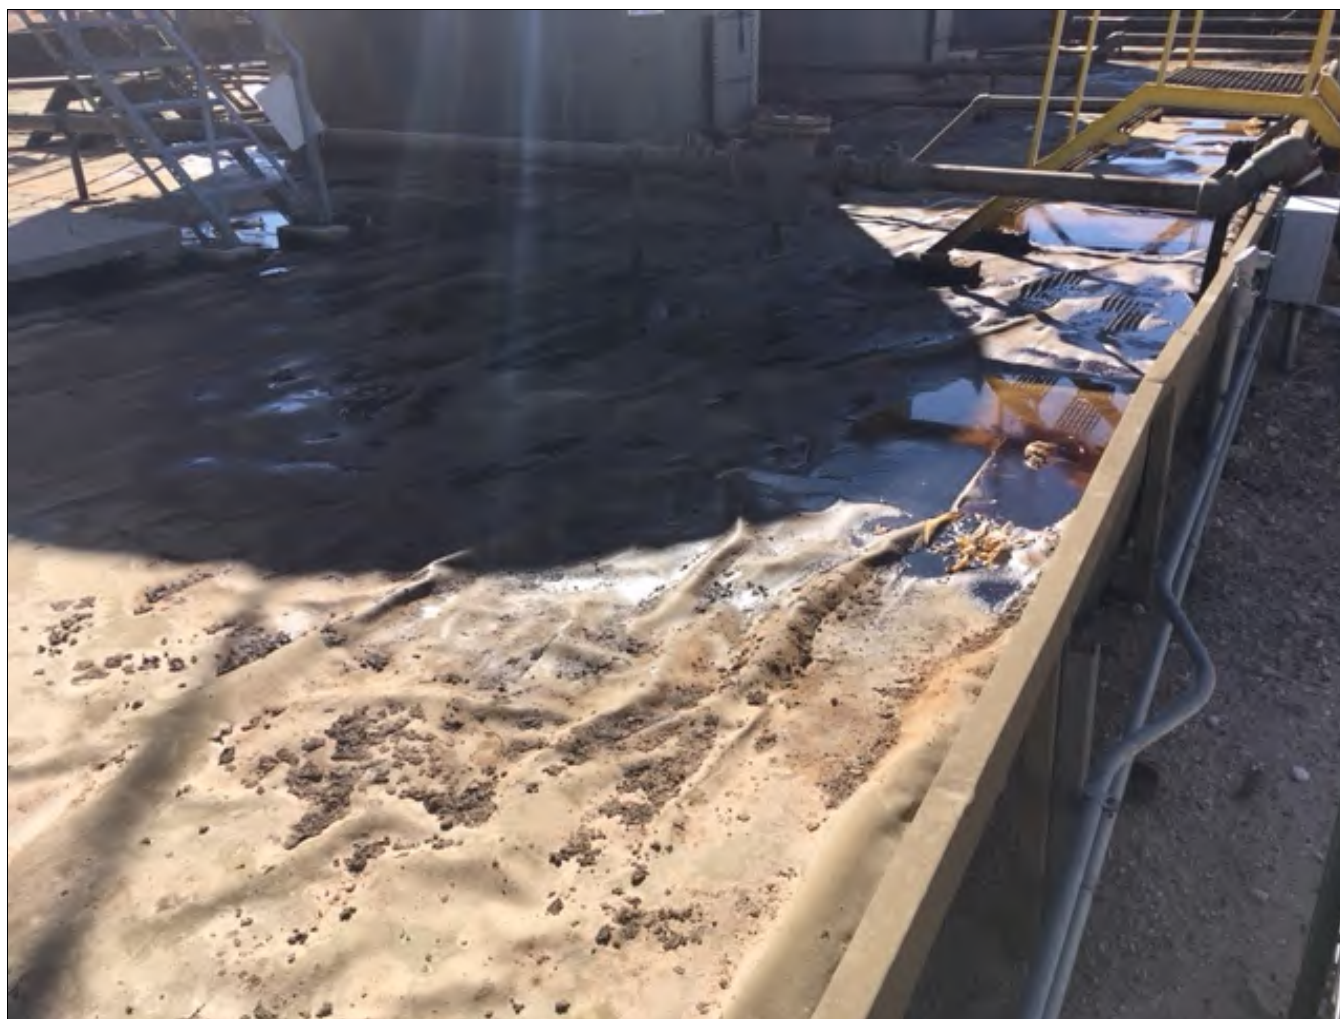
**View of lined tank battery containment and liner hole during soil sampling activities.**

Because depth to groundwater is estimated to be greater than 200 feet bgs, there no nearby surface features, and the impacted soil exists above and beneath a liner, LTE and XTO do not believe deferment will result in imminent risk to human health, the environment, or groundwater. The lined containment was repaired by XTO and will restrict potential vertical migration of residual impacts. XTO requests deferral of final remediation for this release event until final reclamation of the well pad or major construction, whichever comes first. An updated Form C-141 is attached.
