Release Notification and Corrective Action

NM State "S" Tank Battery 5

Remediation Proposal

RE: Remediation Proposal
ExxonMobil Corporation
New Mexico "S" State Tank Battery #5
UL-F (SE ¼ of the NW ¼) of Section 02, T 22 S, R 37 E
NMOCD Ref. #1RP-10-4-2489; EPI Ref. #190041

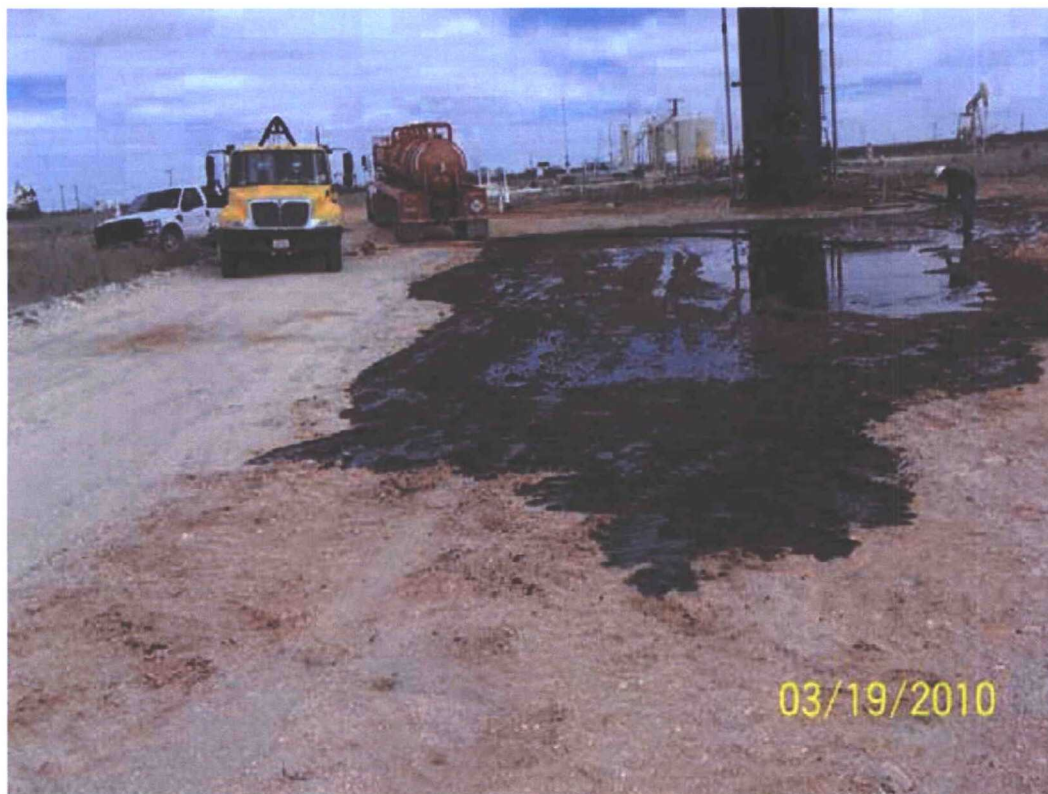
Photograph No. 2 – Looking northerly at release area and cleanup effort

A vacuum truck was called out to pick up free fluid. Emergency one call was put in and contaminated soil was excavated. Site will be delineated and remediated according to NM guidelines.

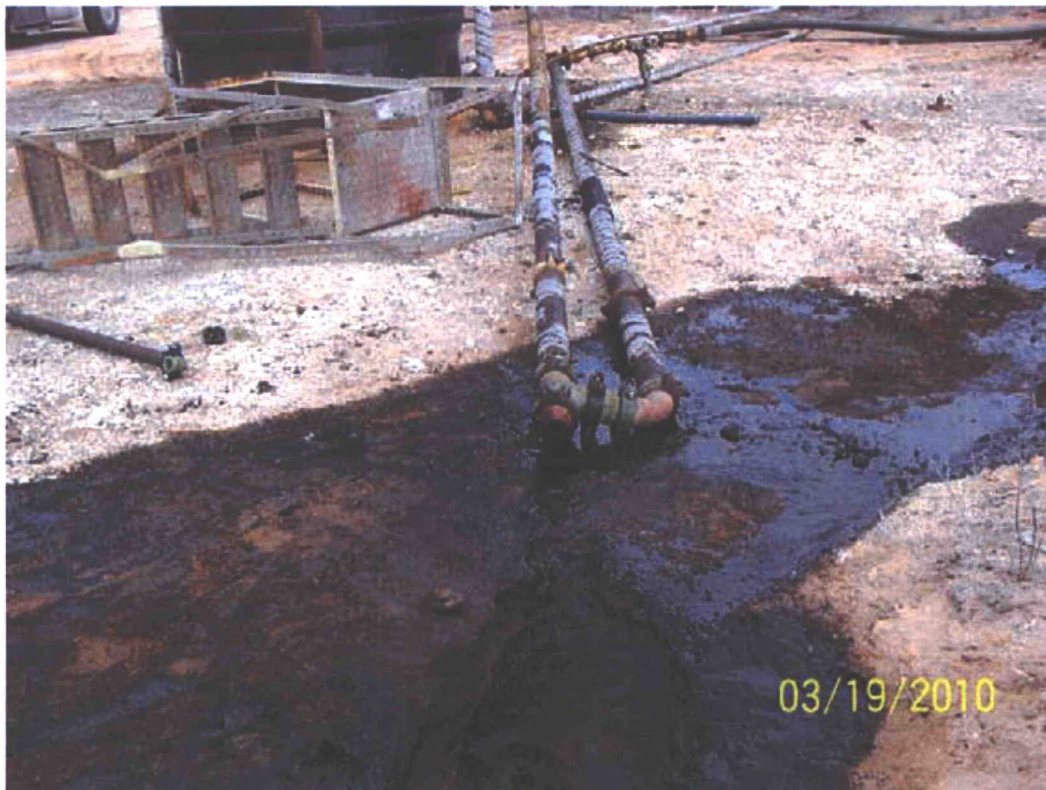
2" drain line water leg on heater broke off of heater due to groove in piping developing corrosion.

Photograph No. 3 – Looking a broken water leg

In viewing the physical location of the release area, it would require a very large excavation for removal of all chloride impacted soil to approximately fifteen (15) vertical feet. The northern end is blocked by an active heater treater while the west side is confined by the lease road. Excessive excavation in the northerly direction would endanger the heater treater base. Removal of impacted material near the lease road would require a detour and closure of the main north-south route. Adding to the complexity of excavating the release area are three (3) buried steel pipelines. The 3" diameter steel pipelines would require careful excavation procedures and installation of metal braces for support. The 8" and 3" diameter steel pipelines nearly intersect in the mid- to south section of the release area. There is sufficient room on east side of the 3" and west side of the 8" pipelines for limited excavation. However, excavating between pipelines on convergent and divergent sides may not allow sufficient room to do it mechanically. In lieu of this, EPI proposes to excavate the release area a maximum of six (6) feet below ground surface (bgs) which is below root zone (~3-feet bgs) protecting vegetation. While not eliminating all, it will remove bulk of chloride impacted material. Excavation of the north end will commence five (5) feet south of the heater treater and continue in a southerly direction until soils comply with NMOCD Goals. Excavation in a westerly direction will continue until it abuts east edge of existing lease road. Impacted material will be excavated from around the 8" diameter steel pipeline the entire length of the release area. Sidewalls on the east side of the release area will be excavated until soil displaying NMOCD Goals for chloride concentrations are achieved.

A forty (40) mil thick polyethylene liner will be placed in the bottom of the excavation extending up the north (heater treater) and west (lease road) sidewalls to within six (6) inches of finish grade. Polyethylene liner will extend three (3) feet up the east and south sidewalls. Bottom of the polyethylene liner will lay on a one (1) foot thick layer of clean top soil or cushion sand. Depth of excavation will be a maximum of one and one-half (1.5) feet below bottom of the 8" diameter pipeline. This will allow both working area to insert the polyethylene liner under the 8" diameter steel pipeline and tamping backfill soil under the barrel for lateral support. Remainder of the excavation will be backfilled with selected top soil to finish grade. Top soil will be free of deleterious material, rocks or large clumps. Caliche will be placed around the heater treater to provide a working service area. Special care will be taken to ensure the two (2) 3" diameter steel pipelines are encased in clean top soil or sand extending a minimum of one (1) foot around outer sidewalls, top and bottom. Finished gradient will allow natural flow of water away from the heater treater and remediated release area onto the lease road. Soil in disturbed areas will be disced and deep drill seeded with either BLM Mix #2 or a blend preferred by the NMSLO.

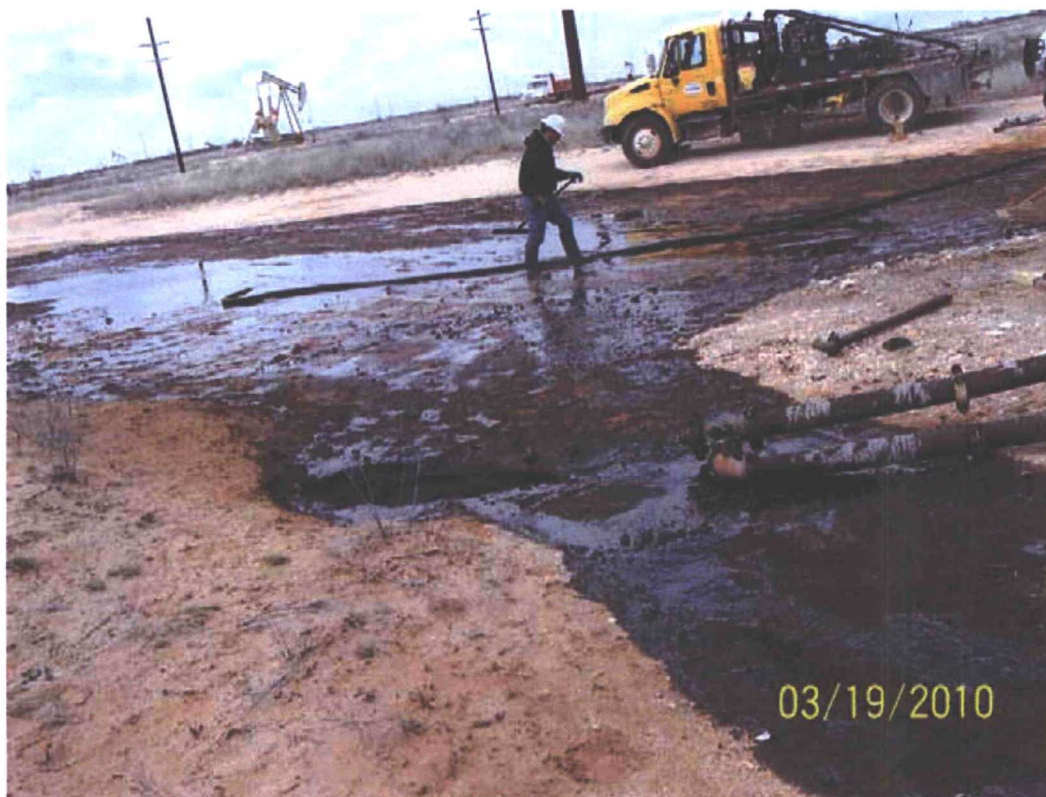
Photograph No. 4 – Looking southerly at release area and cleanup efforts
