**STATE OF NEW MEXICO  
ENERGY, MINERALS AND NATURAL RESOURCES DEPARTMENT  
OIL CONSERVATION DIVISION**

**APPLICATION OF WHIPTAIL MIDSTREAM  
LLC FOR HEARING ON REMEDIATION AND  
CLOSURE PLAN, RIO ARRIBA COUNTY, NEW  
MEXICO**

**Case No. 22782**

**MOTION FOR SUMMARY JUDGMENT AND CLOSURE**

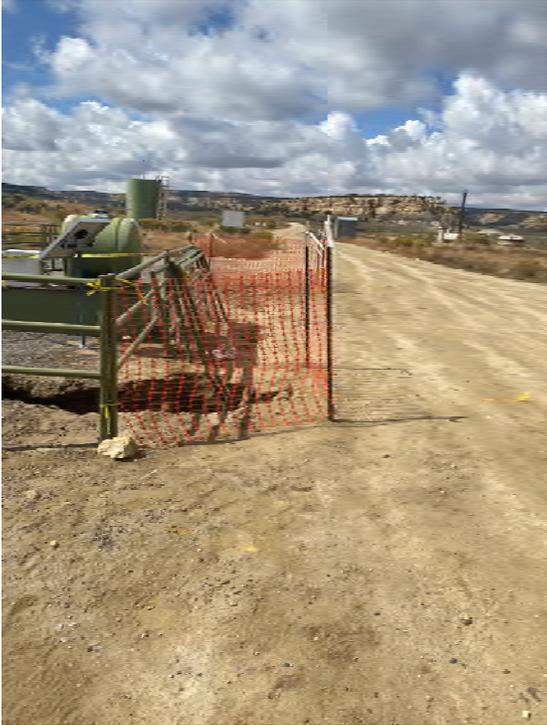
Photo No.	Date	
1	9/28/2021

View of excavated area where release breached containment. Area where SS33 was collected (looking west)

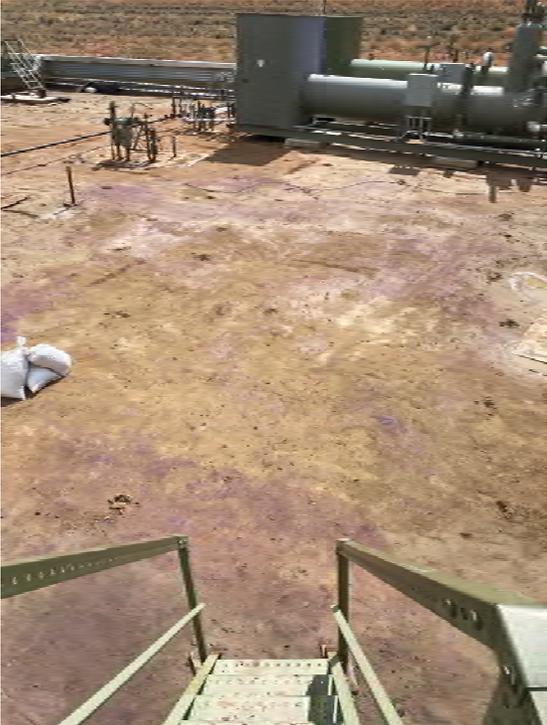
Photo No.	Date	
2	9/28/2021

View of the center of the release/excavation area within the containment, showing various soil sample locations (looking south).

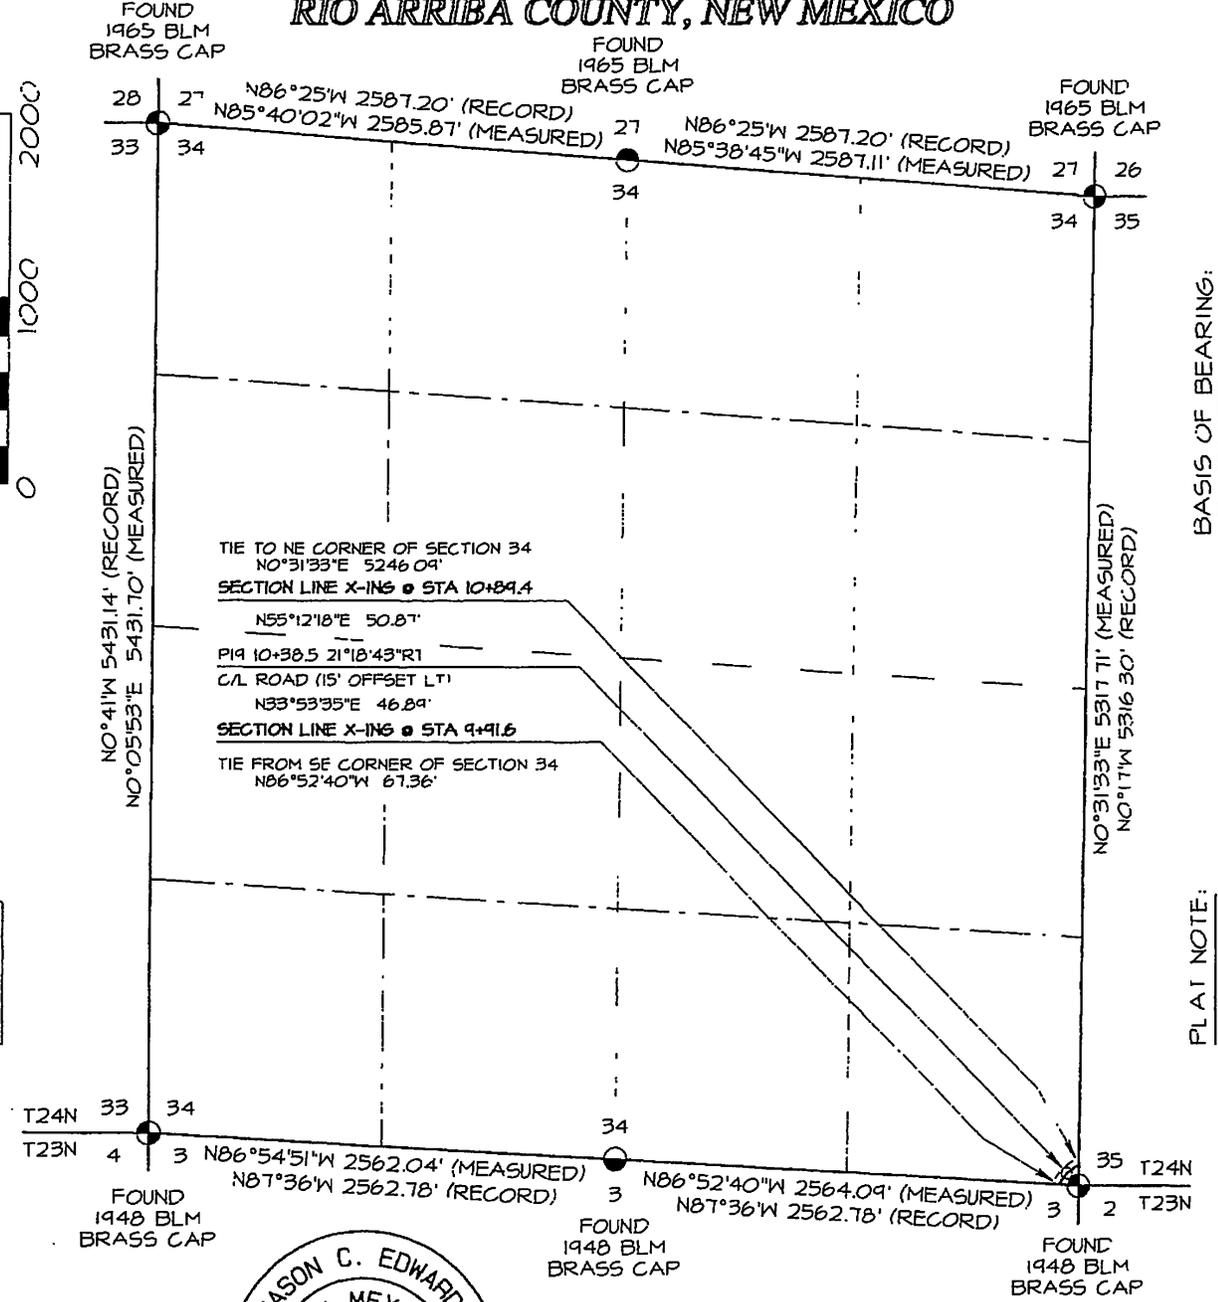
# WPX ENERGY PRODUCTION, LLC CHACO 7-35I #159H PROPOSED PIPELINE SURVEY LOCATED IN THE SE/4 SE/4 OF SECTION 34, T24N, R7W, N.M.P.M. RIO ARriba COUNTY, NEW MEXICO

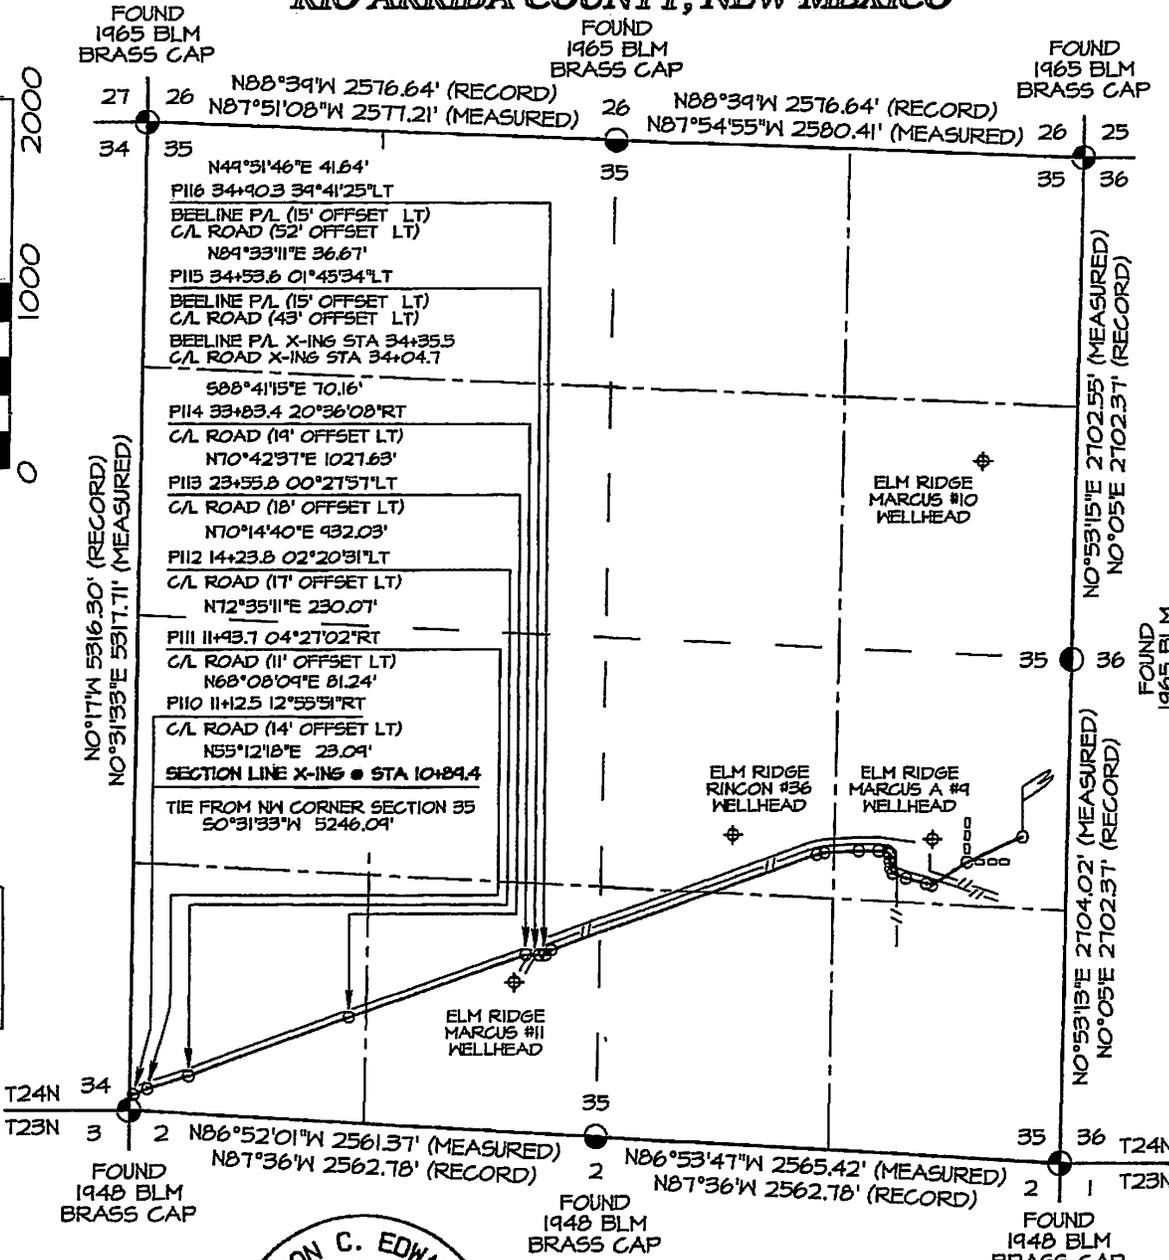
# WPX ENERGY PRODUCTION, LLC CHACO 27-35I #159H PROPOSED PIPELINE SURVEY LOCATED IN THE S/2 OF SECTION 35, T24N, R7W, N.M.P.M. RIO ARriba COUNTY, NEW MEXICO

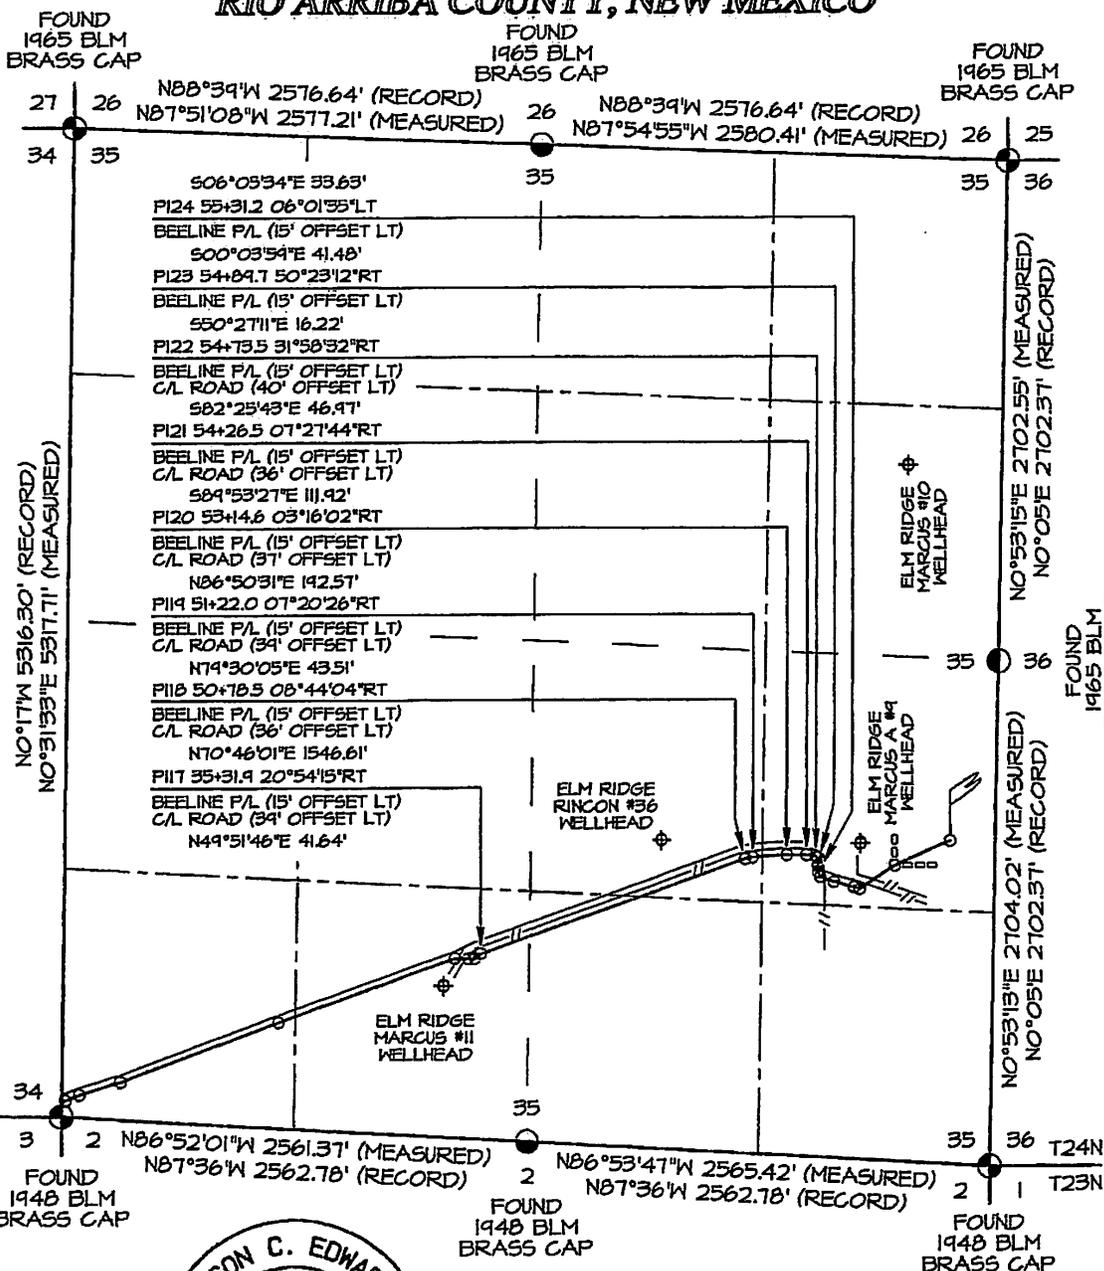
# WPX ENERGY PRODUCTION, LLC CHACO 2-17-35I #159H PROPOSED PIPELINE SURVEY LOCATED IN THE S/2 OF SECTION 35, T24N, R7W, N.M.P.M. RIO ARriba COUNTY, NEW MEXICO

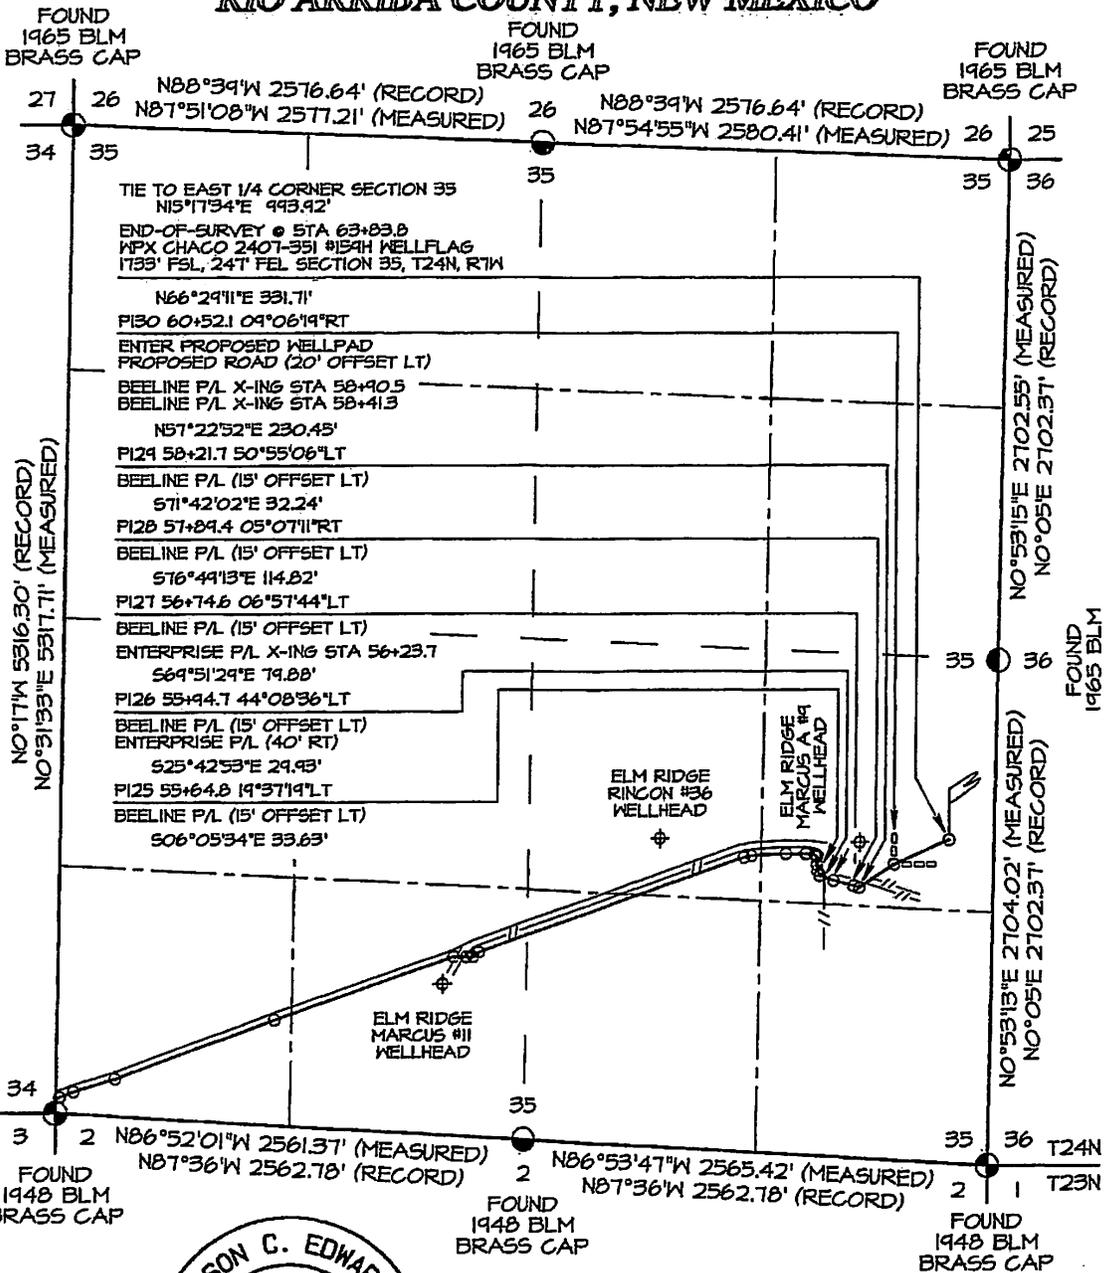
# WPX ENERGY PRODUCTION, LLC CHACO 2407-35I #159H PROPOSED PIPELINE SURVEY LOCATED IN THE S/2 OF SECTION 35, T24N, R7W, N.M.P.M. RIO ARriba COUNTY, NEW MEXICO
