Recycling Facility and/or Recycling Containment

RE: Closure Report for Quail Ranch Air Gap AST (1RF-450)

Appendix A: Closure Sampling at Quail Ranch Air Gap

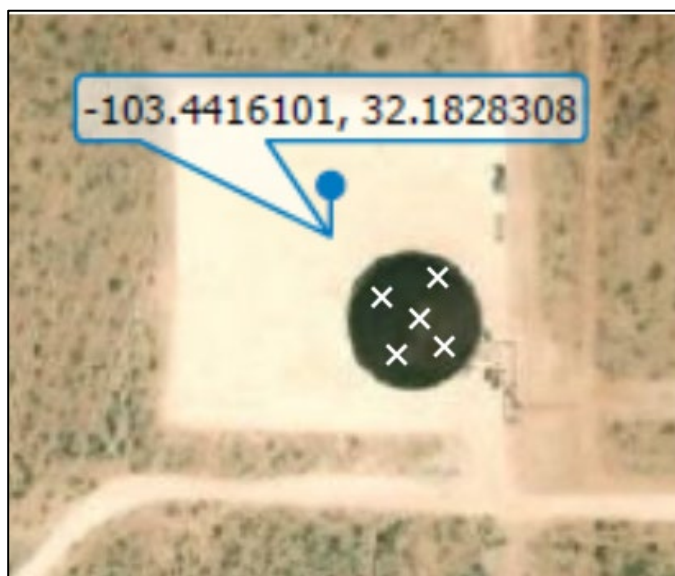
Auger 5 holes in “dice” pattern at site of former tank at N SE corner of pad to 4.3 ft BGS each.

The AST was approximately 140 ft in diameter as indicated in the image. Although the outline of the tank was not visible on the pad, directions from Solaris, the image to the right, and the size of the tank provide high confidence that all borings were within the tank footprint.
