RE: SWMU-1 Closure Plan
Western Refining Southwest LLC, D/B/A Marathon Gallup Refinery
(DBA Western Refining Southwest LLC)
EPA ID# NMD000333211

**WESTERN REFINING SOUTHWEST LLC, D/B/A
MARATHON GALLUP REFINERY
SWMU-1 CLOSURE PLAN
SEPTEMBER 22, 2021**

Trihydro Corporation (Trihydro) has prepared this Closure Plan (Plan) to address environmental impacts associated with Solid Waste Management Unit (SWMU) 1 at the Marathon Gallup Refinery (Refinery), owned and operated by Western Refining Southwest LLC. SWMU-1 consists of the former aeration lagoons (AL-1 and AL-2) and an evaporation pond (EP-1). Lagoons AL-1 and AL-2 were formerly operated as a biological treatment unit for the treatment of Refinery wastewater. This Plan describes the activities necessary to complete corrective action associated with AL-1 and AL-2 at the Refinery in 2022.

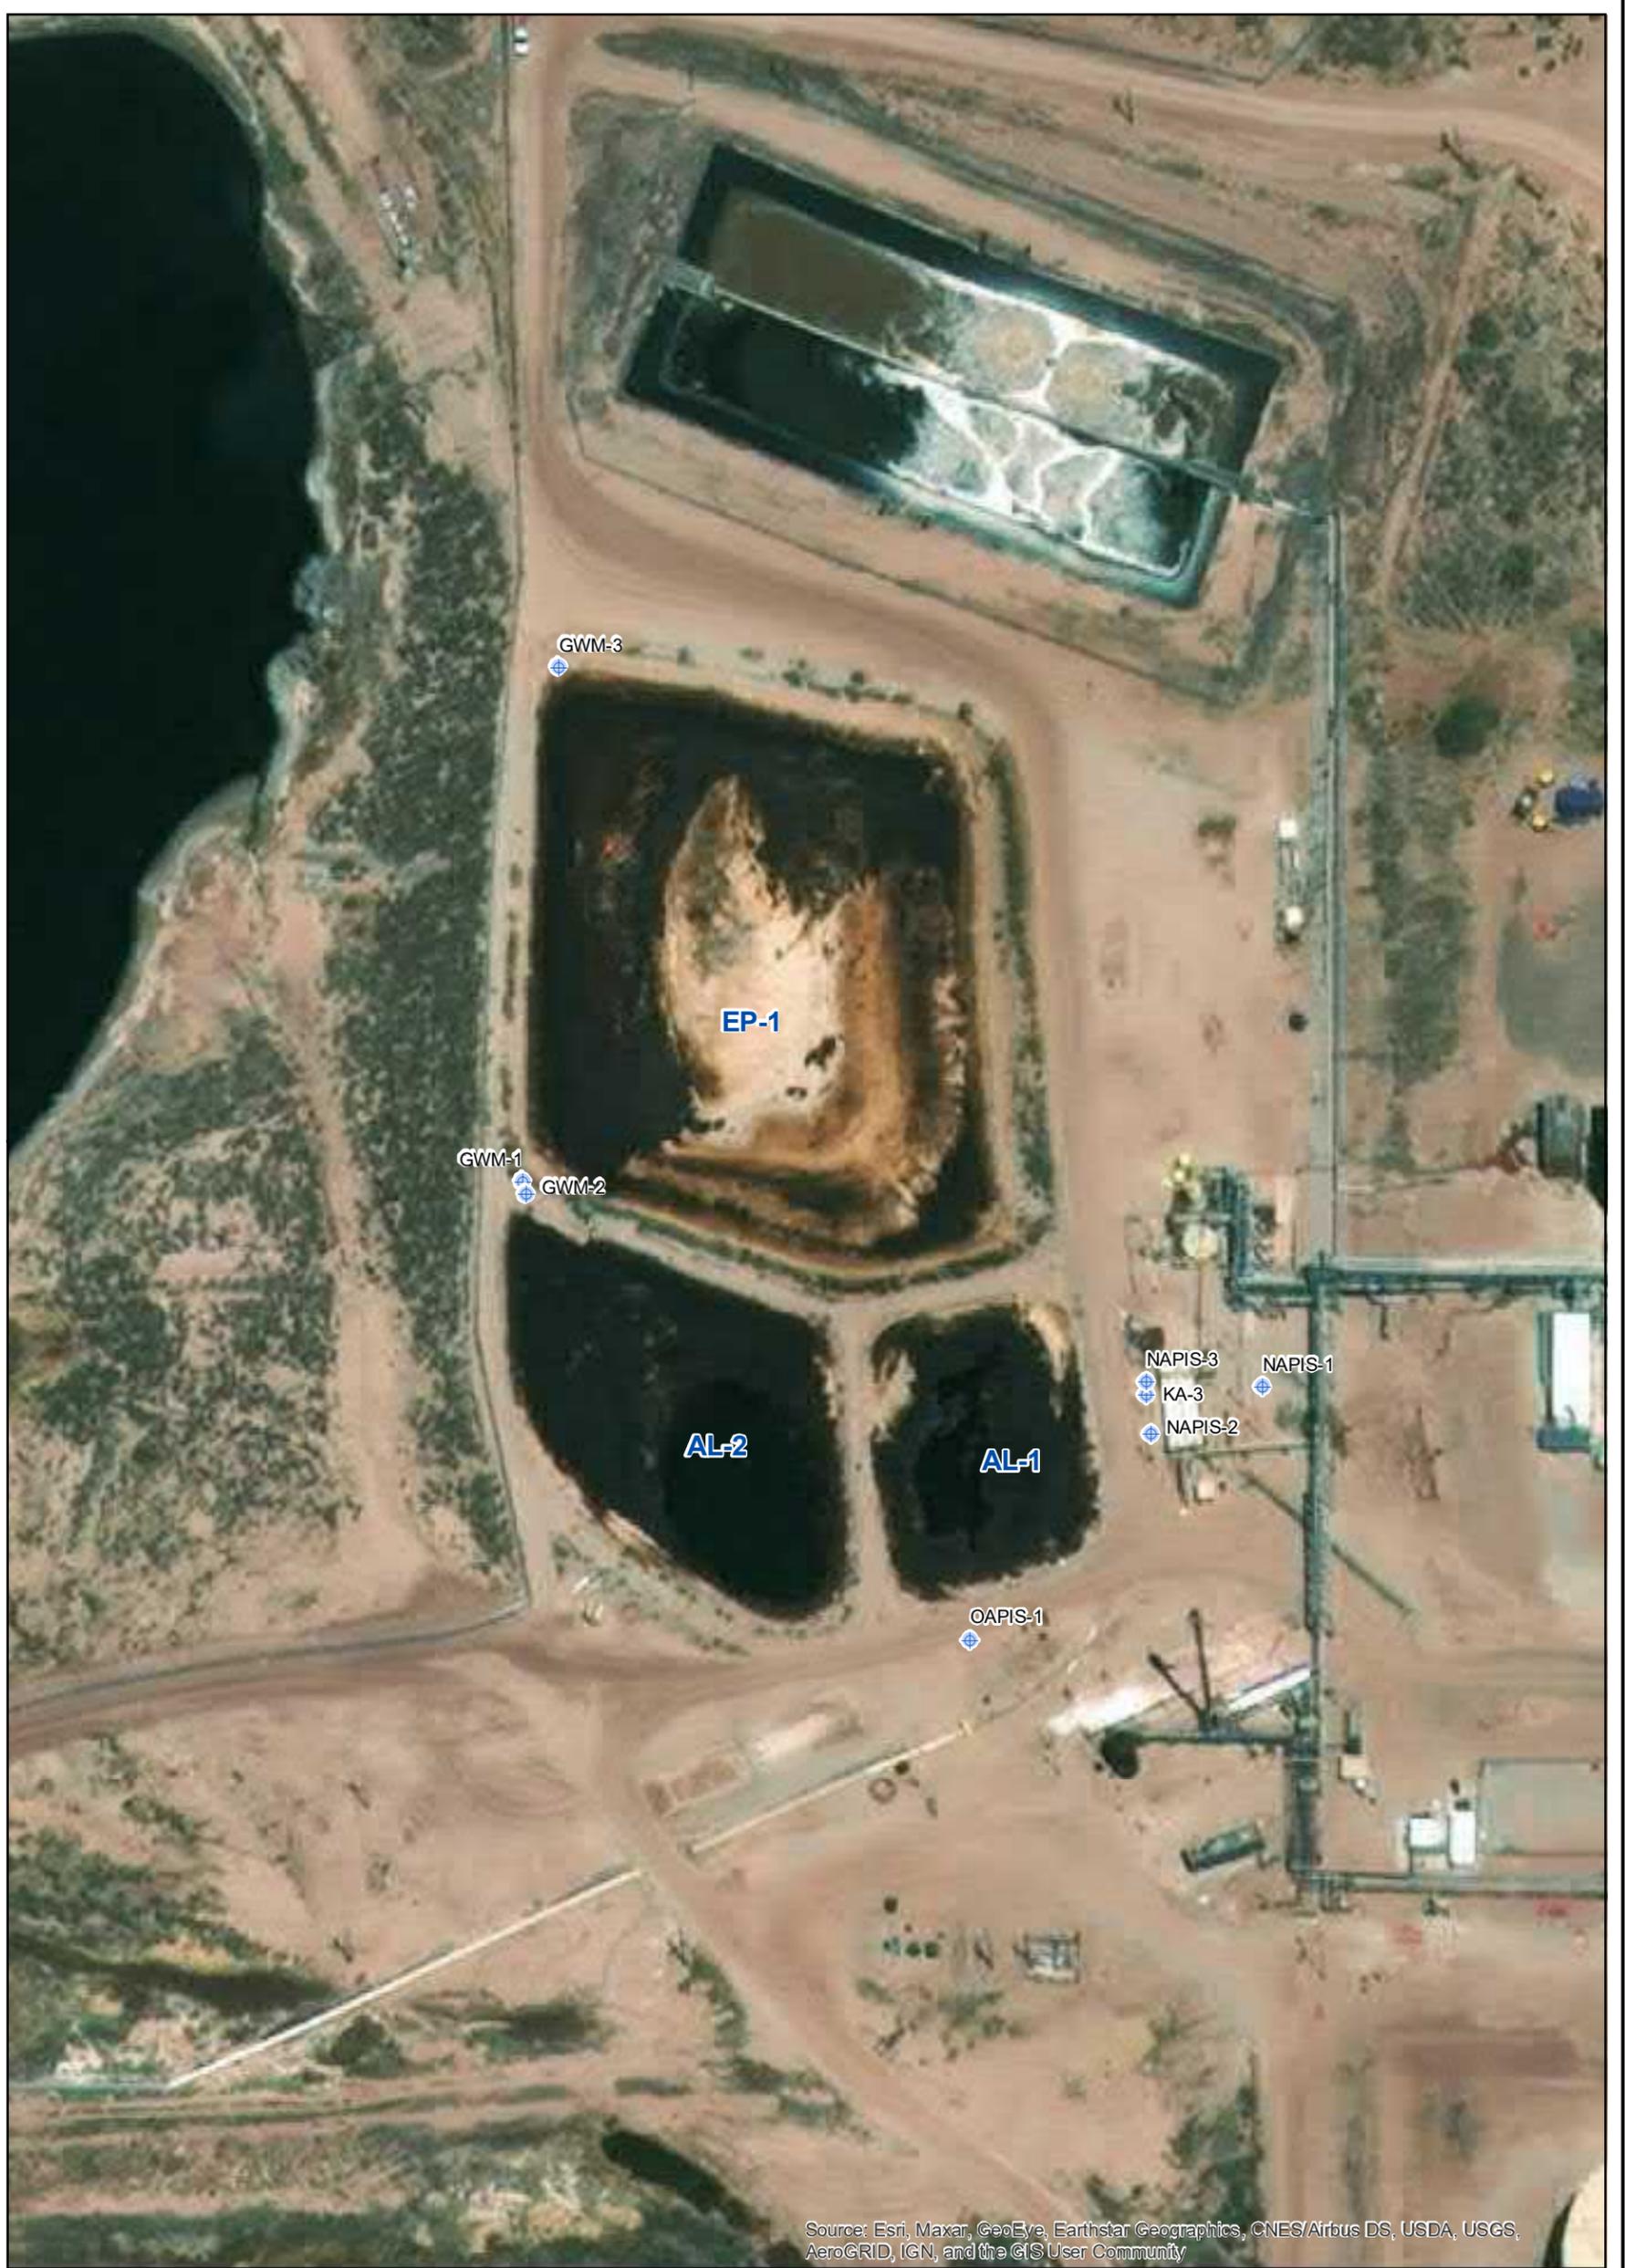
SWMU-1 consists of two former aeration lagoons (AL-1 and AL-2) and an evaporation pond (EP-1) (Figure 1-2). AL-1 and AL-2 were formerly operated as an aggressive biological treatment unit (ABTU) for the treatment of Refinery wastewater. Following ABTU treatment, water flowed by gravity to EP-1 for initial evaporation, followed by gravity flow to several downstream evaporation ponds, which are within SWMU-2 and are not a part of SWMU-1. SWMU-1 was constructed in 1987 and operated until 2013, when it was replaced by the current system, including a new aeration basin.

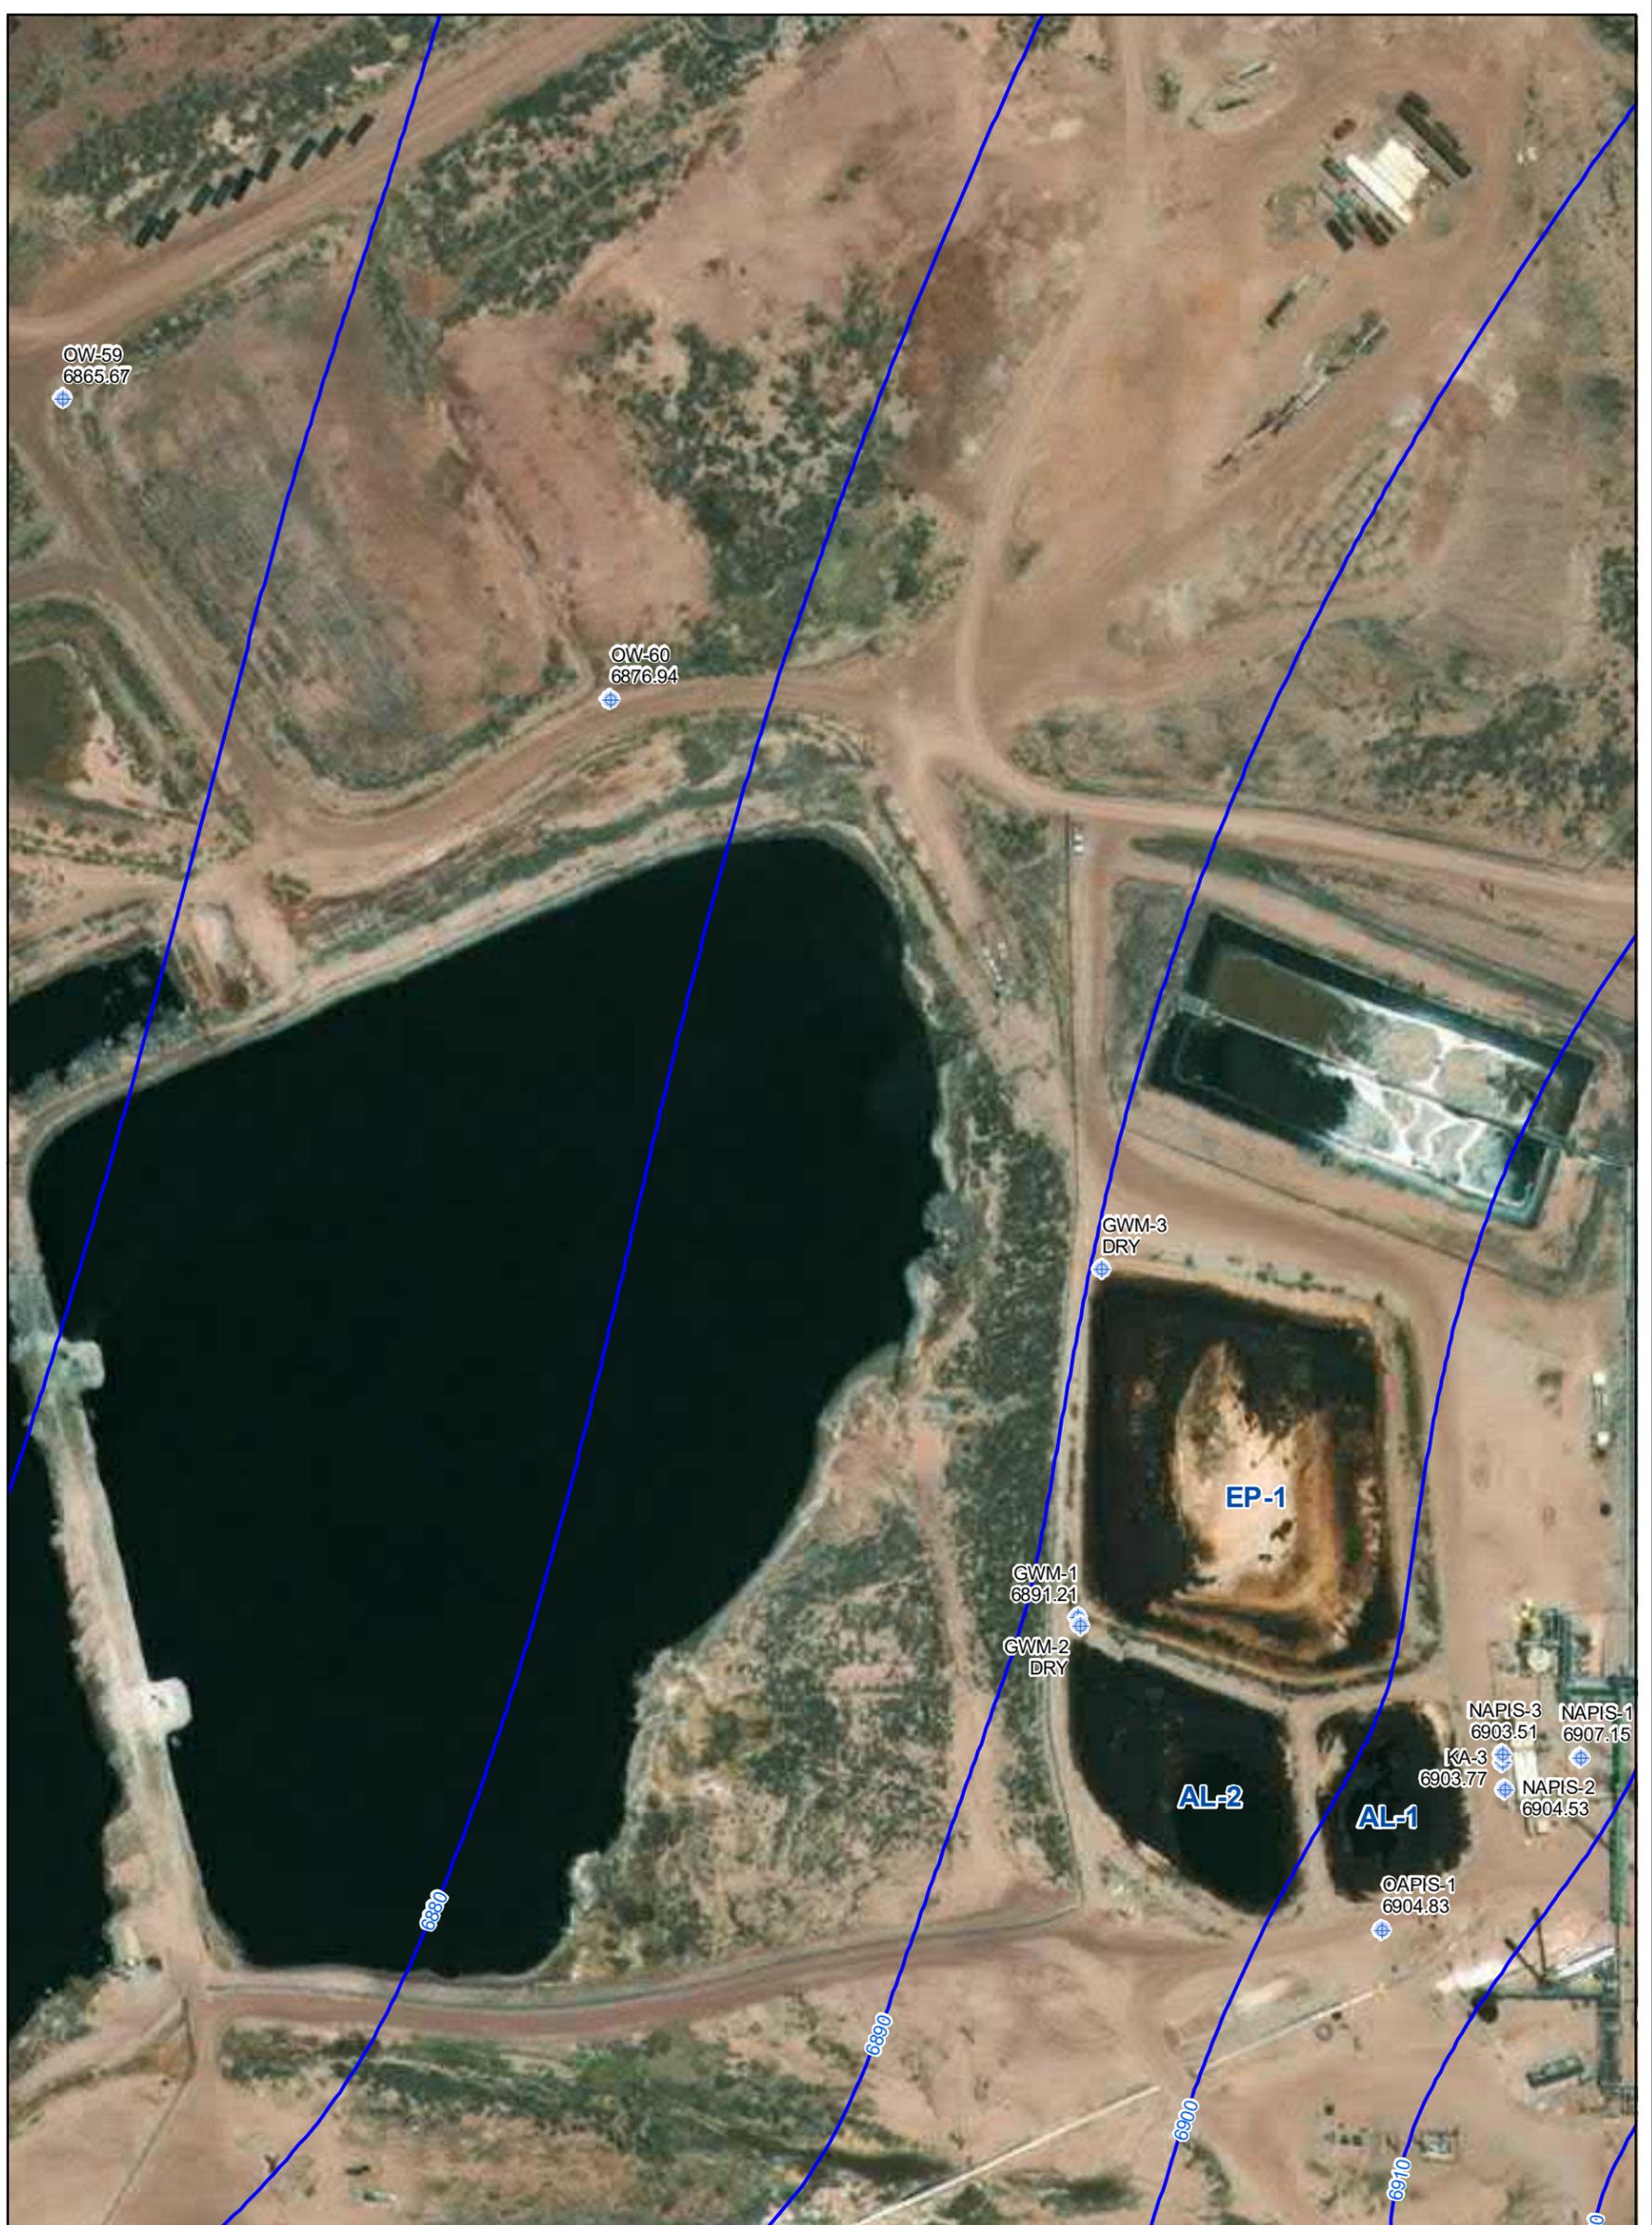
FIGURE 1-2

SWMU-1 consists of the former aeration lagoons, AL-1 and AL-2, and the evaporation pond, EP-1 (Figure 1-2). The lagoons and the pond are located in an area approximately 280 ft by 440 ft. AL-1 and AL-2 are approximately 0.3 acres and 0.5 acres, respectively, and EP-1 is approximately 1.3 acres. The Refinery's process wastewater treatment train historically consisted of an American Petroleum Institute separator, benzene air strippers, and an ABTU consisting of AL-1 and AL-2 in series, followed by evaporation in EP-1. AL-1, AL-2, and EP-1 are earthen surface impoundments with native clay functioning as a bottom liner (DiSorbo 2018).

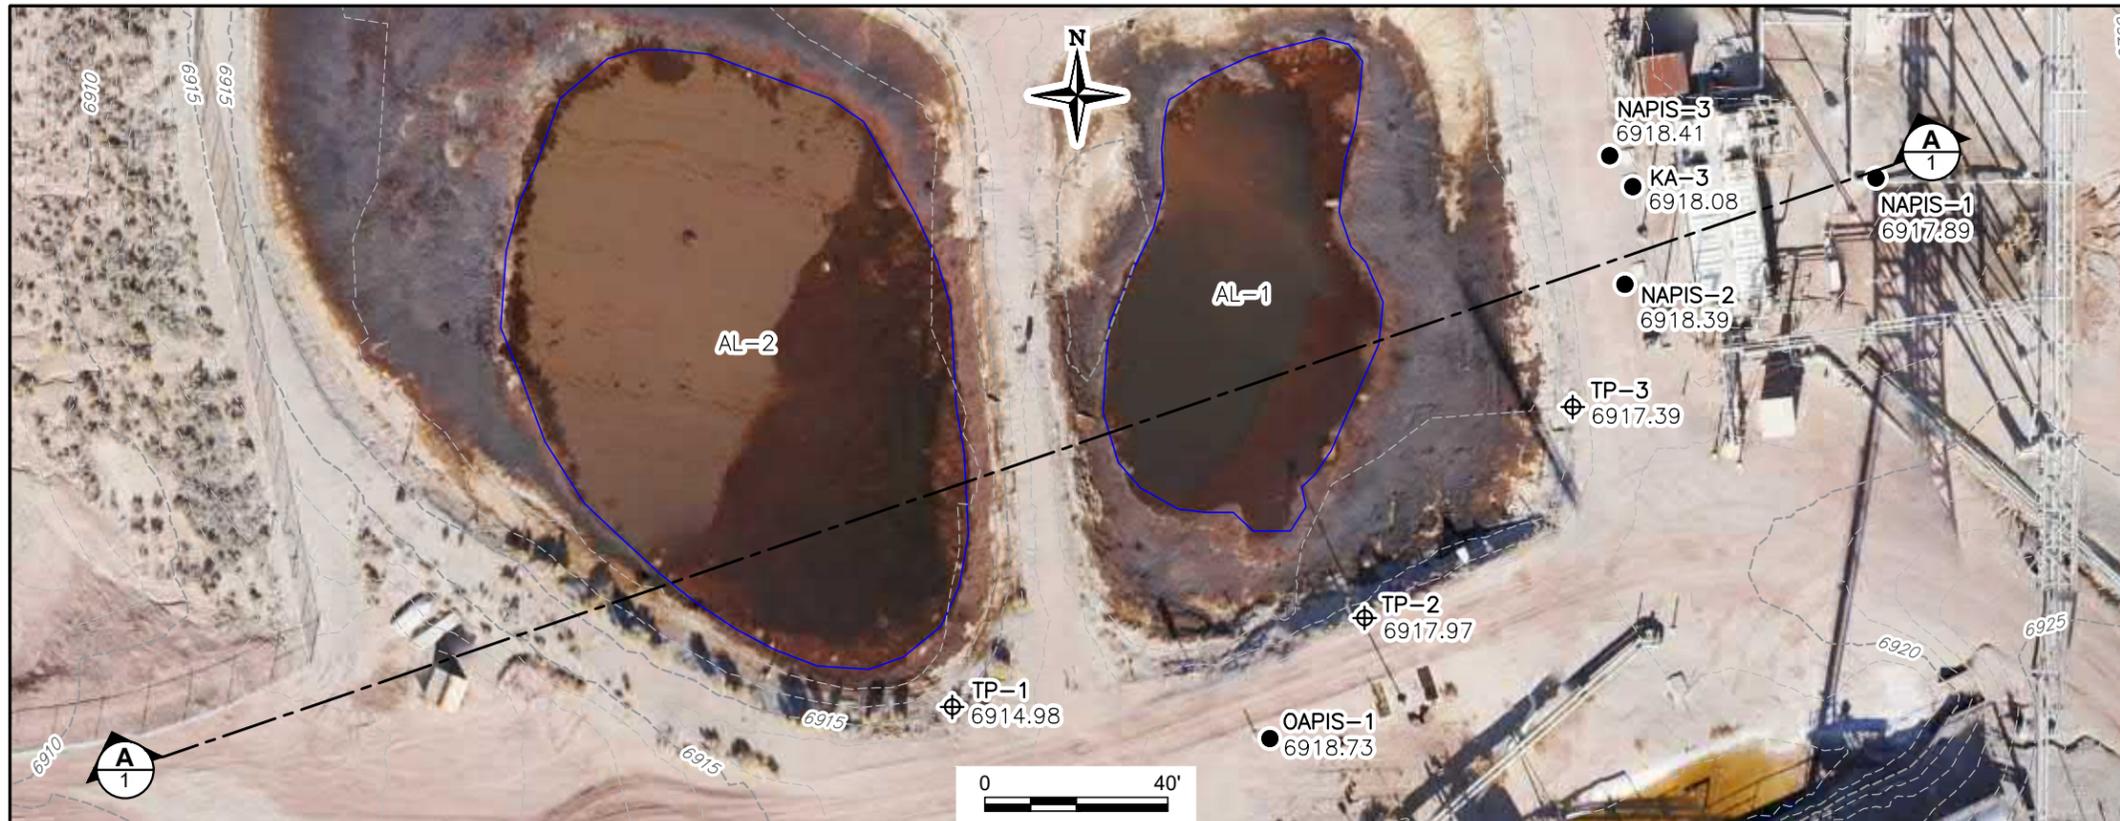
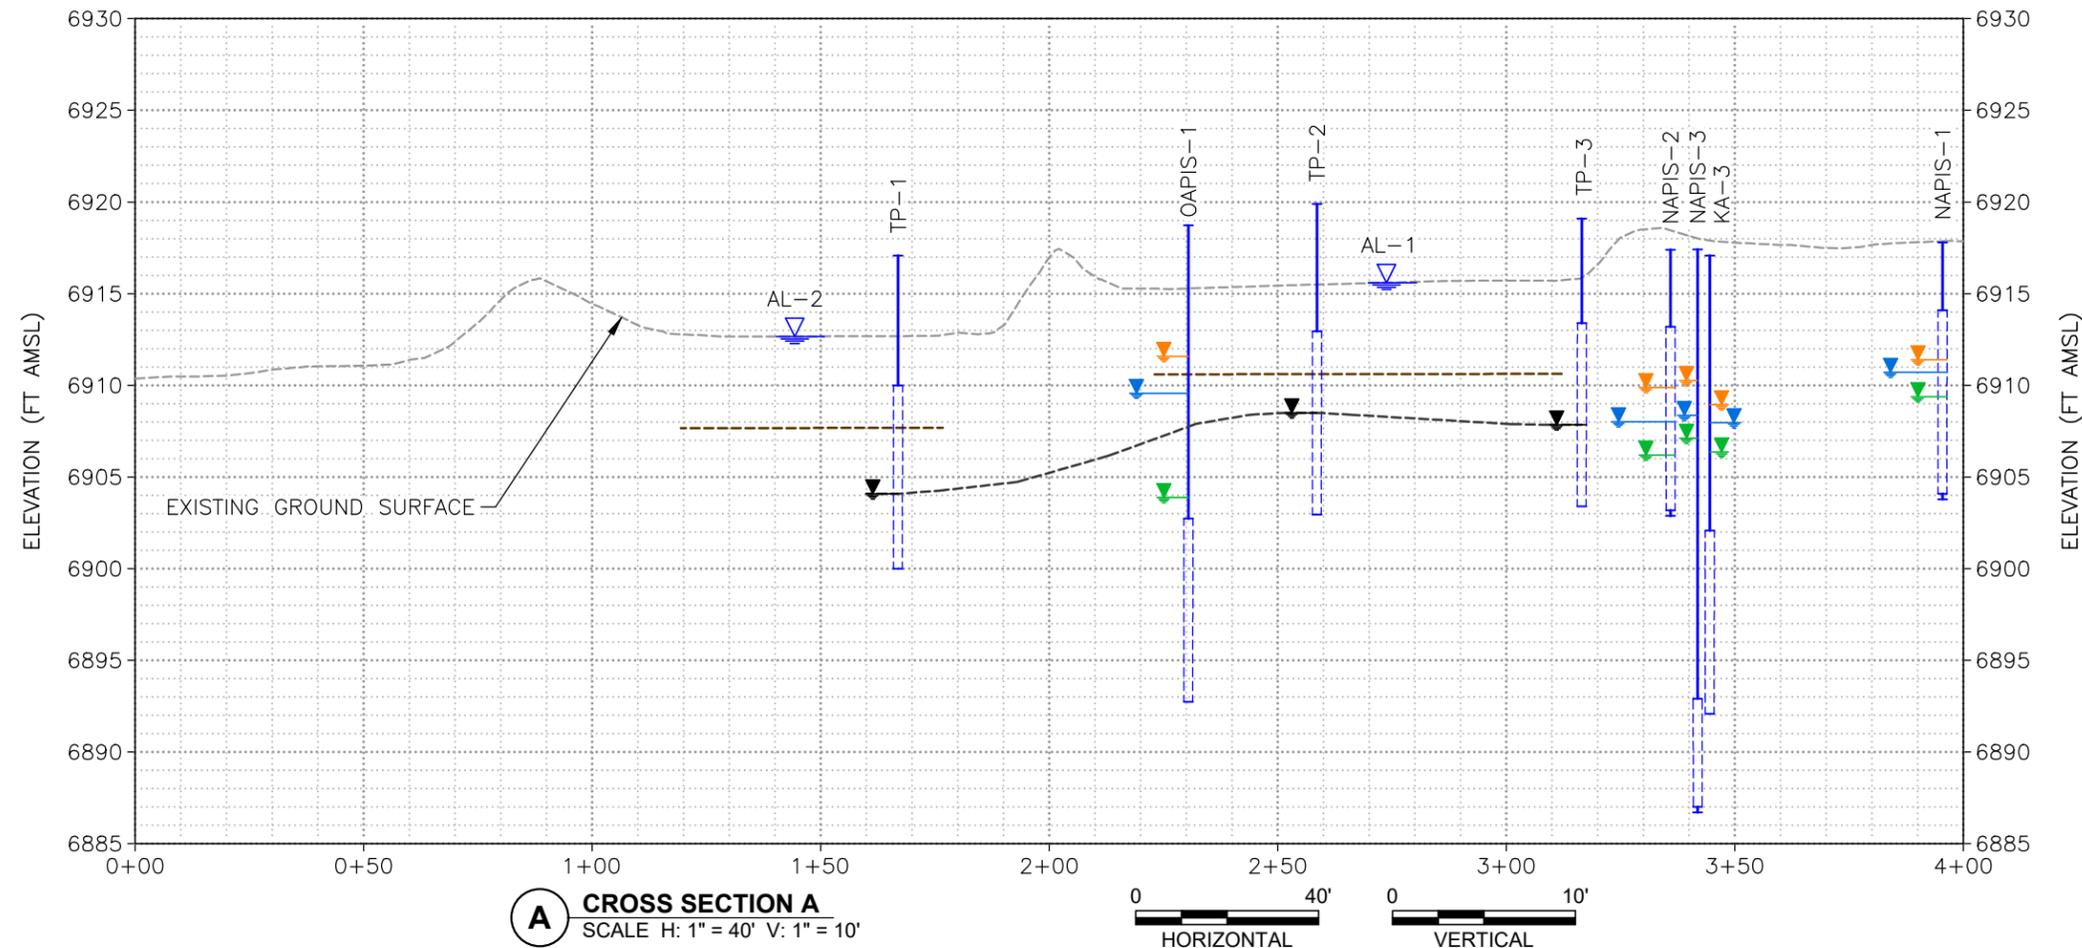
FIGURE	2-2	REV: -
--------	------------	--------

1 CROSS SECTION A PLAN VIEW
SCALE: 1" = 40'

SWMU 1 - AL-1 AND AL-2 CROSS SECTION
WESTERN REFINING SOUTHWEST, LLC
MARATHON GALLUP REFINERY
GALLUP, NEW MEXICO

The topographical data in Figure 2-2 are based on an unmanned aerial survey (UAS) flight conducted in November 2018 using Trihydro's UAS drone. The topographic elevation surface was generated from aerial imagery, with vertical accuracies of 0.1 to 0.2 ft in open areas. All groundwater levels were referenced to ground surface of the UAS survey, thereby providing a basis for comparison of groundwater elevations with respect to the surface water elevations in AL-1 and AL-2 observed in November 2018 during the UAS survey. The photograph on Figure 2-2 was taken at the same time as the ground survey and shows the extent of water

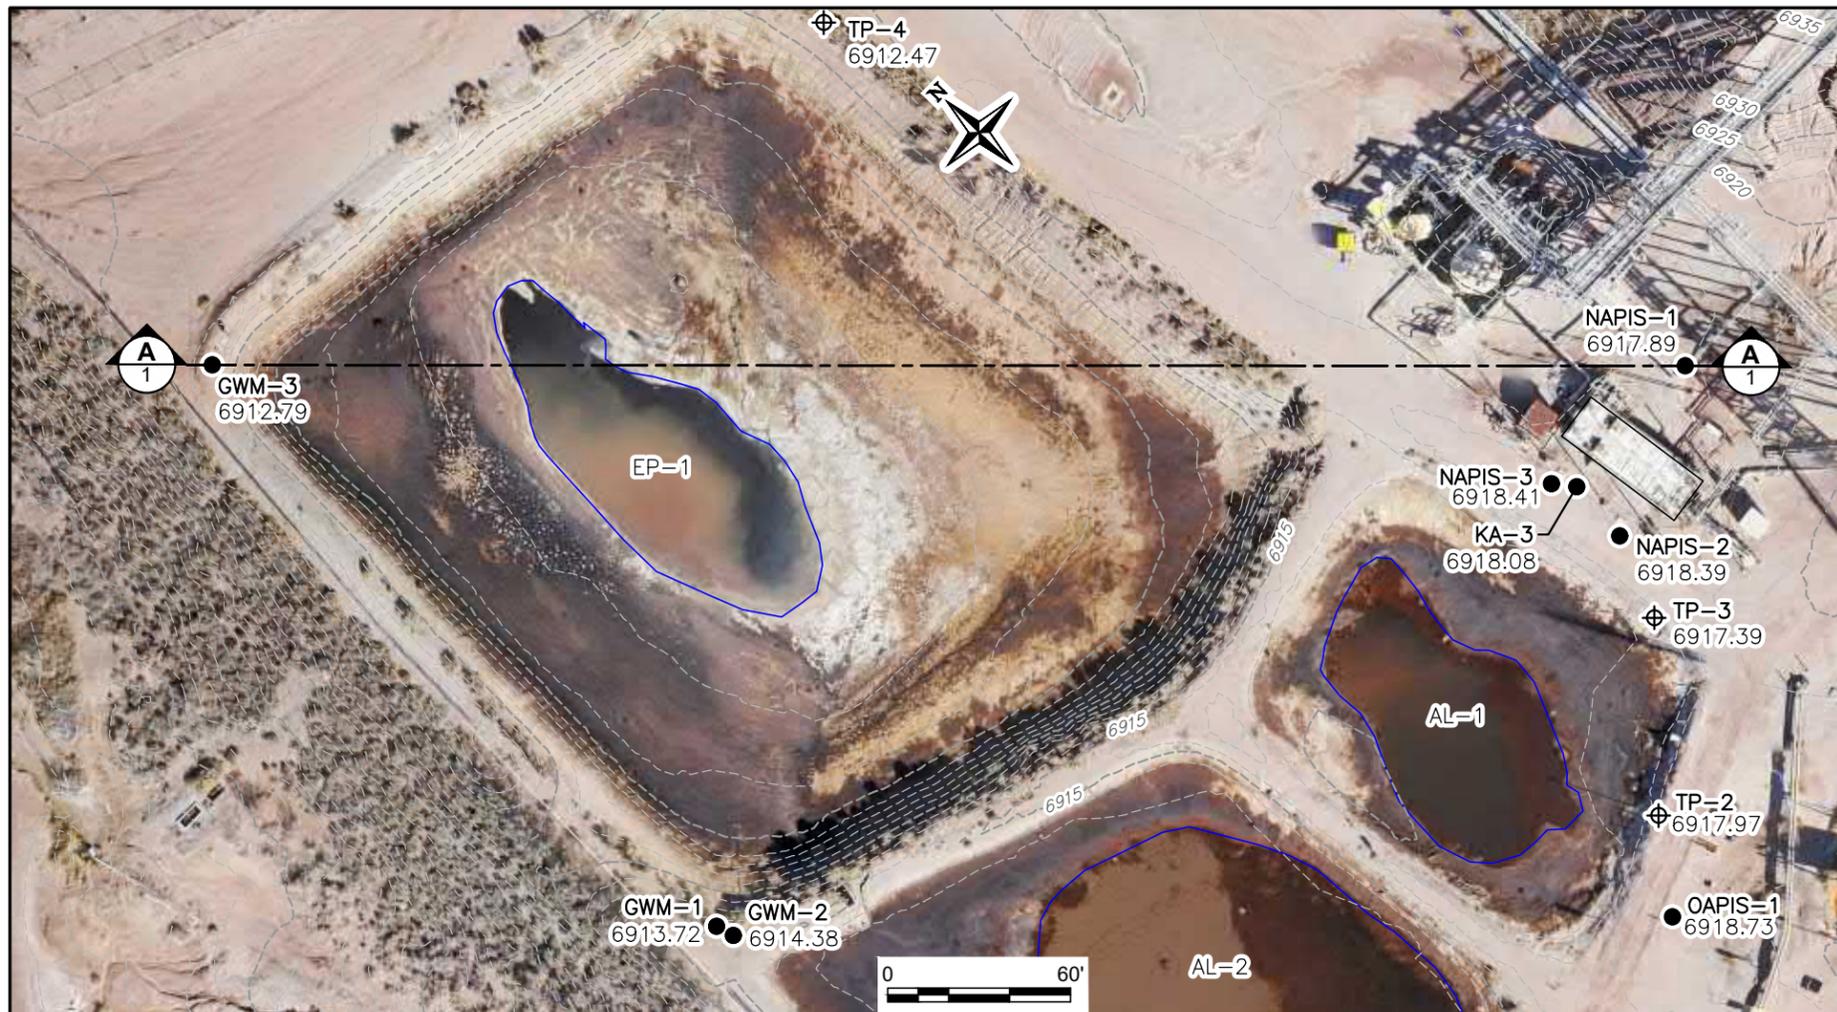
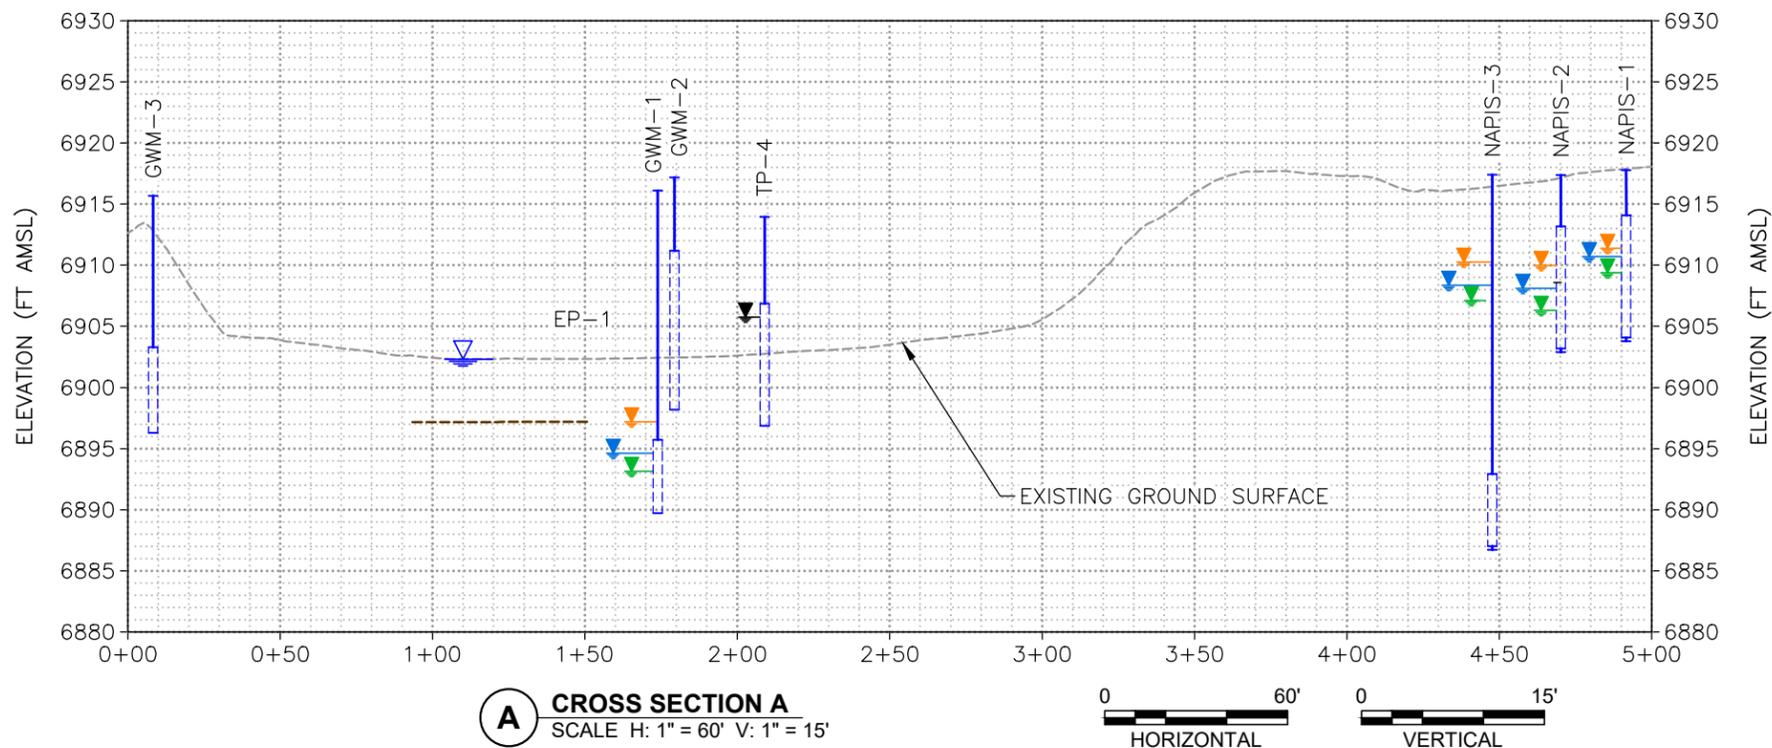
FIGURE	2-3	REV: -
--------	-----	--------

1 CROSS SECTION A PLAN VIEW
SCALE: 1" = 60'

A CROSS SECTION A
SCALE H: 1" = 60' V: 1" = 15'

A cross-section was also prepared for EP-1 (Figure 2-3). As shown in this figure, the water levels in nearby monitoring wells indicates the potential for groundwater seepage into EP-1. In particular, the water level at TP-4, located adjacent to EP-1, is higher in elevation than the EP-1 surface water level. The aerial photograph shown on Figure 2-3 dates from November 2018. EP-1 has been mostly dry for the past several years, but accumulates surface water during monsoon rain events, which then evaporates. Outside of precipitation events, the dry condition of EP-1 indicates that the evaporation rate exceeds any seepage rate of groundwater.

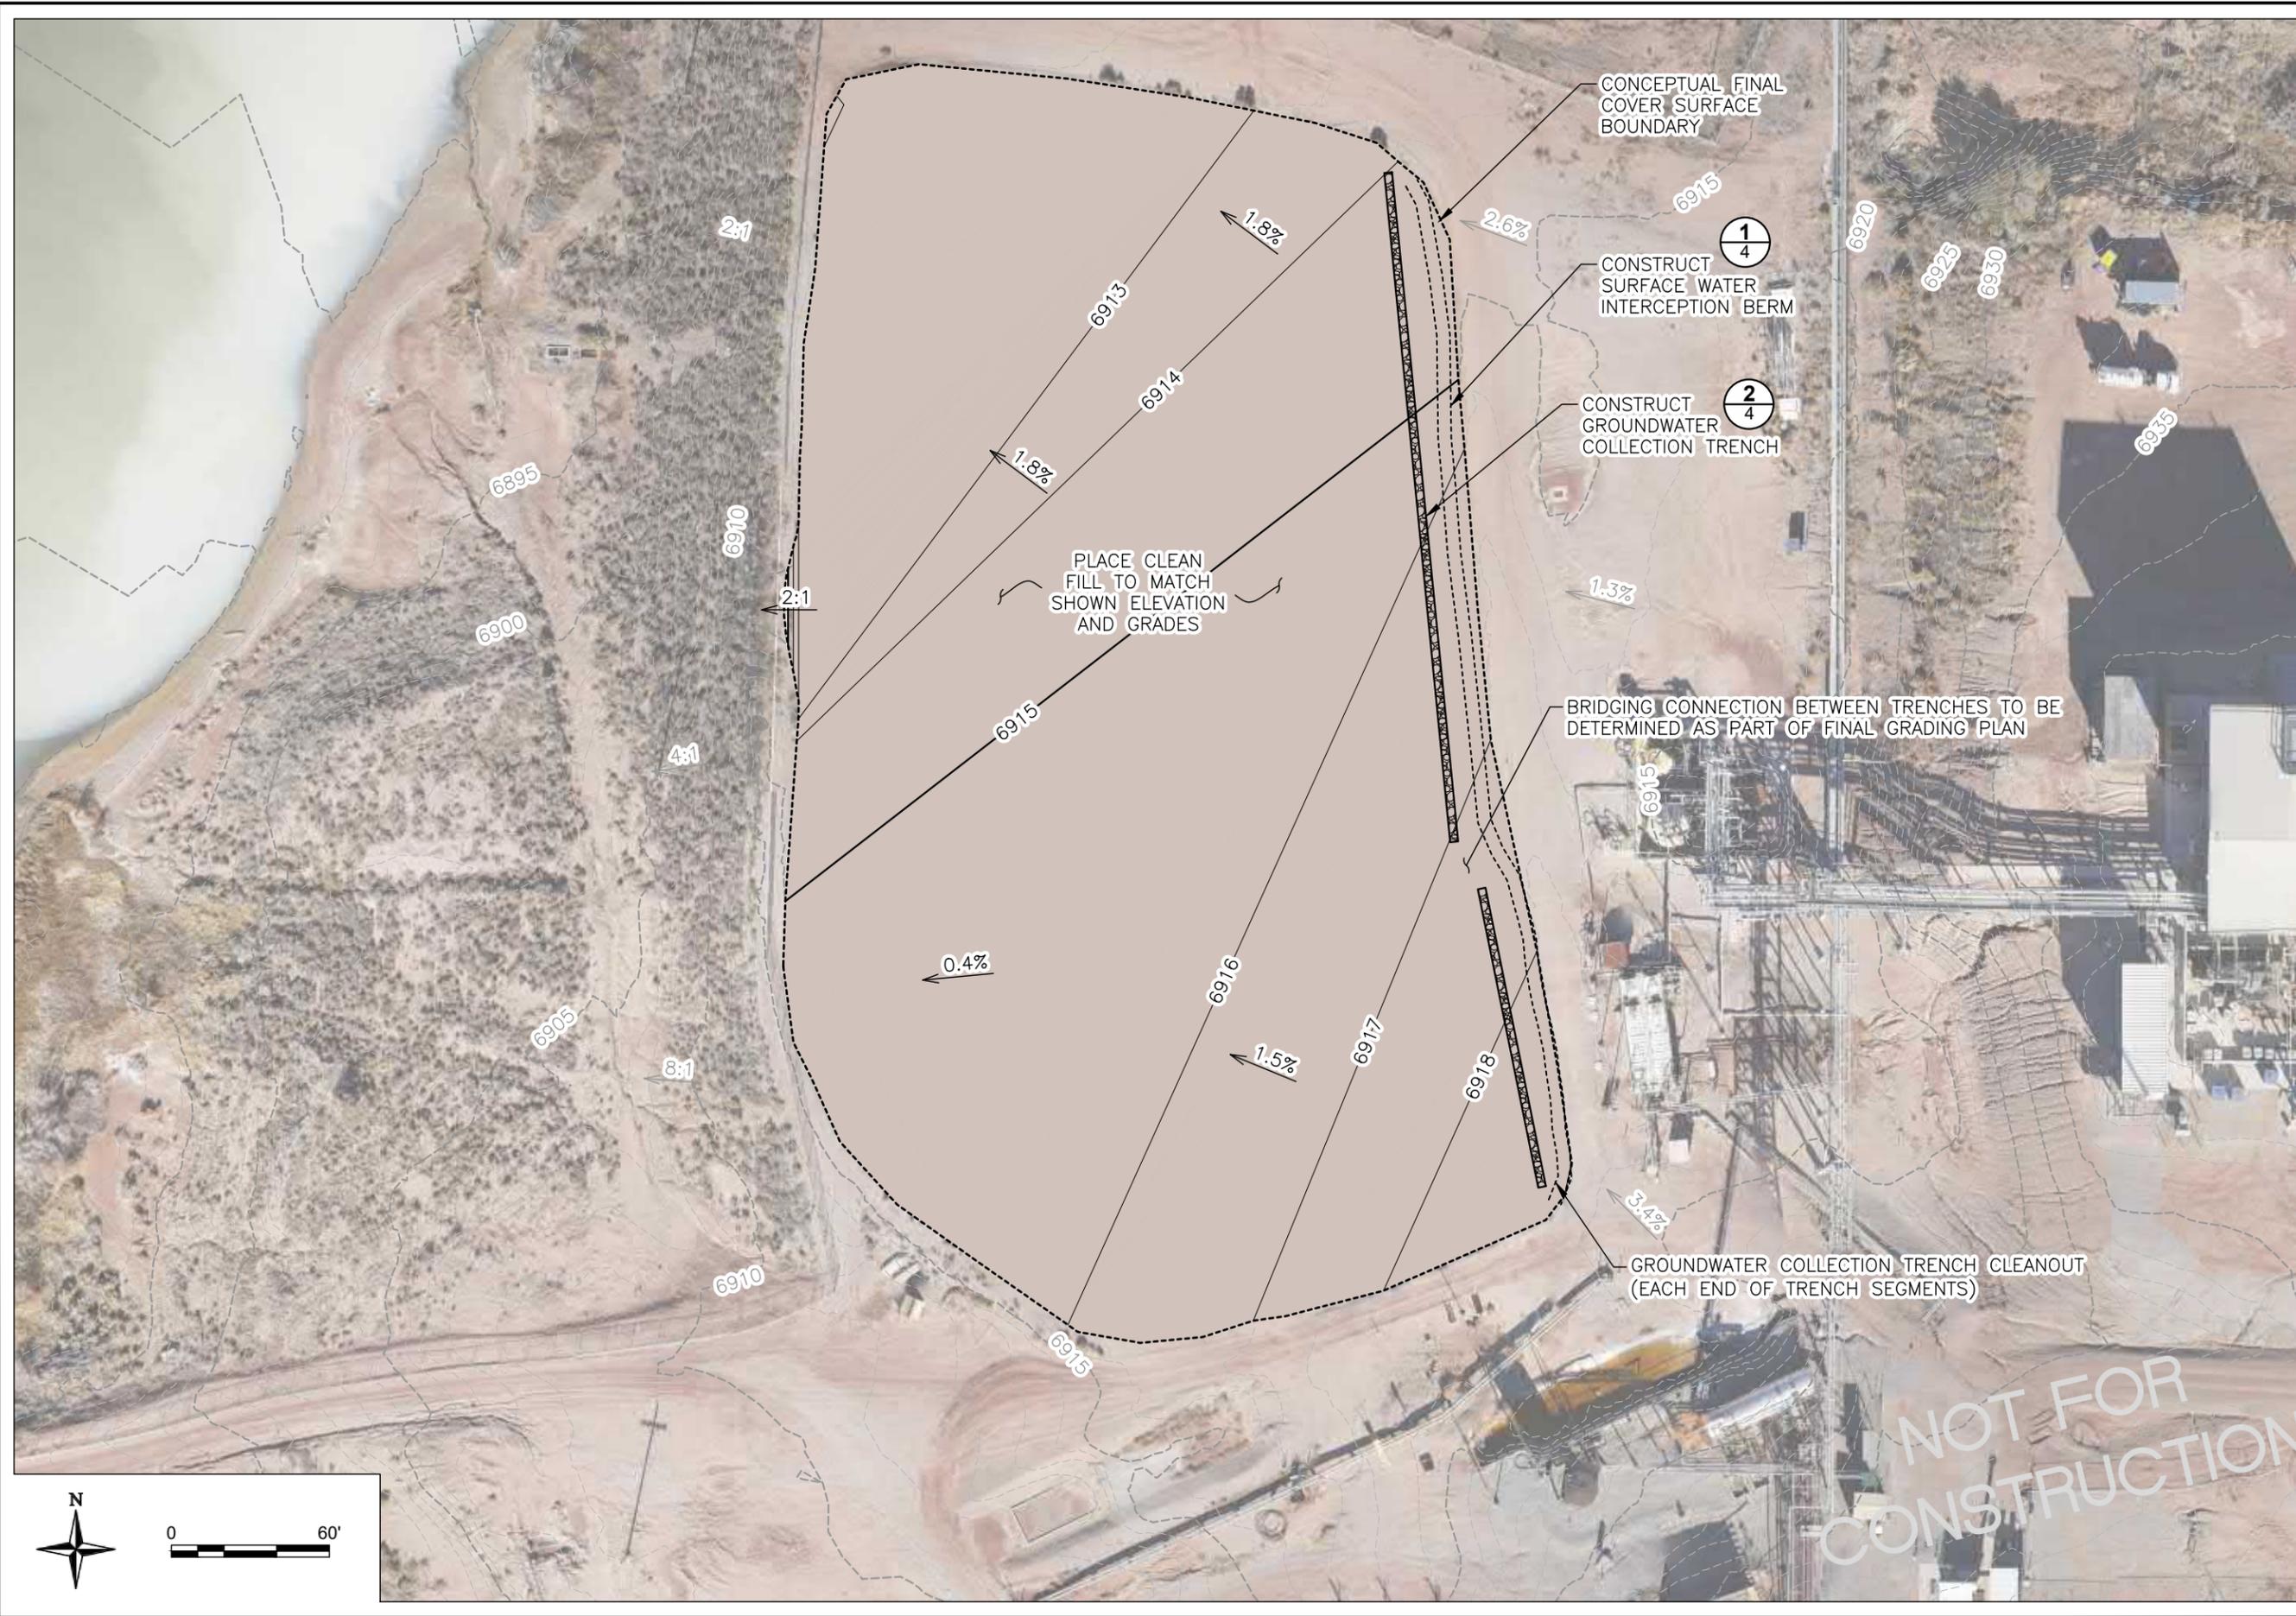
SHEET 3 3 OF 4 REV: A	CONCEPTUAL GRADING PLAN

Final grading of SWMU-1 will provide a relatively flat surface for potential future Refinery use while maintaining positive drainage to reduce ponding.

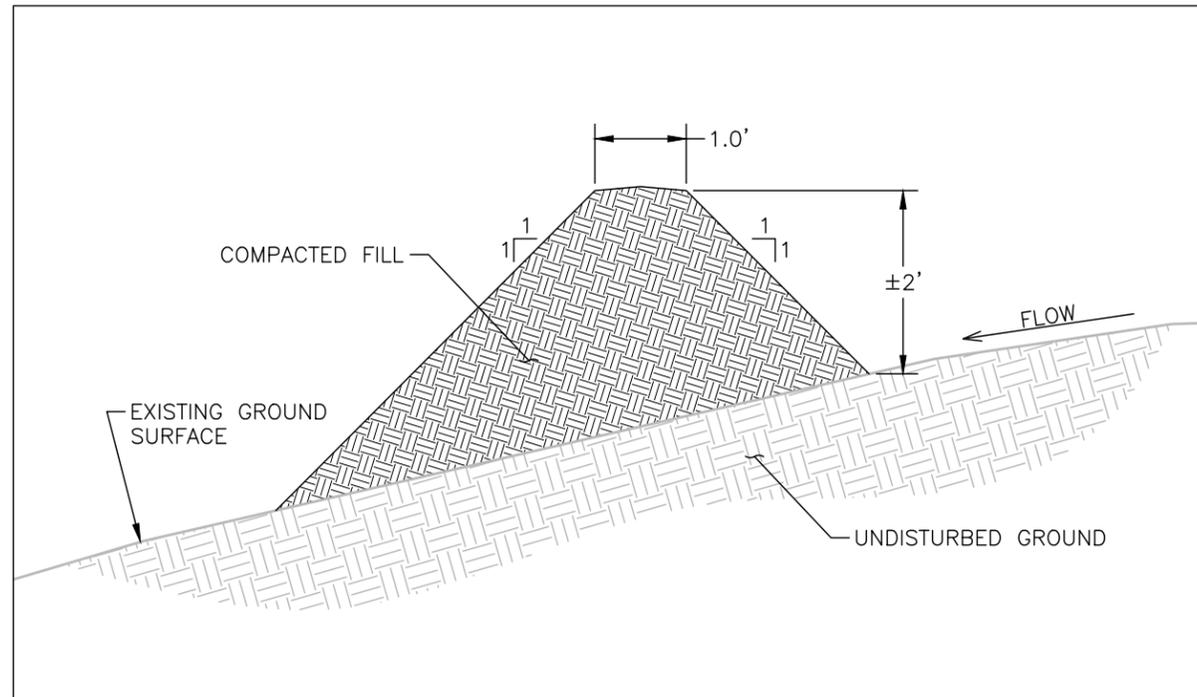
1 TYPICAL STORMWATER INTERCEPTOR BERM SECTION
SCALE: NONE

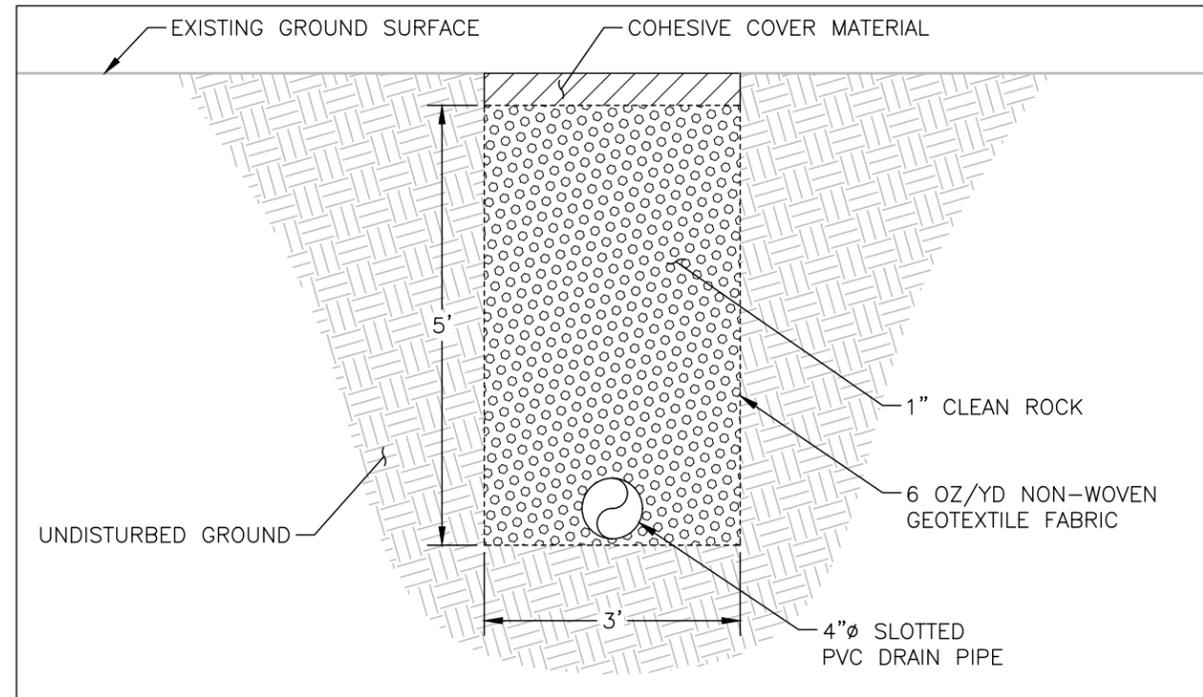
2 TYPICAL GROUNDWATER COLLECTION TRENCH SECTION
SCALE: NONE

The results of investigation activities at SWMU-1 indicate that groundwater seepage into SWMU-1 is unlikely for AL-1 and AL-2. For EP-1, the seepage potential is higher, but the currently observed dry conditions of EP-1 indicates that if present, the groundwater seepage rate is very low. Should seepage occur into any excavation, typical construction water management methods, such as sumps or drainage ditches will be utilized to collect water for treatment through the Refinery WWTP.

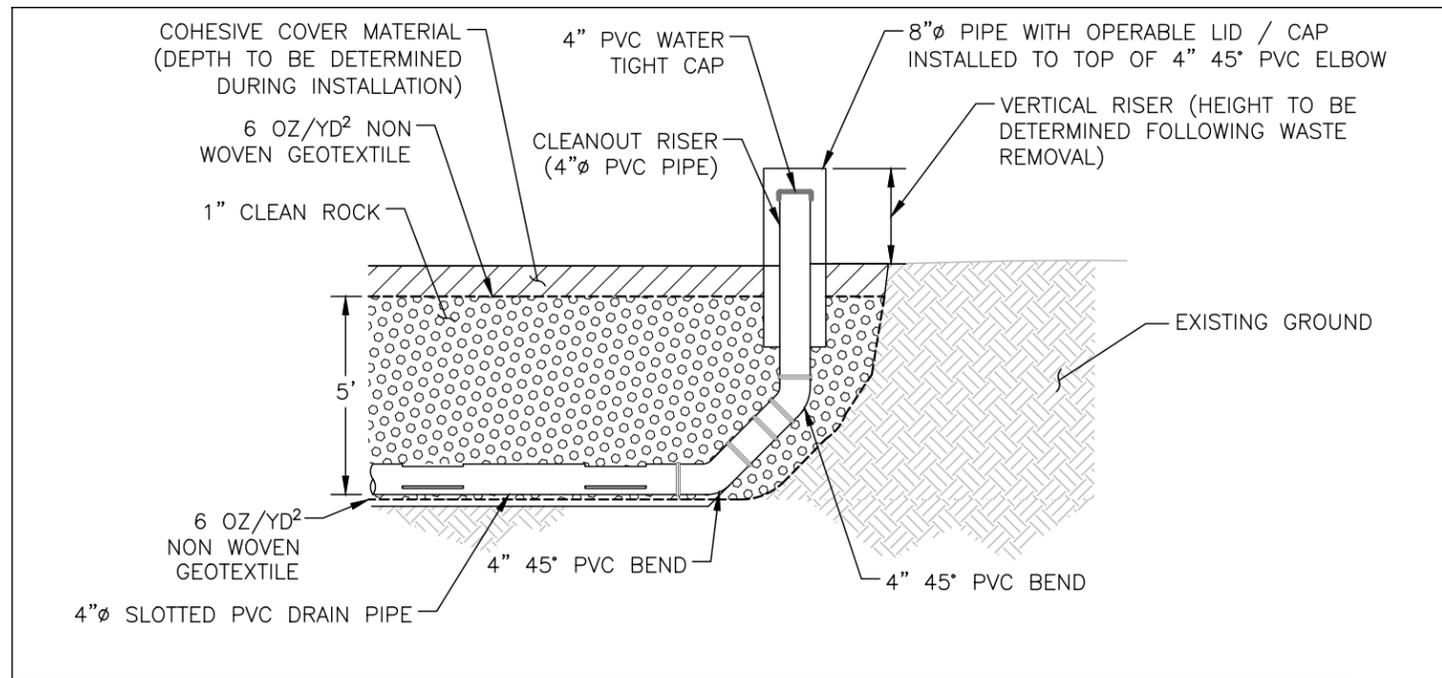
3 CLEANOUT DETAIL
SCALE: NONE

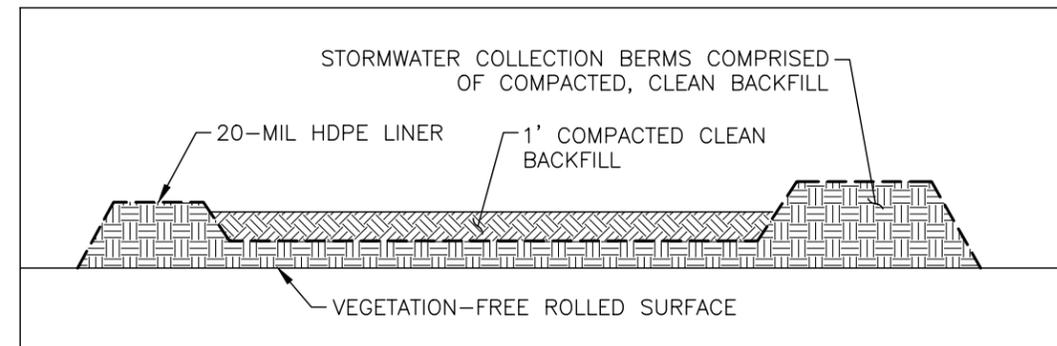
4 WASTE MANAGEMENT AREA SECTION
SCALE: NONE

A decontamination (decon) area will be required at the lagoons loadout area to prevent the spread of excavated waste. Waste loadout (e.g., into roll-off containers) will be performed in such a manner to reduce the amount of waste contacting the exterior of the container or truck body. Loose waste will be removed from container exteriors via brooms or with water spray if necessary. Decon pads will be graded such that removed waste is conveyed into sumps for removal via backhoe for management and disposal.
