**RE: Heat Exchanger Bundle Pad Investigation Report  
Western Refining Southwest LLC, D/B/A Marathon Gallup Refinery  
EPA ID #NMD000333211  
HWB-WRG-21-013**

# Heat Exchanger Bundle Pad Investigation Report

## Heat Exchanger Bundle Pad Investigation Report

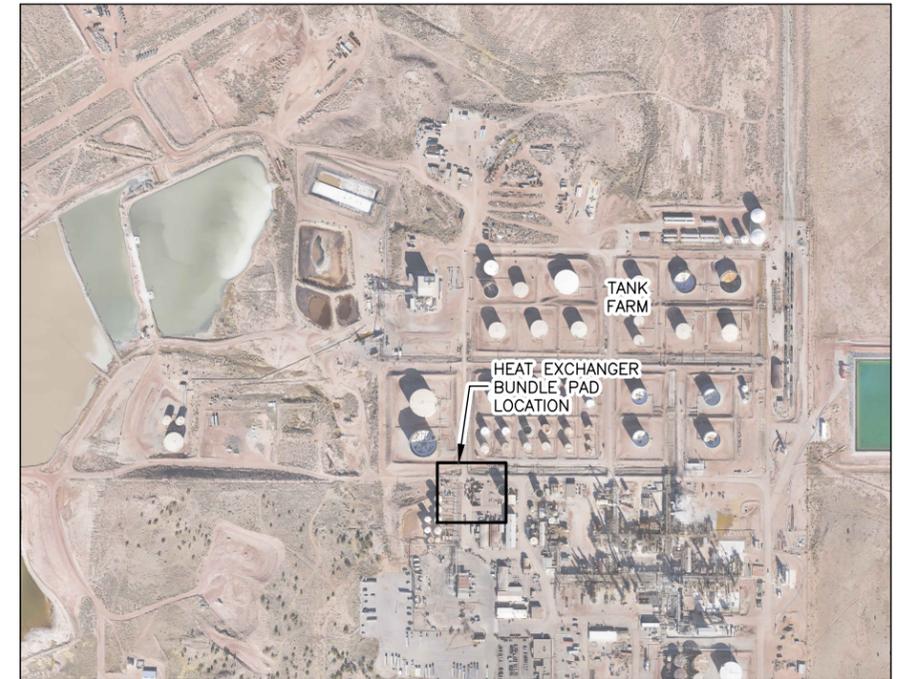
**1 KEY MAP**  
SCALE: 1" = 800'

The Bundle Pad is located north of the truck loading rack, northwest of the process units, and southwest of the tank farm (Figure 1). The Bundle Pad is within the Solid Waste Management Unit (SWMU) 3 which was combined with the Empty Container Storage Area during the 2010-2013 Resource Conservation and Recovery Act (RCRA) Permit renewal (RPS 2014).

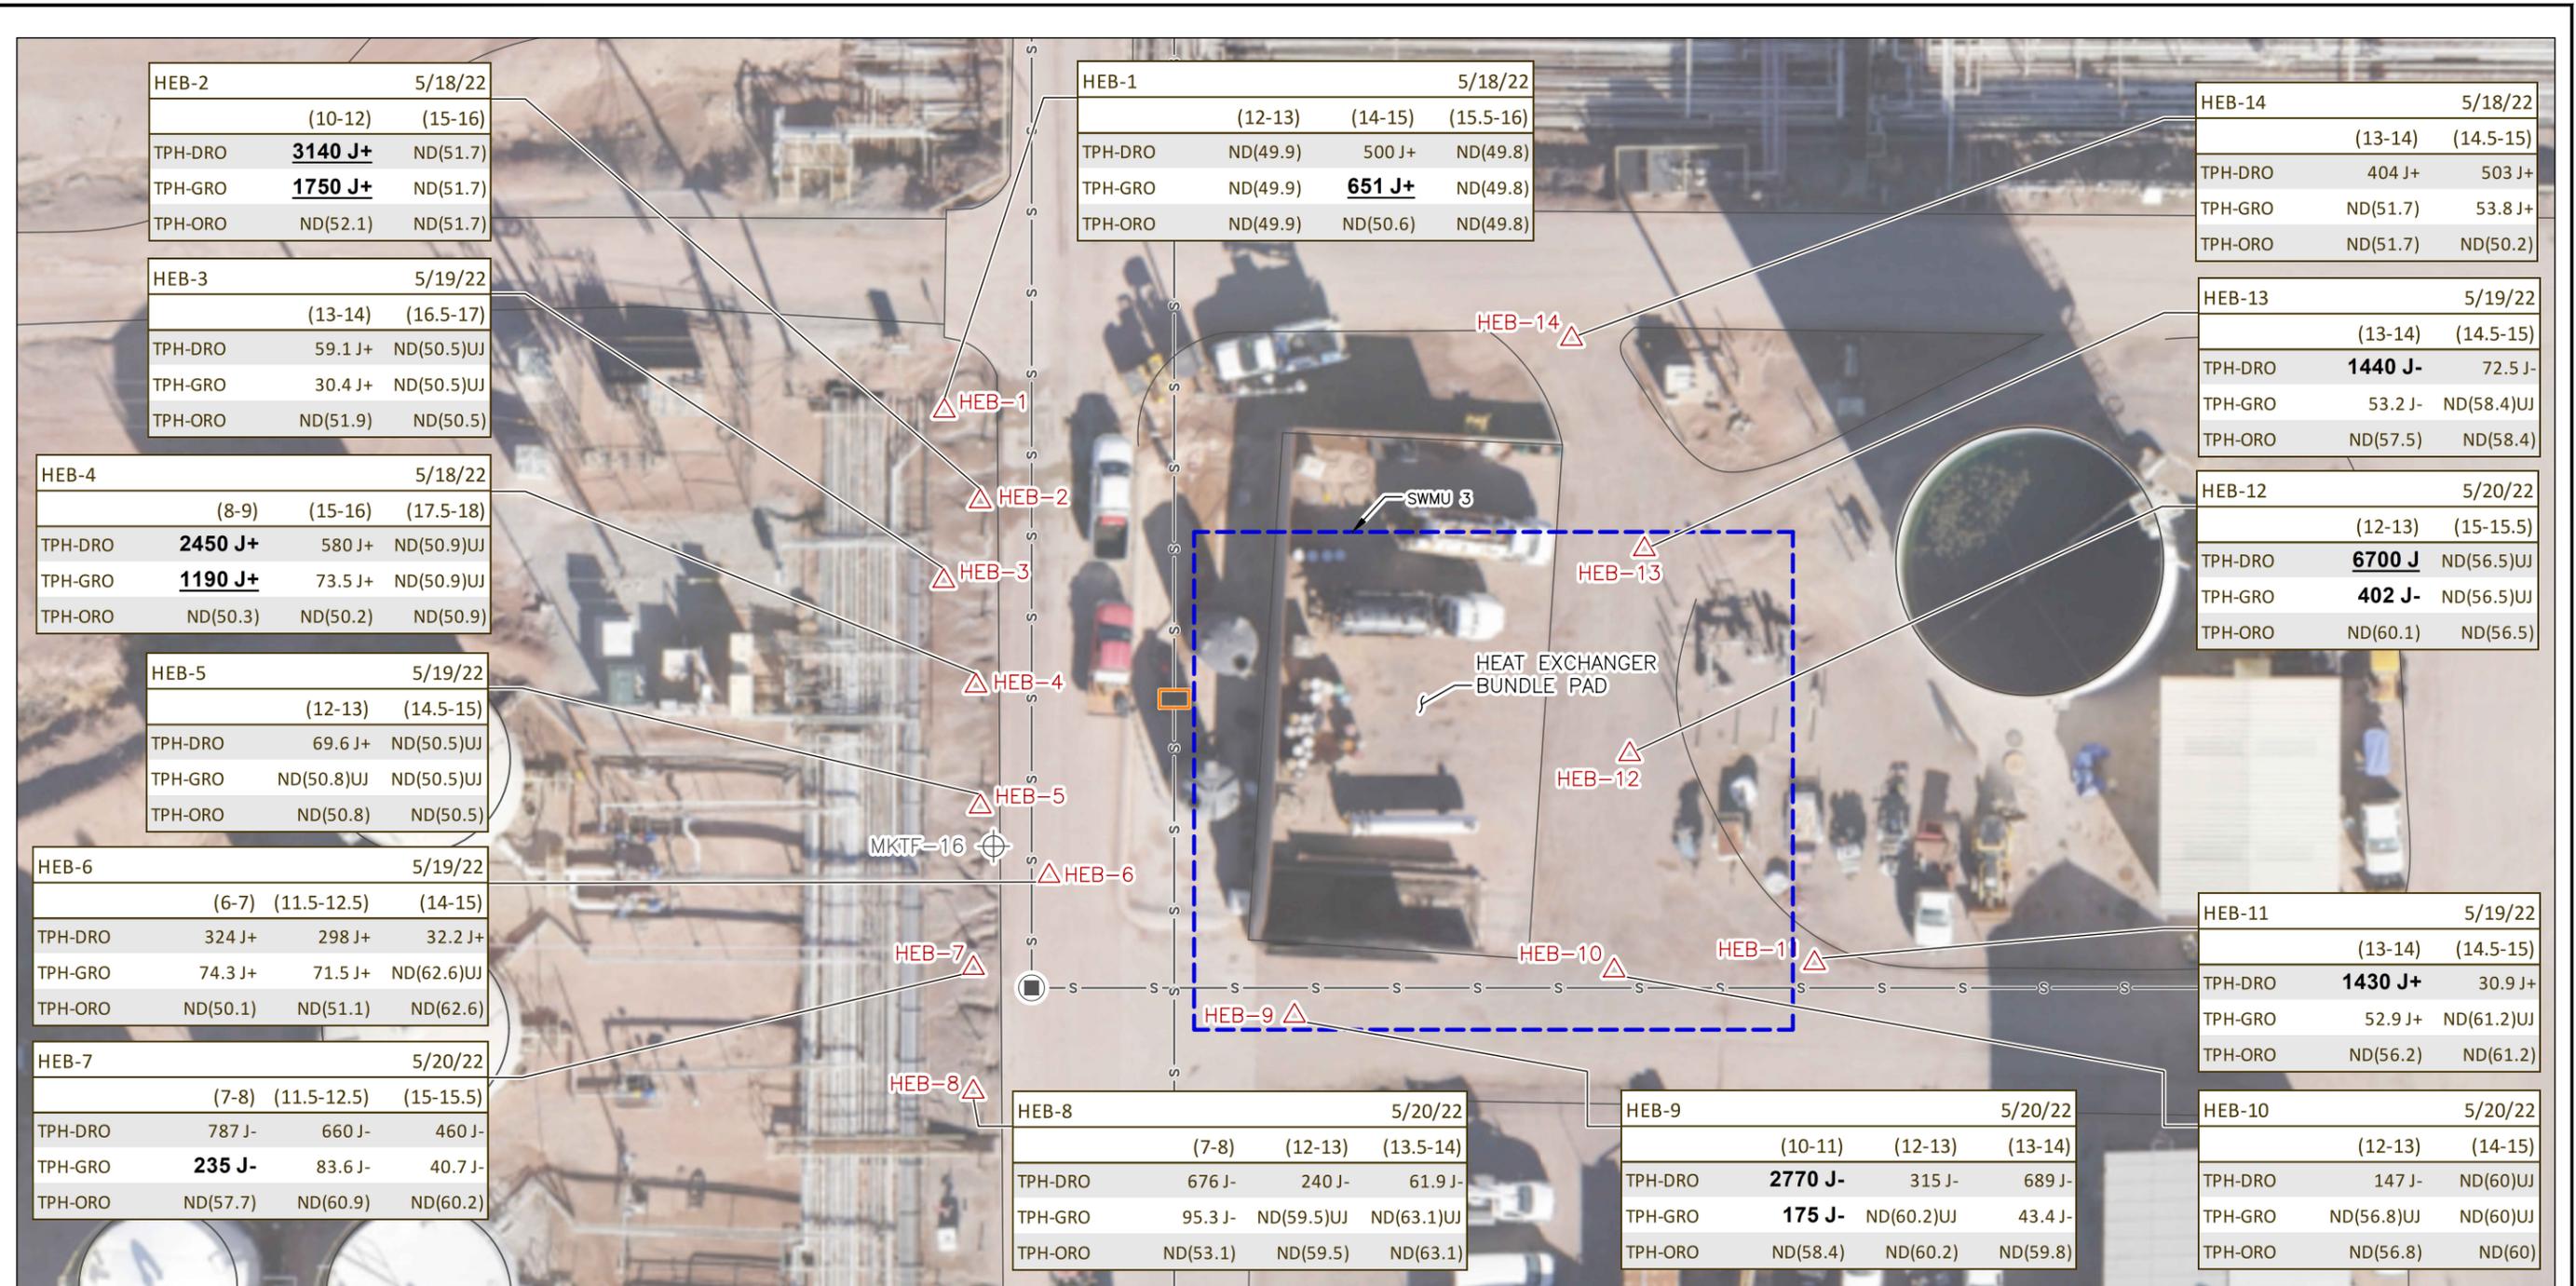
HEB-2	5/18/22
(10-12)	(15-16)
TPH-DRO	<b>3140 J+</b> ND(51.7)
TPH-GRO	<b>1750 J+</b> ND(51.7)
TPH-ORO	ND(52.1) ND(51.7)

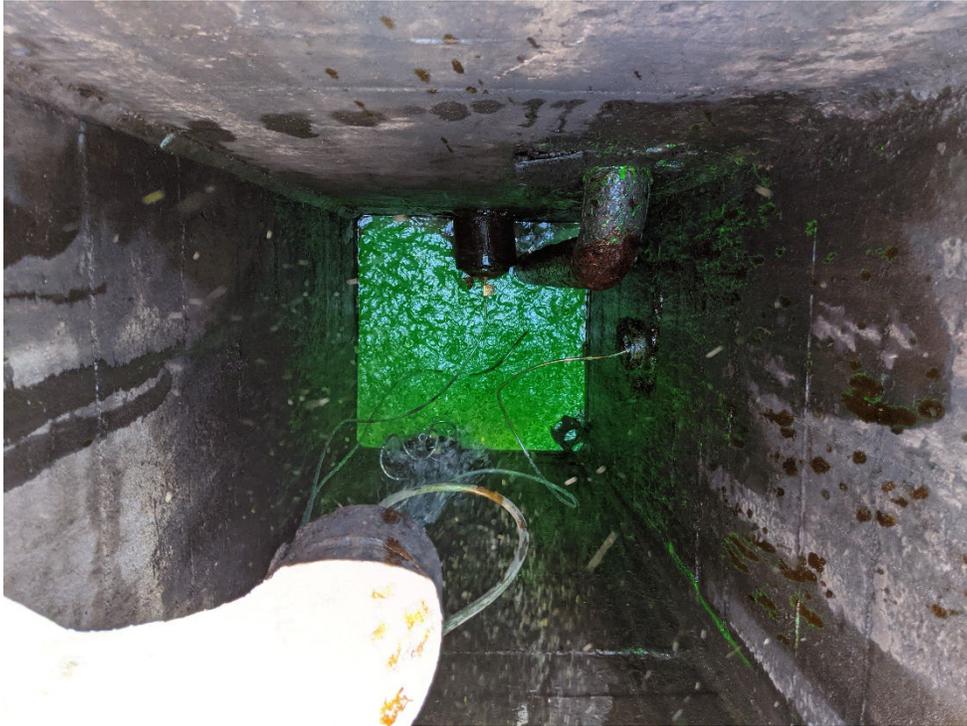
The March 2021 dye test was accomplished by plugging the inlets and outlet of the Bundle Pad sump and adding a mixture of green, fluorescent dye and water until the sump was full (photos included as Appendix A). The sump was inspected 24 hours later and no decrease in fluid level was noted, indicating that no leakage occurred. Additionally, no sewer integrity issues were identified during the 2020 remote visual and cleaning inspection (Appendix B).

Photo 1. Dye Test #1.

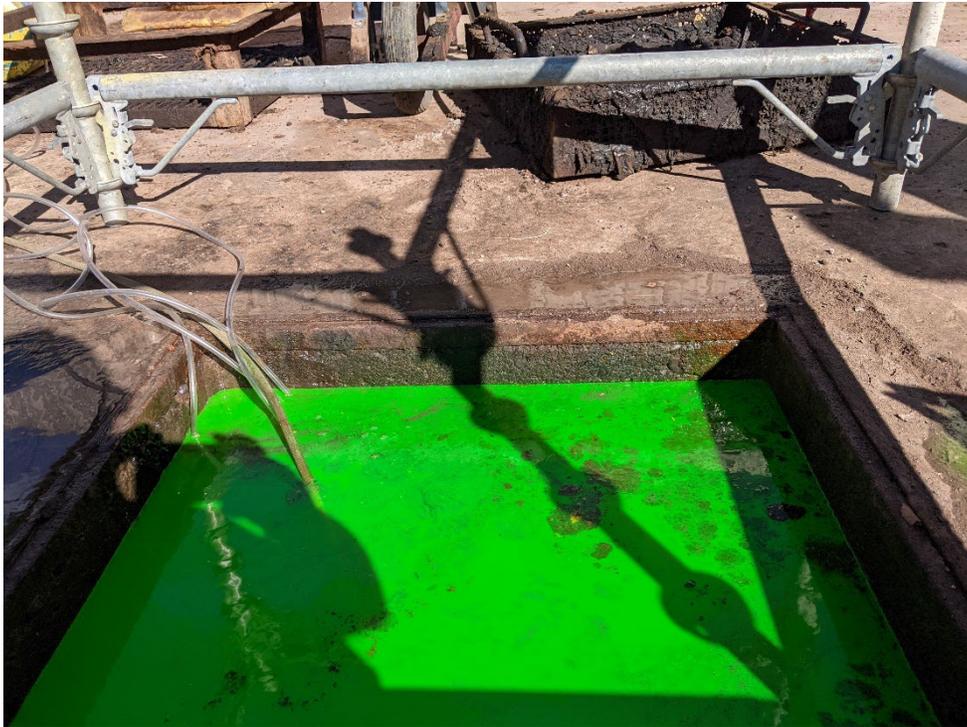
Photo 2. Dye Test #2.

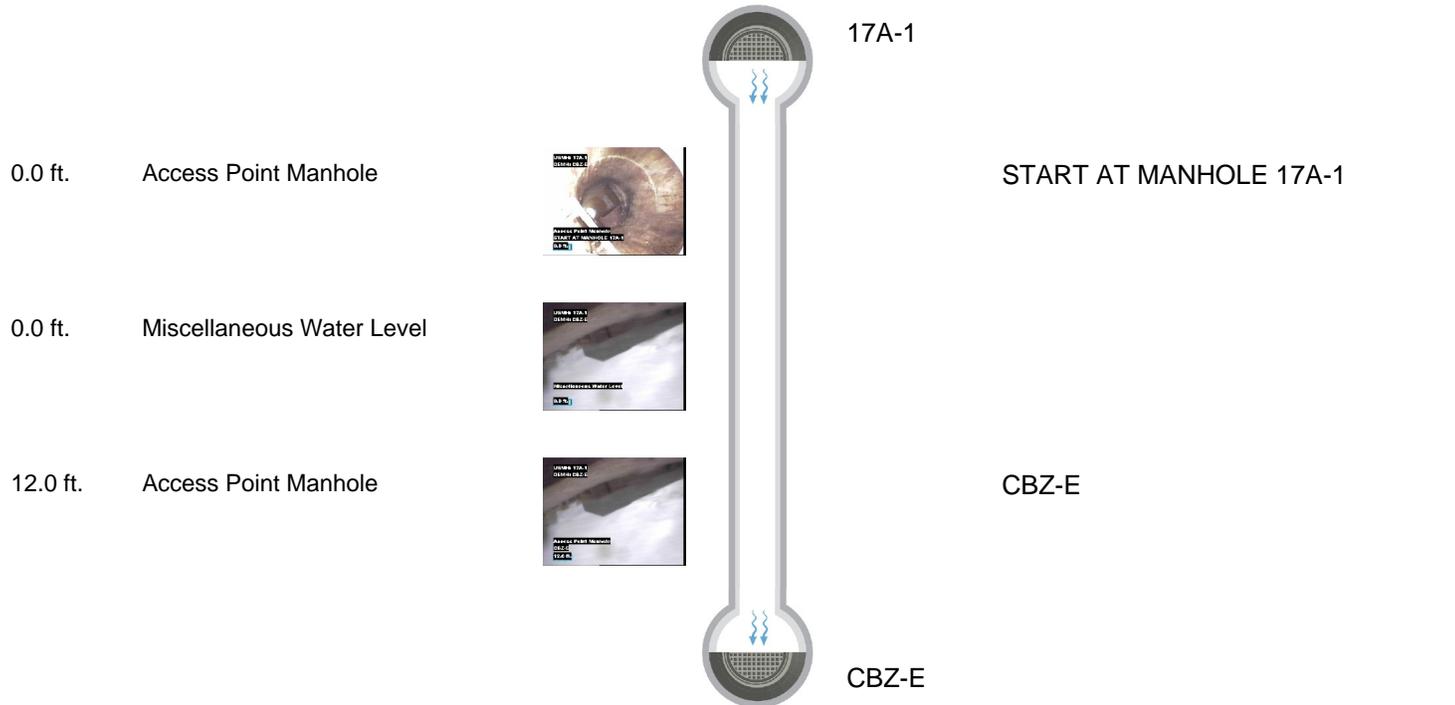
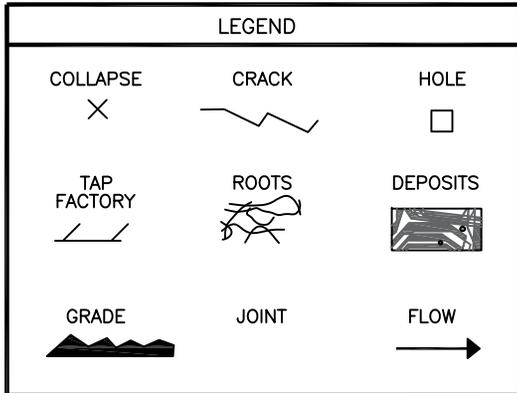
Pipe Segment Refere...	<b>City</b> GALLUP	<b>Street</b> BUNDLE PAD	<b>Material</b> PolyVinyl Chloride		Location C...	<b>Pipe Use</b> Stormwater
<b>Upstream MH</b> 17A-1	Total Length	Year Constructed	<b>Shape</b> Circular		Location Details	
<b>Downstream MH</b> CBZ-E	Length surveyed 12	Year Renewed	<b>Height</b> 16	Width 16	Pipe Joint...

SPR	0	MPR	0	PO Number		Customer	
SPRI	0	MPRI	0	Work Order Number		Purpose	
QSR	0000	QMR	0000				
OPR	0	<b>Surveyed By</b> BJAMES	<b>Direction</b> Downstream	<b>Date</b> 20200129		<b>Media label</b>	
OPRI	0	<b>Certificate Number</b> U-0317-07007227	<b>Pre-Cleaning</b> Light Cleaning	Time 11:40		Weather	
Date Cleaned				End Time 11:47		Additional Info

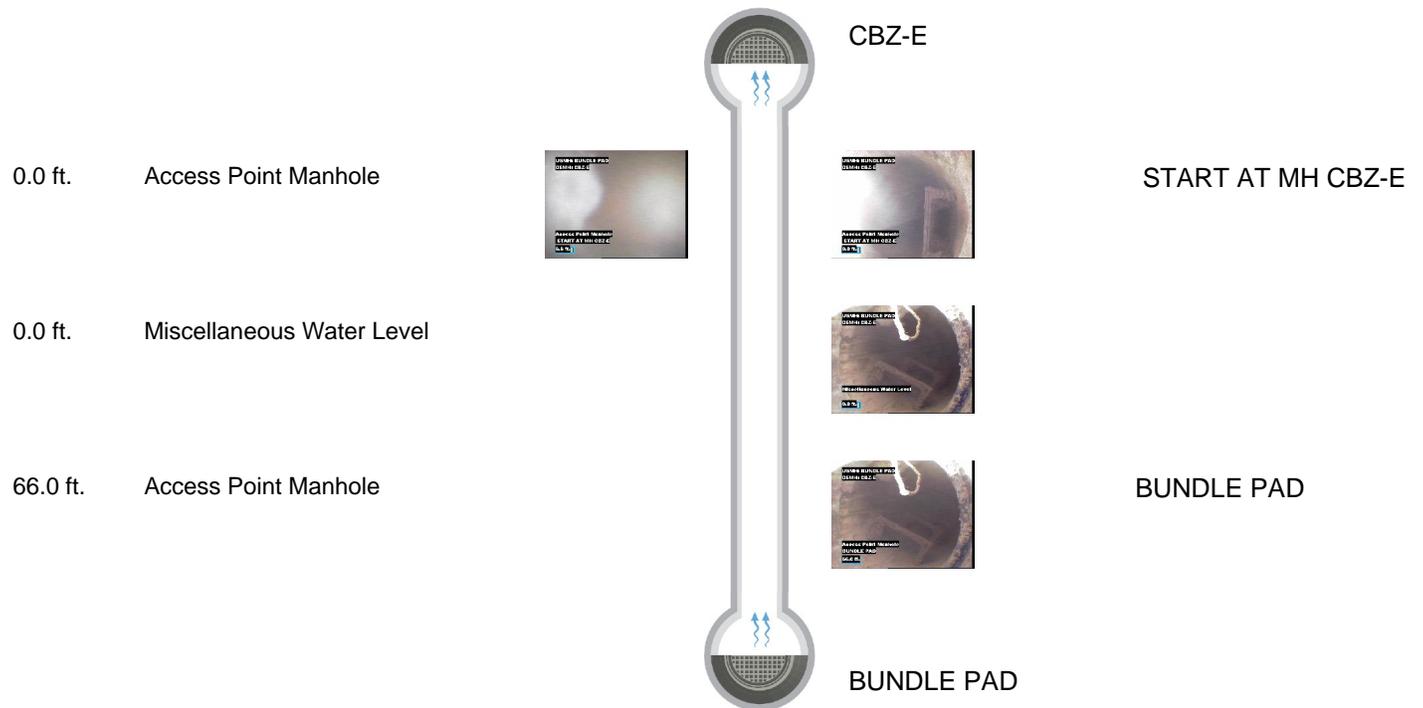
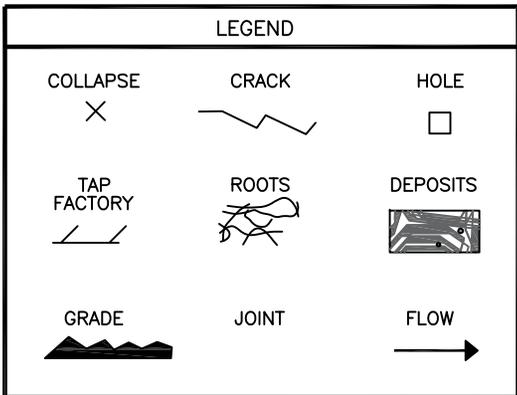
Pipe Segment Refere...	<b>City</b> GALLUP	<b>Street</b> BUNDLE PAD	<b>Material</b> Ductile Iron Pipe	Location C...	<b>Pipe Use</b> Stormwater
<b>Upstream MH</b> BUNDLE PAD	Total Length	Year Constructed	<b>Shape</b> Circular	Location Details	
<b>Downstream MH</b> CBZ-E	Length surveyed 66	Year Renewed	<b>Height</b> 8	<b>Width</b> 8	Pipe Joint...
SPR 0	MPR 0	PO Number		Customer	
SPRI 0	MPRI 0	Work Order Number		Purpose	
QSR 0000	QMR 0000				
OPR 0	<b>Surveyed By</b> BJAMES	<b>Direction</b> Upstream	<b>Date</b> 20200128	Media label	
OPRI 0	<b>Certificate Number</b> U-0317-07007227	<b>Pre-Cleaning</b> No Pre-Cleaning	<b>Time</b> 11:04	<b>Weather</b>	
Date Cleaned			<b>End Time</b> 11:15	Additional Info

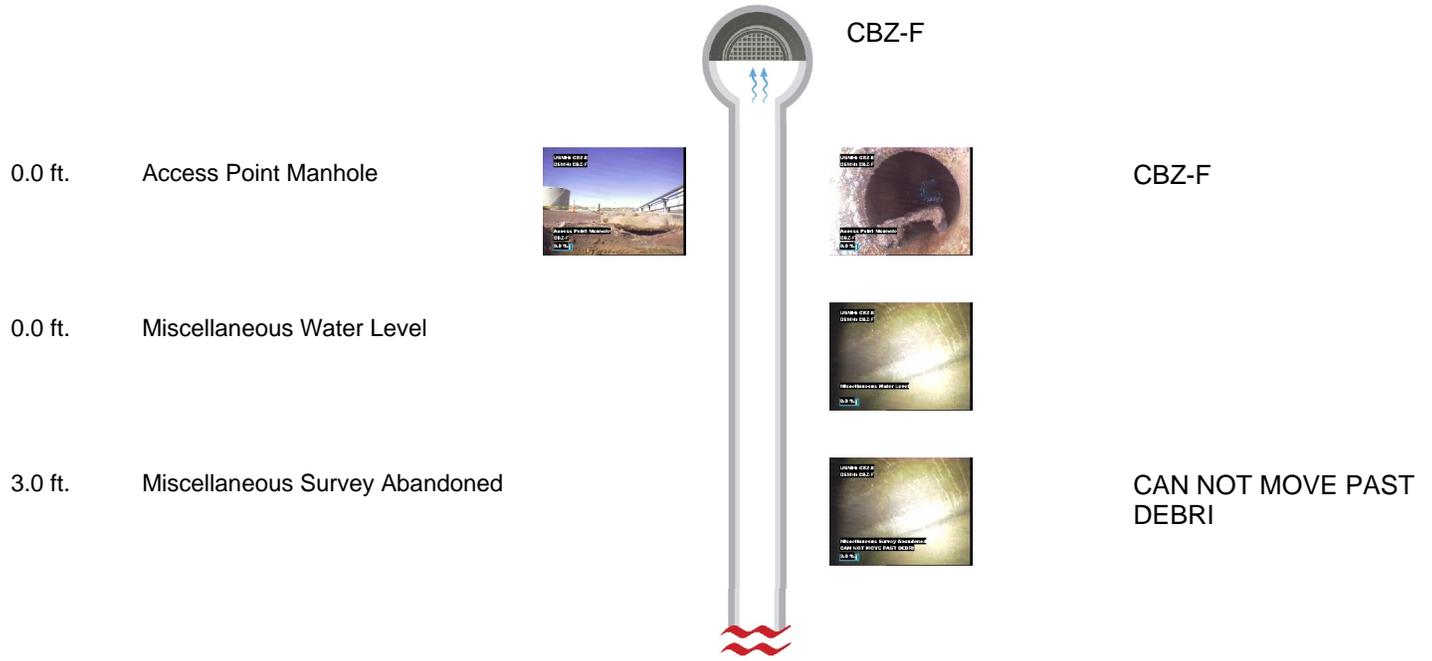
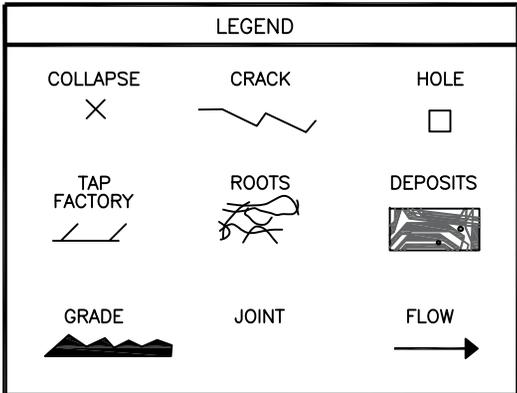
Pipe Segment Refere...	<b>City</b> GALLUP	<b>Street</b> BUNDLE PAD	<b>Material</b> PolyVinyl Chloride		Location C...	<b>Pipe Use</b> Stormwater
<b>Upstream MH</b> CBZ-E	Total Length	Year Constructed	<b>Shape</b> Circular		Location Details	
<b>Downstream MH</b> CBZ-F	Length surveyed 3	Year Renewed	<b>Height</b> 16	Width 16	Pipe Joint...

SPR 0	MPR 0	PO Number		Customer		
SPRI 0	MPRI 0	Work Order Number		Purpose		
QSR 0000	QMR 0000					
OPR 0	<b>Surveyed By</b> BJAMES	<b>Direction</b> Upstream	<b>Date</b> 20200128		<b>Media label</b>	
OPRI 0	<b>Certificate Number</b> U-0317-07007227	<b>Pre-Cleaning</b> No Pre-Cleaning	Time 12:45		Weather	
Date Cleaned			End Time 12:51		Additional Info

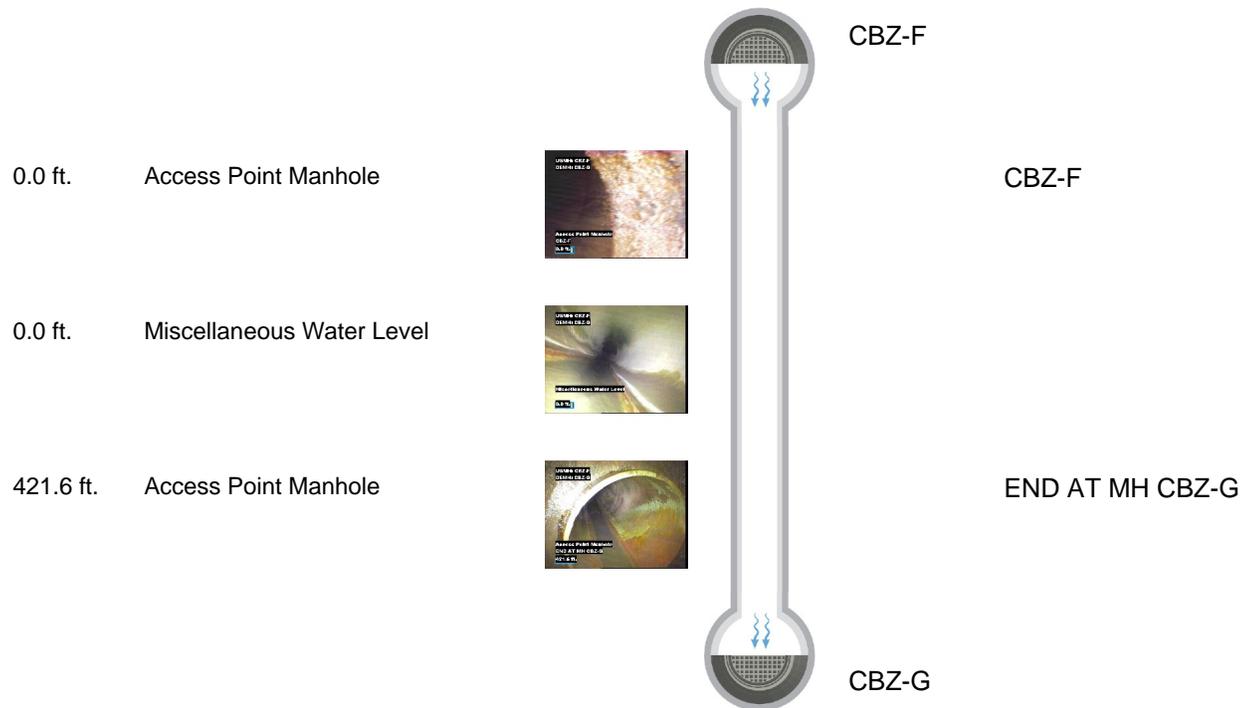
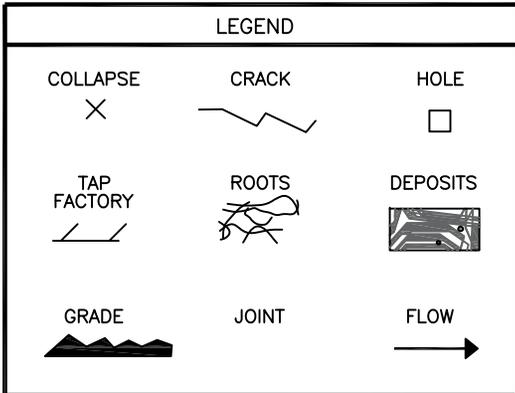
Pipe Segment Refere...	<b>City</b> GALLUP	<b>Street</b> BUNDLE PAD	<b>Material</b> PolyVinyl Chloride		Location C...	<b>Pipe Use</b> Stormwater
<b>Upstream MH</b> CBZ-F	Total Length	Year Constructed	<b>Shape</b> Circular		Location Details	
<b>Downstream MH</b> CBZ-G	Length surveyed 421.6	Year Renewed	<b>Height</b> 16	Width 16	Pipe Joint...

SPR 0	MPR 0	PO Number		Customer		
SPRI 0	MPRI 0	Work Order Number		Purpose		
QSR 0000	QMR 0000					
OPR 0	<b>Surveyed By</b> BJAMES	<b>Direction</b> Downstream	<b>Date</b> 20200128		<b>Media label</b>	
OPRI 0	<b>Certificate Number</b> U-0317-07007227	<b>Pre-Cleaning</b> No Pre-Cleaning	Time 13:21		Weather	
Date Cleaned			End Time 13:41		Additional Info

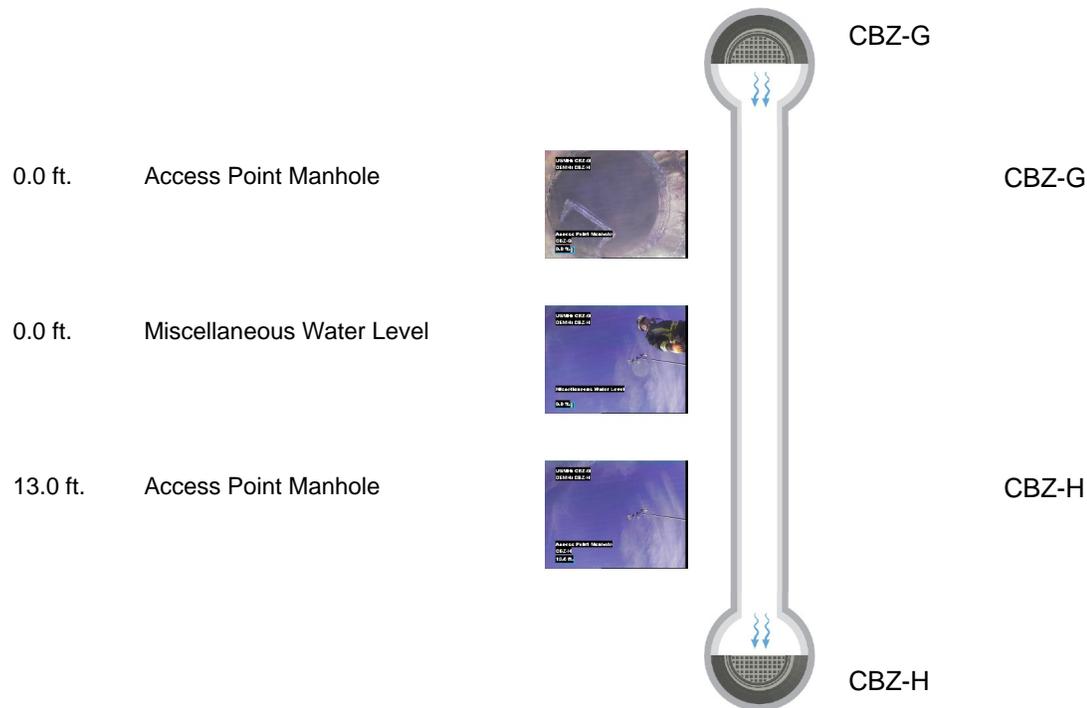
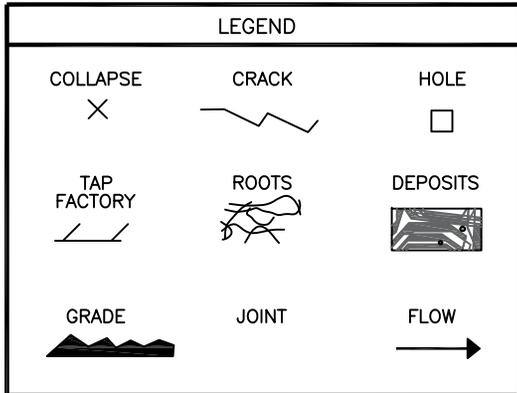
Pipe Segment Refere...	<b>City</b> GALLUP	<b>Street</b> BUNDLE PAD	<b>Material</b> Ductile Iron Pipe		Location C...	<b>Pipe Use</b> Stormwater
<b>Upstream MH</b> CBZ-G	Total Length	Year Constructed	<b>Shape</b> Circular		Location Details	
<b>Downstream MH</b> CBZ-H	Length surveyed 13	Year Renewed	<b>Height</b> 12	Width 12	Pipe Joint...

SPR 0	MPR 0	PO Number		Customer	
SPRI 0	MPRI 0	Work Order Number		Purpose	
QSR 0000	QMR 0000				
OPR 0	<b>Surveyed By</b> BJAMES	<b>Direction</b> Downstream	<b>Date</b> 20200130		Media label
OPRI 0	<b>Certificate Number</b> U-0317-07007227	<b>Pre-Cleaning</b> No Pre-Cleaning	Time 09:12		Weather
Date Cleaned			End Time 09:16		Additional Info

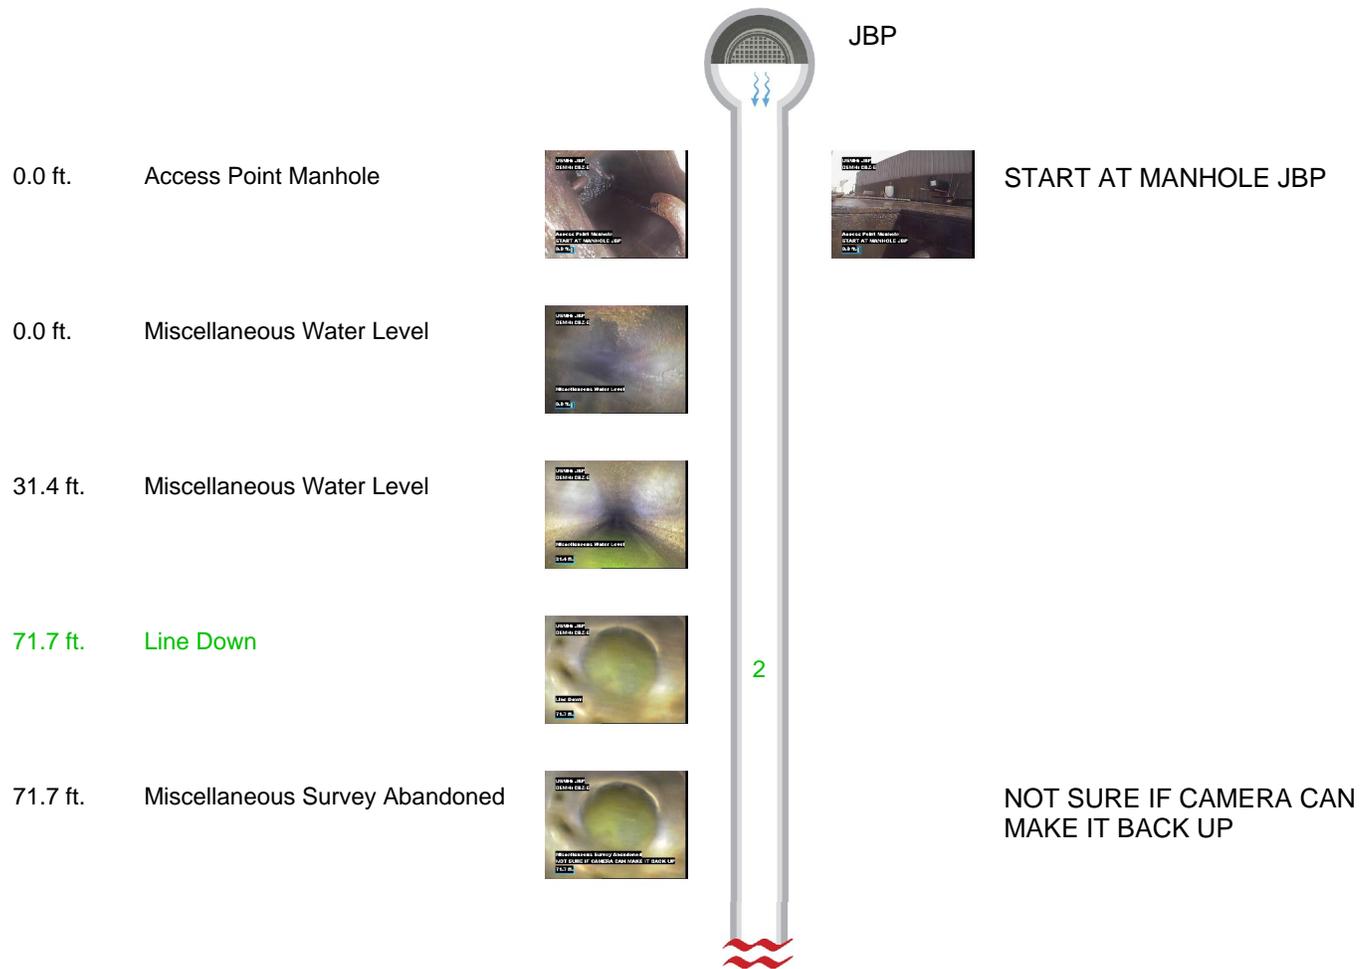
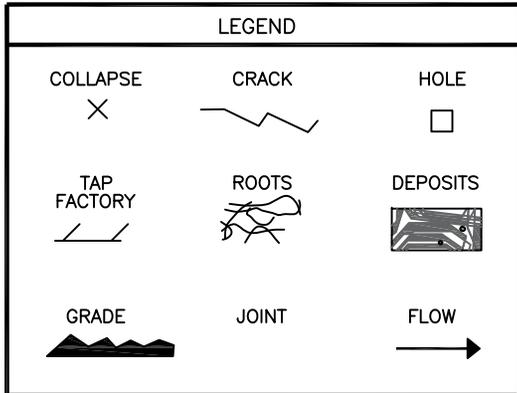
Pipe Segment Refere...	<b>City</b> GALLUP	<b>Street</b> BUNDLE PAD	<b>Material</b> Ductile Iron Pipe		Location C...	<b>Pipe Use</b> Stormwater
<b>Upstream MH</b> JBP	Total Length	Year Constructed	<b>Shape</b> Circular		Location Details	
<b>Downstream MH</b> CBZ-E	Length surveyed 71.7	Year Renewed	<b>Height</b> 8	Width 8	Pipe Joint...	
SPR 0	MPR 2	PO Number		Customer		
SPRI 0	MPRI 2	Work Order Number		Purpose		
QSR 0000	QMR 2100					
OPR 2	<b>Surveyed By</b> BJAMES	<b>Direction</b> Downstream	<b>Date</b> 20200129		<b>Media label</b>	
OPRI 2	<b>Certificate Number</b> U-0317-07007227	<b>Pre-Cleaning</b> No Pre-Cleaning	<b>Time</b> 10:26		<b>Weather</b>	
Date Cleaned			<b>End Time</b> 10:36		<b>Additional Info</b>
