ENTERPRISE PRODUCTS PARTNERS L.P. ENTERPRISE PRODUCTS HOLDINGS LLC (General Partner) ENTERPRISE PRODUCTS OPERATING LLC

RE: Response to Notice of an Administratively Incomplete Discharge Permit Application for the Chaco Gas Plant Enterprise Field Services, LLC Chaco Gas Plant

Spill Prevention, Control and Countermeasure Plan

SPILL PREVENTION, CONTROL, AND COUNTERMEASURES PLAN

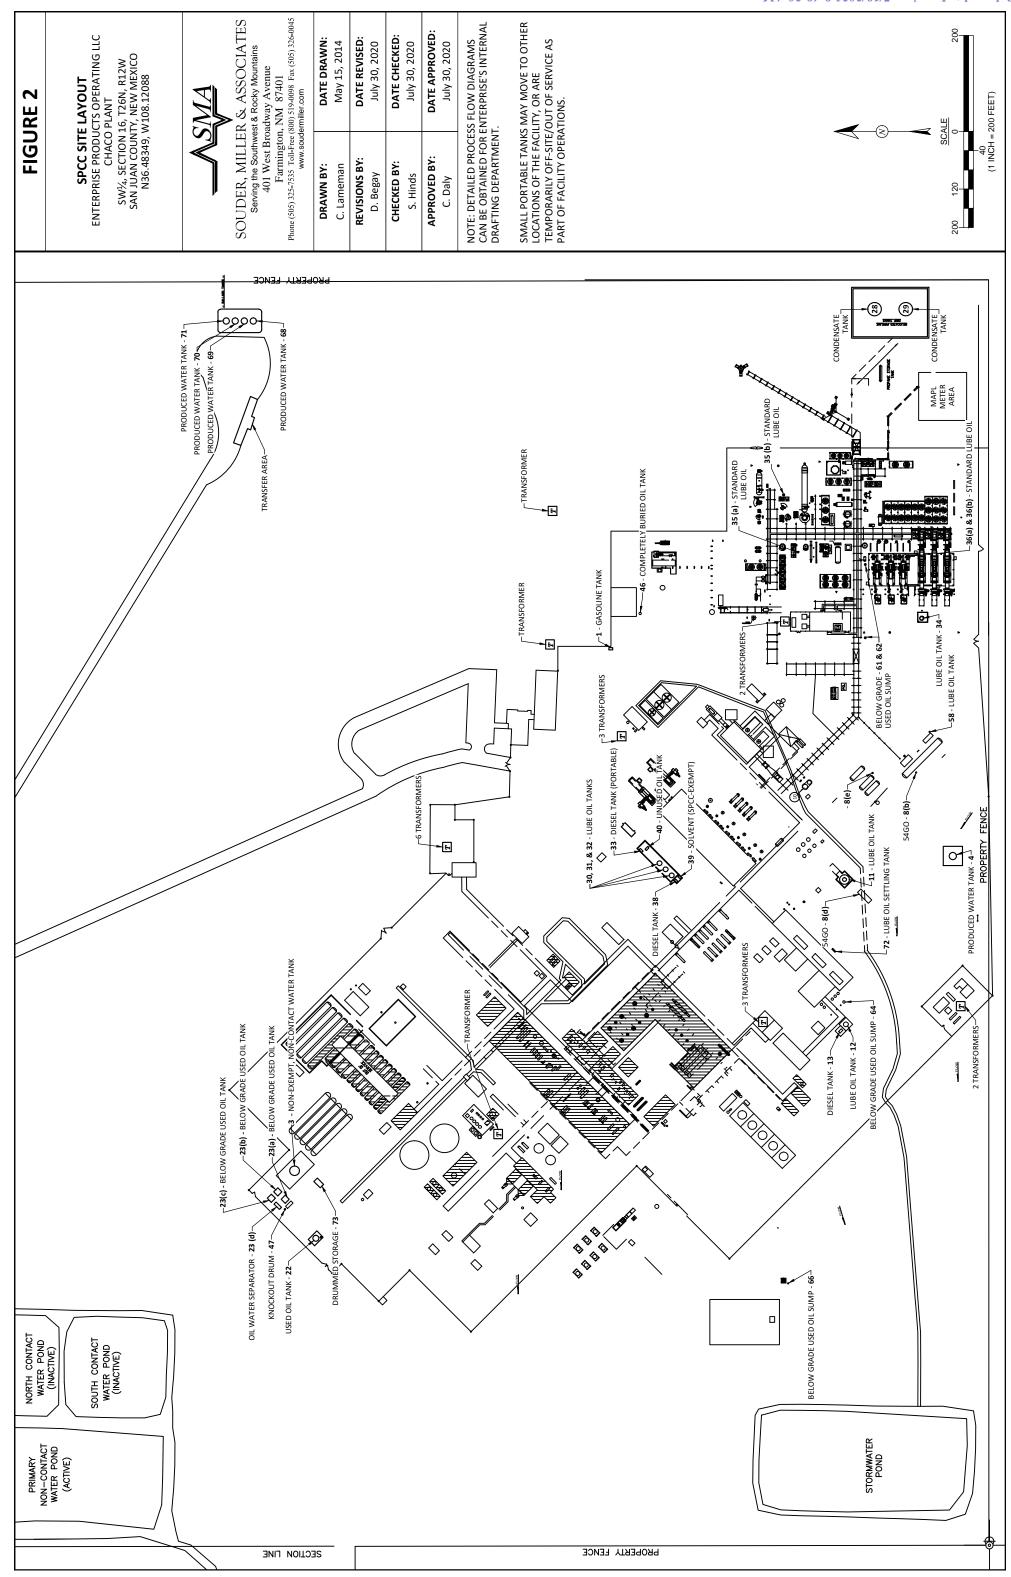
Released to Imaging: 7/18/2023 Scuder, Miller & Associates, Juli ReinerBeserM&A 2020 Farmington (5129034)/SPCC/BG76 - Chaco Plant/Cad/Figure 2 Chaco SPCC Site Layout Map.dwg, DJB, 8/14/2020 11:44 AM

- (4) **Corrosion protection of buried metallic storage tanks**: There is one completely buried metallic storage tanks at the facility (Tank 46 on Figure 2). Corrosion protection for buried piping, buried tank, and tank bases is provided by the facility's impressed current cathodic protection system.

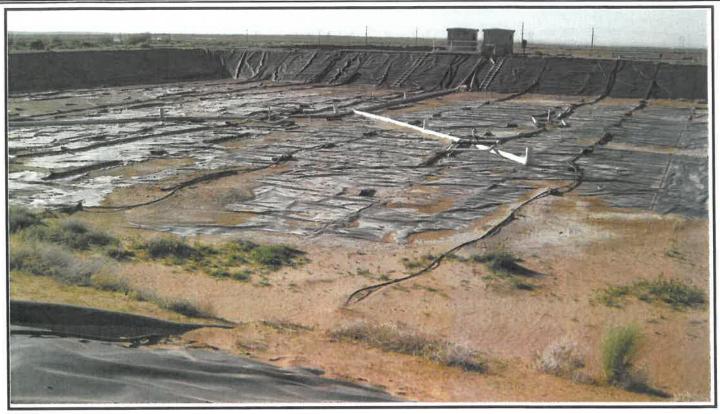
1.) General view of the lined contact water pond to be closed at the Site.

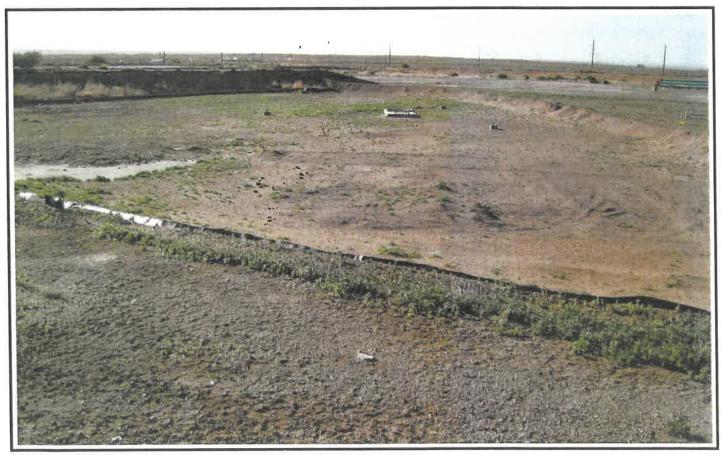
2.) General view of the area to the north of the contact water pond and the northern berm on the contact water pond.
