RE: Ameredev Operating – Ike’s Containment #1 C-147 Registration/Permit Application
Section 27, T26 S, R36 E, Lea County

C-147 Registration Package for Ike's Recycling Containment #1 and Recycling Facility Section 27 T26S R36E, Lea County

Appendix A

Design Specifications

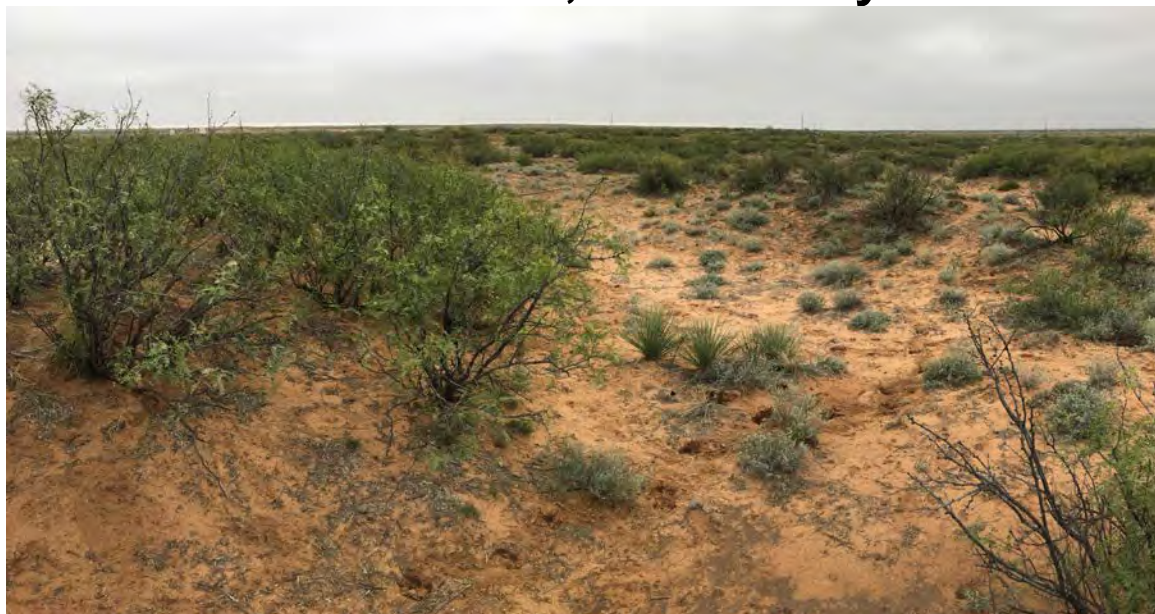
View to east-southeast from west-center area of the proposed containment showing the vegetated sand dunes. High magnification of this image reveals the abandoned windmill east of County Road 32.

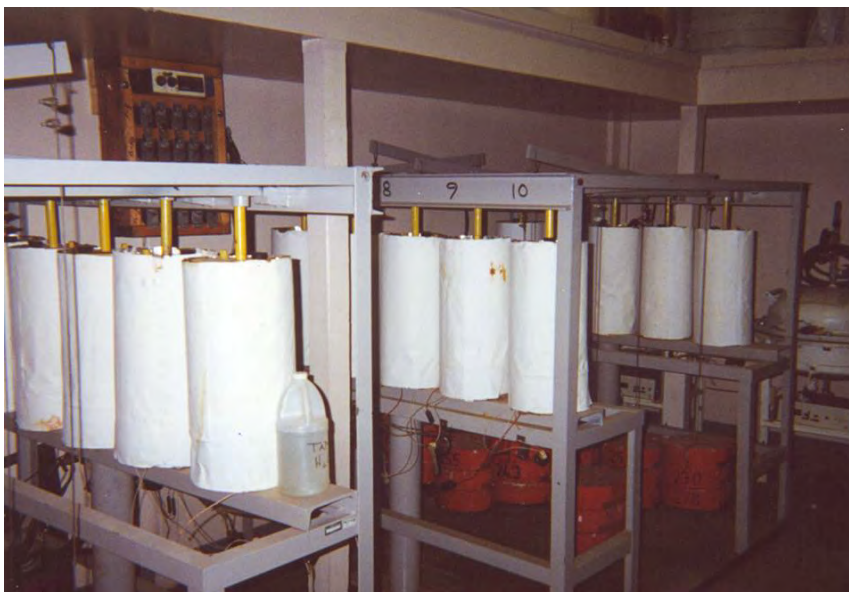
Figure 1. Incubation schematic and photograph of multiple cells maintained at various constant temperatures.

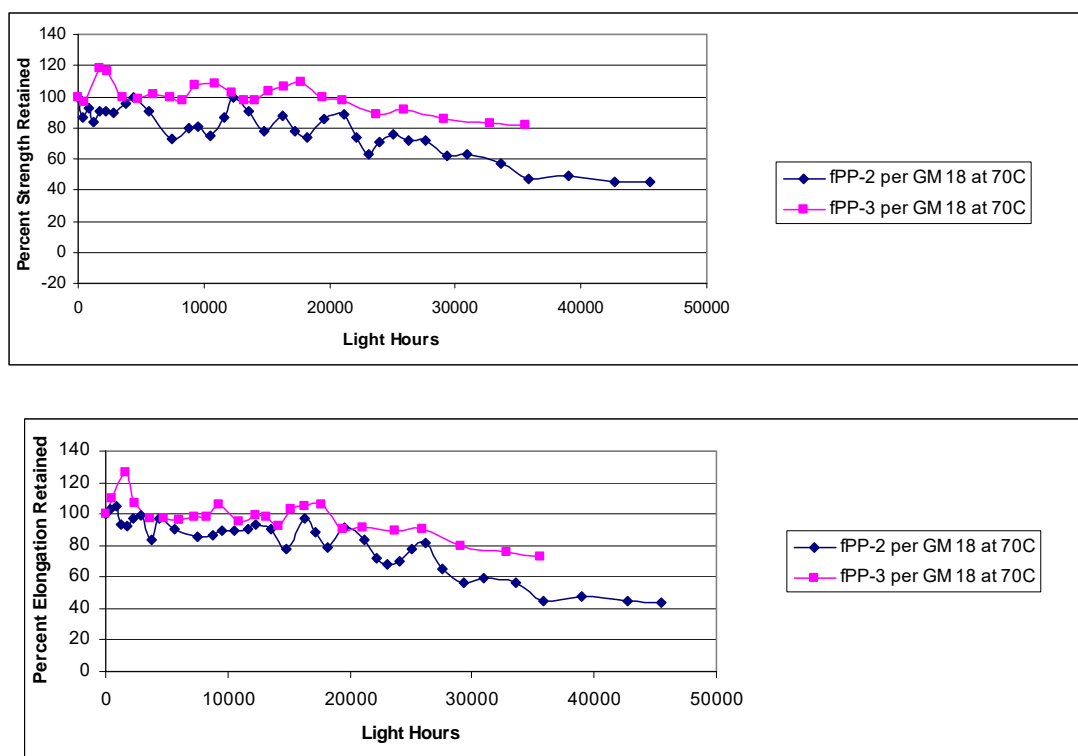
Figure 6a. Flexible polyethylene (fPP) geomembrane behavior.

- Two black 1.0 mm (4.0 mil) unreinforced flexible polypropylene geomembranes formulated per GRI-GM18 Specification; see Figure 6a.
- Two black unreinforced polyethylene geomembranes, one 1.5 mm (60 mil) high density per GRI-GM13 Specification and the other 1.0 mm (40 mil) linear low density per GRI-GM17 Specification; see Figure 6b.
- One 1.0 (40 mil) black ethylene polypropylene diene terpolymer geomembrane per GRI-GM21 Specification; see Figure 6c.
- Two polyvinyl chloride geomembranes, one black 1.0 mm (40 mil) formulated in North America and the other grey 1.5 mm (60 mil) formulated in Europe; see Figure 6d.

From the response curves of the various geomembranes shown in Figure 6a-d, the 50% reduction value in strength or elongation (usually elongation) was taken as being the “halflife”. This value is customarily used by the polymer industry as being the materials lifetime prediction value. We have done likewise to develop Table 6 which is our predicted values for the designated exposed geomembrane lifetimes to date.

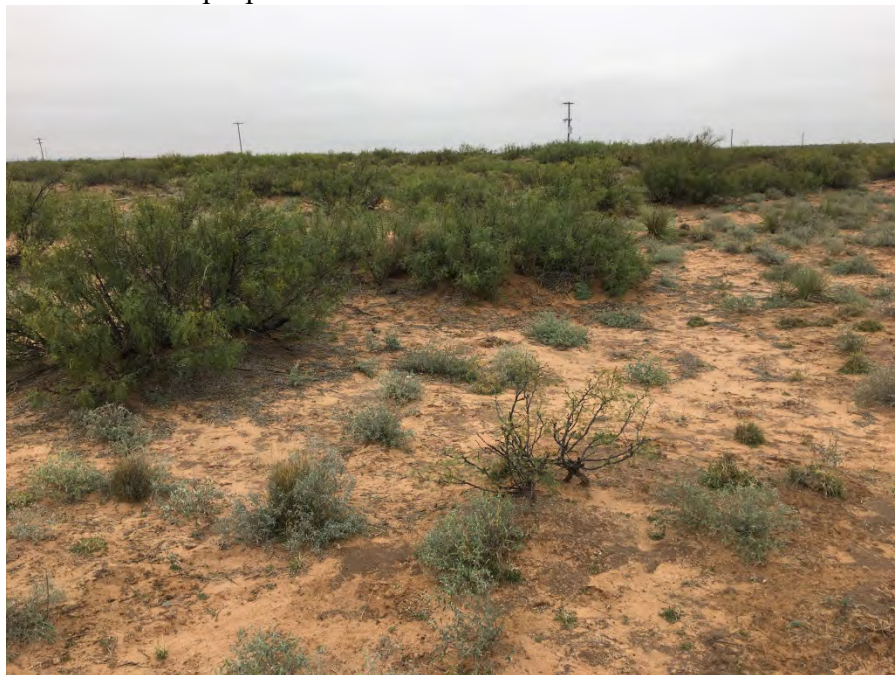
This view to the southwest at the southwest corner of the Ameredev-owned surface is on the northeastern edge of the mapped closed depression shown in Figure 3. The area shows no historic evidence of a lake bottom, such as saline soils, wetland vegetation, ancient shorelines, etc.

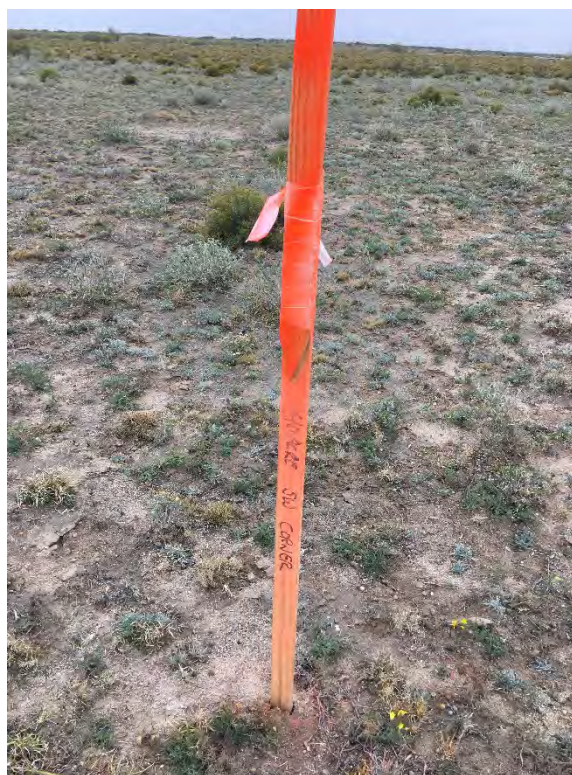
The image below shows the nature of the vegetation and surface within the closed depression to the southwest of the Ameredev-owned surface. The corner stake in the image above is within the red circle. The surface is characterized by angular caliche clasts and possibly exposure of the underlying caliche layer.

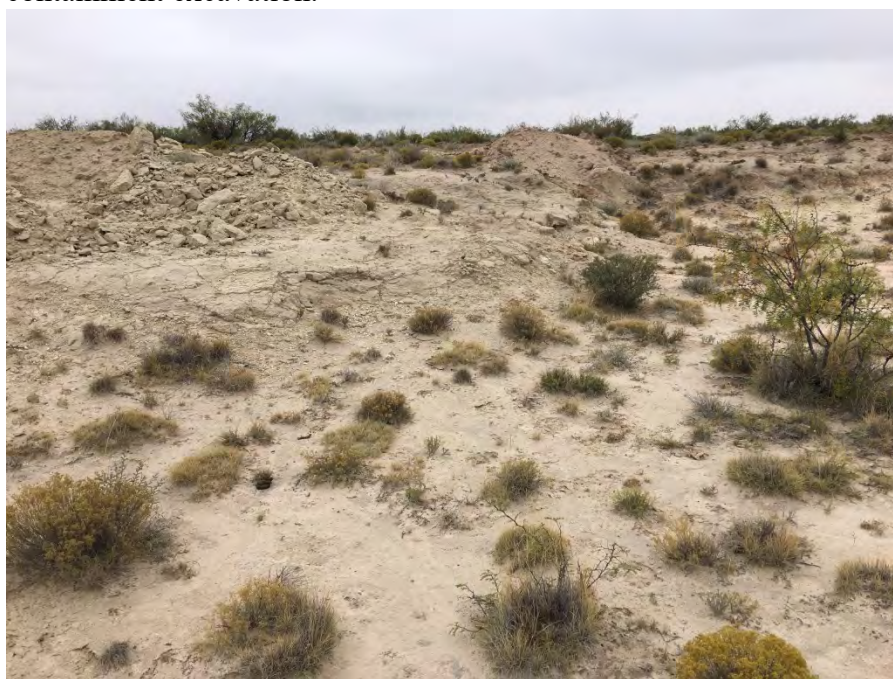
The caliche pit shown below is located about 1500 feet southeast of the proposed containment area. The elevation of the pit suggests that caliche will be present in the bottom of the containment excavation.
