RE: EKG Containment

Magrym Consulting has been working with Aris Water Solutions at the EKG Containment since 2021. Magrym prepared a plan set for the EKG pond conversion from freshwater to produced water in February 2021. When the pond was converted the old liner was removed, slopes were re-dressed, and the containment was relined with a new 60 MIL HDPE primary liner, 200 MIL Geonet, and 40 MIL HDPE secondary liner in accordance with the requirements pursuant to NMAC 19.15.34.

Appendix B: AirScan 3D Mapping Report (Transwater, Inc.)

Appendix C: Site Photographs

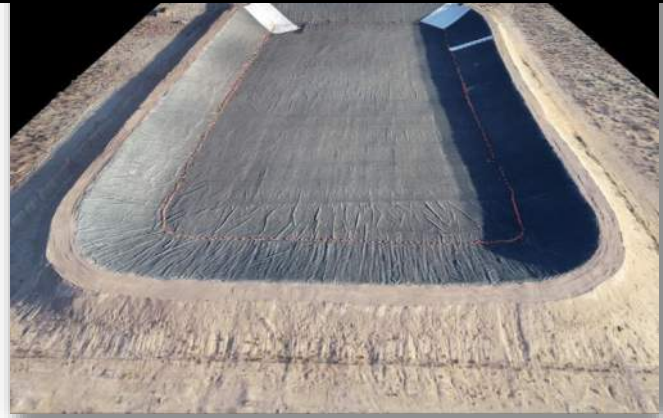
Level/Volume Curve

Max fill to 2ft freeboard	14.5	ft	15	14	205,533
Volume at 2ft freeboard fill	213,703	bbls	14	13	188,171
Berm Slope Reference Calculations			13	12	169,337
			12	11	152,024
			11	10	132,590
North Berm Grade:	30.88%		10	9	115,851
South Berm Grade:	34.22%		9	8	98,831
East Berm Grade:	34.15%		8	7	84,122
West Berm Grade:	32.14%		7	6	69,104
			6	5	56,072
Summary Notes			5	4	42,067
To ensure a 2ft Freeboard minimum across the entire brim, 14.5ft is the recommend "full" line in this pit. East Gauge was used as the reference point.			4	3	31,251
			3	2	20,427
			2	1	15,001
			1	0	0

To ensure a 2ft Freeboard minimum across the entire brim, 14.5ft is the recommend "full" line in this pit. That is indicated with the highlighted line in the volume table.

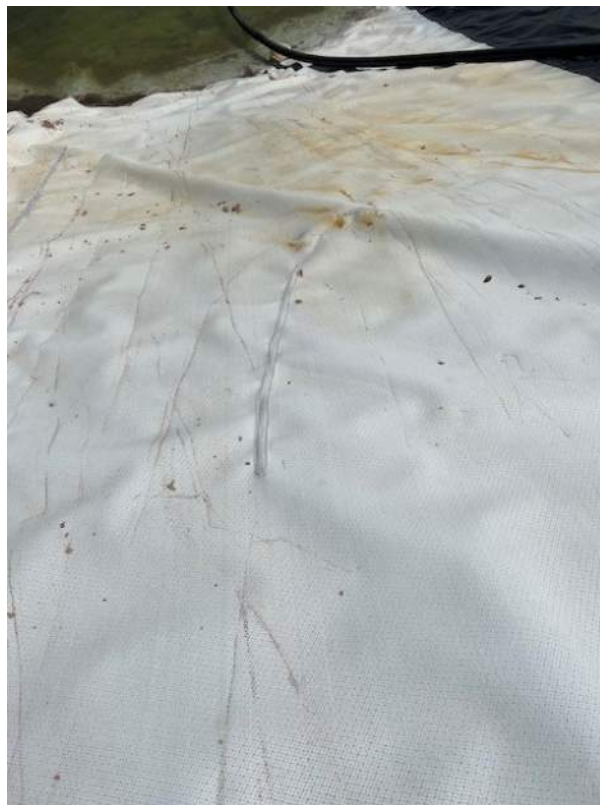
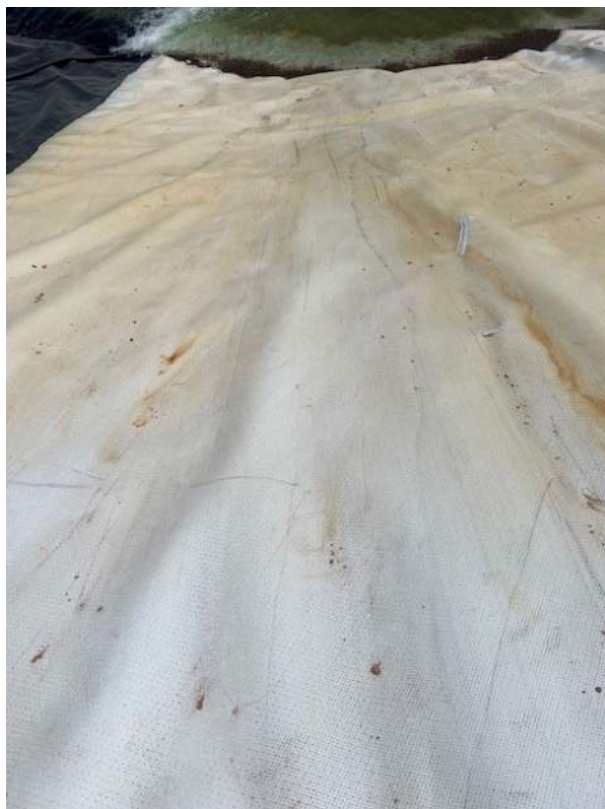
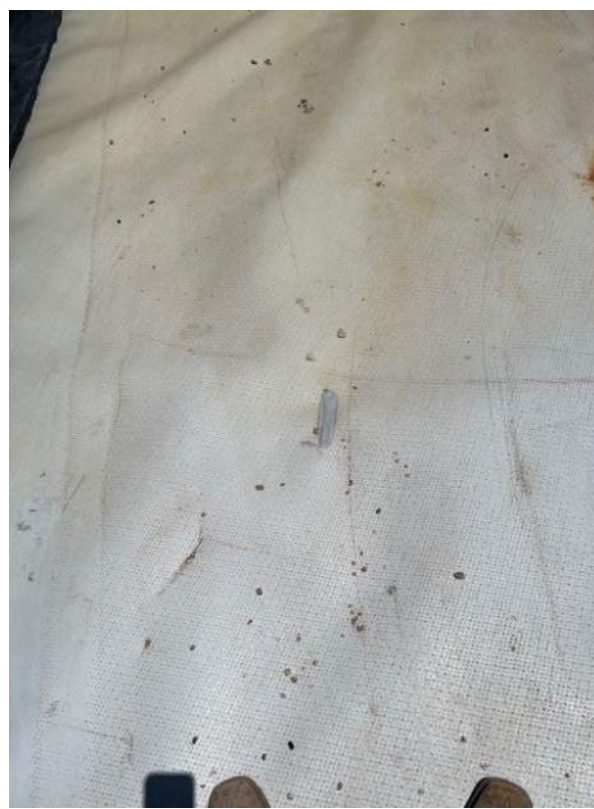
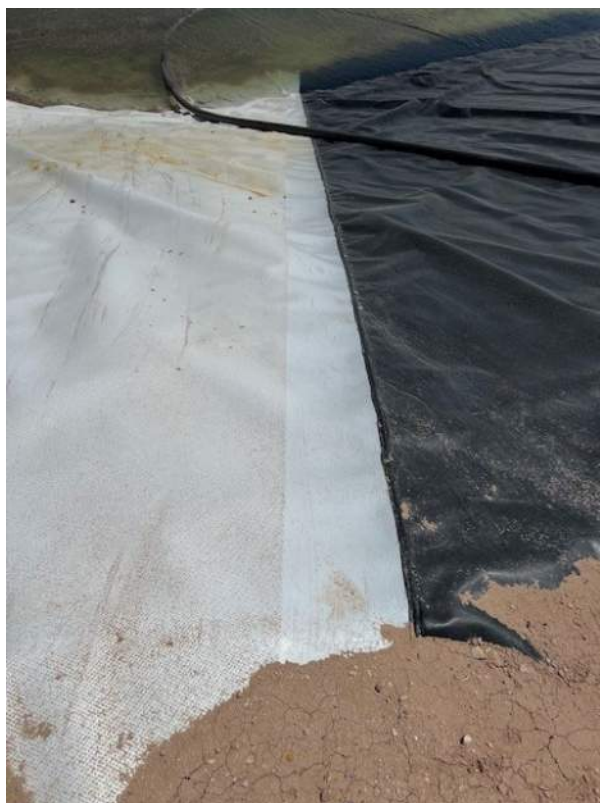
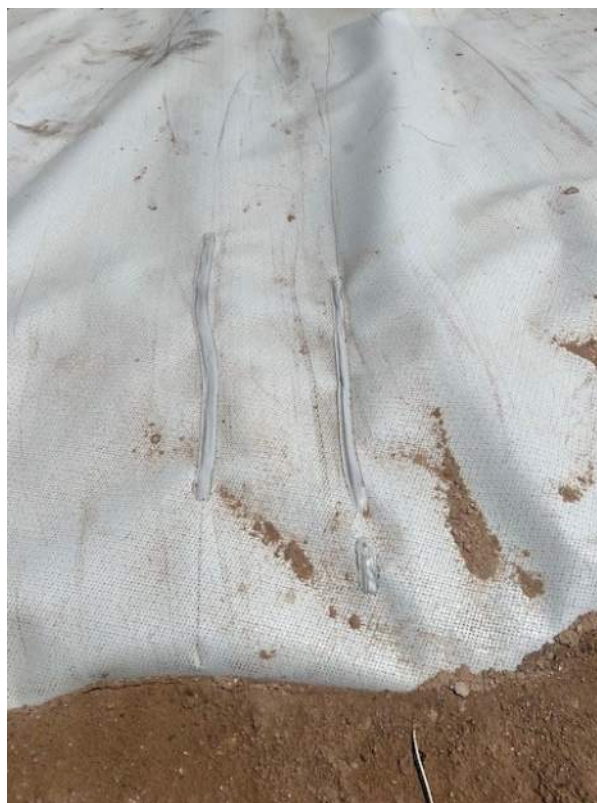
Figure 10

As the Engineer for the EKG Containment, Magrym performed a review of the Lined Water Impoundment Inspection/Repair Log (Appendix A), AirScan 3D Mapping Report (Appendix B), and Site Photographs (Appendix C) provided by Chad Gallagher of Aris Water Solutions. The *Lined Water Impoundment Inspection/Repair Log* performed by Souksan Inthavongsa (Lee) of Patriot Environmental focused on the liner welds, rub sheets, the liner surface, depth gauge, pipe boots and the leak detection system. This analysis concluded no fluid was found in the leak detection sump and apart from small holes in the rub sheet, no damage was indicated. These small holes have been repaired, as shown in figures 10-14.
