AQUATIC RESOURCES DELINEATION TECHNICAL MEMORANDUM ADDENDUM Version2

Re: **Enduring's NE Lybrook WSW 2306-06P Oil and Gas Project, Rio Arriba County, New Mexico, Aquatic Resources Delineation Technical Memorandum Addendum Version2/ SWCA Project No. 75253-082**

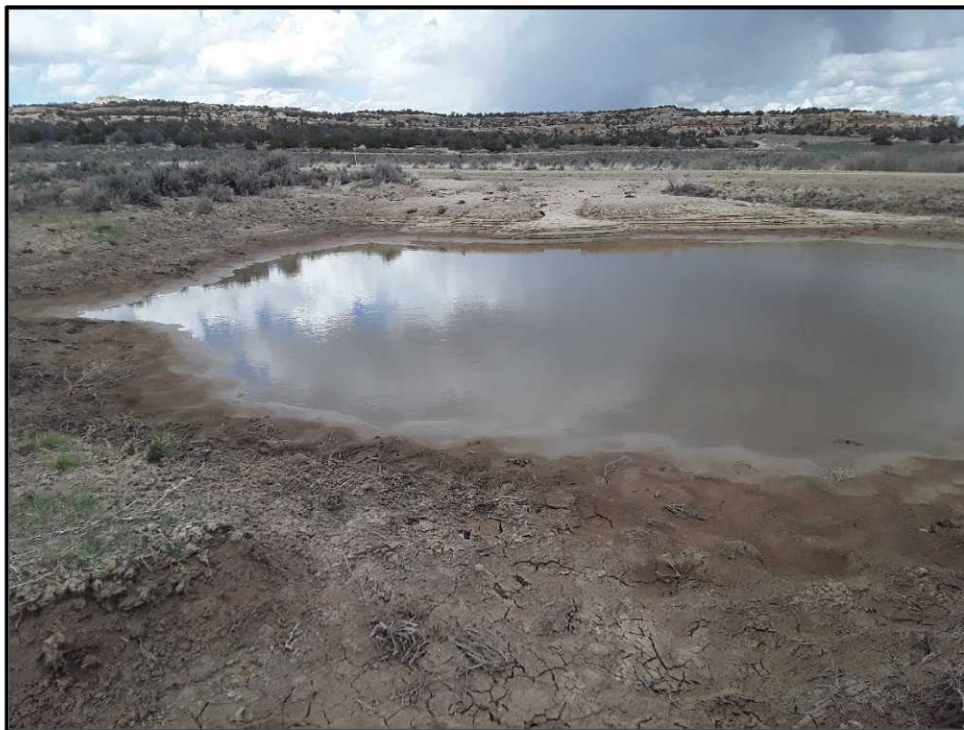
Figure 1. Overview of P01, a non-wetland surface aquatic feature (pond), facing east on April 4, 2023.

Three livestock ponds (P01, P02, and P03) were observed within the survey area but did not intersect the project area. Field crew noted that each of the three observed ponds appeared to be constructed entirely within uplands for livestock watering. Field crew took photographs of each pond (Figures 1 through 4 in Appendix B). They had also noted that drainage from the roadside ditch was being directed into P01 and there was cattle sign throughout the survey area.

The three ponds observed in the survey area were identified as artificial or manmade ponds, created by excavating or diking dry land, and used exclusively for such purposes as stock watering or settling basins. These types of ponds are typically excluded from waters of the U.S. jurisdiction (40 Code of Federal Regulations 120.2(b)(5)). Although hydrology indicators were present at the ponds, including water, saturation, and mud cracks, hydrophytic vegetation was not. Due to soil disturbances from grading and excavating, and the relative newness of the ponds having been constructed in what was likely upland, hydric soils were not expected to be present. The ponds did not meet the criteria necessary for three-parameter wetlands due to the lack of required indicators. These features are unlikely to be considered jurisdictional.

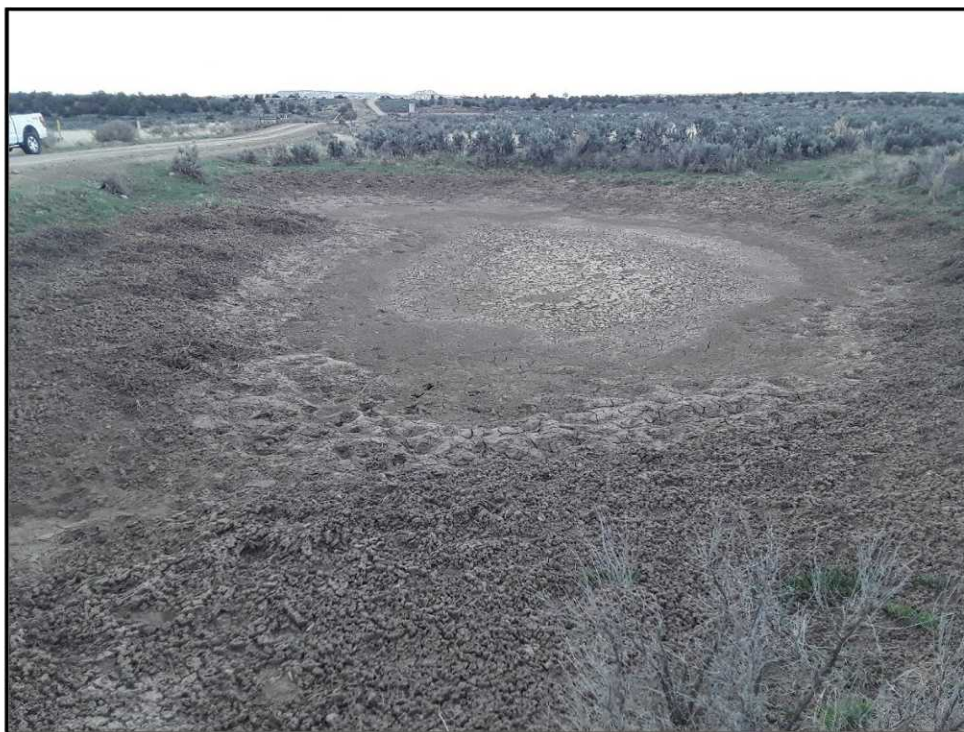
Figure 2. Overview of P02, a non-wetland surface aquatic feature (pond), facing south on April 4, 2023.

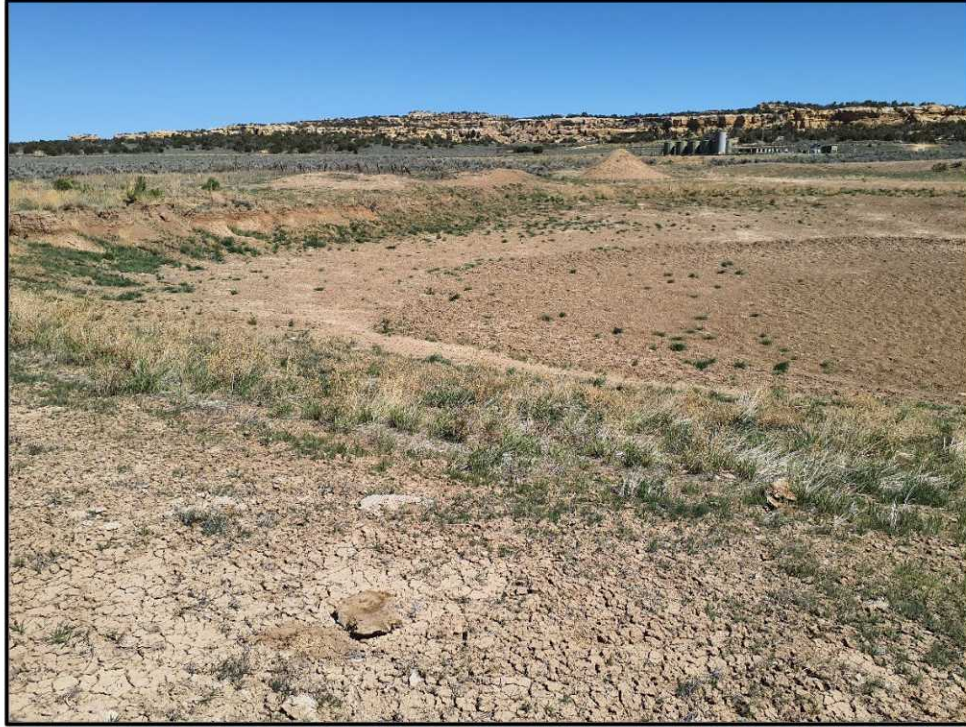
Figure 3. Overview of P03, a non-wetland surface aquatic feature (pond), facing north toward WPX's NE Chaco COM #254H APD project and cattle scat in foreground on May 8, 2024.

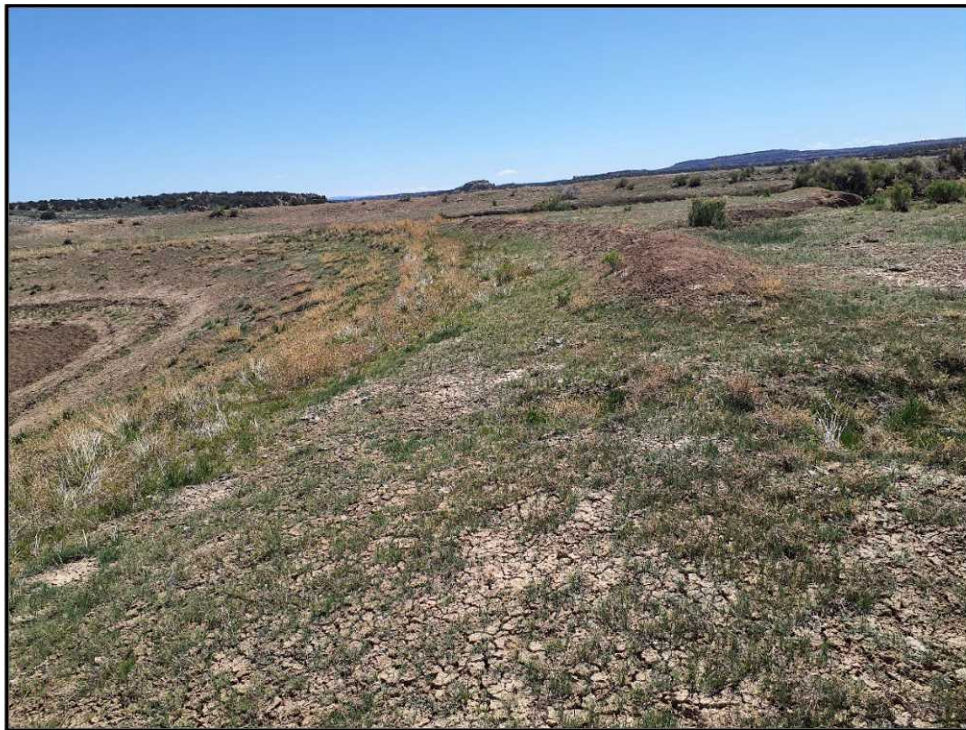
Figure 4. Overview of P03, a non-wetland surface aquatic feature (pond), facing east toward dike and berm structures on May 8, 2024.

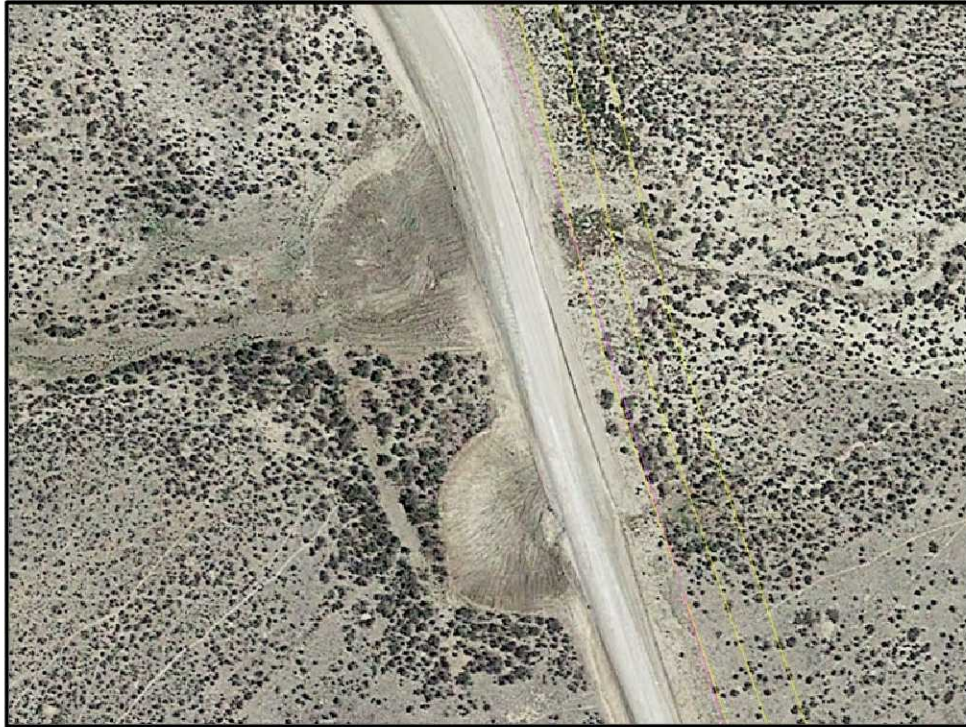
Figure 5. Google Earth Imagery Date 6/24/2014 – P01 and P02 - evidence of manmade livestock ponds; note the grading from heavy equipment cleaning out the area of the ponds.

SWCA further investigated historical imagery available from Google Earth Pro. Imagery from 2014 shows what appears to be heavy equipment tracks from grading or cleaning of the ponds P01 and P02 (Figure 5) (Google Earth Pro 2025). Imagery from 2017 of ponds P01 and P02 show the ponds with contained water held by constructed dikes on the western and southern sides of the ponds (Figure 6) (Google Earth Pro 2025). Imagery from 2024 of P03 shows what appears to be a constructed dike to the eastern side of the pond (Figure 7) (Google Earth Pro 2025).

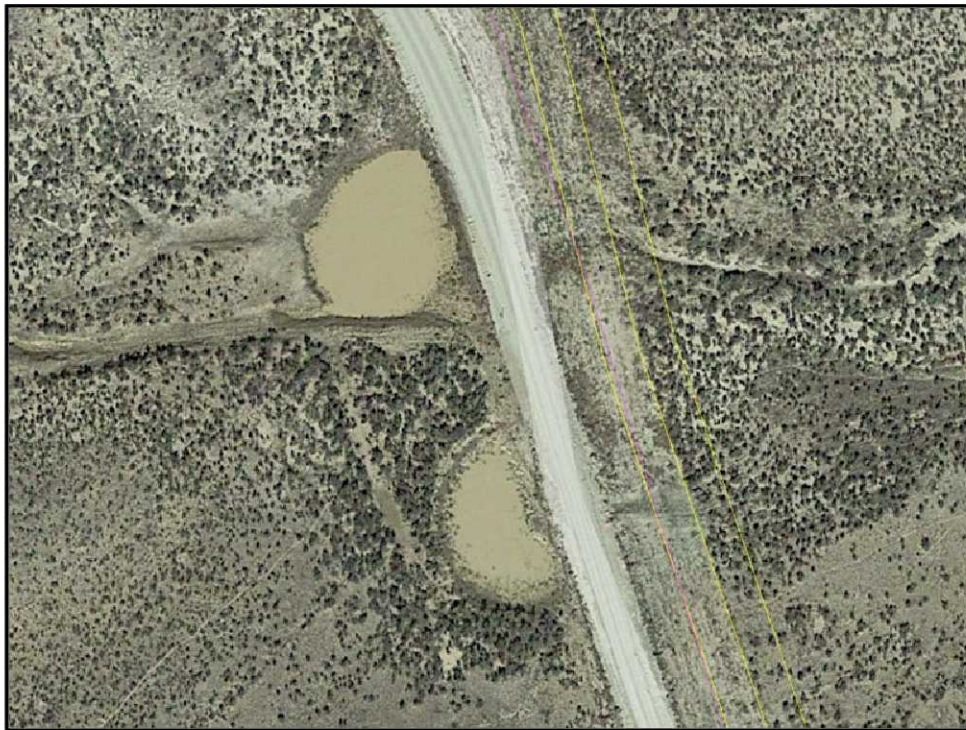
Figure 6. GoogleEarth Imagery Date 10/13/2017 – P01 and P02 - evidence of manmade livestock ponds; note the surrounding dikes constructed to contain water.

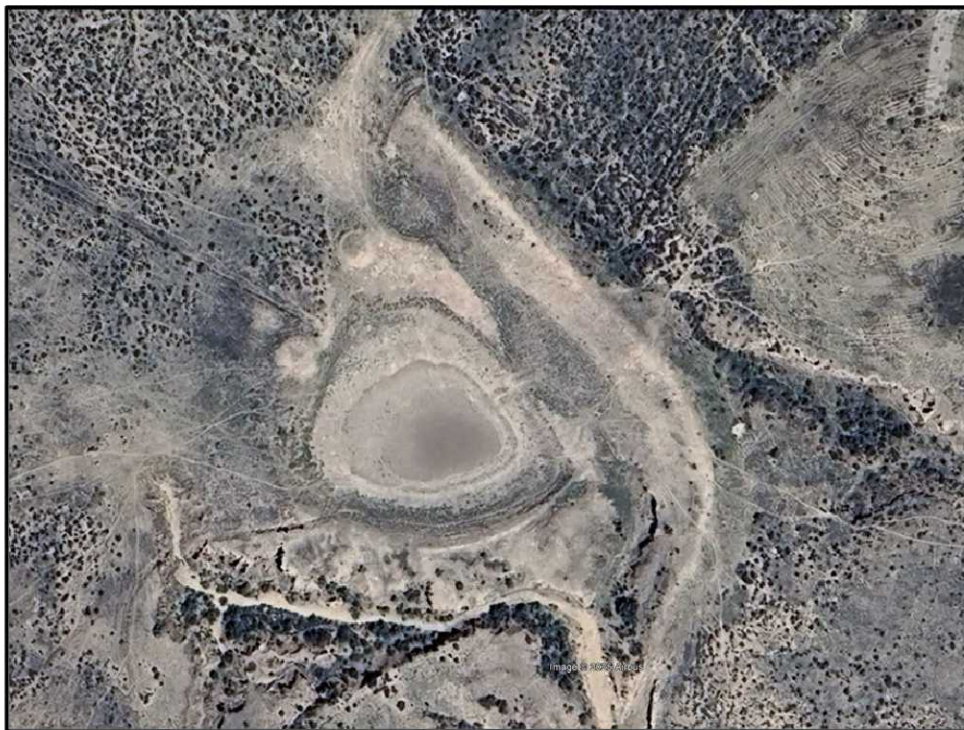
Figure 7. GoogleEarth Imagery Date 5/21/2024 – P03 - evidence of manmade pond; note the dike on the eastern side.

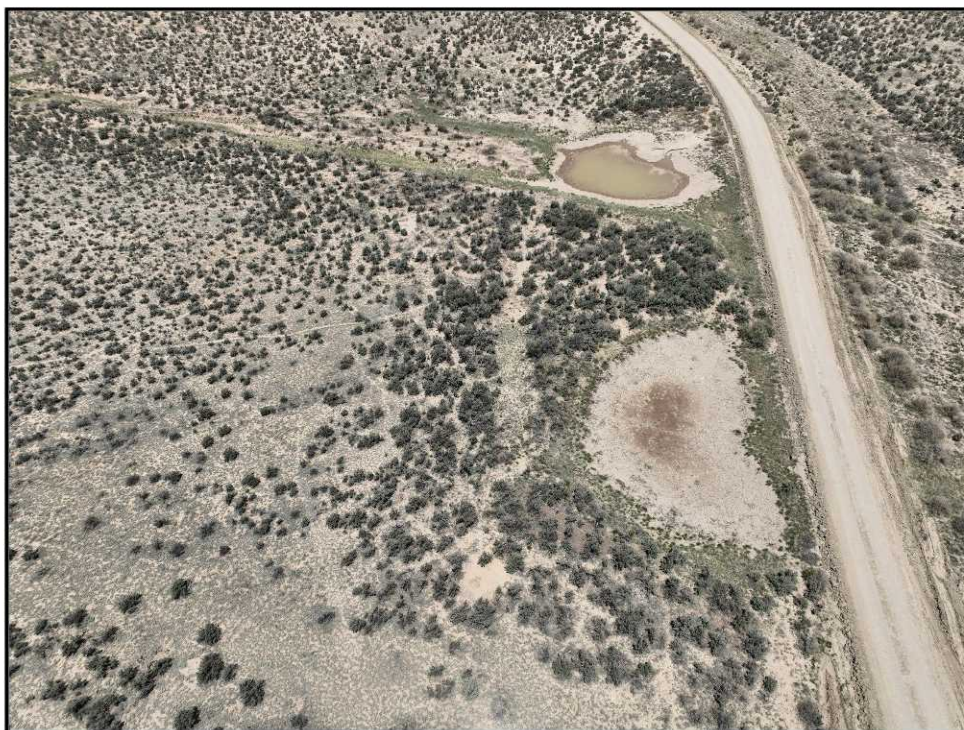
Figure 8. Overview of P01 (top) and P02 (bottom), from drone imagery facing north on May 12, 2025.

Enduring investigated the history of the construction of these ponds and found that all three were likely constructed and have been cleaned out in association with nearby WPX Energy Production, LLC (WPX) projects and existing resource road upgrades (Enduring 2025). The Surface Use Plan of Operation for WPX's NE Chaco COM #254H APD project (DOI-BLM-NM-F010-2019-0084-EA) just north of the observed pond P03 states "Sediment would be cleaned from a stock pond located to the south of the proposed project area". Enduring also collected drone imagery of the ponds on May 12, 2025 (Figures 8 through 10).

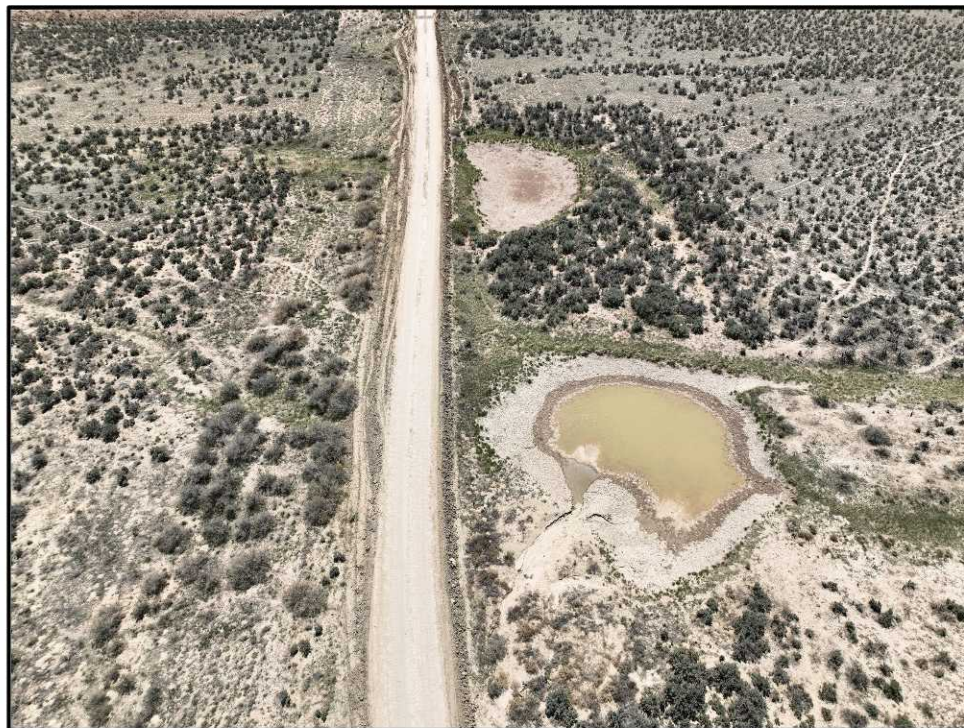
Figure 9. Overview of P01 (bottom) and P02 (top), from drone imagery facing south on May 12, 2025.

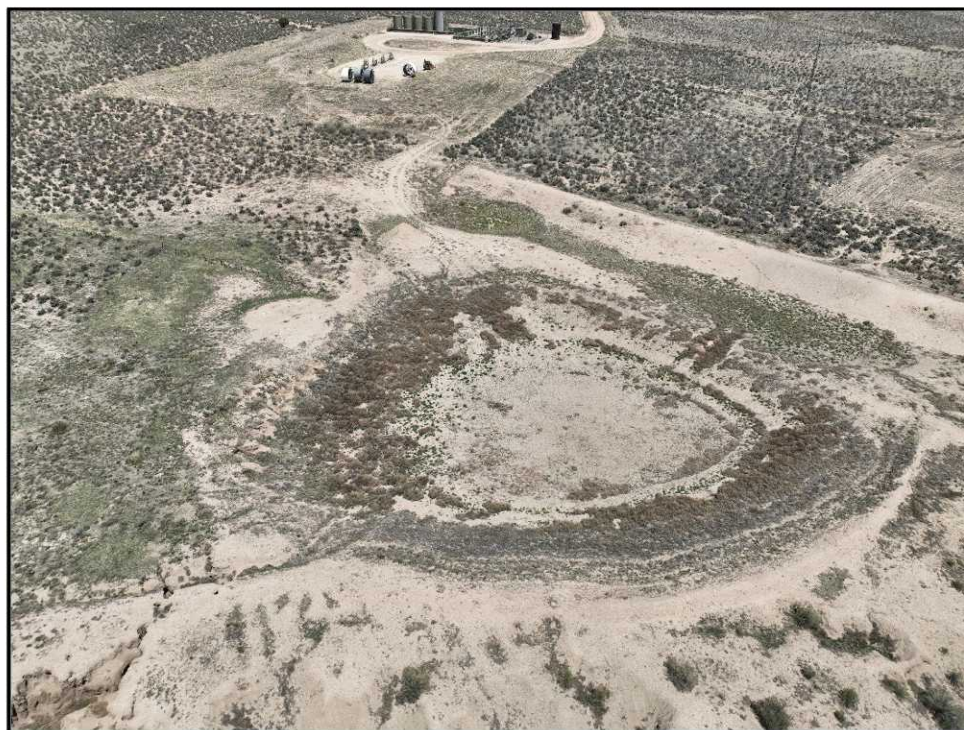
Figure 10. Overview of P03 from drone imagery facing north toward WPX's NE Chaco COM #254H APD project on May 12, 2025.
