# C-147 REGISTRATION PACKAGE

## Gallo Canyon Unit 2306 M26A AST Pad Recycling Facility and Recycling Containment

October 2025

## **EXHIBIT B. RECYCLING FACILITY AND RECYCLING CONTAINMENT SITE DIAGRAM**

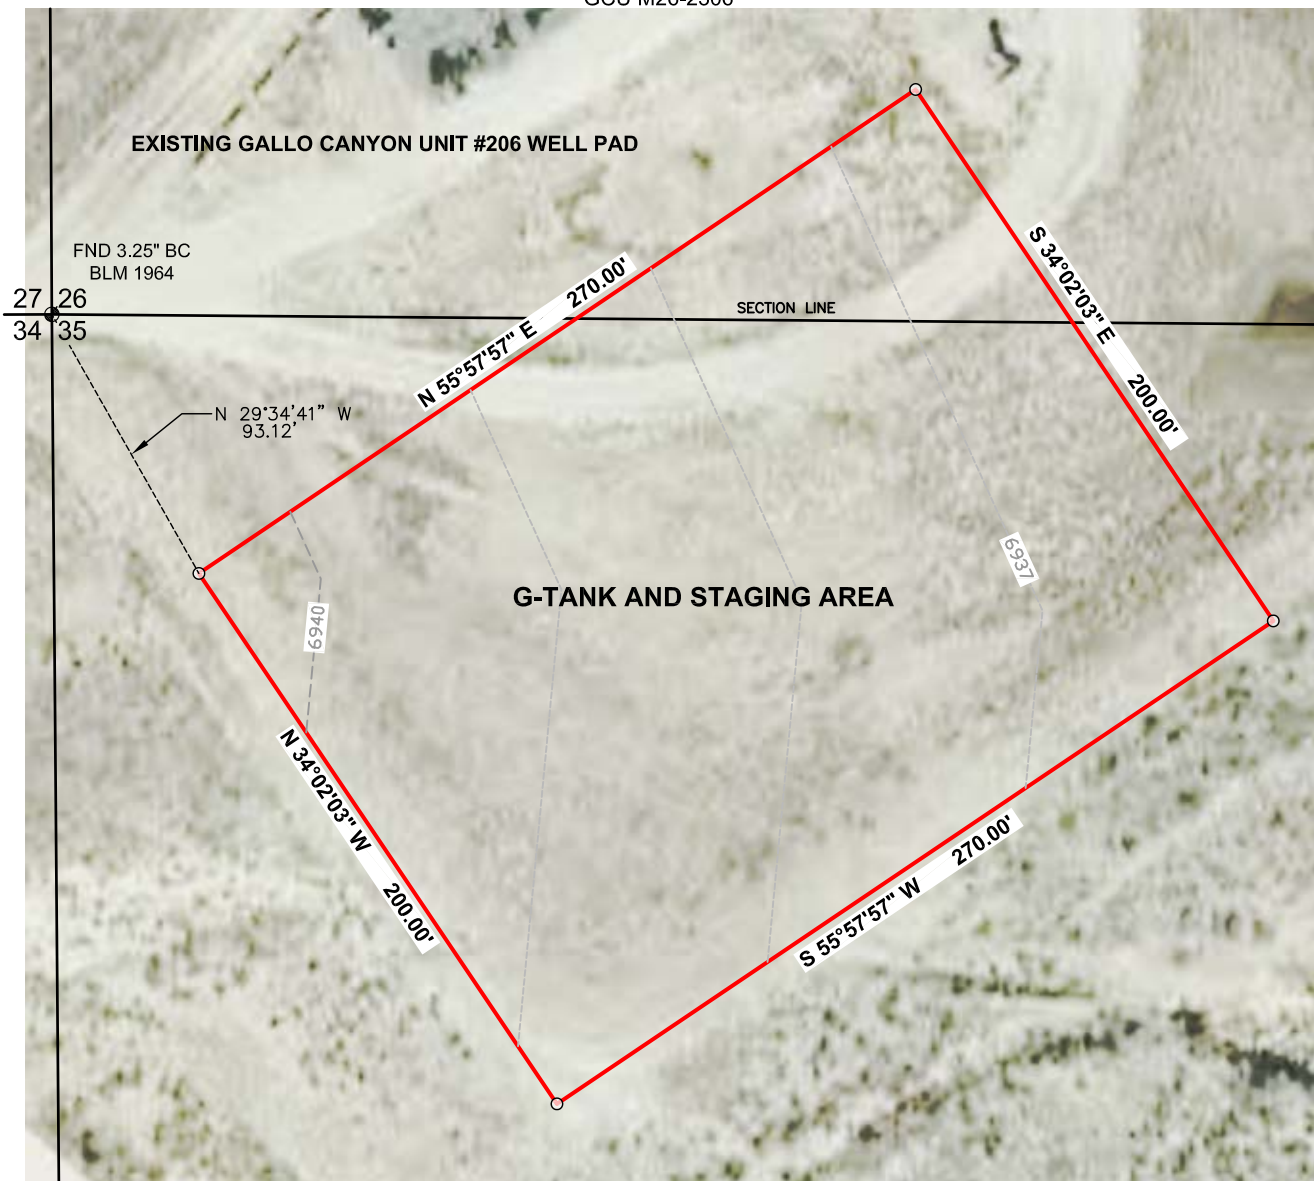
**DJR OPERATING, LLC**  
**GALLO CANYON UNIT #309H**  
**G-TANK AND STAGING AREA**  
LOCATED IN THE SW/4 SW/4 OF SECTION 26  
AND THE NW/4 NW/4 OF SECTION 35  
T23N, R6W, N.M.P.M.,  
SANDOVAL COUNTY, NEW MEXICO  
FINISHED PAD ELEVATION: 6936.0', NAVD 88  
GCU M26-2306

**TOTAL PERMITTED AREA**  
**270' x 200' = 1.2409 ACRES**  
**SCALE: 1" = 100'**  
**DATE: 08/27/20**  
**DRAWN BY: GRR**

SLOPES TO BE  
CONSTRUCTED TO  
MATCH THE ORIGINAL  
CONTOURS AS CLOSE  
AS POSSIBLE.

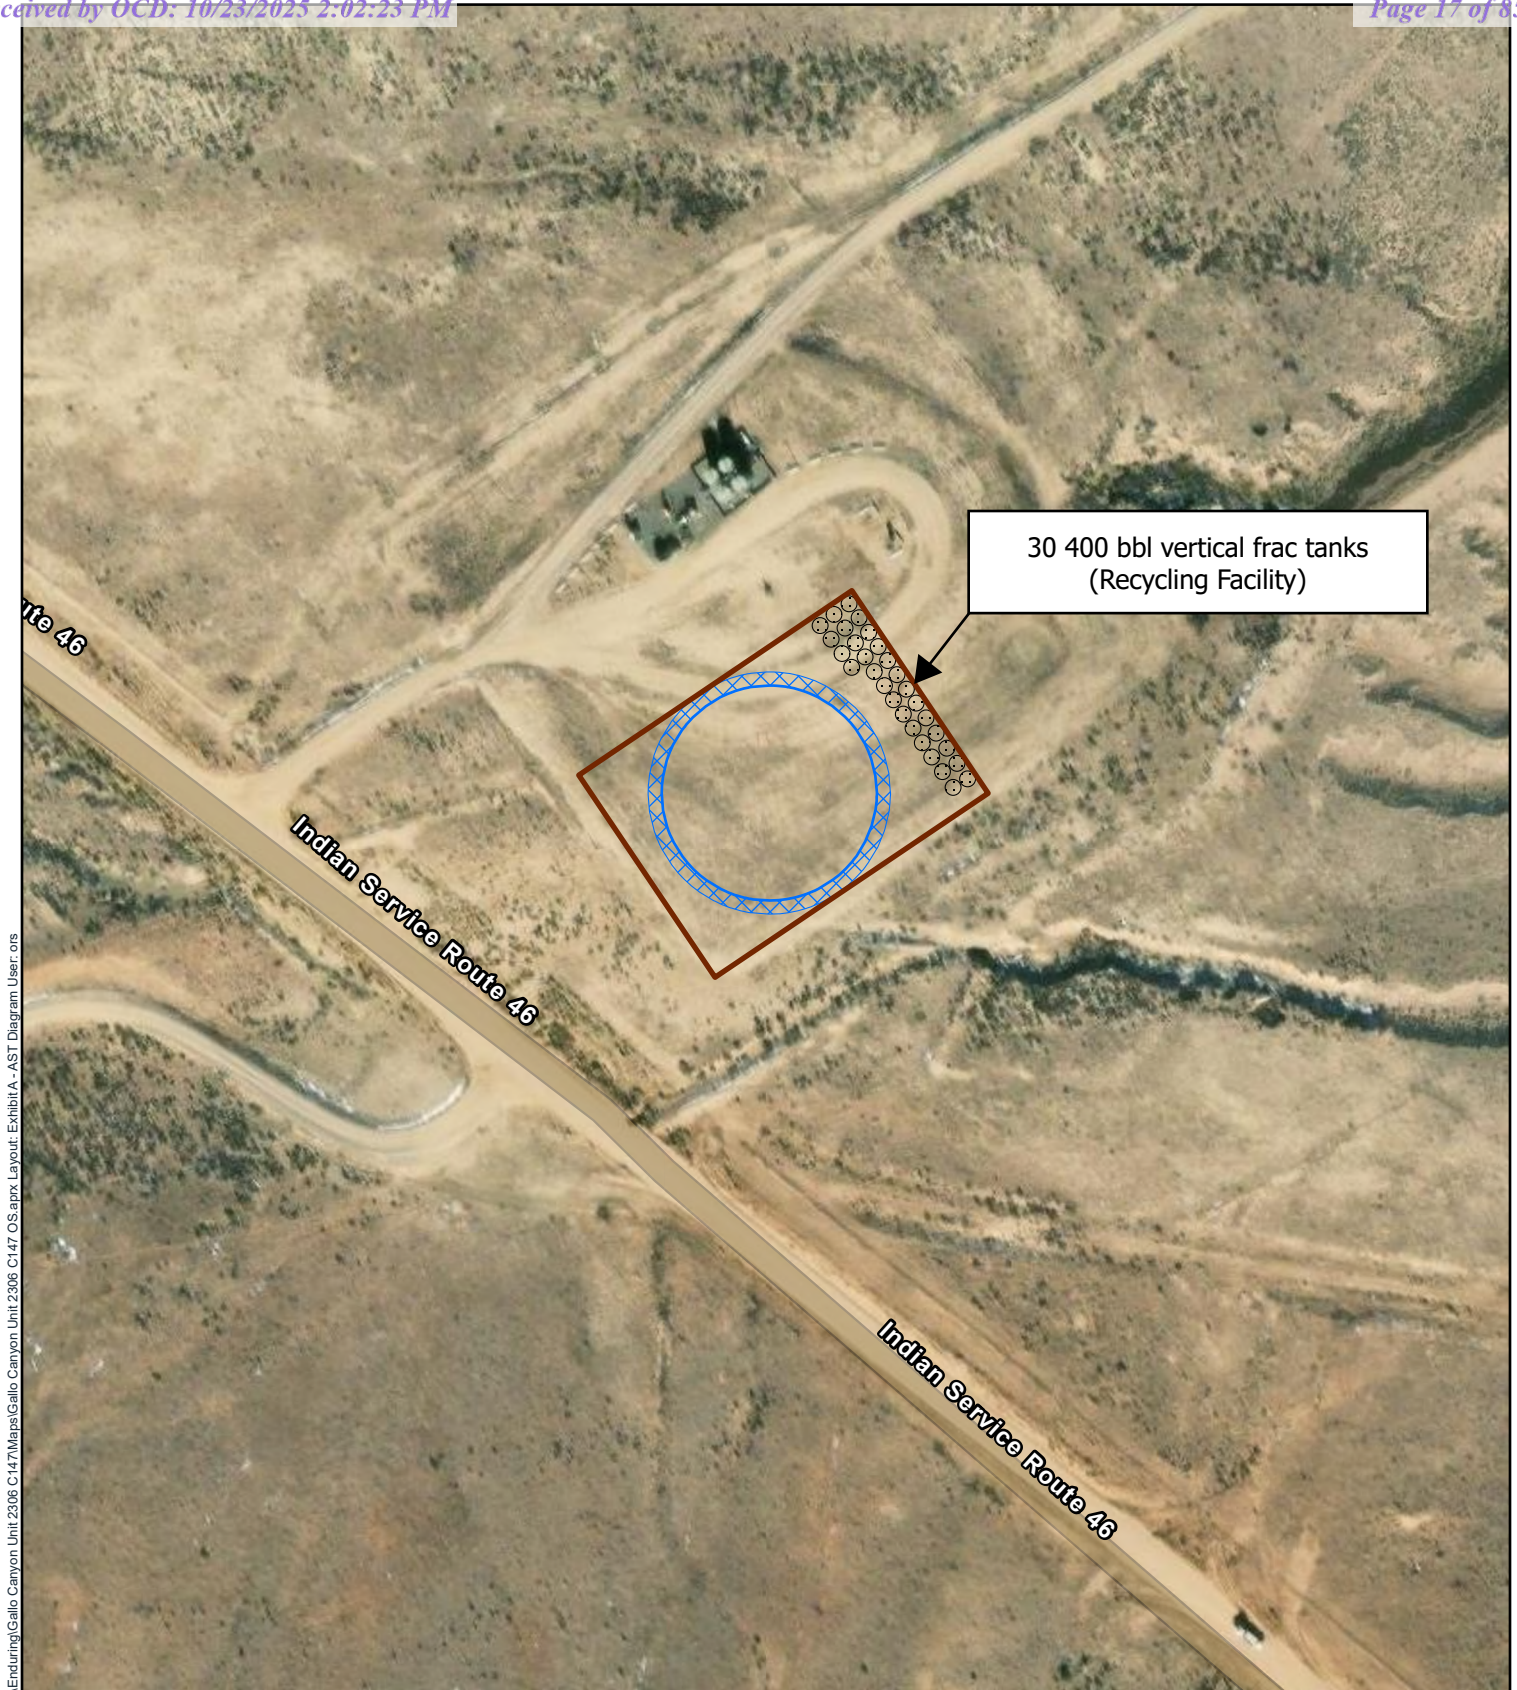
- Staging Area
- 60K bbl Aboveground Storage Tank - 190' diameter
- Aboveground Storage Tank Construction Buffer -12' wide
- 400 bbl Vertical Frac Tanks - 13' diameter

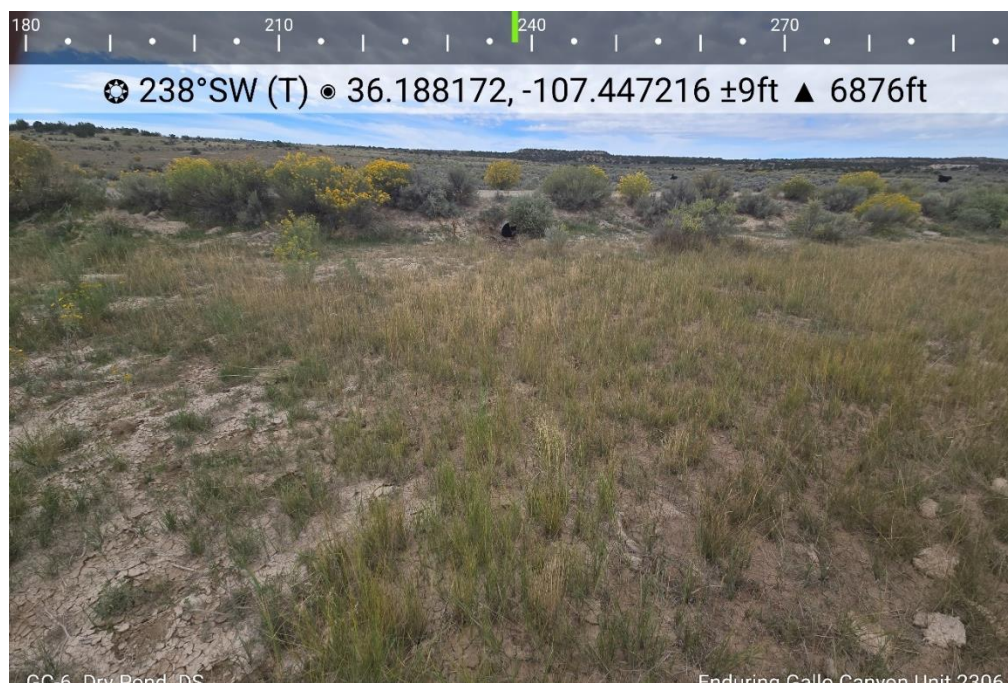
**Photograph 1. The freshwater pond was dry in October 2025.**

Barr biologist John Dodge conducted the aquatic resources delineation survey on June 27, 2025. The field survey verified the absence of a freshwater pond and any associated wetlands (Map 1; Photograph 1 and Photograph 2). There is no defined inlet or outlet to the pond, which is fed by seasonal precipitation, snowmelt, and runoff via a culvert placed in the existing road. The NWI mapped R4SBJ channel was assessed and did not support a defined channel with an OHWM (Photograph 3). The intermittent stream mapped on the NHD did not have a defined channel; however, there is an ephemeral feature located outside the 200-foot buffer (Photograph 4; GC-9 as shown on Map 1). Stream duration assessment method datasheets are attached.

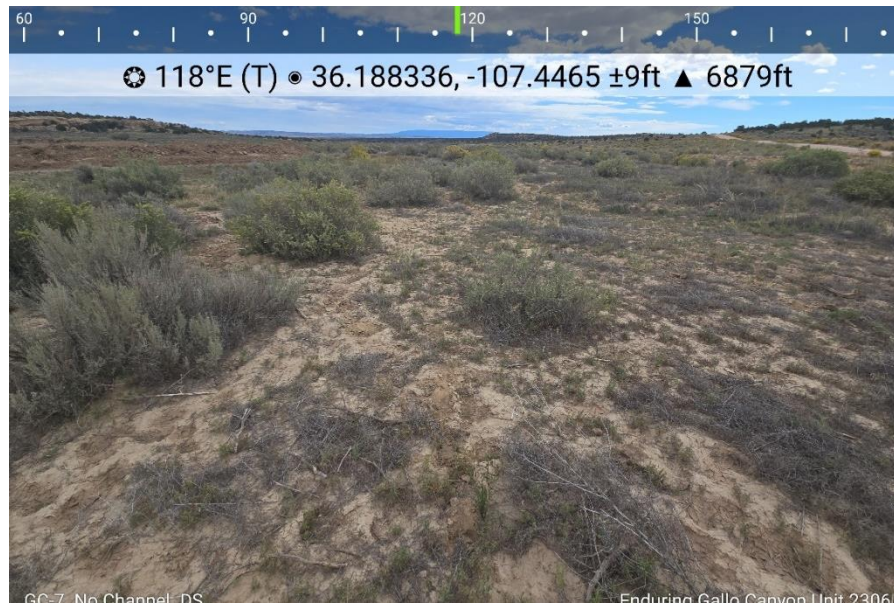
**Photograph 3. No defined channel occurs along the National Wetland Inventory-mapped ephemeral channel designated R4SBJ.**

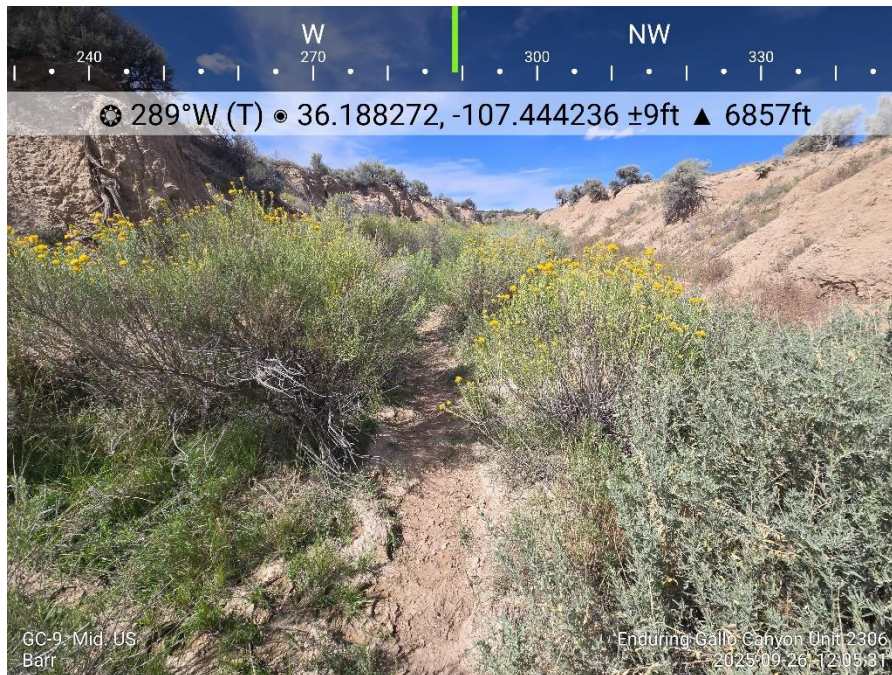
**Photograph 4. Ephemeral feature at GC-9 outside 200-foot buffer**
