## Report Type: Closure Report 2RP-5501

Site:	Wyatt BHT State #1					
Company:	EOG Resources					
Section, Township and Range	Unit C	Sec. 06	T 25S	R 30E		
County:	Eddy County					
GPS:	32.16535			-103.92085		
Surface Owner:	State					
Directions:	From the intersection of Longhorn Rd and Pipeline Rd No 1, travel northeast on Pipeline Rd No. 1 for approx. 7.0 miles, turn north onto lease road and continue for 2.18 mi., turn north onto lease road and continue for 1.2 miles to location.

**Re: Closure Report for the EOG Resources, Wyatt BHT State #1, Unit C, Section 06, Township 25 South, Range 30 East, Eddy County, New Mexico. 2RP-5501**

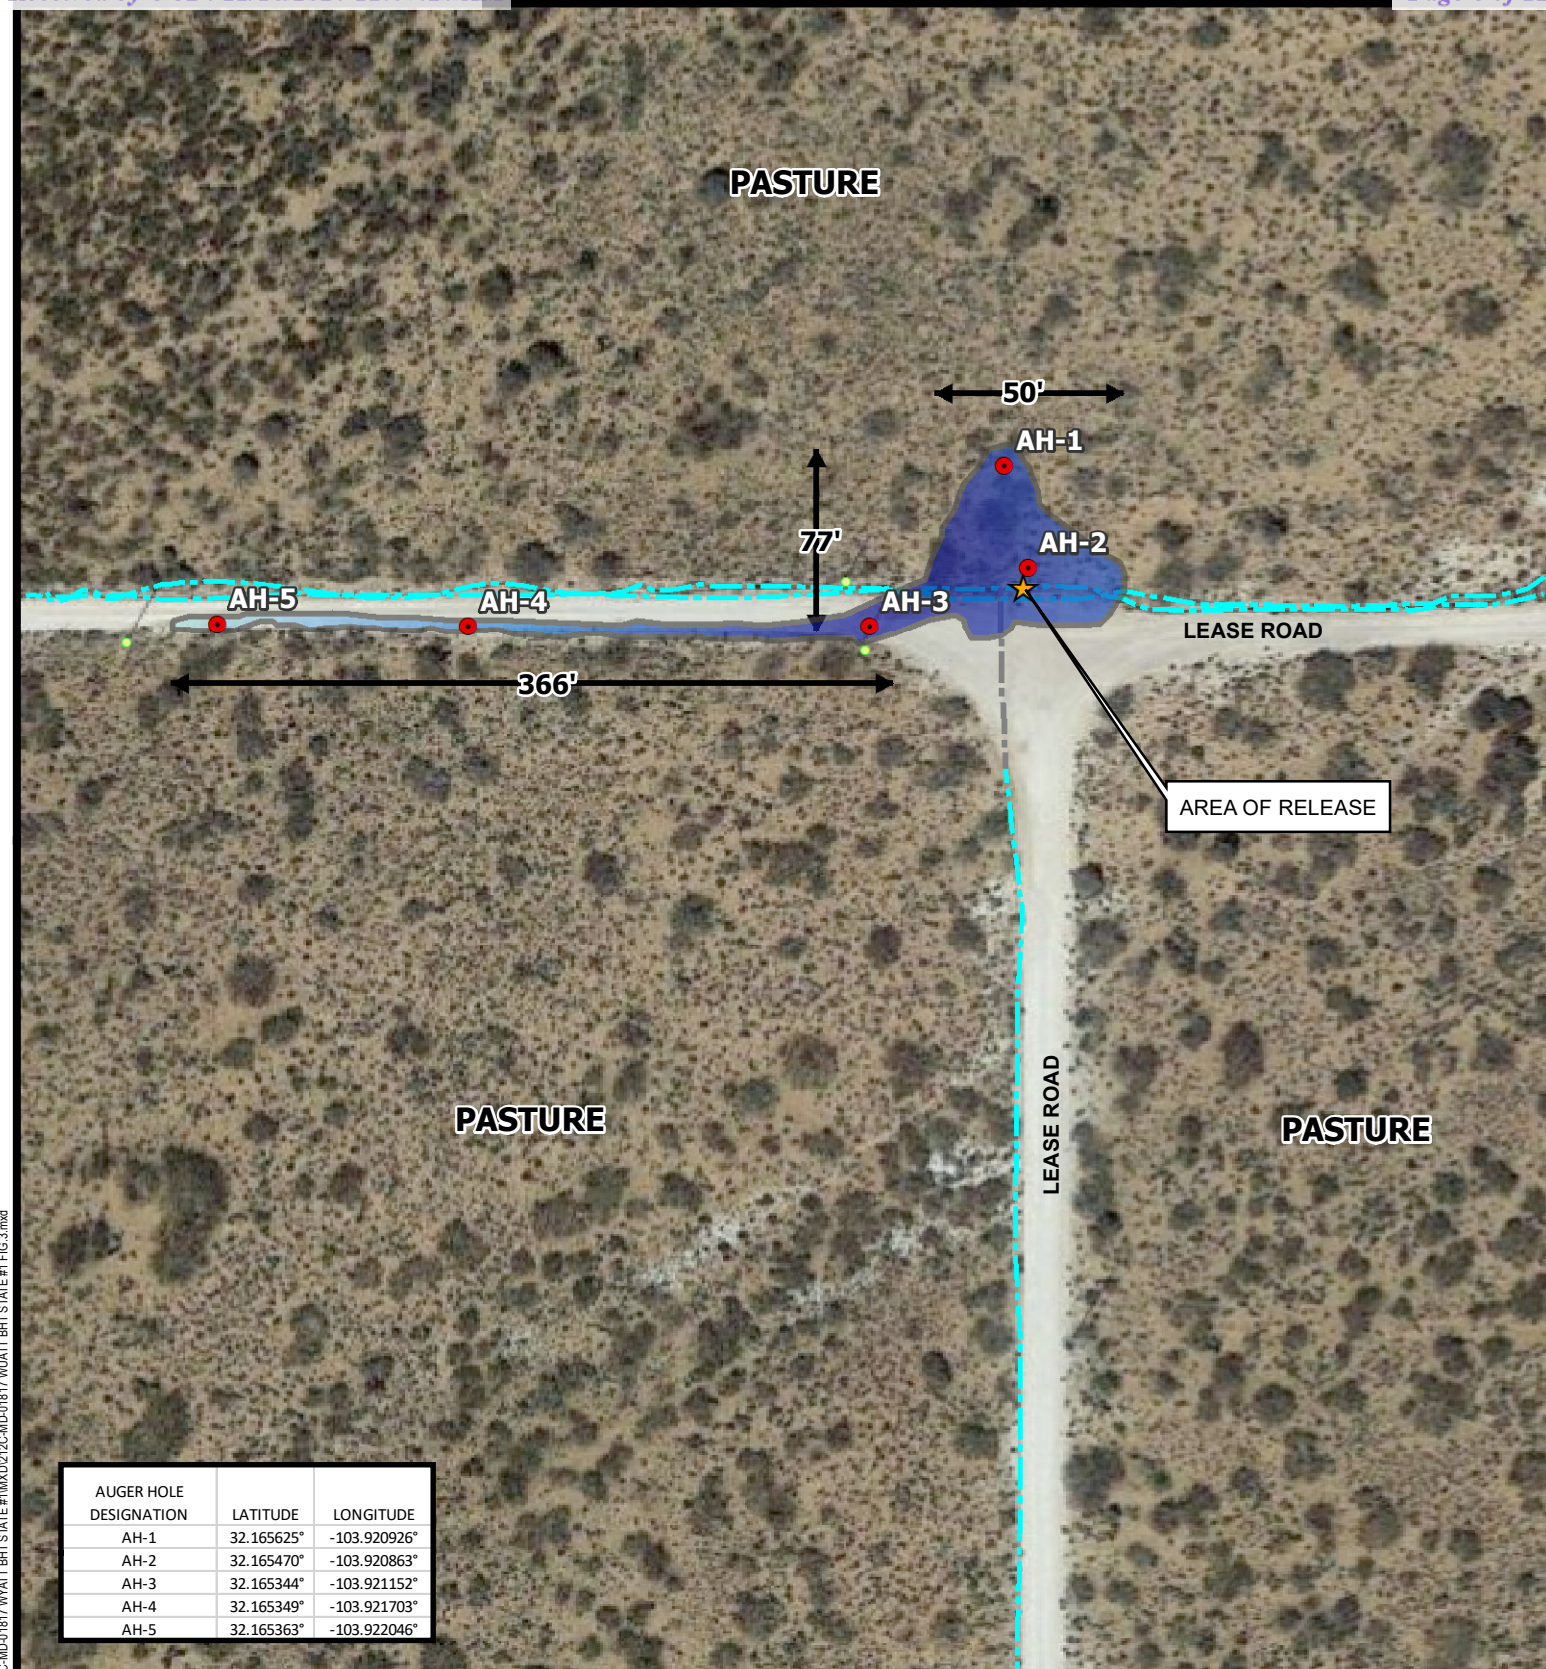
FIGURE  
3

AUGER HOLE DESIGNATION	LATITUDE	LONGITUDE
AH-1	32.165625°	-103.920926°
AH-2	32.165470°	-103.920863°
AH-3	32.165344°	-103.921152°
AH-4	32.165349°	-103.921703°
AH-5	32.165363°	-103.922046°

● AUGERHOLE SAMPLE LOCATIONS

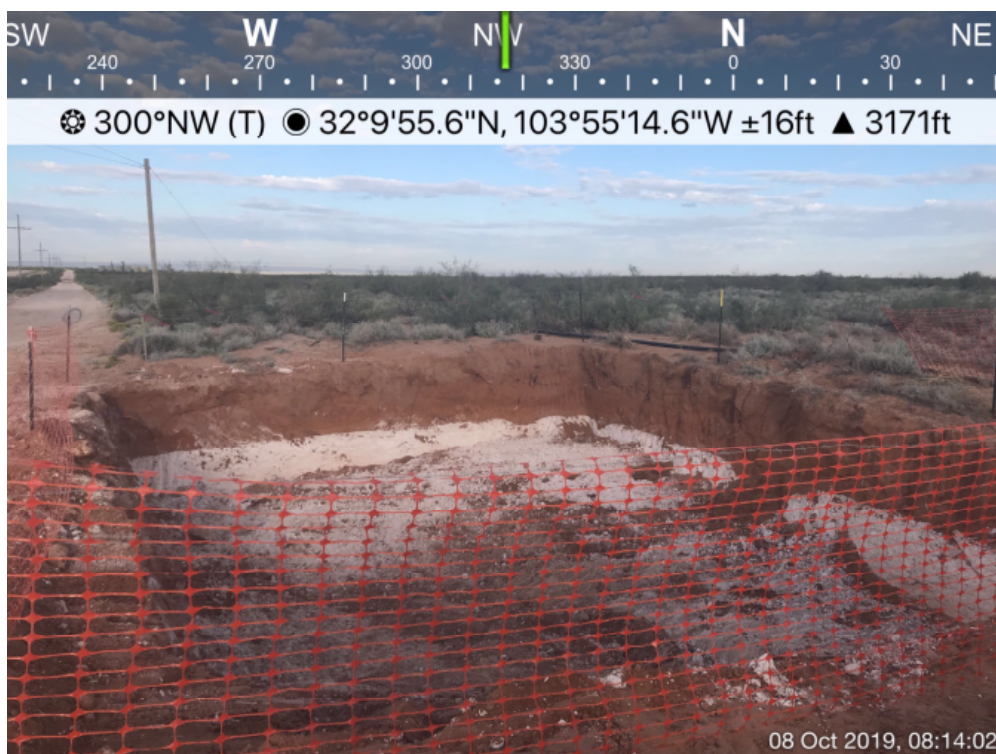
View Northwest – Excavated Area of AH-2

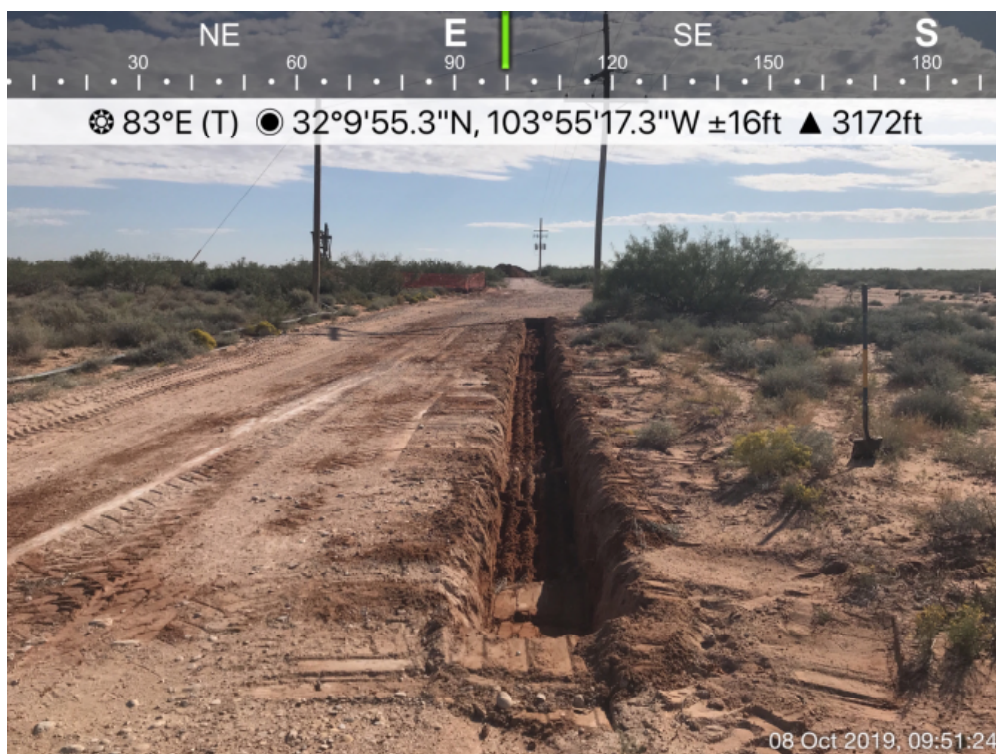
View East – Excavated Area of AH-3

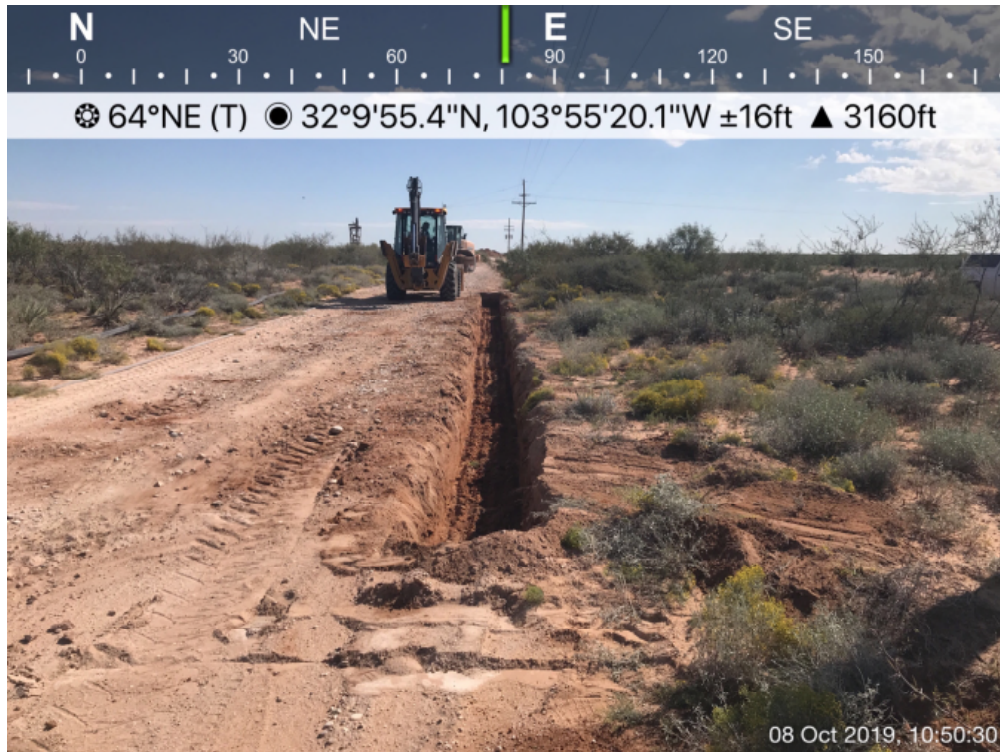
View East – Excavated Area of AH-5
