**RE: SITE ASSESSMENT AND CLOSURE REPORT FOR A HISTORIC BLOW DOWN PIT LOCATED AT THE CENTRAL BISTI UNIT #4 WELL SITE (API: 30-045-13282), SAN JUAN COUNTY, NEW MEXICO**

# **SITE ASSESSMENT AND CLOSURE REPORT**

**LOCATION:  
CENTRAL BISTI UNIT #4 WELL SITE  
SECTION 6, TOWNSHIP 25N, RANGE 12W  
SAN JUAN COUNTY, NEW MEXICO**

**PROJECT #17035-0150  
NOVEMBER 2019**

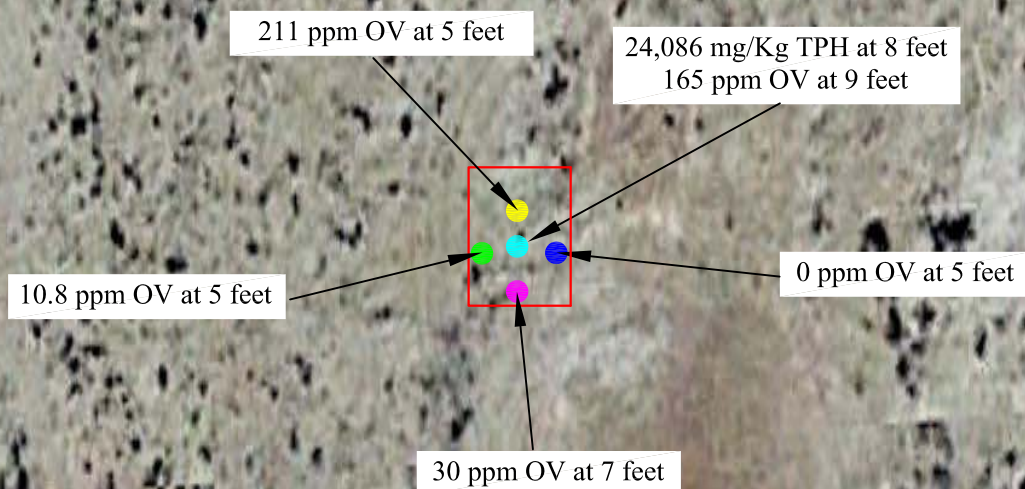
Recommended Excavation  
Dimensions:  
20 feet by 15 feet by 12 feet below  
ground surface = 134 cubic yards

Based on field screening activities and the laboratory analytical results, Envirotech recommended further excavation of the historic blow down pit. Envirotech recommended the impacted area be excavated to approximately 20 feet by 15 feet by 12 feet bgs.

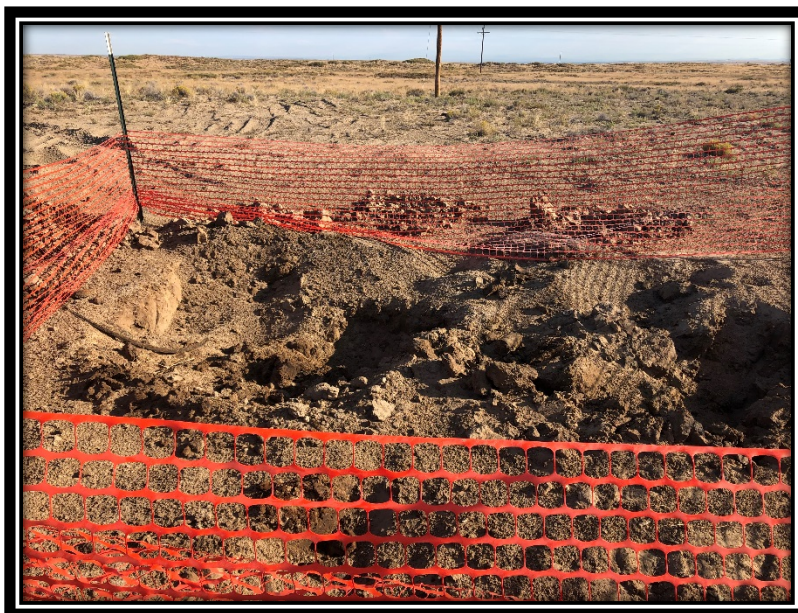
Picture 1: Site Assessment Activities (View 1)

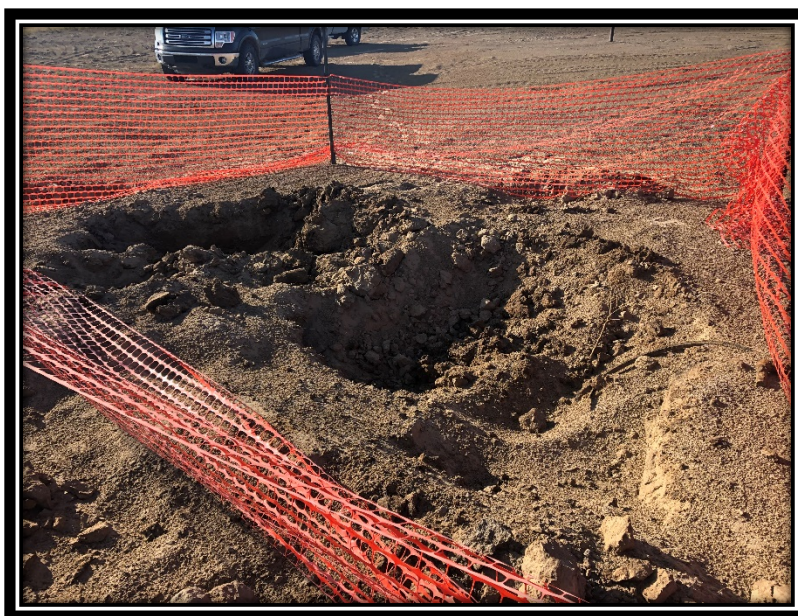
Picture 2: Site Assessment Activities (View 2)

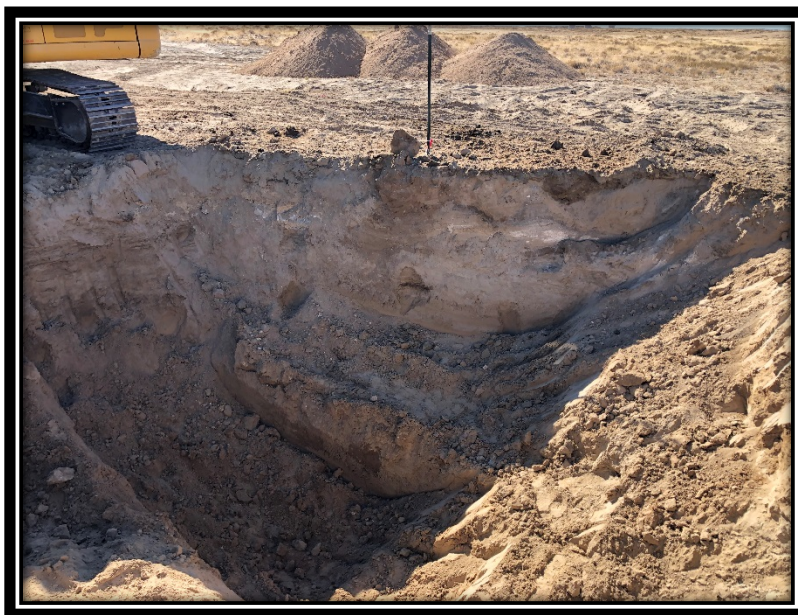
Picture 3: View of West Wall

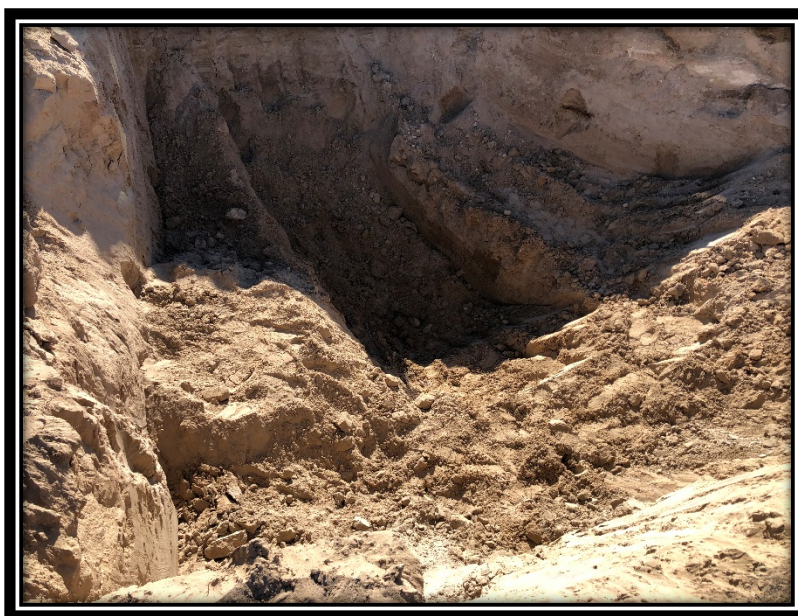
Picture 4: View of Base Center and Base Perimeter

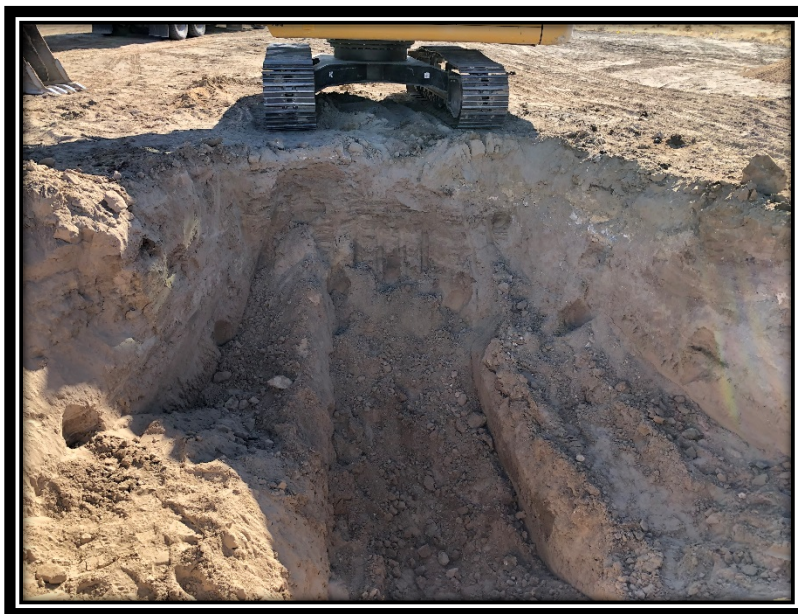
Picture 5: View of South Wall

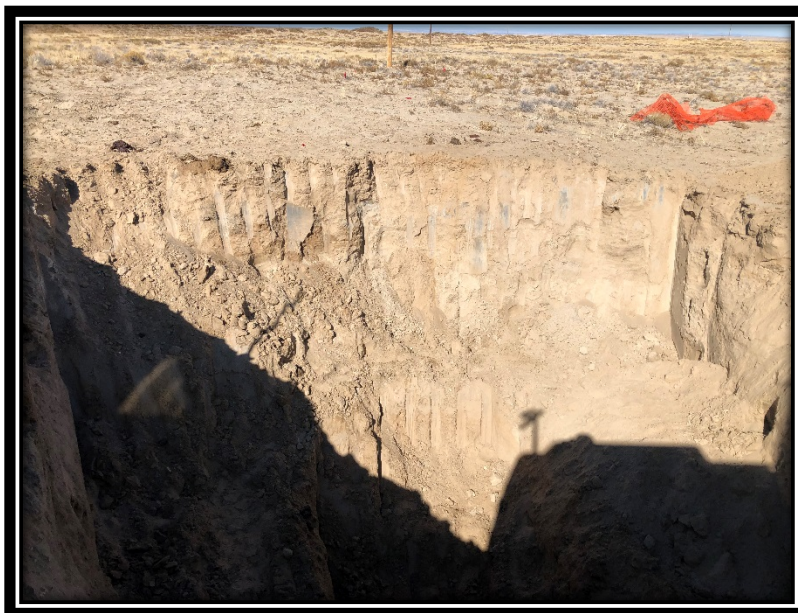
Picture 6: View of North Wall

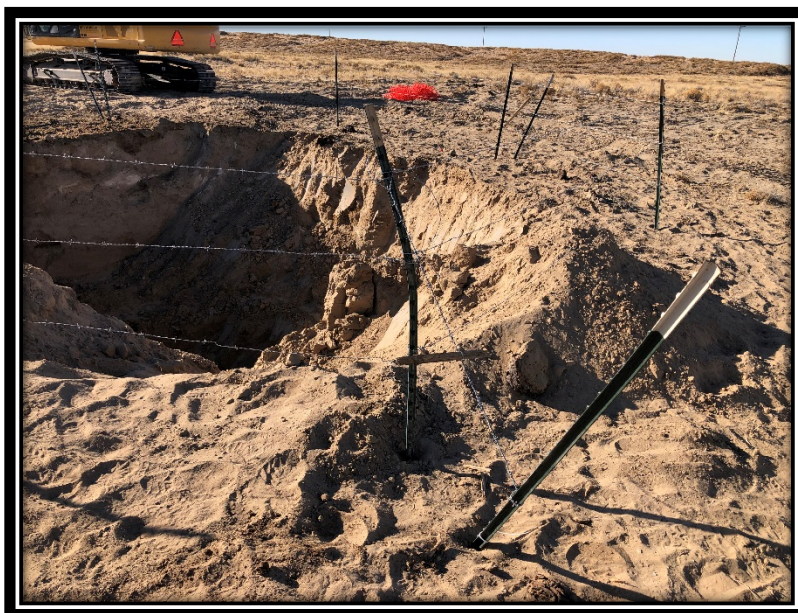
Picture 7: View of East Wall

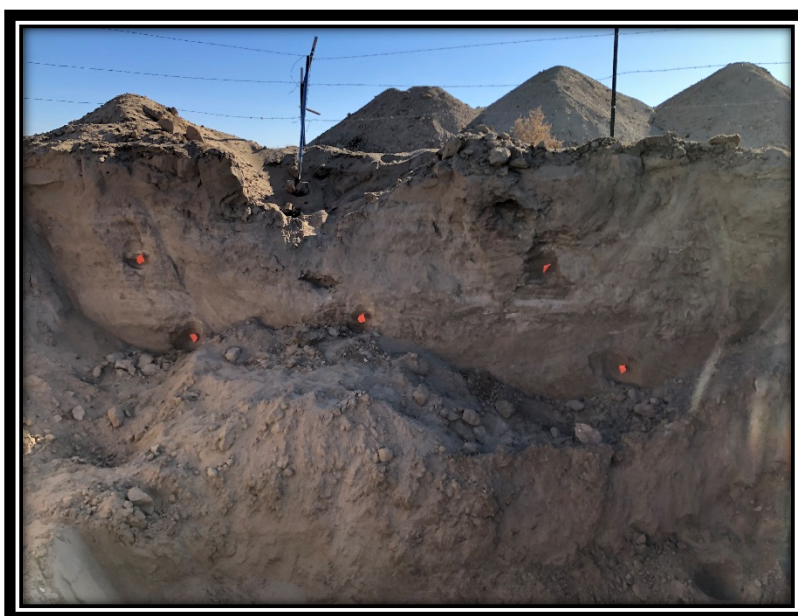
Picture 8: View of West Wall with Pin Flags (indicating sampling points)

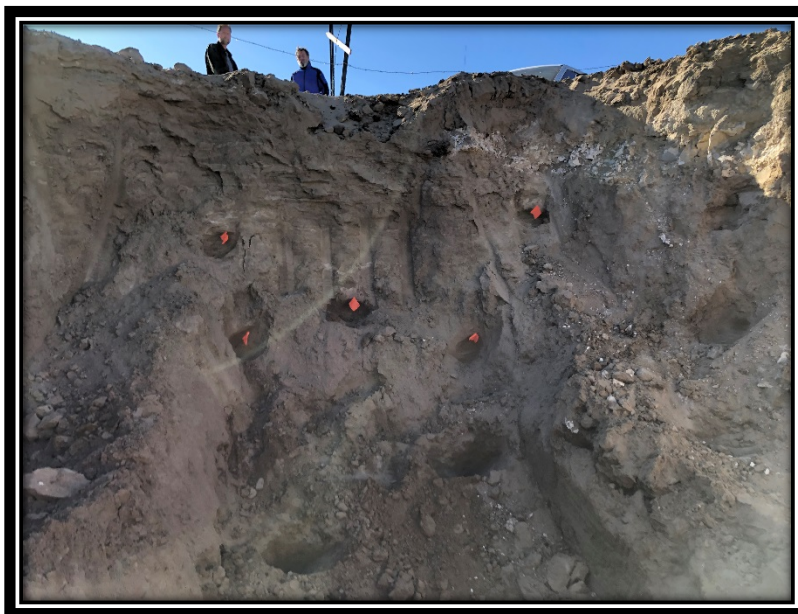
Picture 9: View of South Wall with Pin Flags (indicating sampling points)

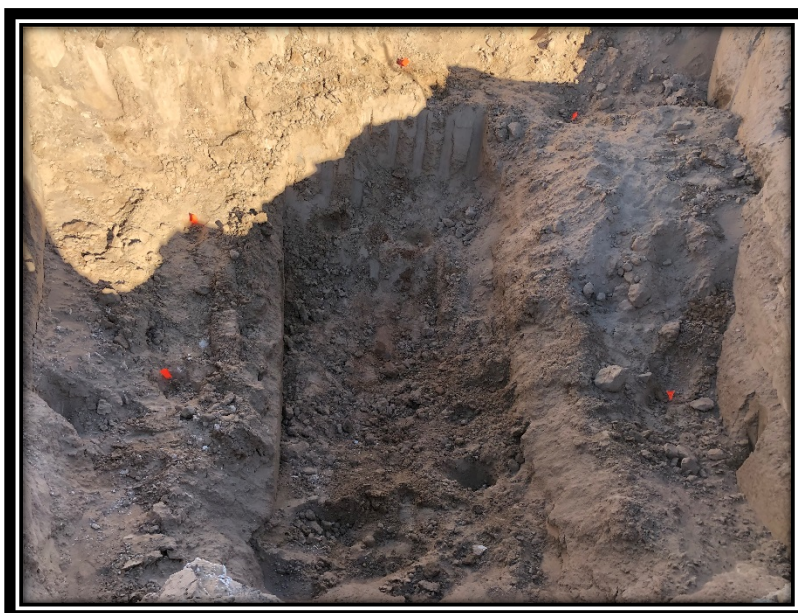
Picture 10: View of Base Perimeter with Pin Flags (indicating sampling points)

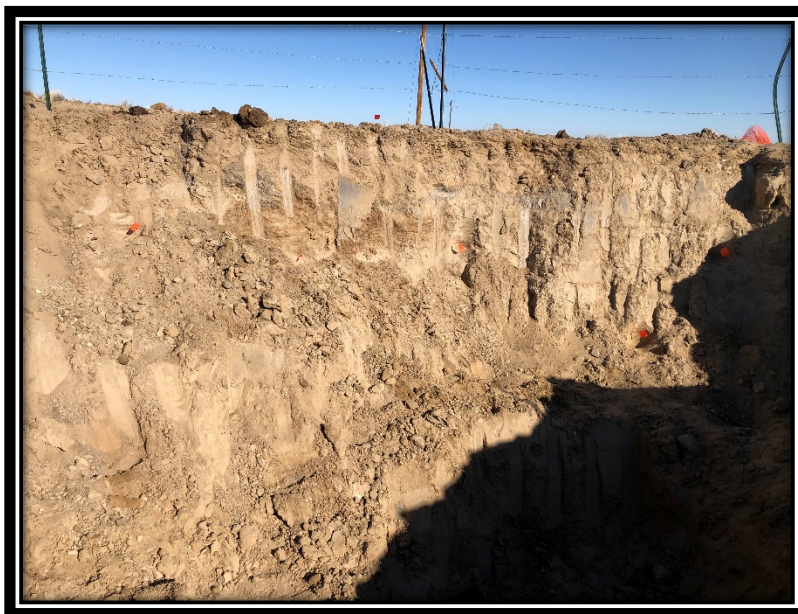
Picture 11: View of North Wall with Pin Flags (indicating sampling points)

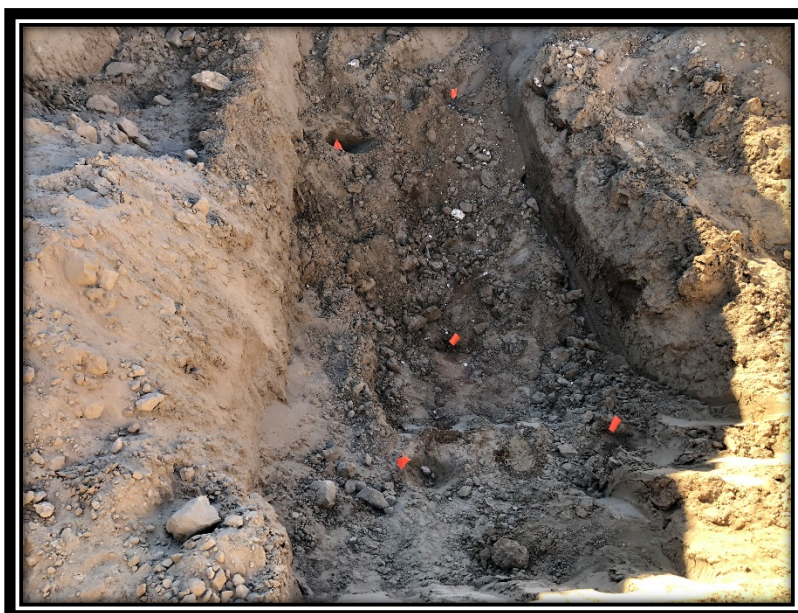
Picture 12: View of Base Center with Pin Flags (indicating sampling points)

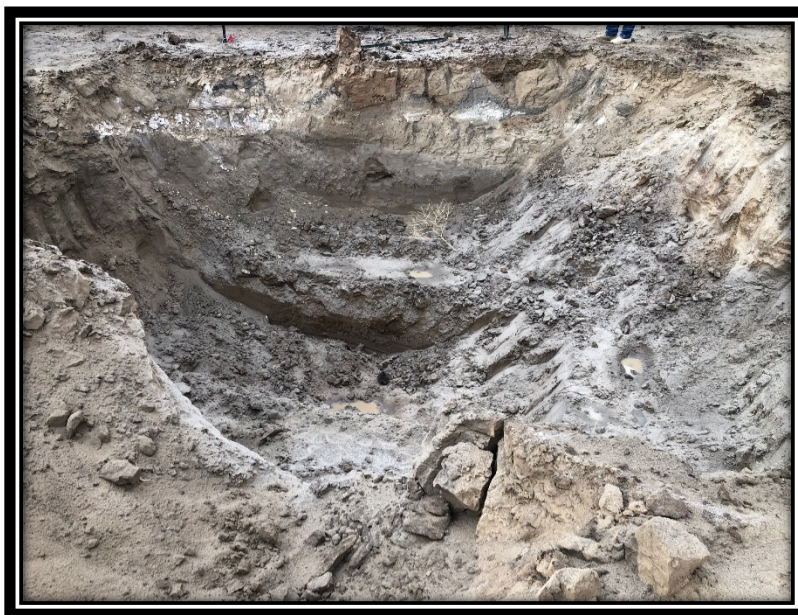
Picture 13: View of Additional Excavation of Base Center

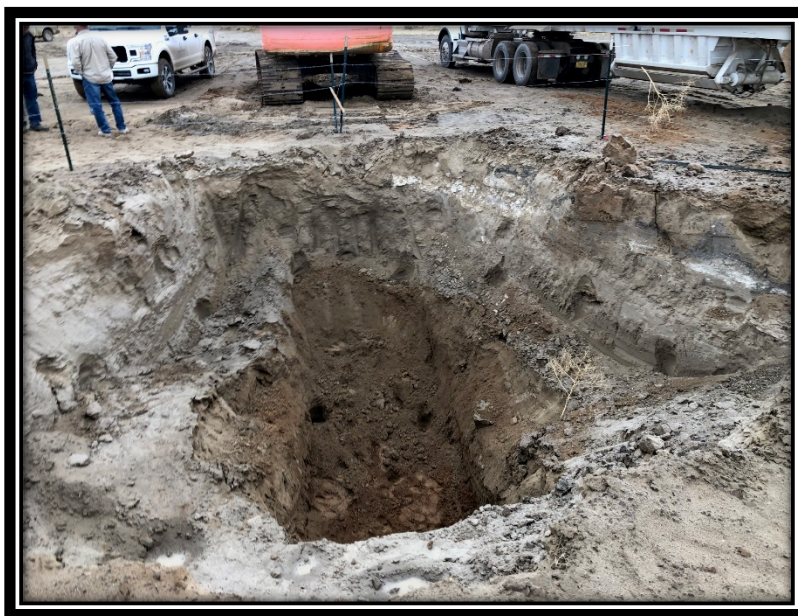
Picture 14: View of Base Center Sampling Points

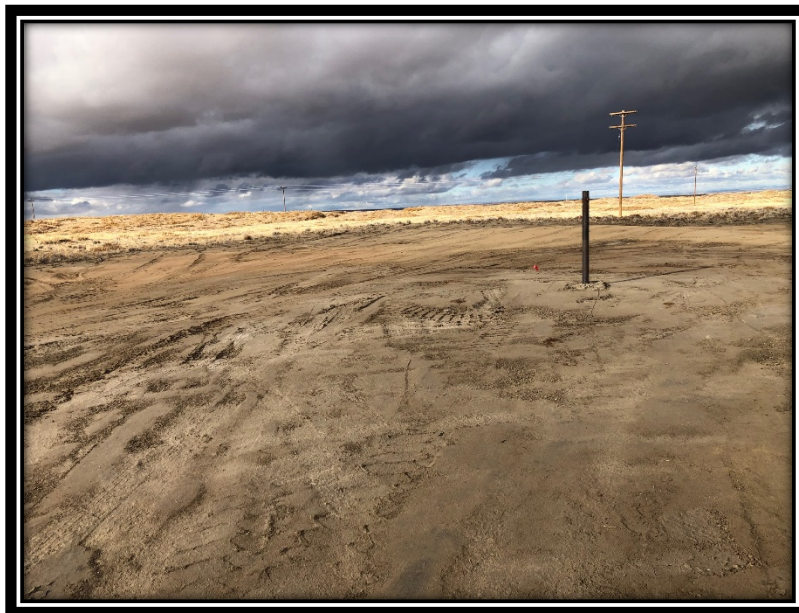
Picture 15: View of Recontoured Area (View 1)

Approximately 110 cubic yards of contaminated soil were excavated from the site and transported to Envirotech's NMOCD permitted soil remediation facility, *Landfarm 2*, located near Hilltop, New Mexico. To complete site restoration, clean backfill was transported to the site. The impacted area was backfilled and re-contoured to pre-incident condition on November 27, 2019. Transport and disposal documentation are provided in **Appendix G, Bills of Lading** and *Special Waste Manifest*.

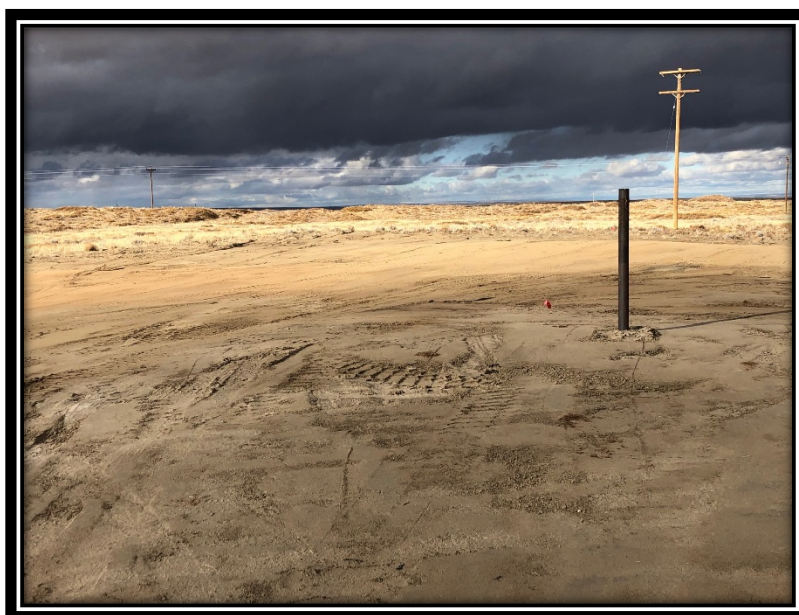
Picture 16: View of Recontoured Area (View 2)
