Release Notification

Site Name: Sheila Hixon 1	Site Type: Well Site
Date Release Discovered: 10/09/2019	API# (if applicable) 30-039-24165

RE: BGT and Release Closure Report for the Sheila Hixon-001 Well Site Located in Section 26, Township 25N, Range 3W, Rio Arriba County, New Mexico

**SITE PHOTOGRAPHY
DJR OPERATING
SHEILA HIXON-001 WELL SITE
API: 30-039-24165
SECTION 26, TOWNSHIP 25N, RANGE 3W
RIO ARRIBA COUNTY, NEW MEXICO
PROJECT # 17035-0132
OCTOBER 2019**

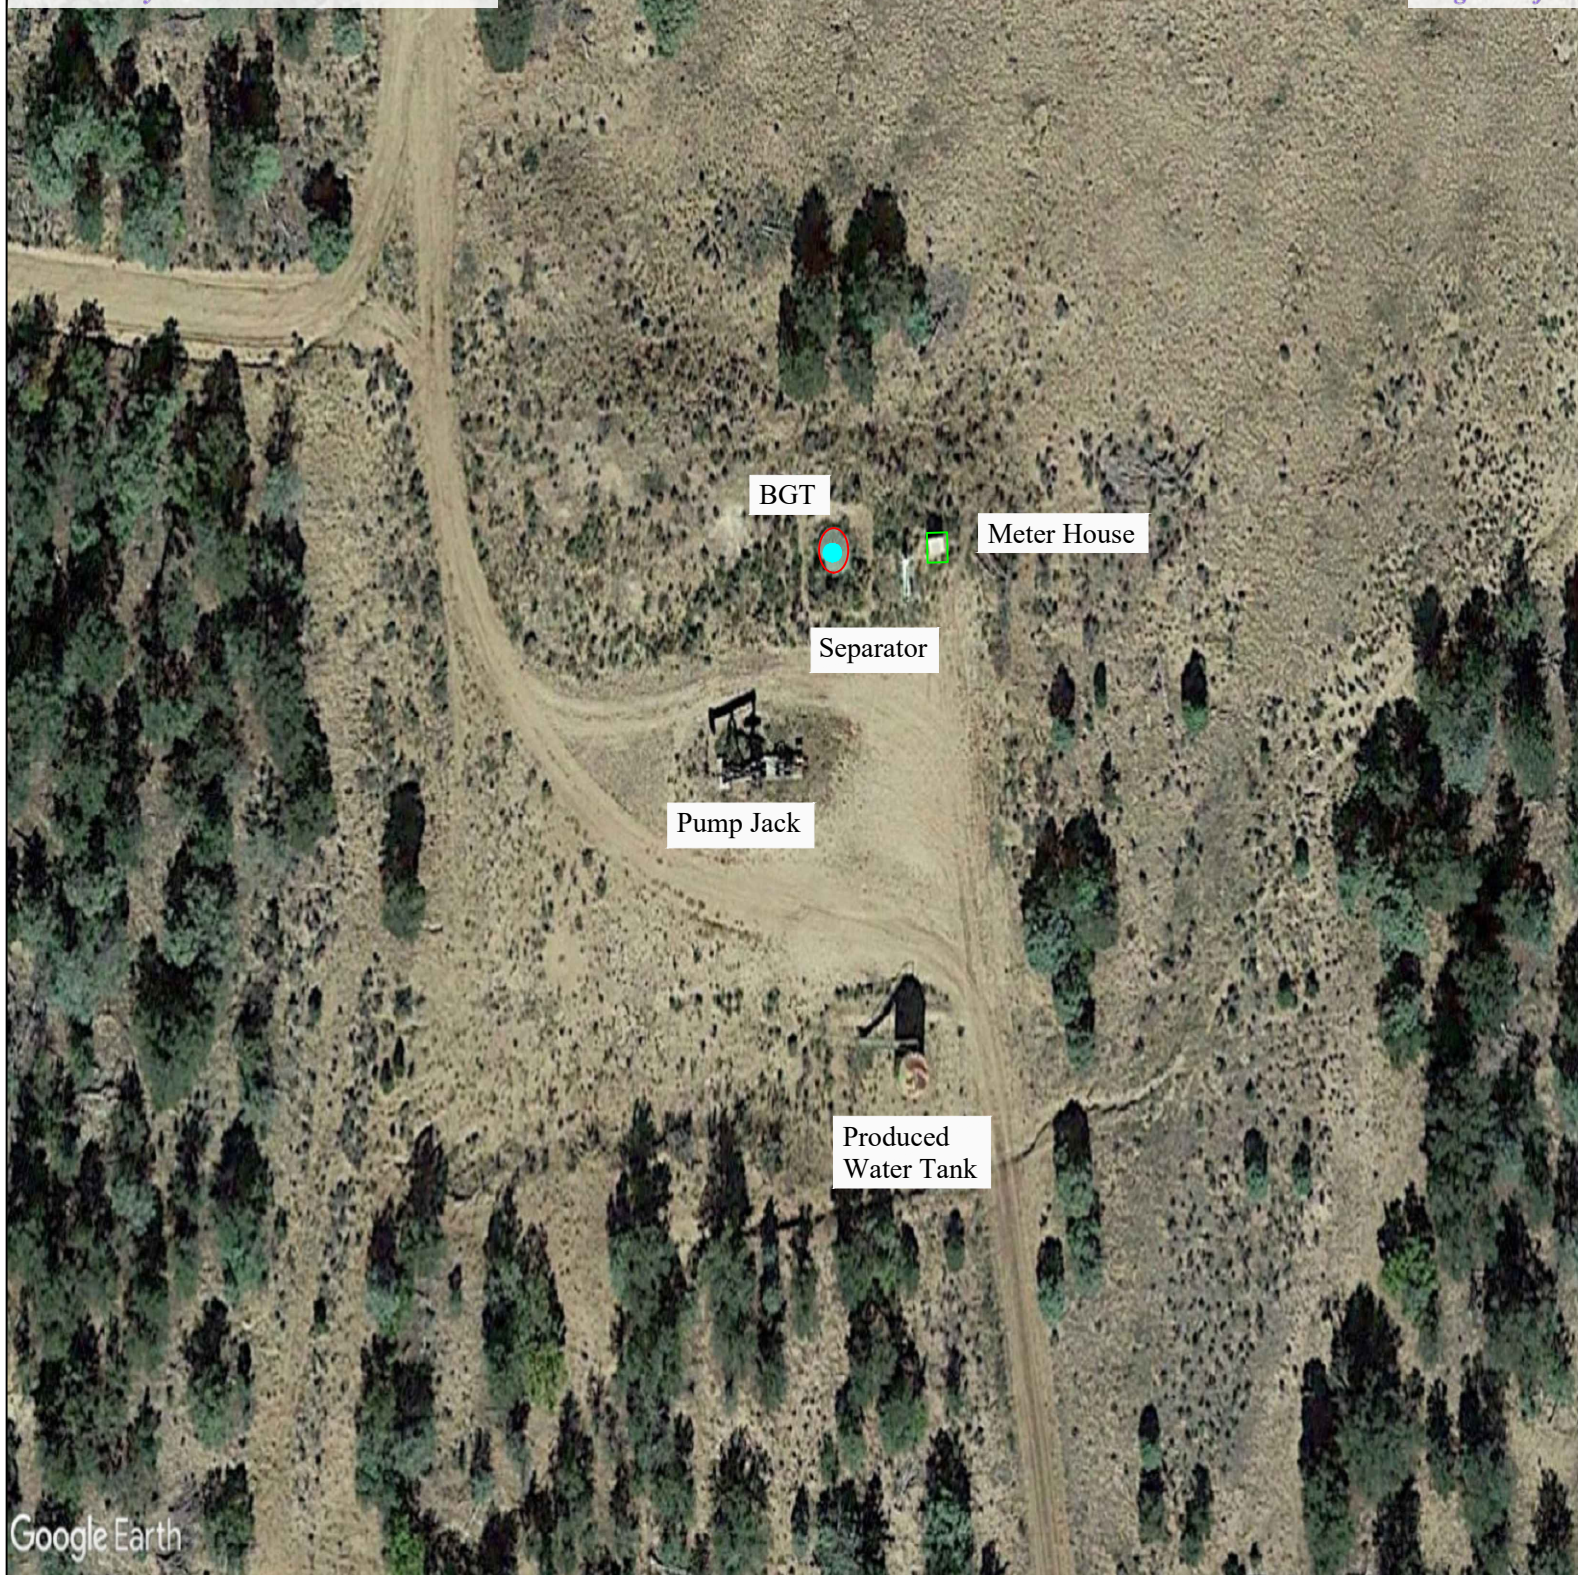
Figure 2, Site Map

The soil sample was placed into individual laboratory provided 4-ounce jars, capped head space free, and transported on ice to Envirotech Analytical Laboratory. The soil sample was analyzed for contaminants of concern identified in the table below. The soil sample location is illustrated in **Figure 2, Site Map** and in the attached **Site Photography**.

Sampling point represents a 5-point composite sample

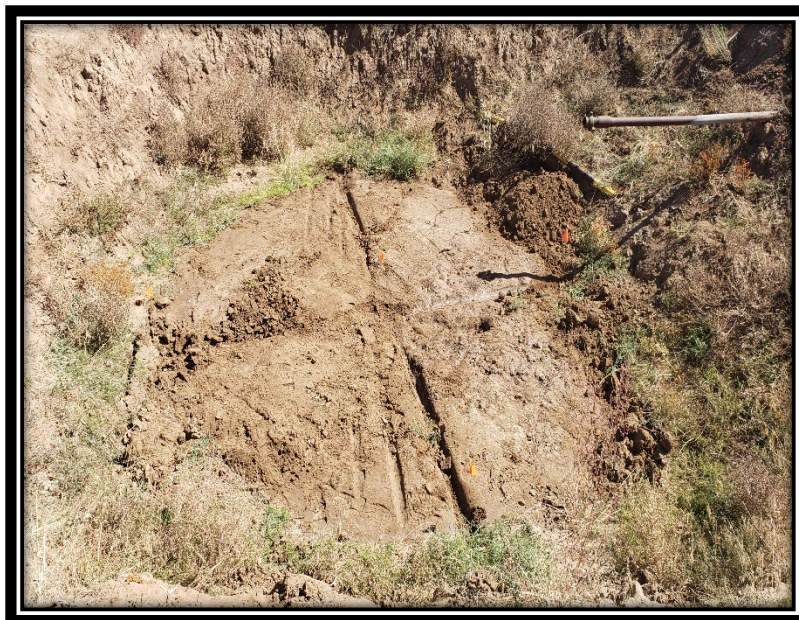
On October 9, 2019, DJR personnel removed the BGT and Envirotech personnel collected a five-point composite soil sample from the exposed surface for laboratory analysis.

Picture 2: Sample Points Below BGT

Based on laboratory analytical results, the concentrations of contaminants of concern were below the applicable release closure criteria and do not require further remediation actions; see **Table 1, Summary of Soil Analytical Results**.

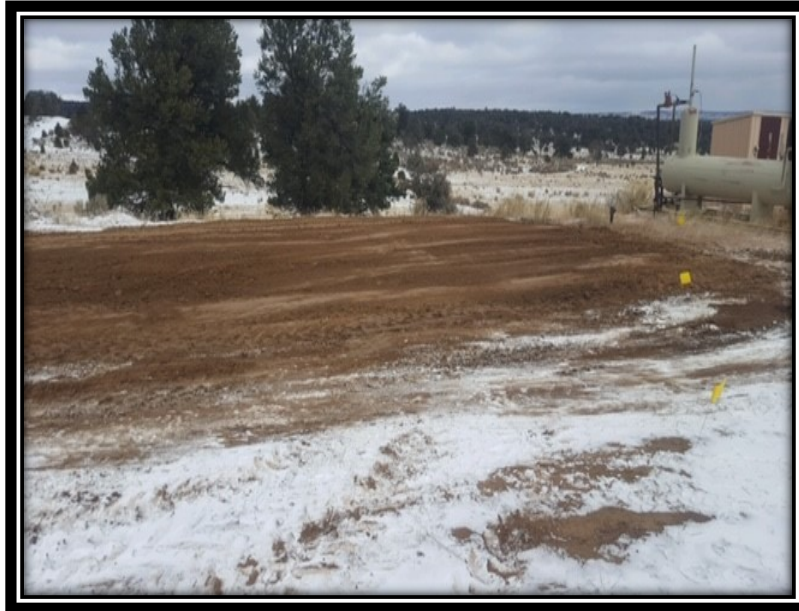
On October 9, 2019, Envirotech personnel completed confirmation sampling of soil beneath the BGT at the Sheila Hixon-001 well site. On November 26, 2019, DJR personnel backfilled and recontoured the location of the former pit. Final reclamation will be performed when the well site is plugged and abandoned. Based on the analytical results, Envirotech recommends requesting a **No Further Action** status from the NMOCD and JOGA regarding the BGT closure and subsequent release investigation.

Picture 3: Former Location of BGT
