**RE: LINER INSPECTION REPORT FOR THE ICE DANCER 30 FED COM #2 BATTERY
(NRM2024746183)**

Souder, Miller & Associates (SMA) is pleased to submit this letter report on behalf of Devon Energy Production Company (Devon) summarizing the liner inspection that occurred as a result of the Ice Dancer 30 Fed Com #2 Battery release. The site is located in Unit Letter A Section 31, T23S, R30E (N32.266909/W-103.913348) Eddy County, New Mexico, on federal land.

Devon Energy Production Company
Ice Dancer 30 Fed Com #2 Battery

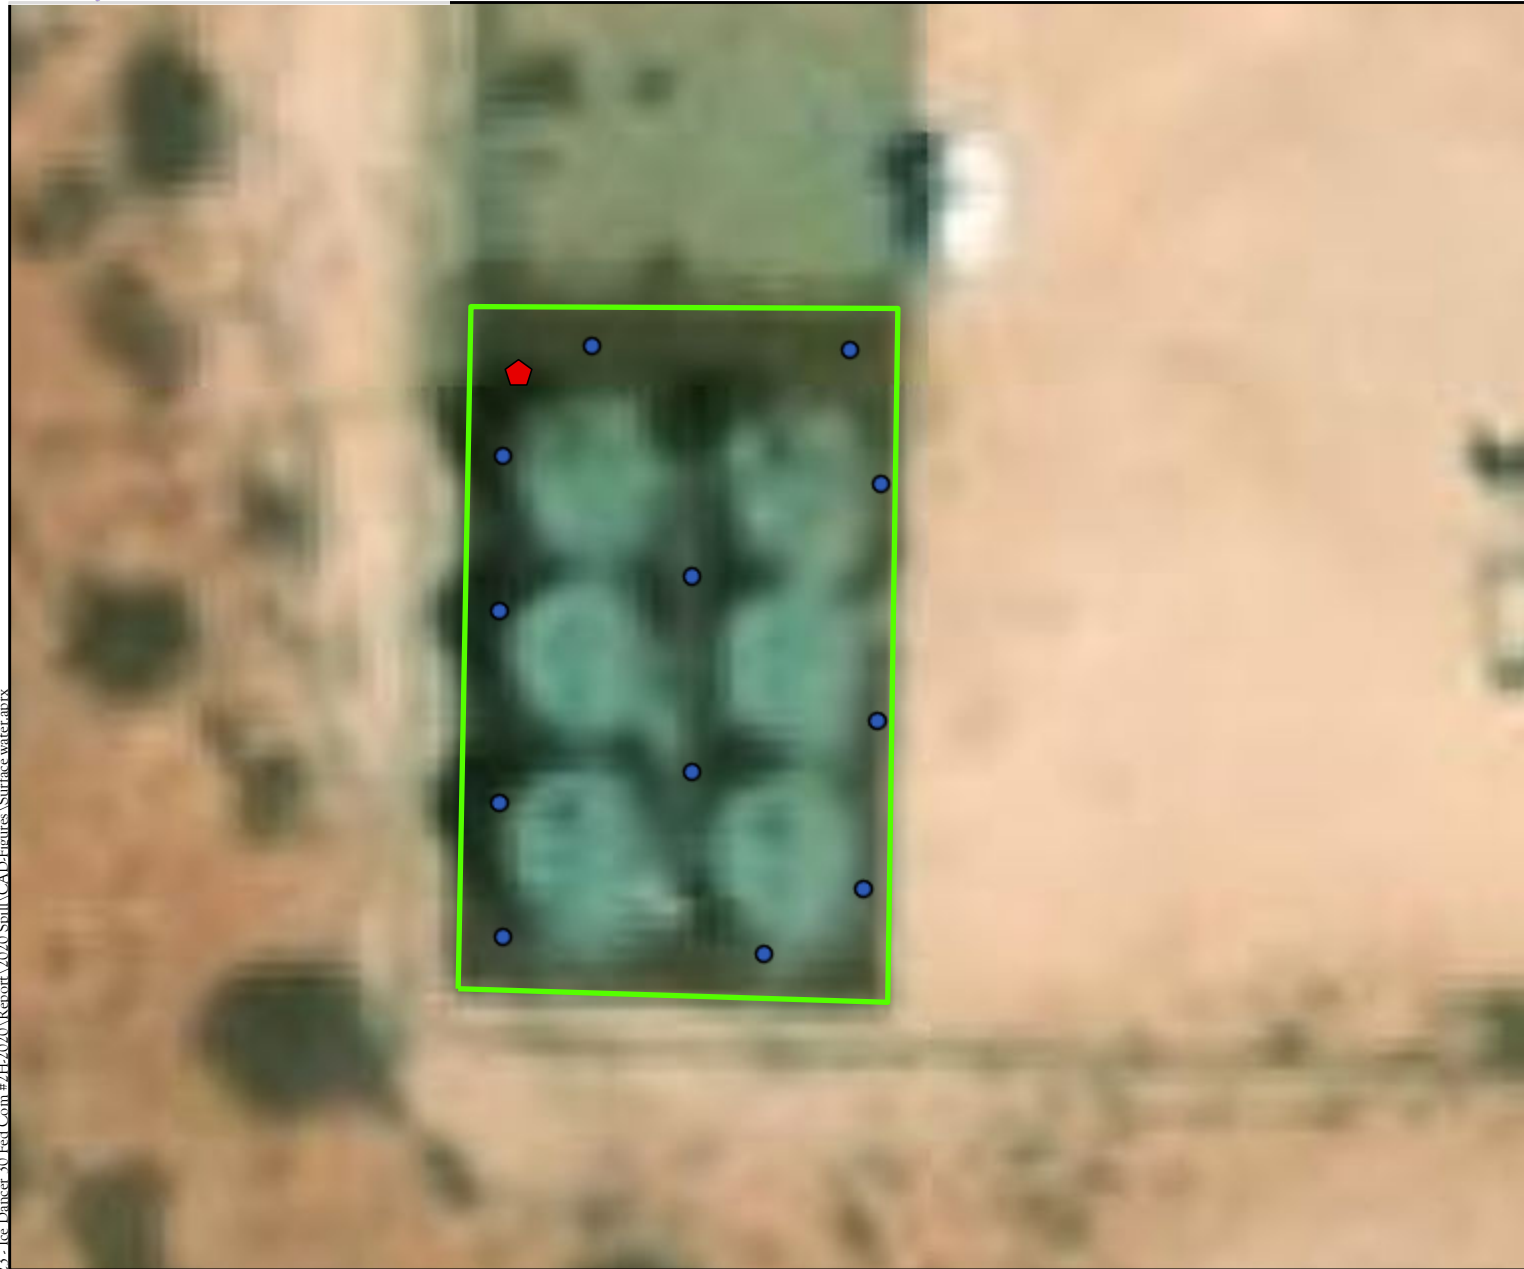
Based upon New Mexico Office of the State Engineer (NMOSE) depth to groundwater in the area is estimated to be 227 feet below grade surface (bgs). There are no water sources within ½-mile of the location, according to the NMOSE and USGS water well databases (https://gis.ose.state.nm.us/gisapps/ose_pod_locations/; accessed July 29, 2020; Appendix C). The nearest significant watercourses are two unnamed draws, located approximately 269 feet to the north and approximately 294 feet to the south. Figures 1 and 2 show the release location and surrounding hydrologic features. Figure 3 shows the location of the facility and the release.

Site and Sample Location Map
Ice Dancer Fed Com #2H Battery - Devon Energy Production Company
UL: A S: 31 T: 23S R: 30E Eddy County, New Mexico

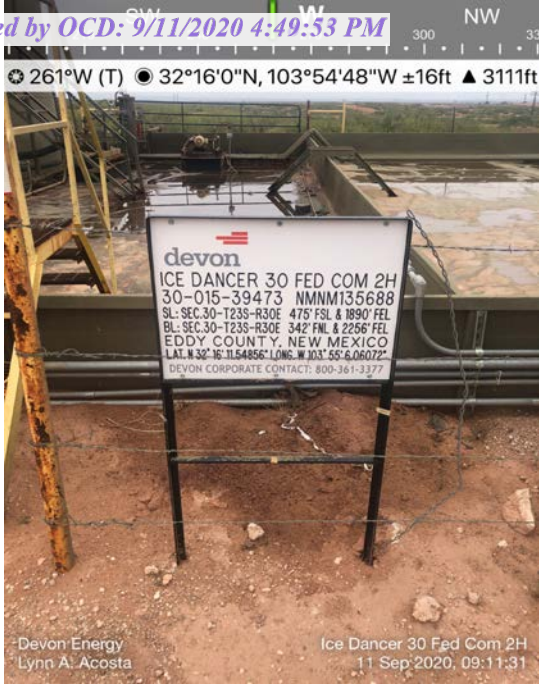
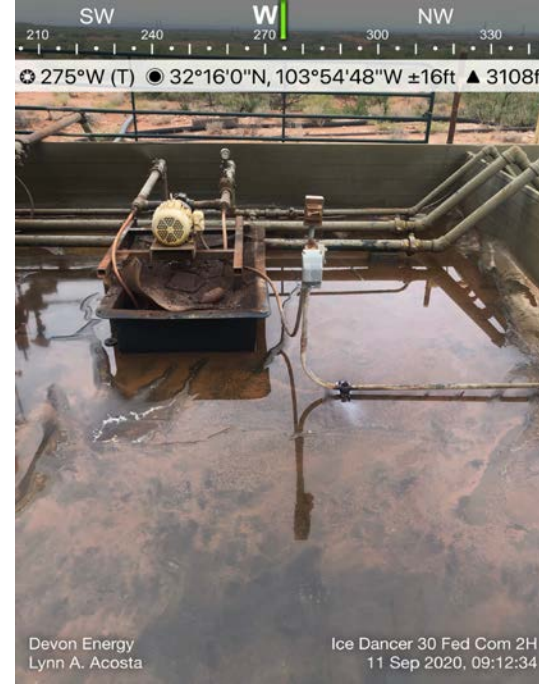
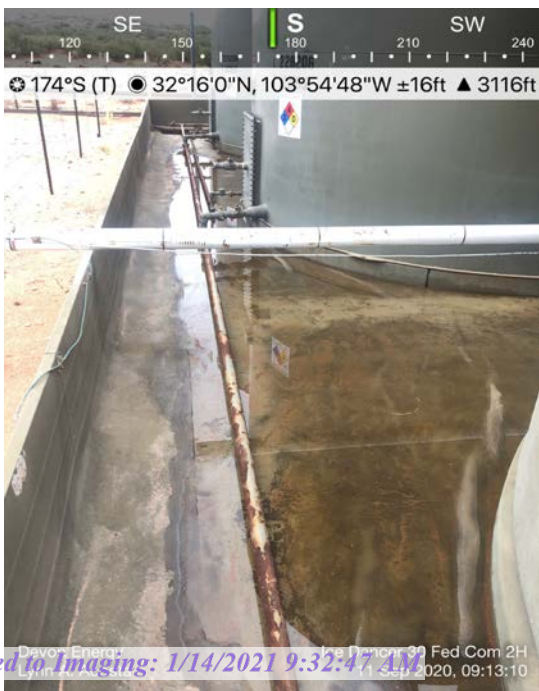
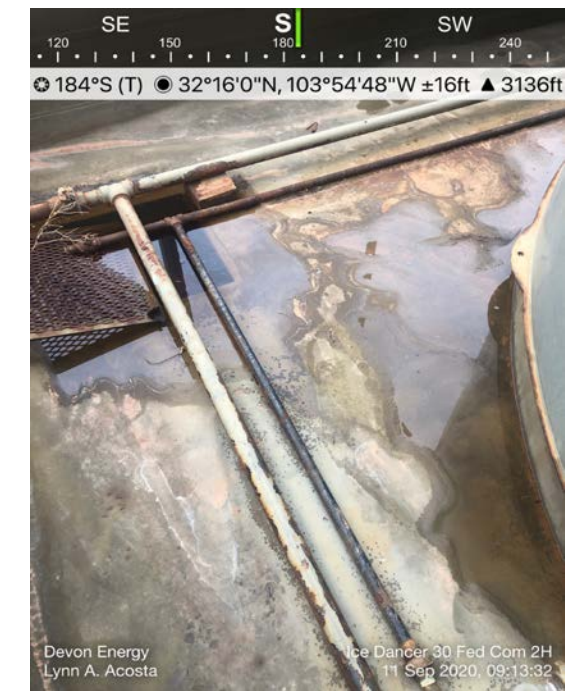
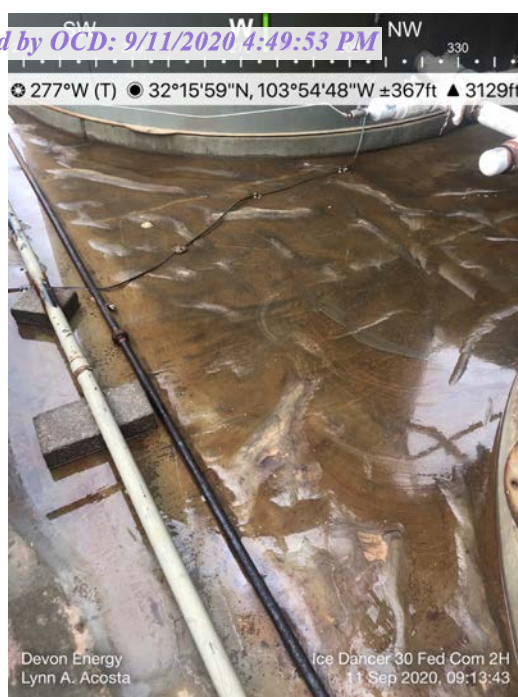
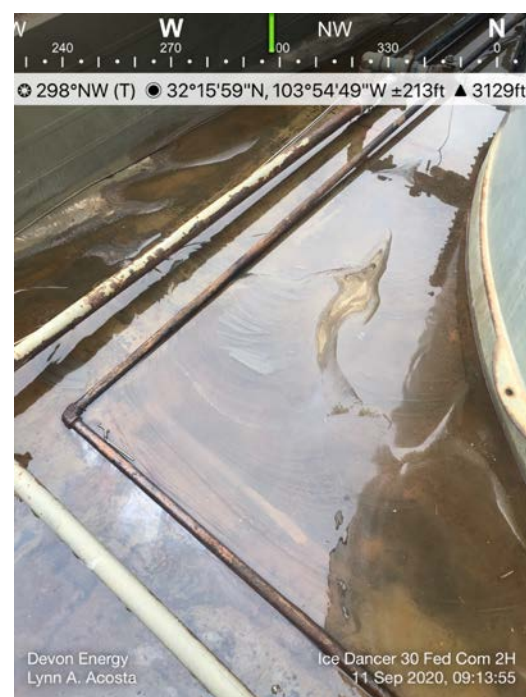
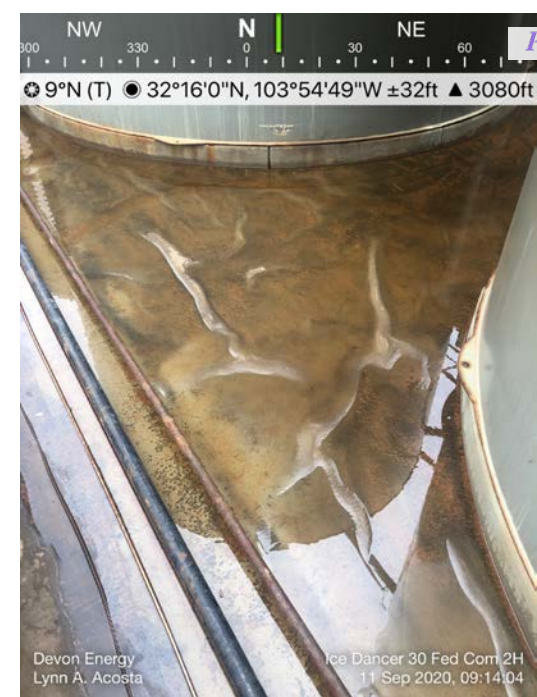
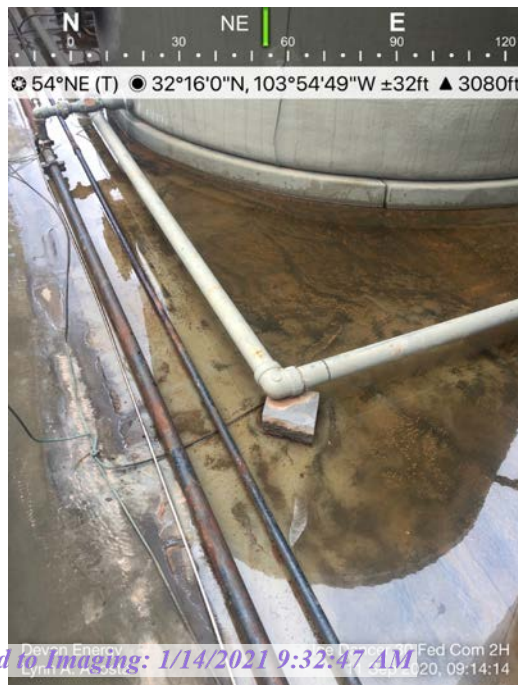
Appendix A
PHOTO LOG & FIELD NOTES

At the request of Devon, SMA conducted a liner integrity inspection per the requirements of 19.15.29.11.A(5)(a) NMAC. NMOCD was notified on September 8, 2020 that the liner inspection was to occur. After a thorough visual inspection of the liner within the tank battery containment, the liner appeared to be intact and had the ability to contain the leak in question and foreseeable future releases. The transfer pump from which the release occurred was identified, and SMA verified that the release did not occur outside of the lined containment. The containment did have standing water due to a recent rain event, supporting evidence of liner integrity. A photo log and field notes of the inspection is included in Appendix A.

- Arrived on site (8:30)
 - Will wait for NMOCB for 30 minutes, then begin inspection.
- Walked to POR and examined if release did in fact stay in containment
 - Release did stayⁱⁿ secondary containment.
- Began to walk containment and search for any tears or other potential compromises throughout containment.
 - No indication of failures were observed during ^{the} inspection of containment.
 - liner did remain intact
 - Water was present, showing liner was not compromised.
- Began to take photos of containment
- Mapped containment and geotagged photos, will includedⁱⁿ in report.
- left site

SMA recommends no further action for this release.
