## **Release Notification**

### **CLOSURE REPORT**

Lateral 2C-24 Pipeline Release NE ¼, S11 T24N R5W Rio Arriba County, New Mexico

February 21, 2020 Ensolum Project No. 05A1226078

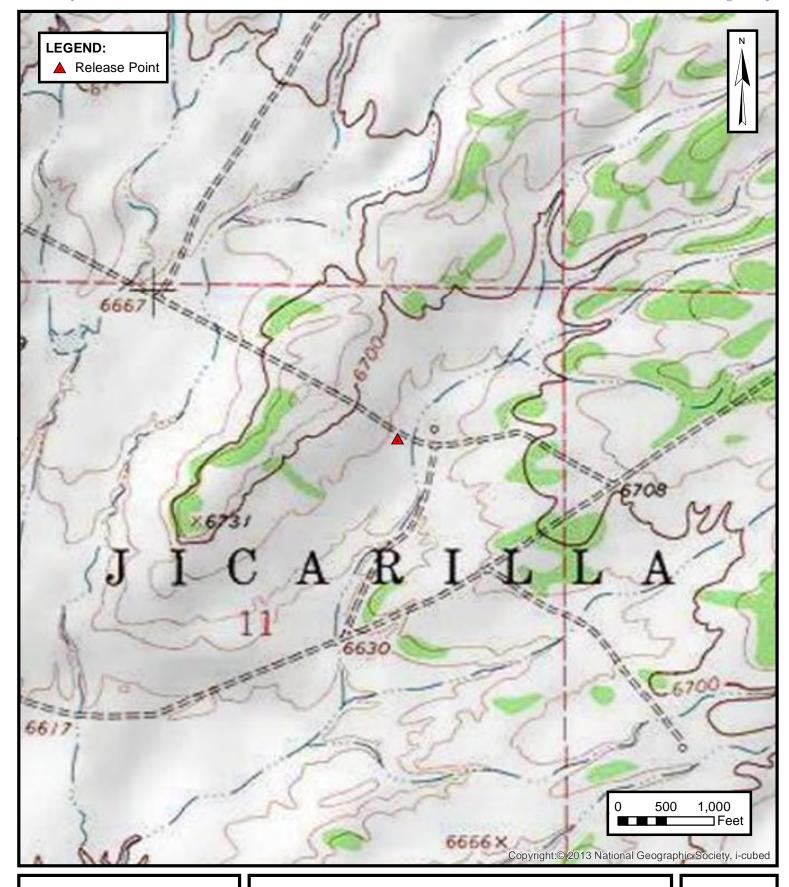
1

### **TOPOGRPAPHIC MAP**

A **Topographic Map** depicting the location of the Site is included as **Figure 1**, and a **Site Vicinity Map** is included as **Figure 2** in **Appendix A**.

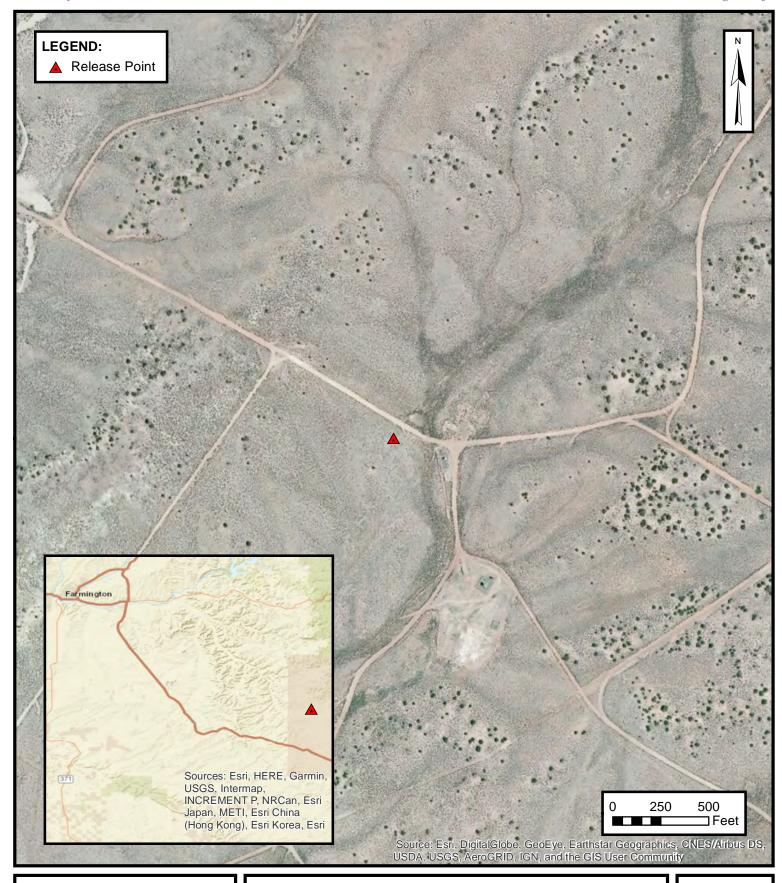
2

### SITE VICINITY MAP

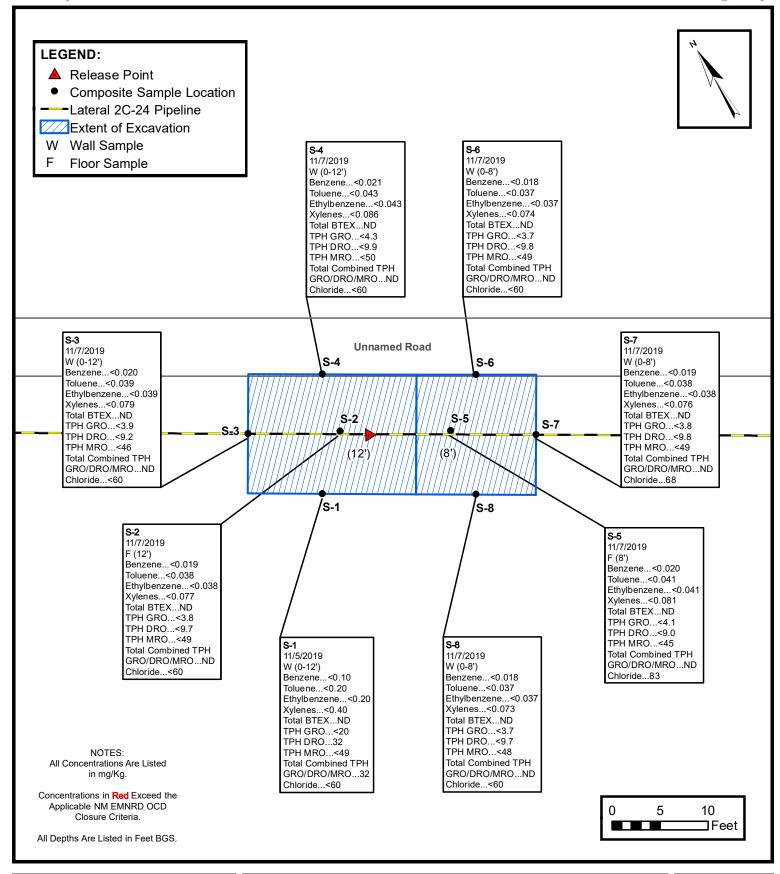
3

**Figure 3** is a map that identifies approximate soil sample locations and depicts the approximate dimensions of the excavation with respect to the pipeline (**Appendix A**). Photographic documentation of the field activities is included in **Appendix C**.

### **SITE MAP**

The final excavation measured approximately 30 feet long and 12 feet wide at the maximum extents. The floor of the excavation measured approximately 12 feet below ground surface (bgs) at the maximum extent.

Ensolum's soil sampling program included the collection of eight (8) composite soil samples (S-1 through S-8), comprised of five (5) aliquots each, from the remediation area for laboratory analysis. Hand tools and an excavator, operated by Sierra, was utilized to obtain fresh aliquots from the excavation. A JANEPO representative was on site to witness the sampling event.

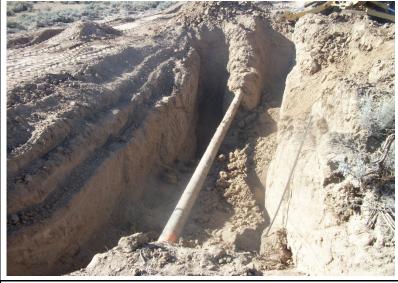
### Photograph 1

Photograph Description: View of in-process excavation activities.

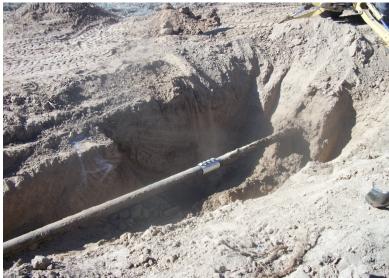
## Photograph 2

Photograph Description: View of in-process excavation activities.

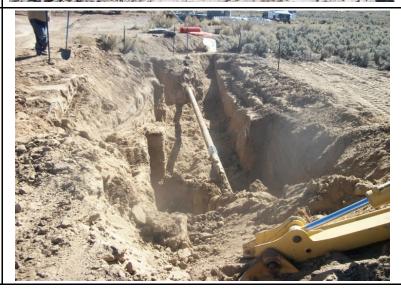
### Photograph 3

Photograph Description: View of the final excavation.

A total of approximately 184 cubic yards (yd³) of petroleum hydrocarbon affected soils were transported to Envirotech landfarm near Hilltop, New Mexico for disposal/remediation. The executed C-138 solid waste acceptance form is provided in **Appendix B**. The excavation was backfilled with imported fill and then contoured to the surrounding grade.
